File No. 14-0107-036

RE: Alexander Dock
Inspection and Condition Assessment, Final – Rev 0

ALEXANDER DOCK

CONDITION ASSESSMENT PLAN

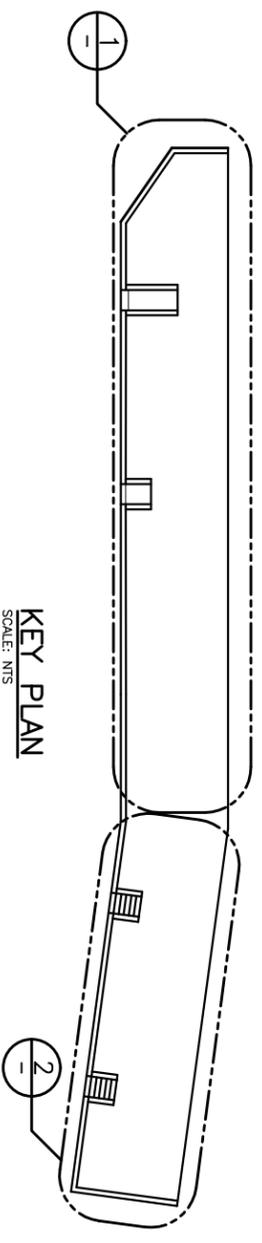
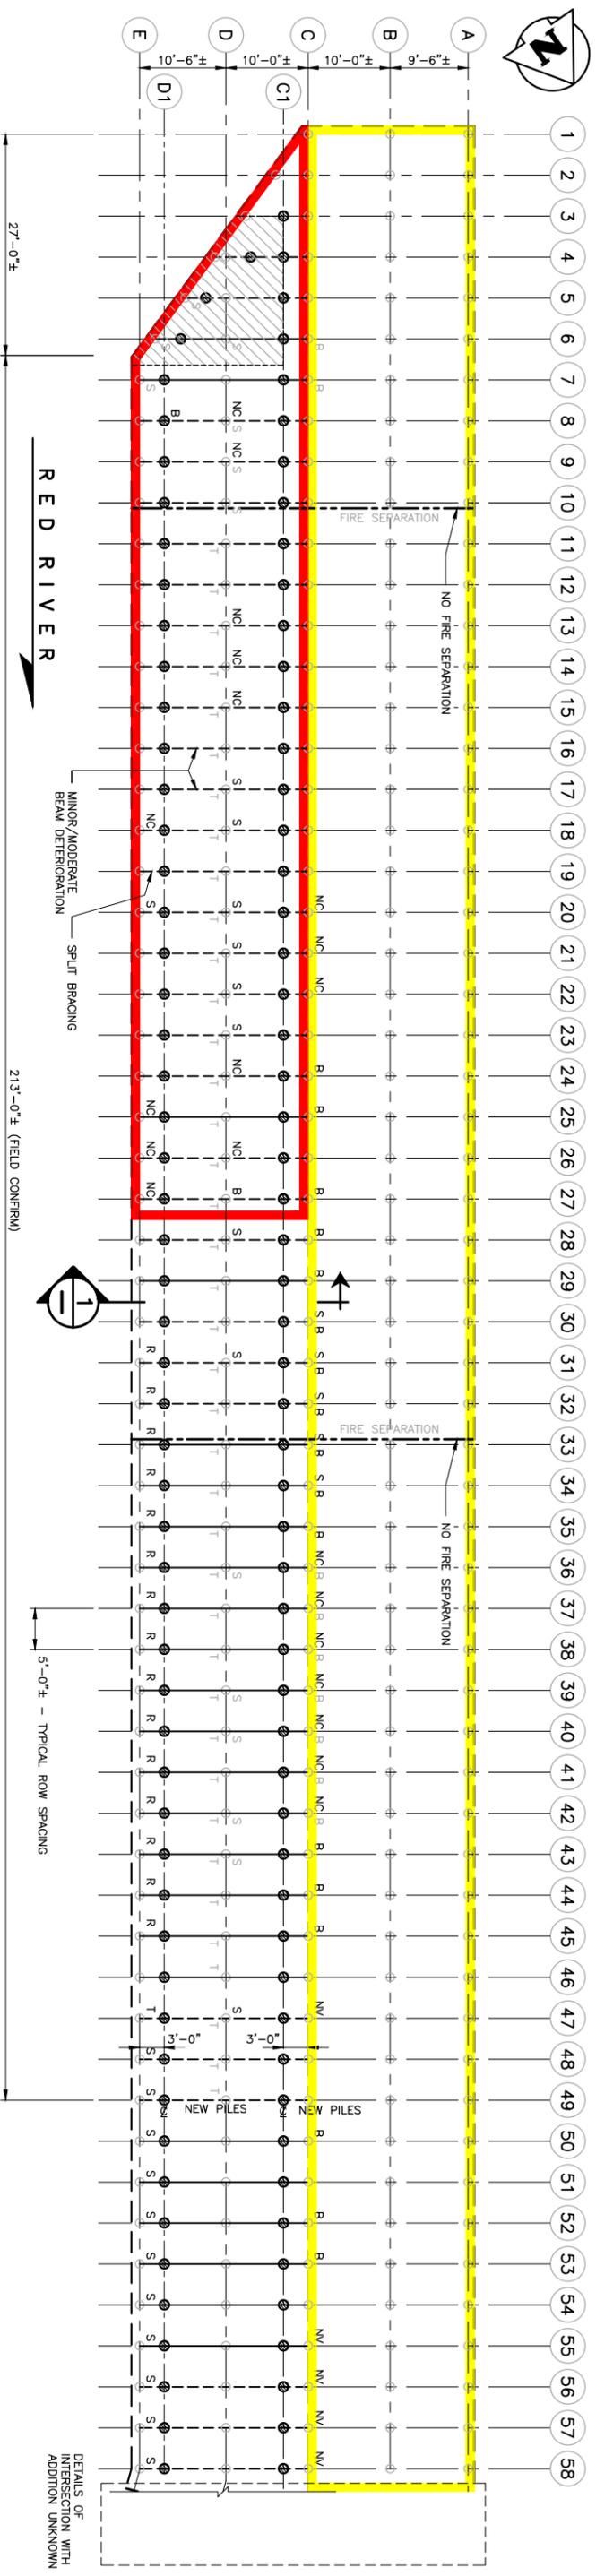
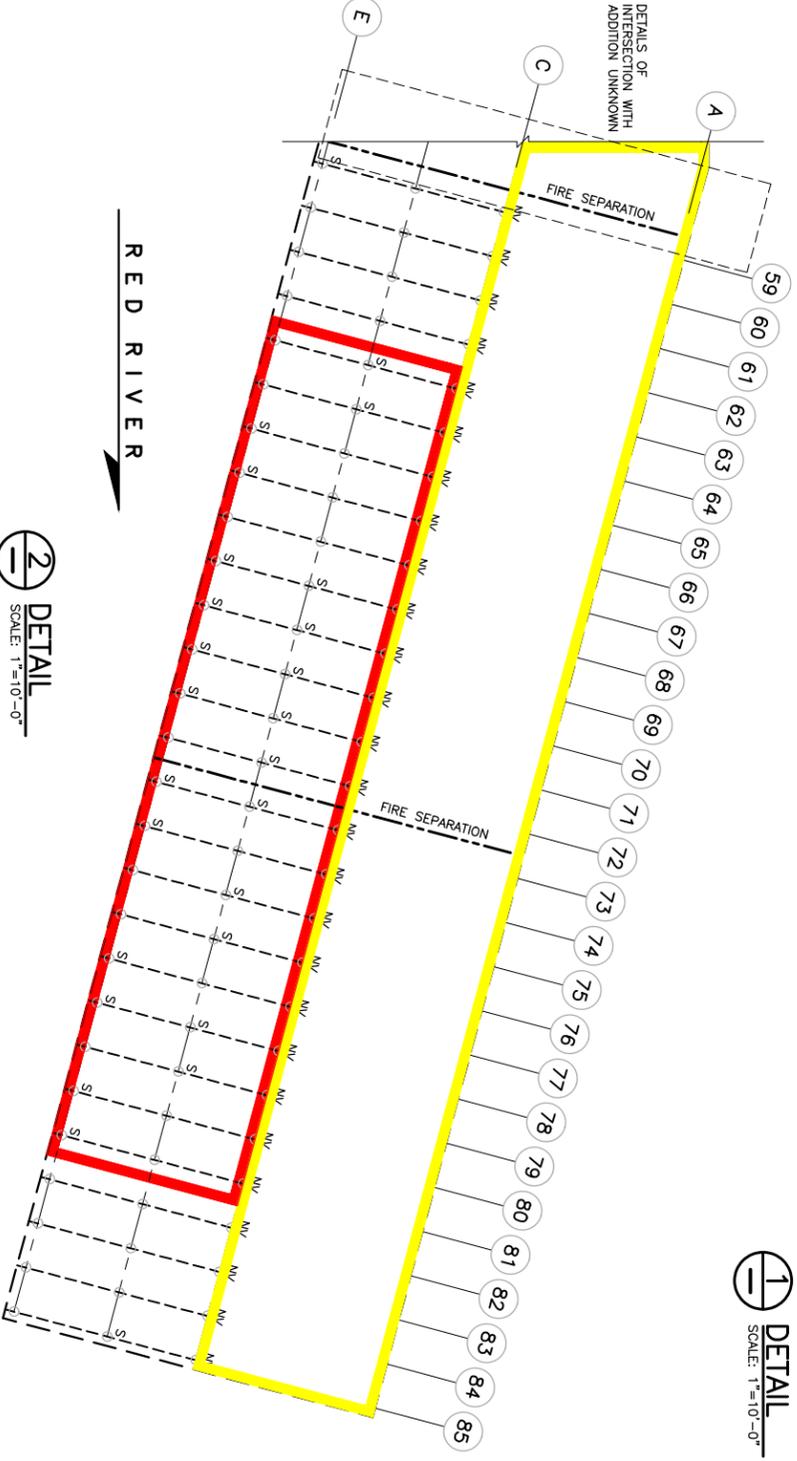
The visual inspection of the structure was performed by Mr. N. Kyriakopoulos, P.Eng. The inspection was planned in two stages with the top side assessment to be completed in late fall of 2014, before winter snow would cover the large deck surface and a second underside inspection to be conducted once river levels dropped to seasonal lows and riverbank ground freezing allowed safe access. The inspection of the top surface of the timber deck and waterside skirting of the Alexander Dock was performed on November 5, 2014. The inspection of the accessible areas of the underside of the timber deck and substructure was performed on February 6, 2015. Figure 1 summarizes the assessment observations for the underside inspection.

deterioration in wet conditions. The approximate lengths of deterioration are provided in Figure 1.

In general, the original timber piles were in poor to severely deteriorated condition while the timber piles installed during the 2004 rehabilitation were still in good condition. The dock structure is supported on 451 timber driven piles as shown on Figure 1. Of these, only 164 are visible for inspection. 287 of the 451 are mostly or entirely encased in the riverbank and not accessible for a condition assessment. Of the 164 piles inspected, approximately 55% are no longer supporting the structure as intended with a summary of compromised condition as follows:

- Photo 21 displays the typical condition of the piles installed after the 2001 KGS Group report and the 2004 rehabilitation work.
- Several piles were found to be significantly inclined (Photo 22). These piles are marked with a "T" on Figure 1.
- Several piles were also found to be split, to varying degree. Photo 23 displays a typical split pile. These piles are marked with a "S" on Figure 1.

- If no corrective actions are taken to rectify the deficient areas, the City of Winnipeg should consider closing off the dock structure. The City of Winnipeg may consider the implementation of "loading lanes" for riverboat operation that could be cordoned off on the dock, such that the deteriorated areas outlined on Figure 1 are not accessible. The location and details of access corridors would require further evaluation.

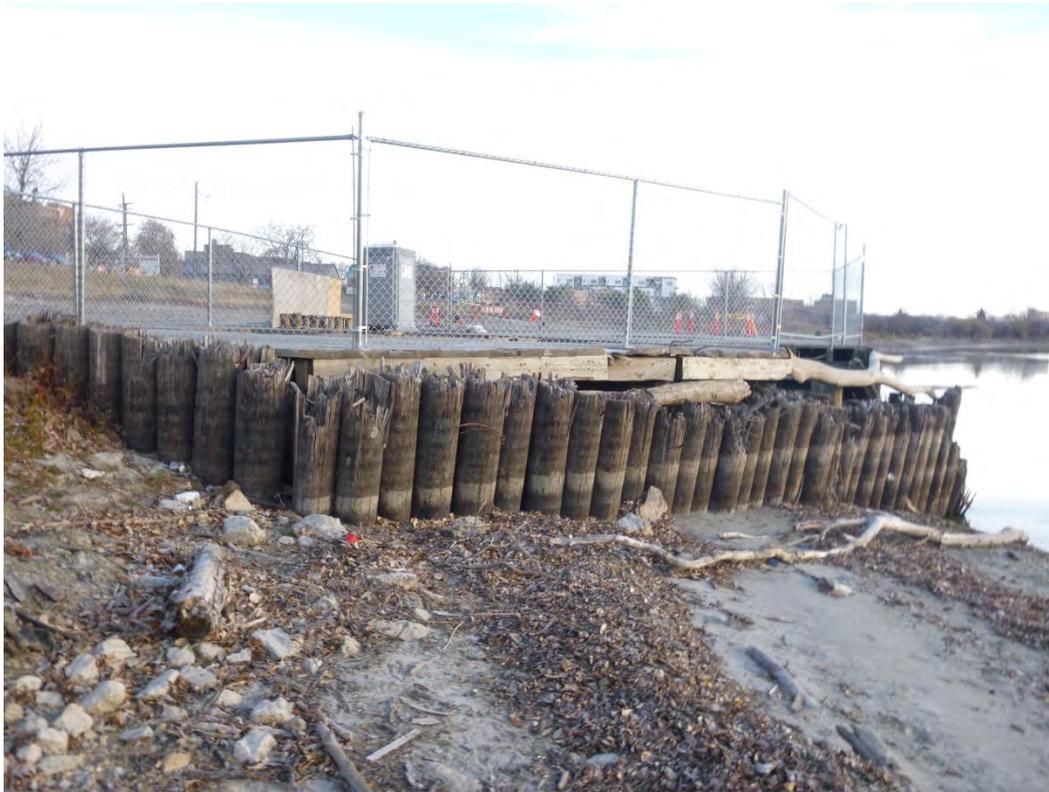
- Photo 1 displays the extent of the ice damage on the upstream end of the dock. This portion of the structure is severely damaged.
- Photo 2 is an overview of the waterside skirting along the structure. It can be seen that large areas of the waterside skirting has been damaged due to river-ice impact and long term

Photo 1 – South waterside skirting damage due to river ice

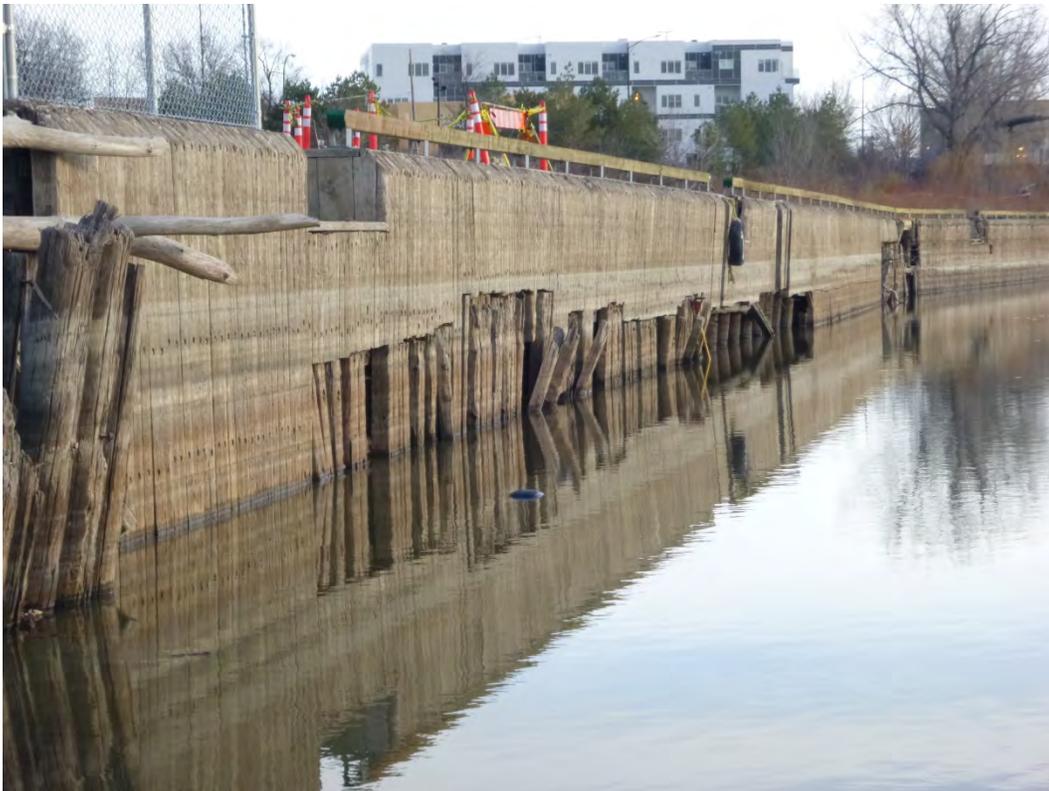
Photo 2 – East waterside skirting damage due to river ice erosion

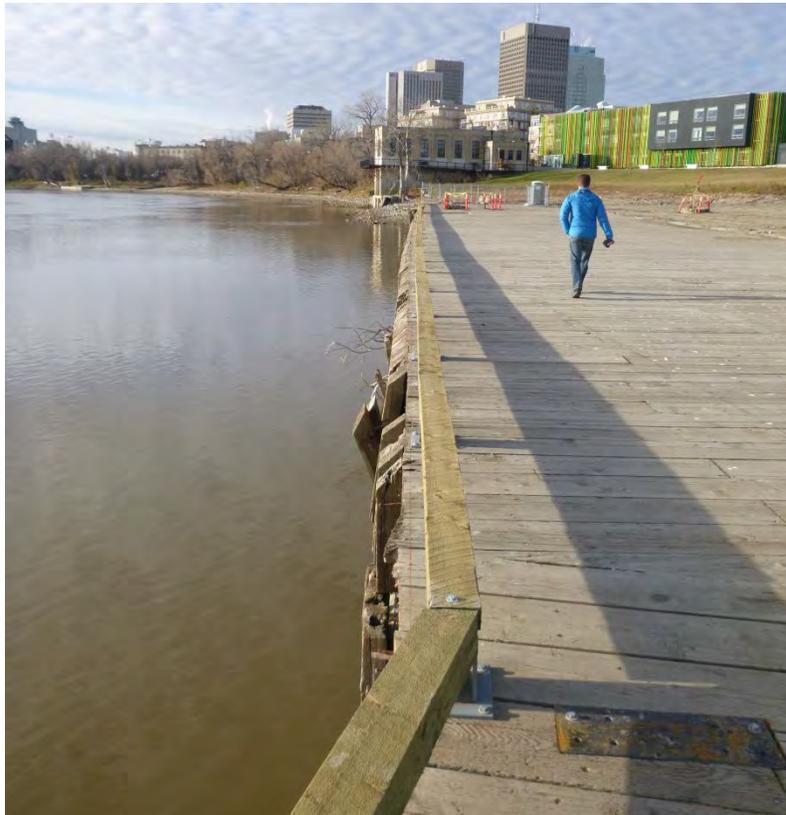
- Photo 3 shows the general deflection (or bulging) near the middle of Section 1, likely the result of historical riverbank movement. This movement was noted in previous reports and does not appear to have visibly advanced since the dock structure was last rehabilitated. However, due to the tolerance of the wood structure construction and damage to localized areas, meaningful survey of the structure alignment to compare with the previous assessment was not possible.
- Photo 4 displays the extent of the ice damage along the South half of the skirting.
- Photo 5 shows the North face of Section 2 with damage in the upper left corner, likely the result of long term rot and disintegration.

Photo 3 – Longitudinal view of Section 1 skirting showing horizontal deflection

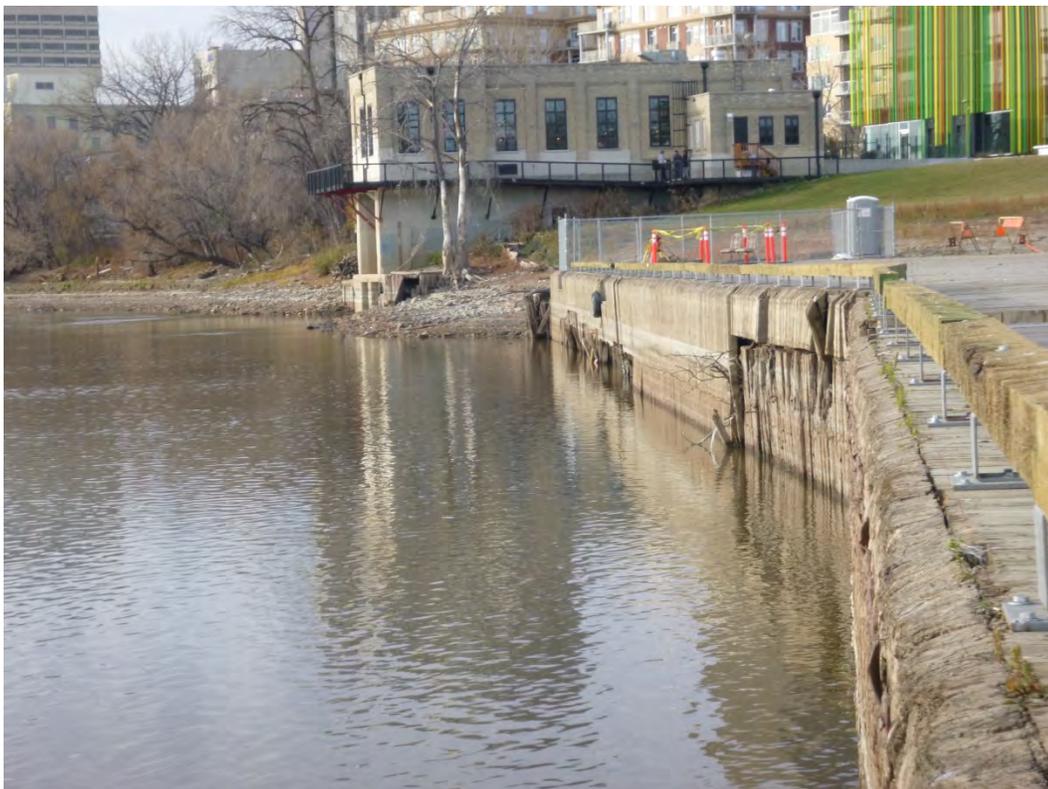
Photo 4 – View of deteriorated waterside skirting from the North end of Section 2

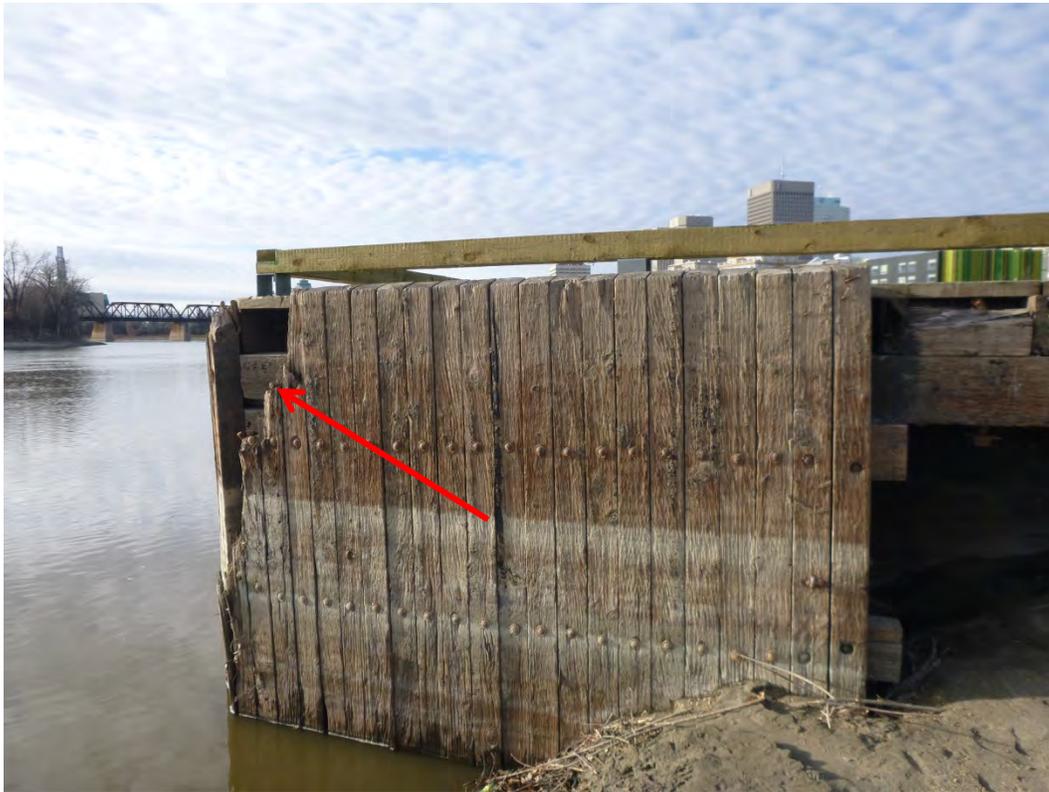
Photo 5 – North face of Section 2 with damage in upper left corner

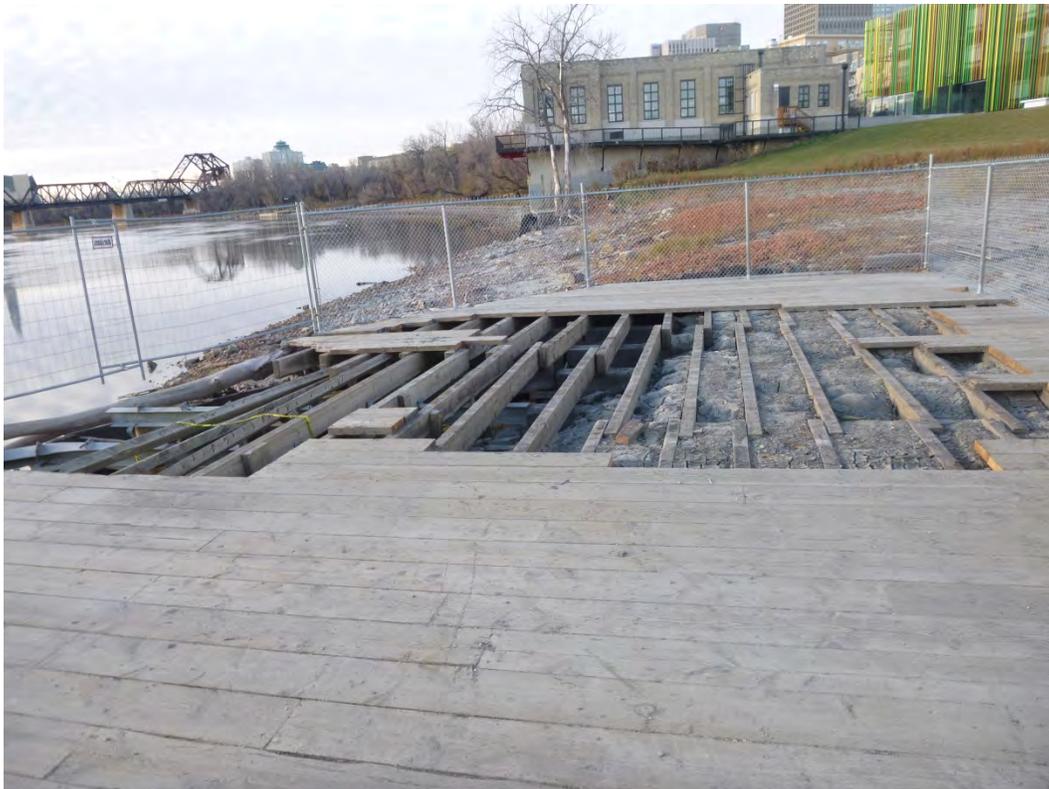
- Photo 6 shows the South end of the deck where several planks have been recently removed for remedial works. The exposed area shows that nearly half of the deck width is resting directly on the embankment material while the other half-width is supported by the deck stringer beams. In the upper riverbank areas it is not possible to determine the condition of beams and piles encased in the riverbank.

Photo 6 – South end of deck with exposed area for remedial works

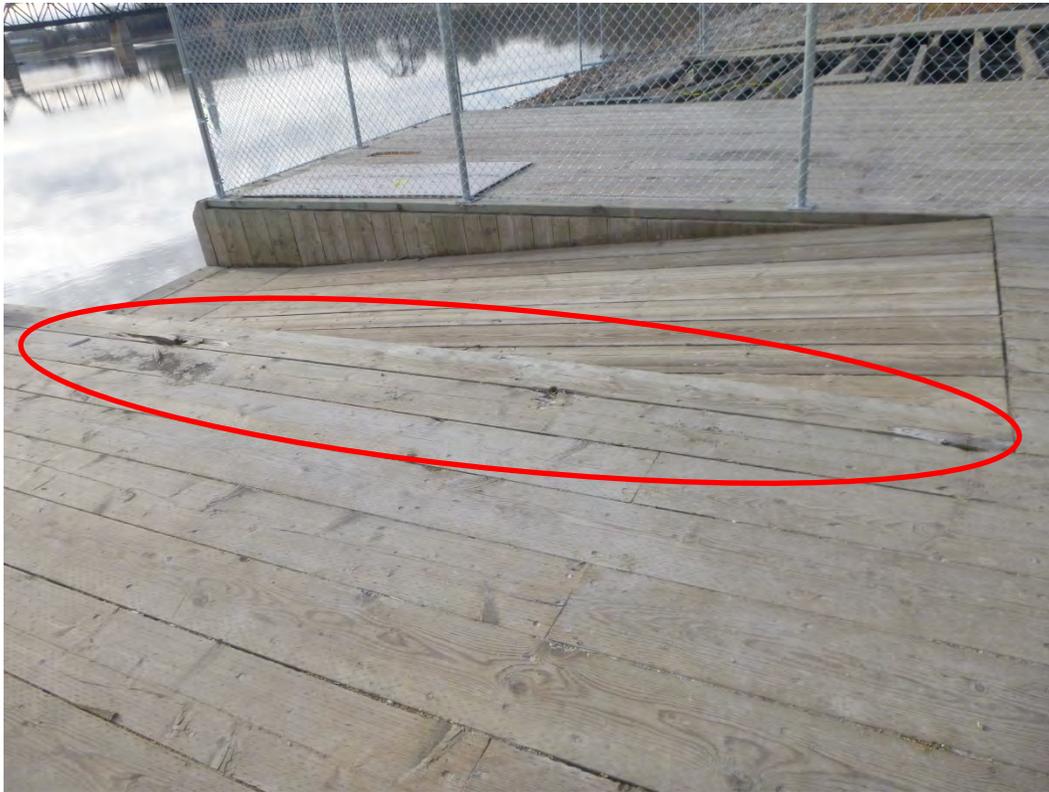
- Photo 7 identifies two planks adjacent to the Southern-most slipway that require replacement. The boards have developed notches that present trip hazards.

Photo 7 – Two planks adjacent to South slipway that require replacement

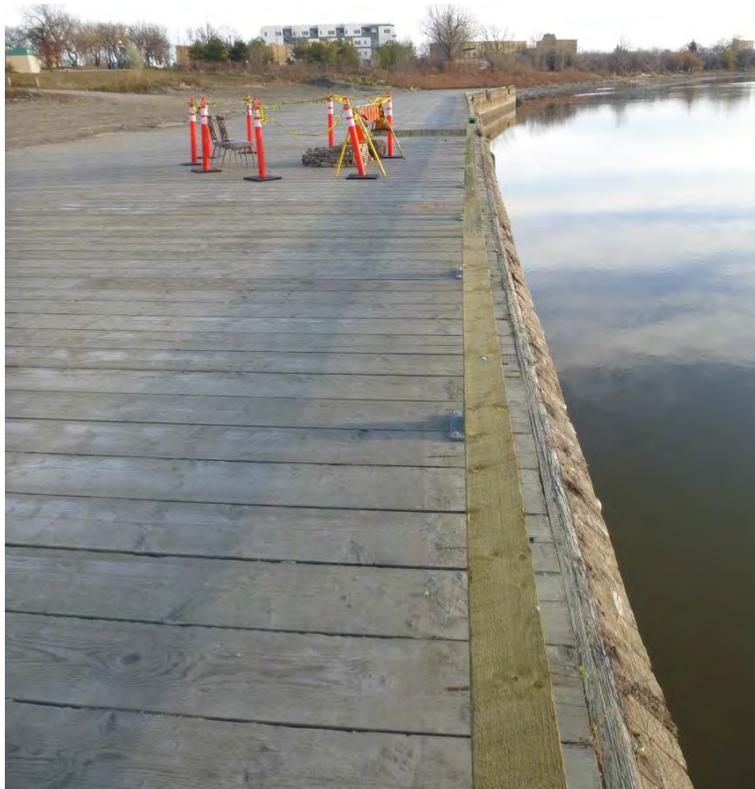
- Photo 8 presents an overall view of the deck just North of the Southern-most slipway. This overall view displays the generally good condition of the deck timbers and the recently replaced perimeter timber curb.

Photo 8 – Overall view of deck looking north; taken just north of South Slipway

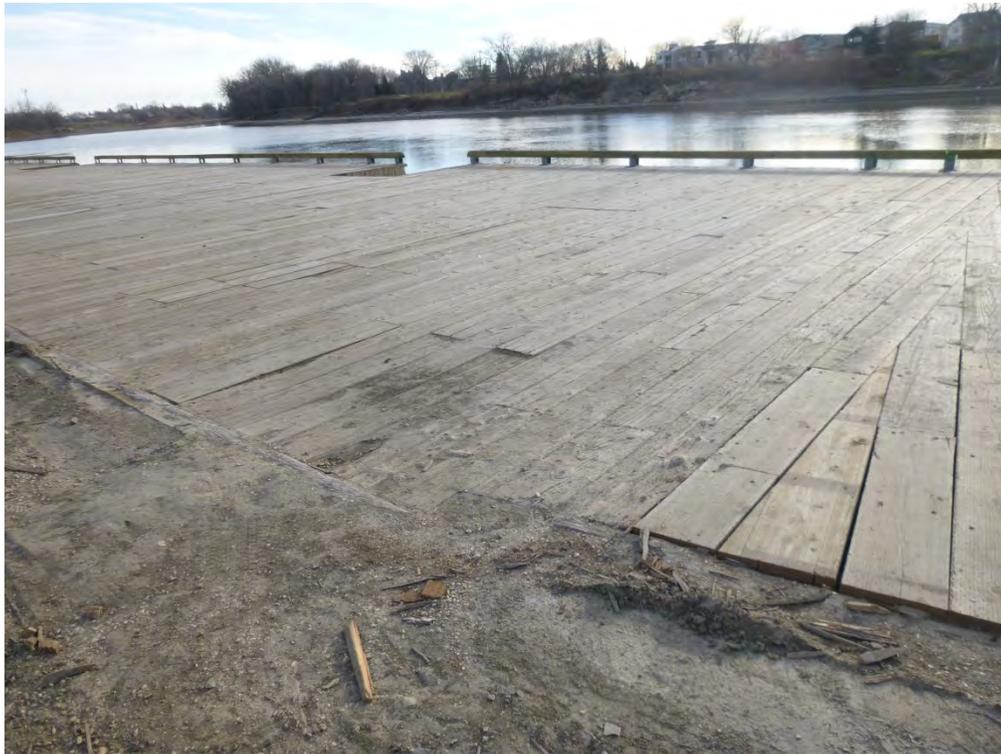
- Photo 9 identifies a depressed area, of approximately 4 m in diameter, where the deck planks, or their supporting structure, have deteriorated (softened) and settled. This deck area is likely no longer supported on structurally sound stringers, beam and/or piles.

Photo 9 – Area of depressed and deteriorated planks opposite bend marking transition between Section 1 and Section 2, approximately 4.5 m in diameter

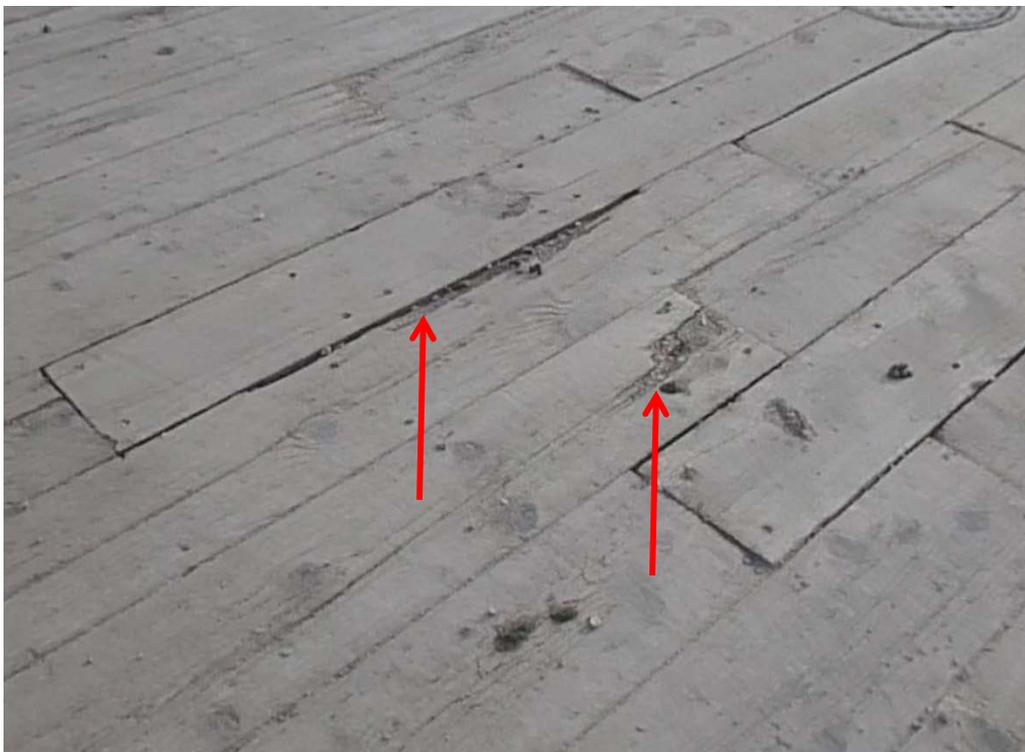
- Photo 10 displays a localized example of planks that have deteriorated and developed notches that present trip hazards. There are approximately a dozen instances of similarly-deteriorated planks throughout the structure.

Photo 10 – Plank deterioration resulting in a trip hazard near the Section 1 / Section 2 transition

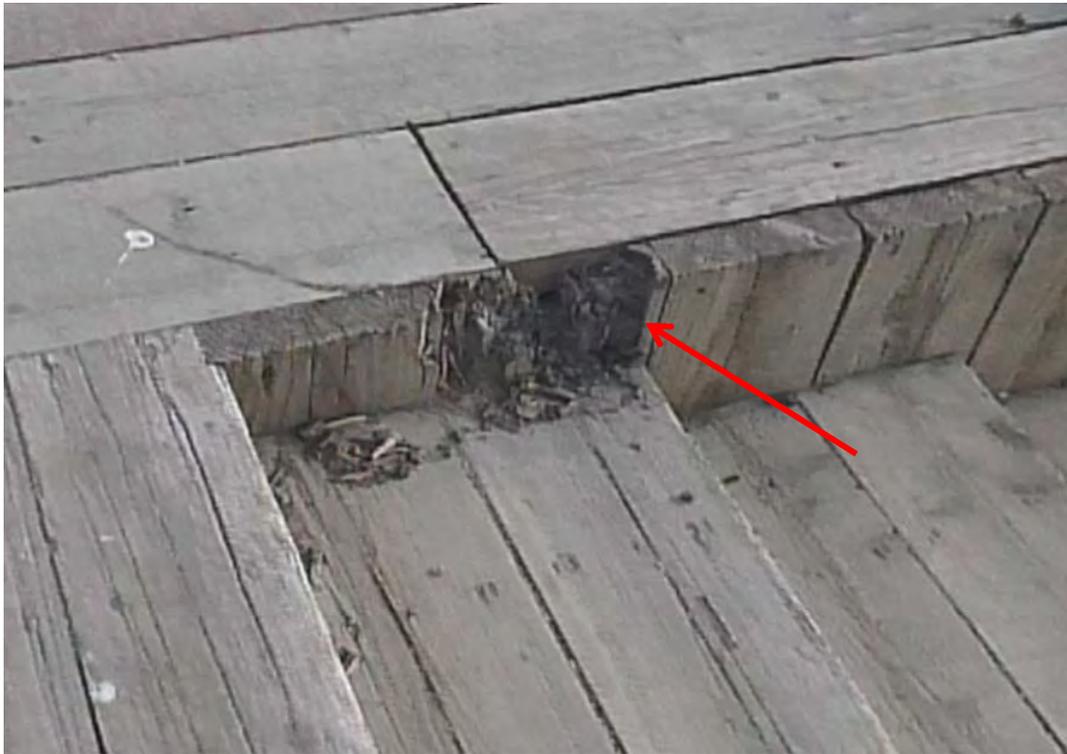
- Photo 11 displays a non-structural side-plank of the Southern Section 2 slipway that may present a trip hazard.

Photo 11 – Deteriorated plank at southern Section 2 slipway

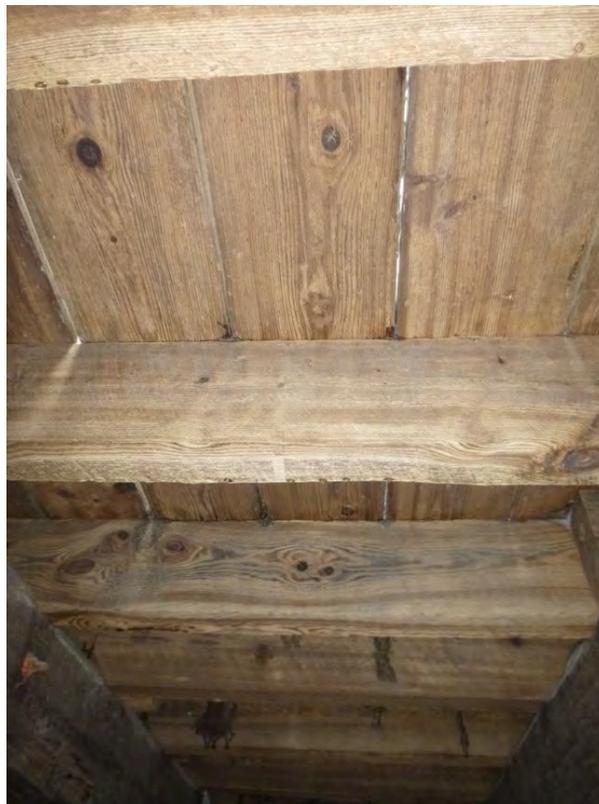
In general, the deck and the stringers (that were visible) were all in fair to good condition. No visible deterioration or warping was noticed. Photo 12 shows a typical view of the underside of the deck with stringers. Nearly half (the West side) of the dock supporting structure including stringers, beams and piles is encased in the riverbank and not visible for inspection.

Photo 12 – Typical underside view of decking and stringers

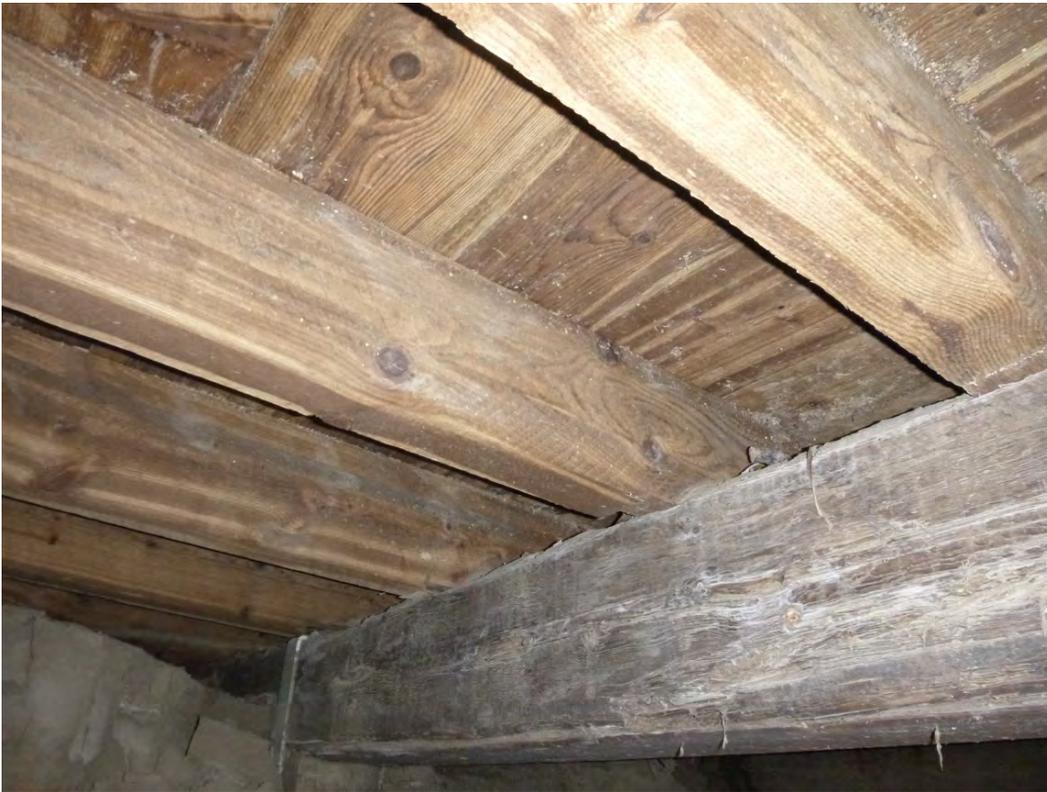
- Photo 13 displays the typical condition of a timber pile cap beam.
- The timber beams along lines 16 and 17 were noted to be in a deteriorated state. Photo 14 shows the beam along line 17.

Photo 13 – Typical condition of timber pile cap beam

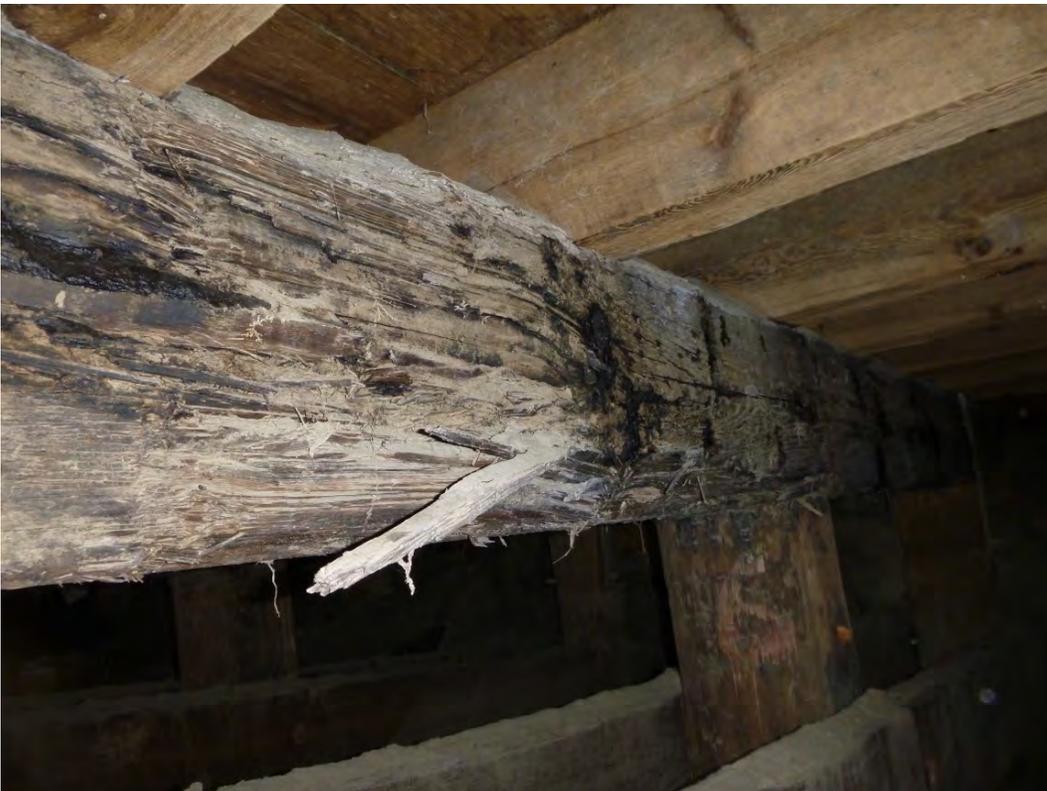
Photo 14 – Deteriorated pile cap beam at line 17

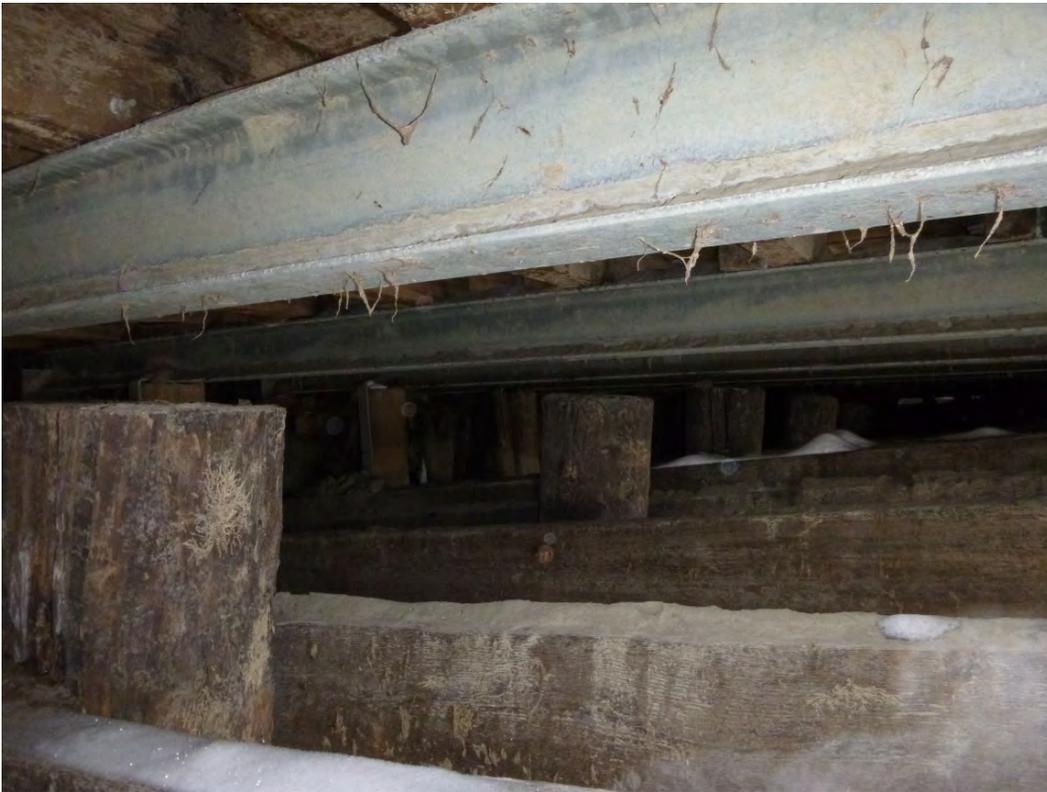
- With the exception of the damaged and deformed steel W200x27 sections on the upstream (South) end of the dock (where the decking is currently removed), the remainder of the W200x27 sections were in good condition, as shown in Photo 15.

Photo 15 – Typical steel W200x27 girder

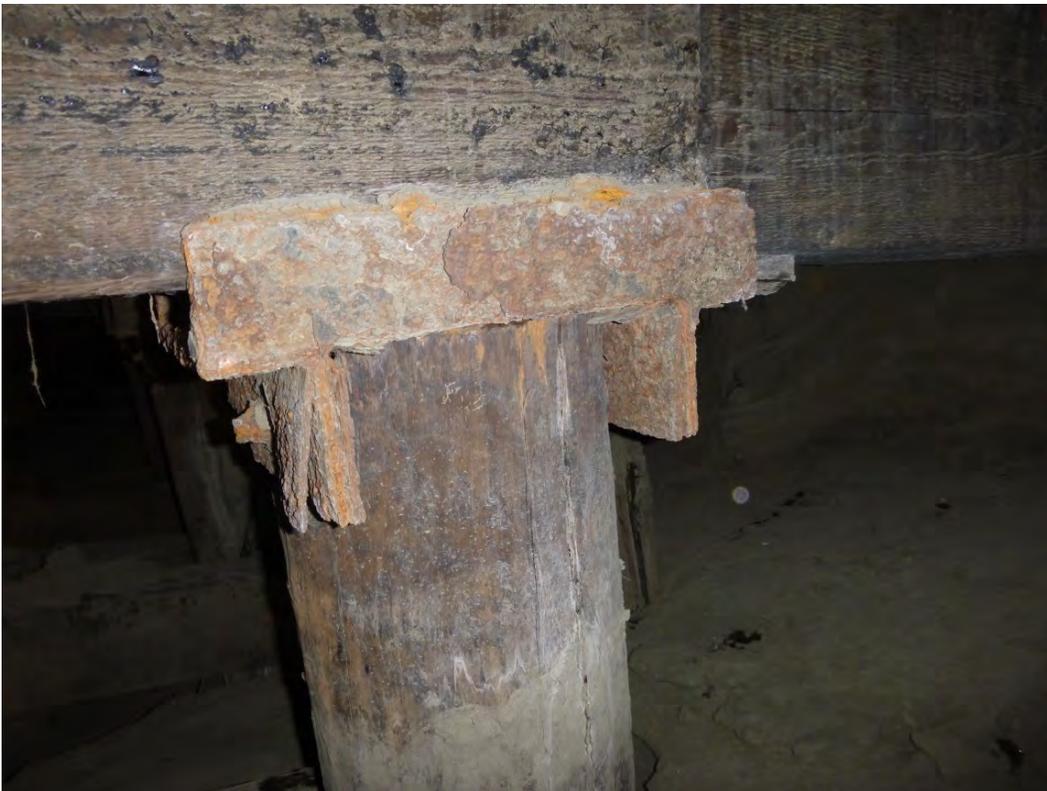
- Many of the steel bearing seats that were installed as part of the original construction phases, prior to the 2001 KGS Group report, were severely deteriorated, as shown in Photo 16. Several of these seats were observed to have deteriorated since the previous assessment.

Photo 16 – Deteriorated steel pile cap beam support

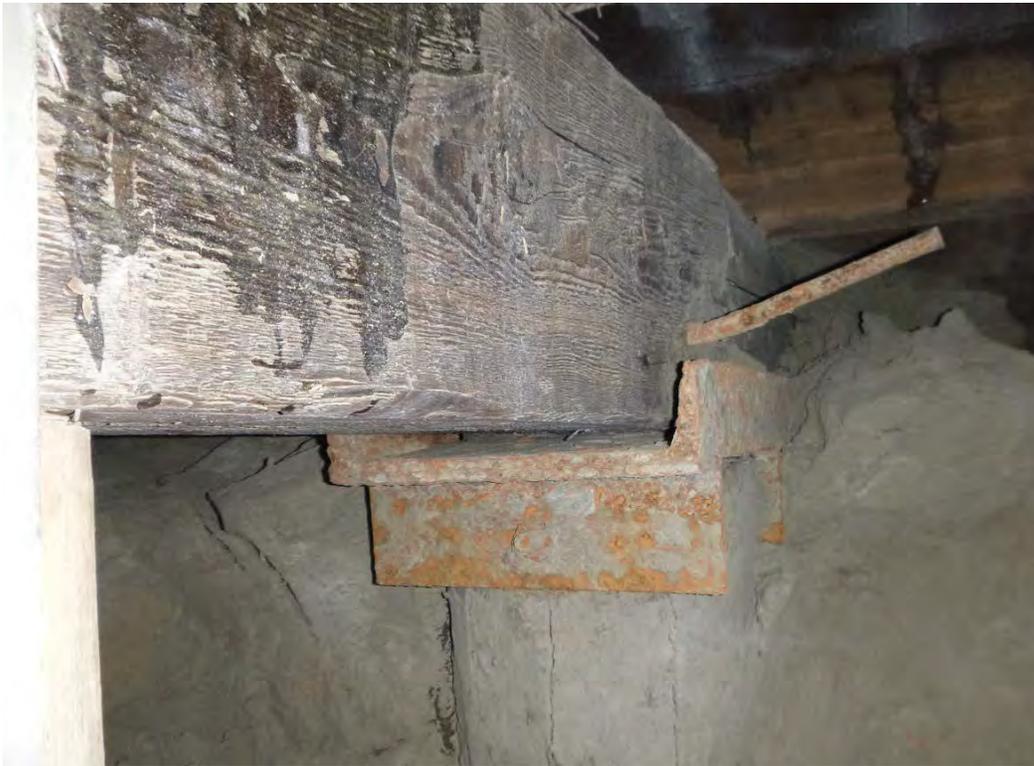
- Several timber pile cap beams spanning between lines C and E were observed to have insufficient bearing support on the pile at line C, where movement prior to the riverbank stabilization or ongoing creep of the inclined pile had caused the steel seat to tilt towards the river (Photo 17).

Photo 17 – Pile cap beam between E and C; reduced bearing length at steel seat

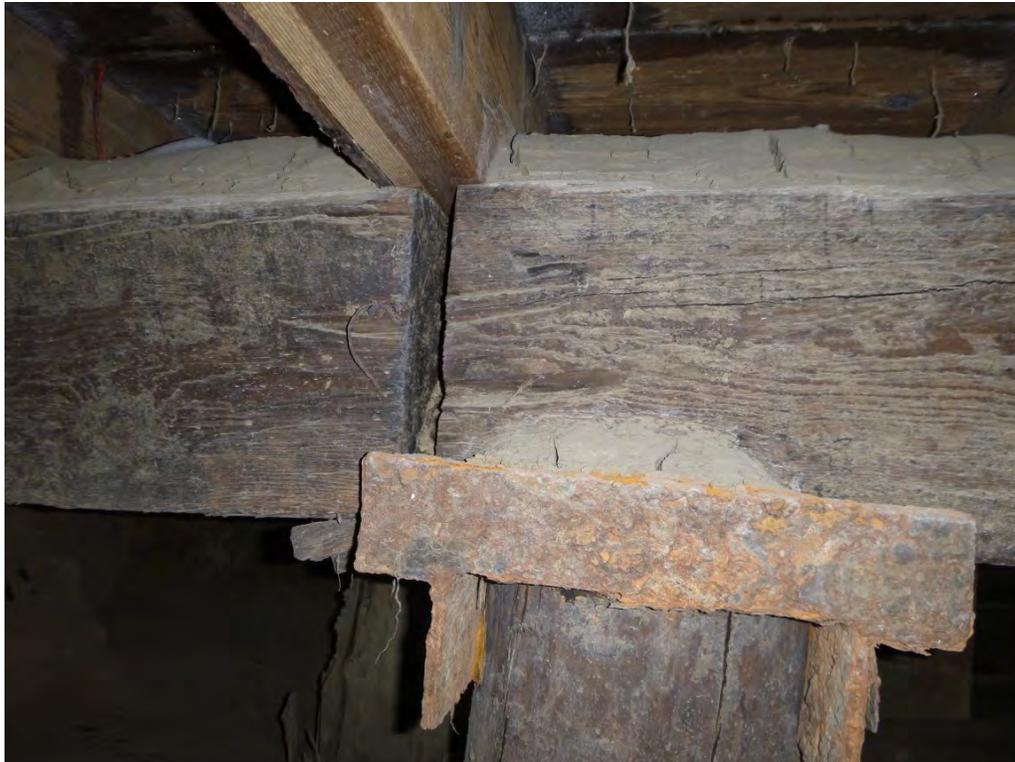
- There were several locations observed where beams embedded in the riverbank had insufficient bearing contact on the steel bearing seats (Photo 18). These beams still had appreciable bearing seat lengths when observed during the 2001 inspection.

Photo 18 – Insufficient bearing length for beam cantilevering out of riverbank at pile along line C

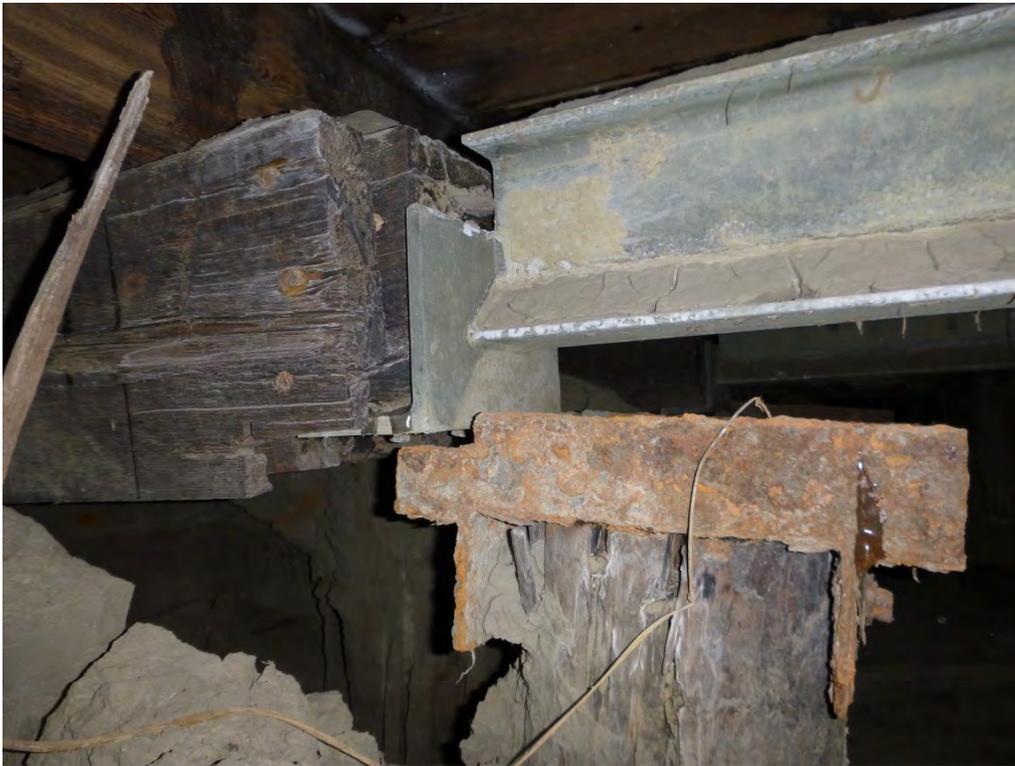
- There were also several locations with beams cantilevering out of the riverbank that had no bearing contact on the steel seats (Photo 19).
- There were several locations where the intermediate support piers of the original timber pile cap beams were tilted or shifted out of place (Photo 20).

Photo 19 – Beam cantilevering out from riverbank and not bearing on pile, but supported on seat extension of steel beam. Beam has increased deterioration since the 2001 inspection.

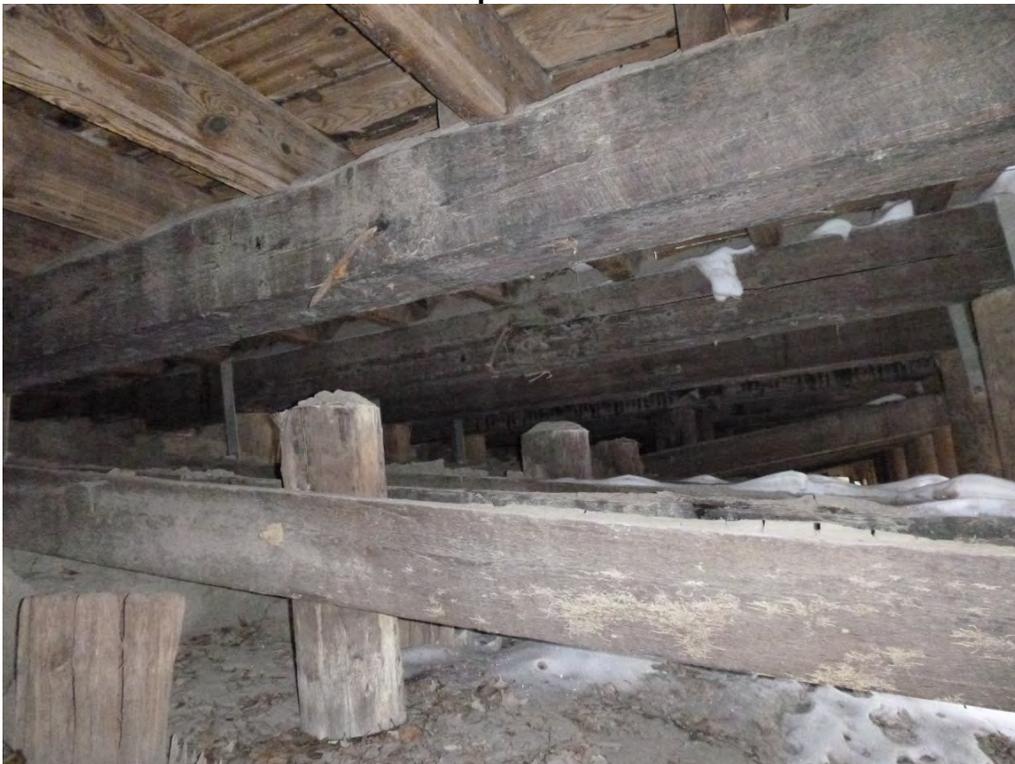
Photo 20 – Intermediate pier support shifted away from original timber pile cap beam

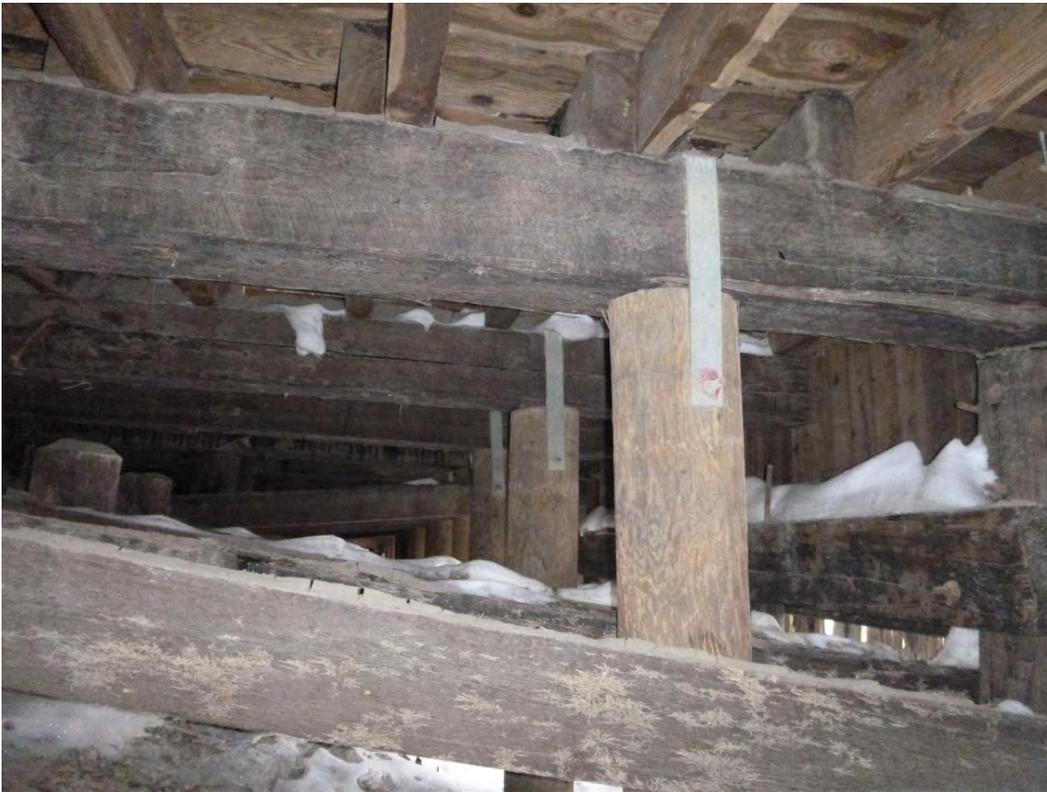
Photo 21 – Typical condition of remedial piles installed in 2004

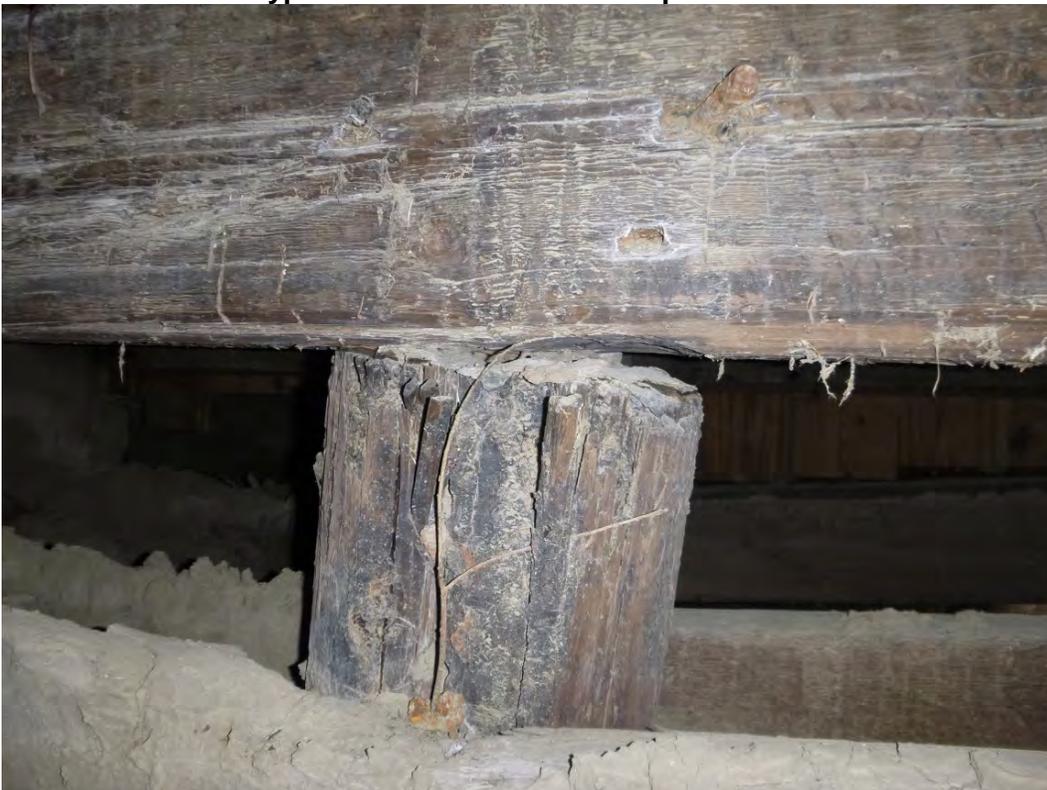
Photo 22 – Typical tilted pile support
