File No. 14-0107-036

RE: Alexander Dock
Inspection and Condition Assessment, Final – Rev 0

ALEXANDER DOCK

CONDITION ASSESSMENT PLAN

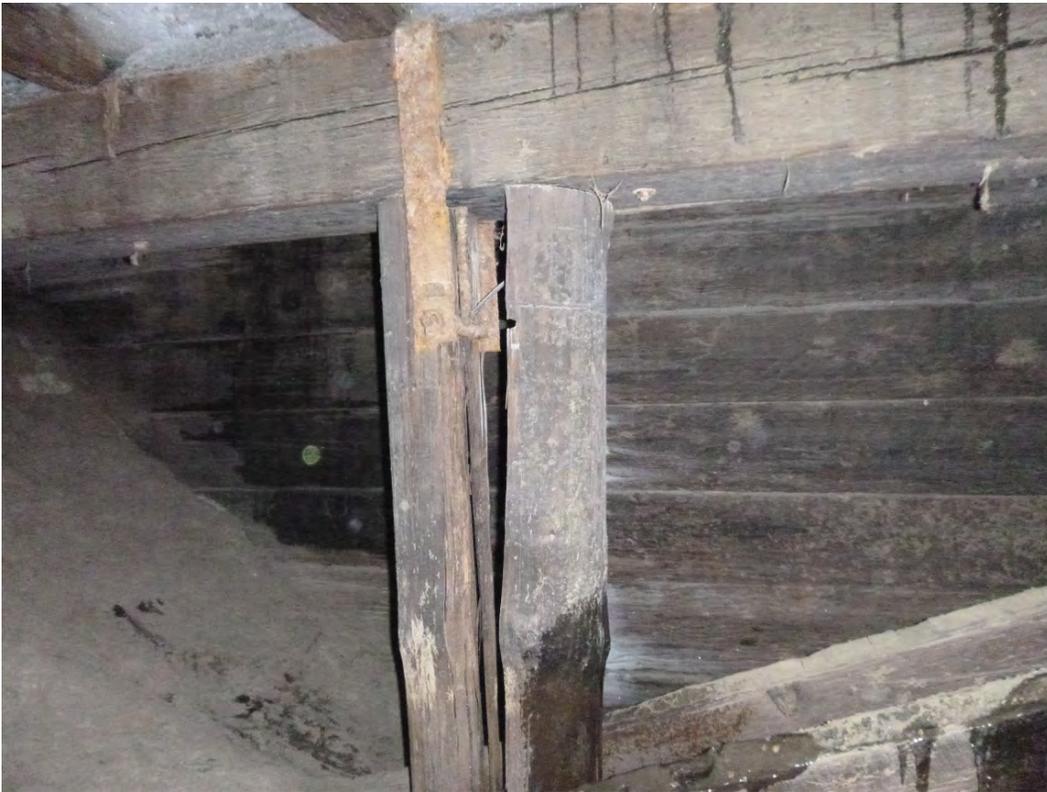
- Photo 21 displays the typical condition of the piles installed after the 2001 KGS Group report and the 2004 rehabilitation work.
- Several piles were found to be significantly inclined (Photo 22). These piles are marked with a "T" on Figure 1.
- Several piles were also found to be split, to varying degree. Photo 23 displays a typical split pile. These piles are marked with a "S" on Figure 1.

The columns marked with an "S" on Figure 1 were split to varying degrees, with Photo 12 representing an example. The axial compressive capacity of some of the split piles may be only slightly reduced from the design strength of the pile but the current load carrying capacity of these piles is difficult to quantify. While load sharing from the decking/stringer system may spread the load to more capable piles, the load carrying capacity of the split piles should be considered to be reduced, and in some cases negligible.

Photo 23 – Split pile at line 85

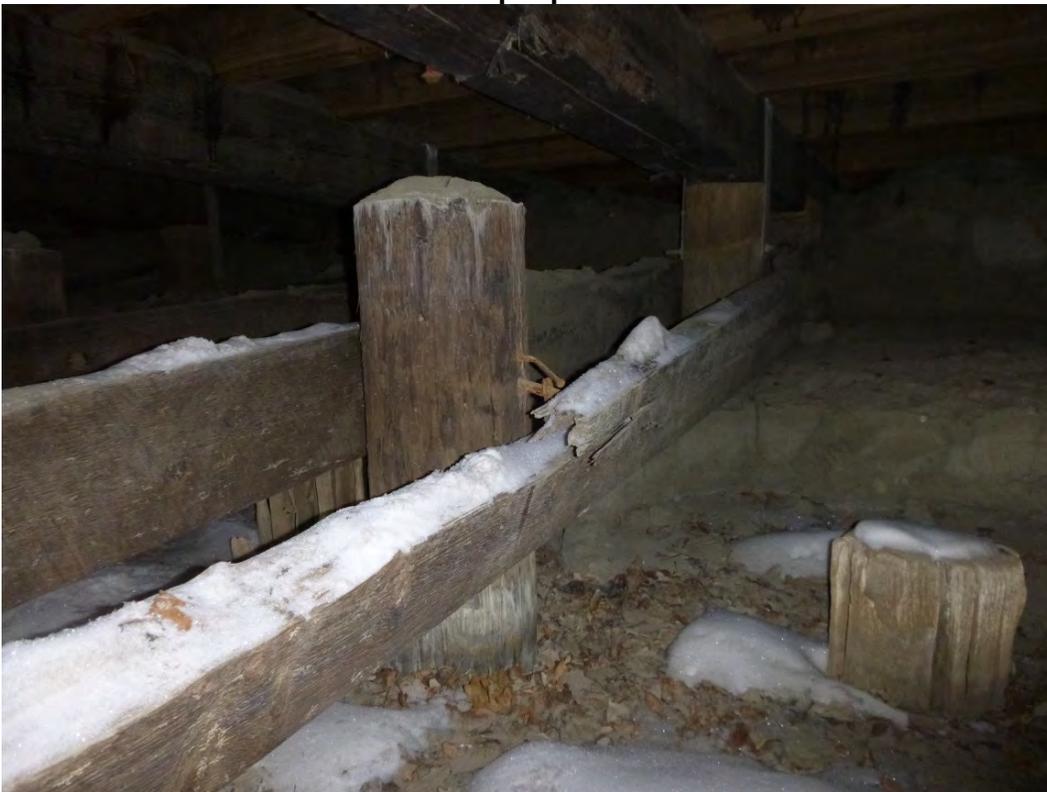
- Several diagonal bracing members were found to be damaged and no longer attached to the timber piles (Photo 24). Of the 82 bracing locations inspected, 15 members (18%) require replacement.

Photo 24 – Diagonal bracing member no long attached to pile

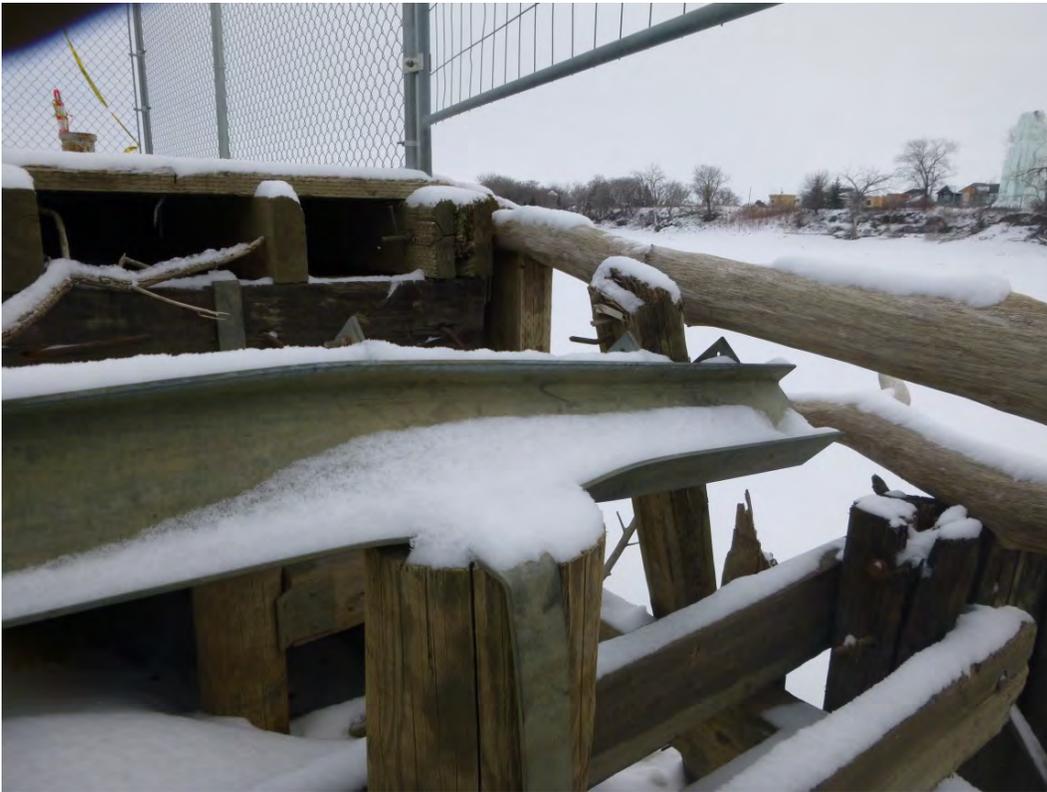
The upstream area of the dock, which has been damaged due to ice impact, appears to be unsalvageable. This area is currently exposed, due to the removal of the decking in this area. The underlying structure is severely damaged and deformed, as shown in Photo 25.

Photo 25 – Damaged upstream side of Alexander Dock
