**APPENDIX B – GATE CHAMBER CONCEPT DESIGN REPORT RUBY AND AUBREY LOCATIONS –
EXISTING CONDITION ASSESSMENTS FOR THE CITY OF WINNIPEG WATER AND WASTE
DEPARTMENT BY MMM GROUP LTD. 5514130-000.101**

4.0 RUBY

5.0 AUBREY

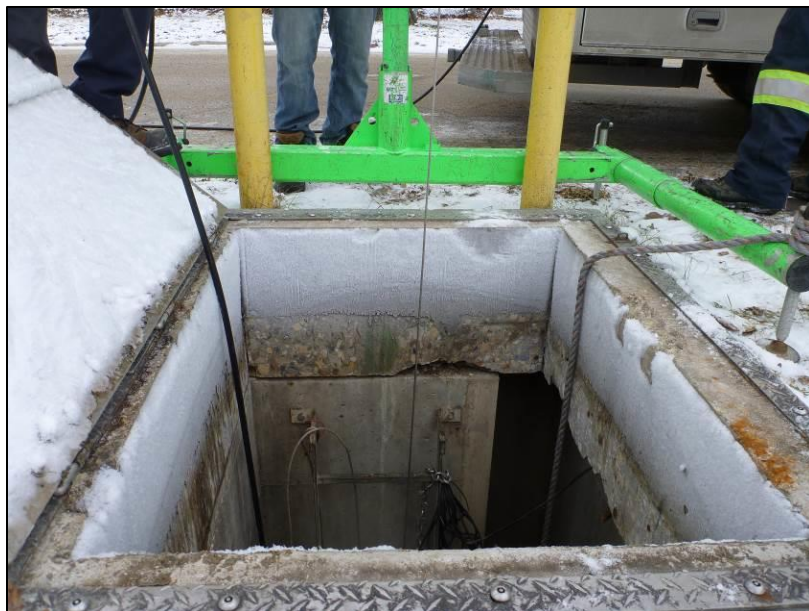
Photograph No. 3

The chambers are cast-in-place concrete with galvanized steel appurtenances. During the inspection high water limited access to some components with some areas inaccessible. Piping for submersible pumps has been added to the chamber and concrete has spalled where openings in the chamber roof were cut for conduits. The round manhole opening of the upstream chamber has been replaced with a rectangular hatch by saw-cutting through the previous roof slab. This saw-cutting has resulted in several spalls around the bottom edge of the opening, and leaves the ends of some reinforcing exposed. The roof slab may require replacing in the long-term due to durability issues. The galvanized safety cage in the upstream chamber has been removed, apparently to facilitate the installation submersible pump piping. This is acceptable by current standards. A 4.5 m high air vent shown on drawings was not observed on site. It is assumed the chamber is adequately vented through the manhole opening however this should be confirmed.

Component	Condition	Notes
Structural Concrete	Fair	Limited access. Spalling and exposed rebar around opening in roof slab.
Galvanized Steel Hatches and Frames	Good	
Galvanized Steel Ladders and Safety Cages	Good	Safety cage in upstream chamber has been removed.
Air Vent	Missing	Air vent not present.
Existing SRS	Unknown	SRS not accessible.

Opening to upstream chamber, spalls and exposed reinforcing

The parts of the chamber that were visible and accessible were in overall good condition. Spalls around openings from earlier chamber upgrades should be repaired with grout in order to maintain adequate cover to reinforcing steel for long-term durability. The stem guide of the existing sluice gate is severely corroded and should be replaced. The condition below the waterline at the time of inspection is unknown and it is possible that there may be maintenance repairs required.

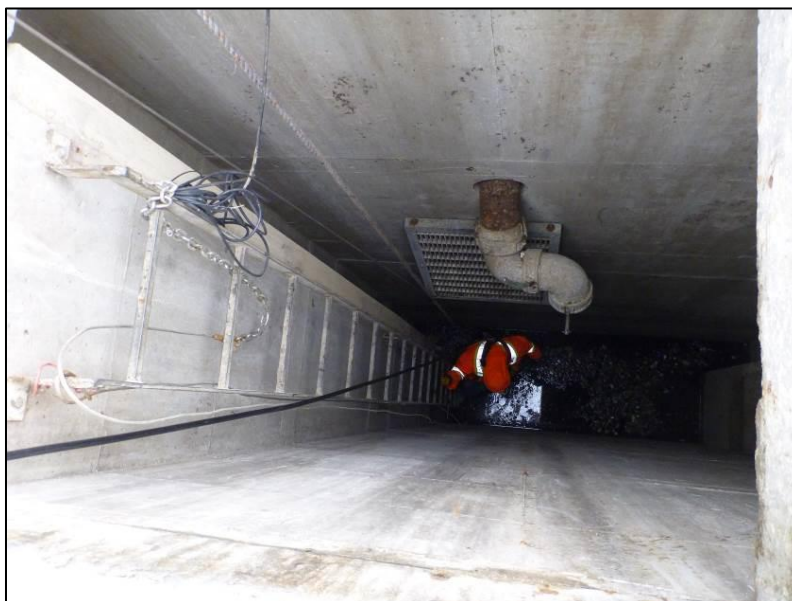
Photograph No. 4

Upstream chamber, ladder safety cage removed

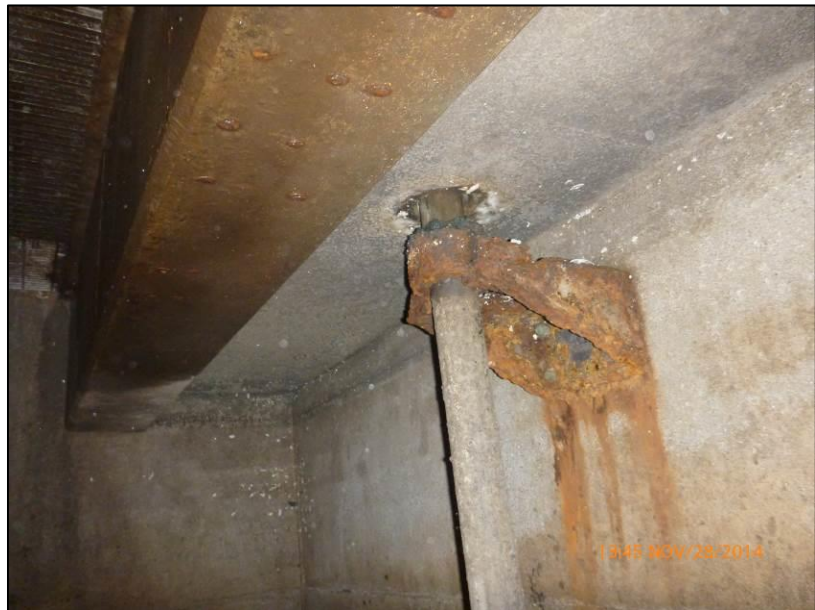
Photograph No. 8

Severe corrosion was present on the gate stem guide, and therefore this component should be replaced.

Severe corrosion on gate stem guide

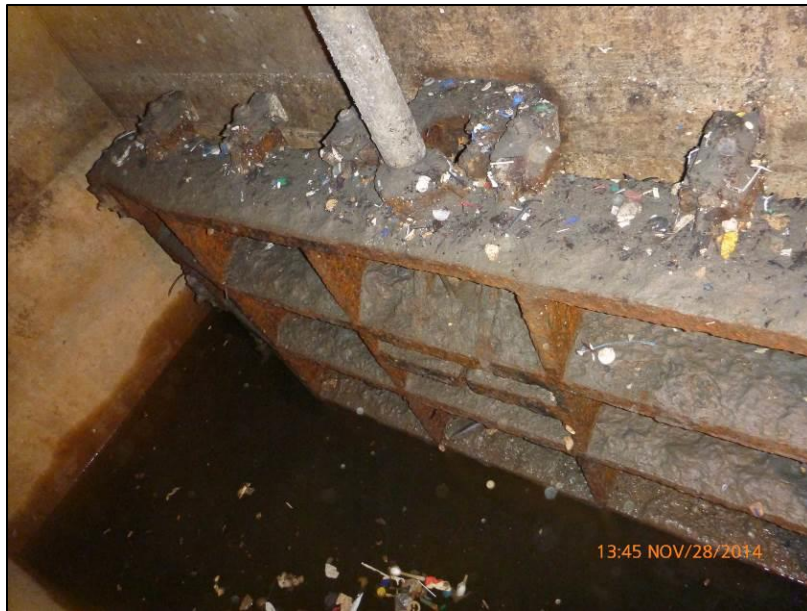
Photograph No. 9
Positive sluice gate

Component	Condition	Notes
Gate	Fair	Rusted with scaling and some section loss, limited access during inspection.
Thimble	Unknown	Not accessible during inspection.
Gate Guides	Unknown	Not accessible during inspection.
Gate Stem	Good	
Stem Guide	Poor	Significant section loss, requires replacement.
Gate Lift	Fair	Rusted with some section loss. Operating shaft not present during inspection.

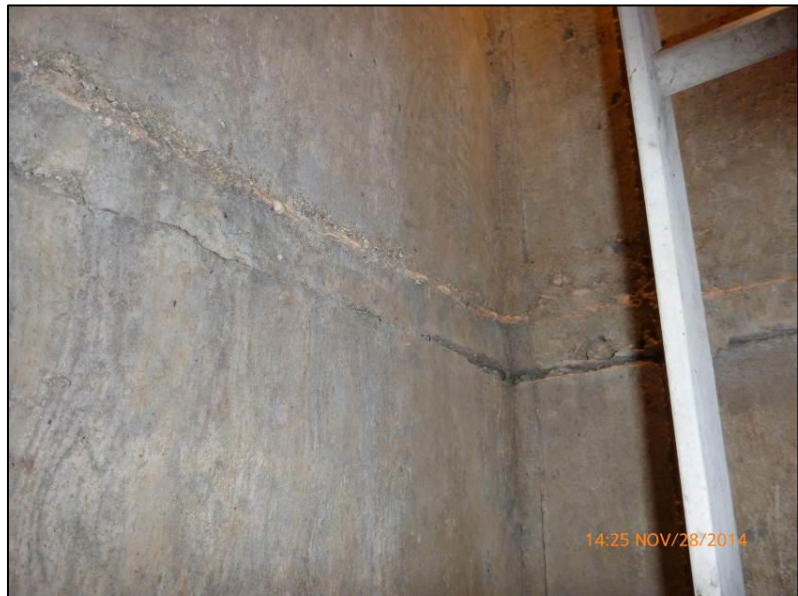
Photograph No. 6

The chambers are cast-in-place concrete with galvanized steel appurtenances. During the inspection high water limited access to some components with some areas inaccessible. Piping for submersible pumps has been added to the chamber. The galvanized safety cage in the upstream chamber has been altered to facilitate the installation submersible pump piping which is acceptable. The cage is also damaged near the bottom of the chamber such that it interferes with the climbing circle, and therefore this should be repaired. In the upstream cell at the construction joint located approximately mid-height there is slight differential movement of the concrete made visible by some feathering of the concrete. No other cracks or visible deflections were noted.

Cracks in construction joint in upstream chamber cell

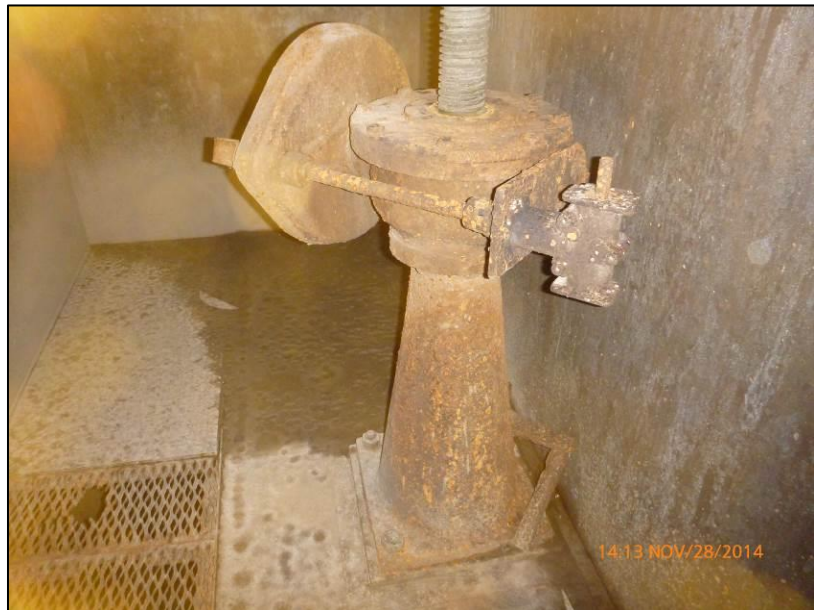
Photograph No. 8

Component	Condition	Notes
Gate	Fair	Rusted with scaling and some section loss, limited access during inspection.
Thimble	Unknown	Not accessible during inspection.
Gate Guides	Unknown	Not accessible during inspection.
Gate Stem	Good	
Stem Guide	Fair	Rusted with some section loss.
Gate Lift	Fair	Rusted with some section loss. Operating shaft not present during inspection.

Gate lift

Due to the age of the existing steel positive gate it is recommended to replace the gate, frame, stem and other appurtenances. A new surface-mounted gate operator would be installed.
