ASBESTOS INVENTORY CONTROL

Building Name:	Melrose Park C.C.	Inspection Date:	March 1, 2016
Building Code:	CC-051	Inspected By:	Ryan Matthews & James Neufeld
Building Address:	480 Kimberly Avenue	Construction Date:	1967

ASBESTOS LOCATIONS

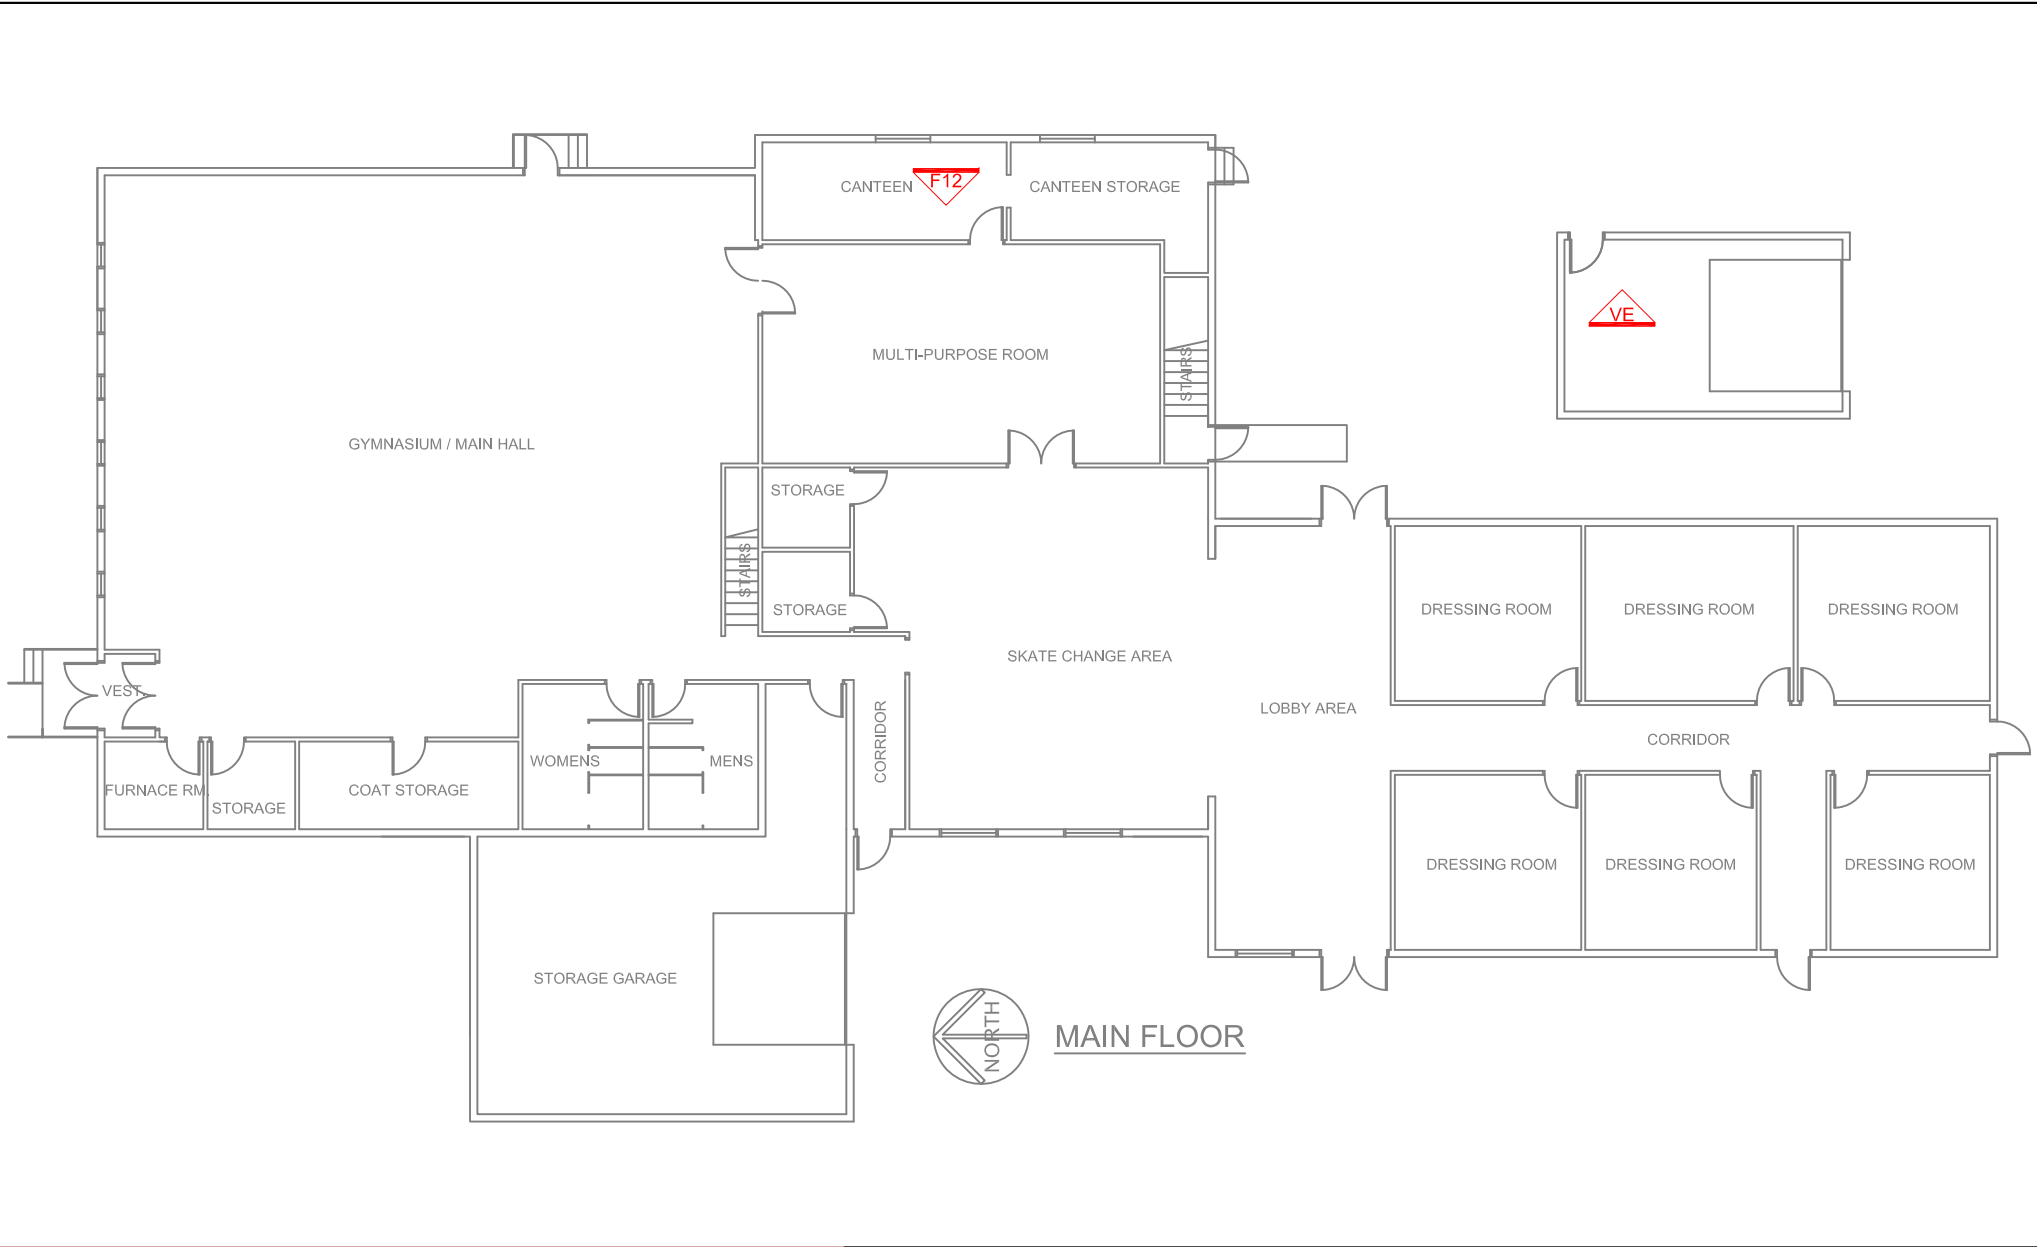
Material Location	Material Description	Drawing Label	Material Condition	Testing Status	Date M/Y	Test %	Est. %
Main Floor							
Canteen	12x12 Floor Tile - Under Sheet Flooring see Note .	F12	Good	TESTED	Jun/'11	2	
Basement							
Dressing Rooms	Asphalt Plank Floor	APF	Good	TESTED	Jun/'13	3	
All areas (except Furnace Rm)	Asphalt Plank Floor	APF	Good				3
South East Detached Garage							
North Portion of Attic Only	Contains Vermiculite Insulation (Which May Contain Asbestos)	VE	Good				
	Note: Curtis Carpets replaced sheet flooring, end of October 2012. 12x12 Floor Tile under existing sub floor not removed as confirmed with Bob Ford of Curtis Carpets 989-1042.
