Appendix E – Site Photos

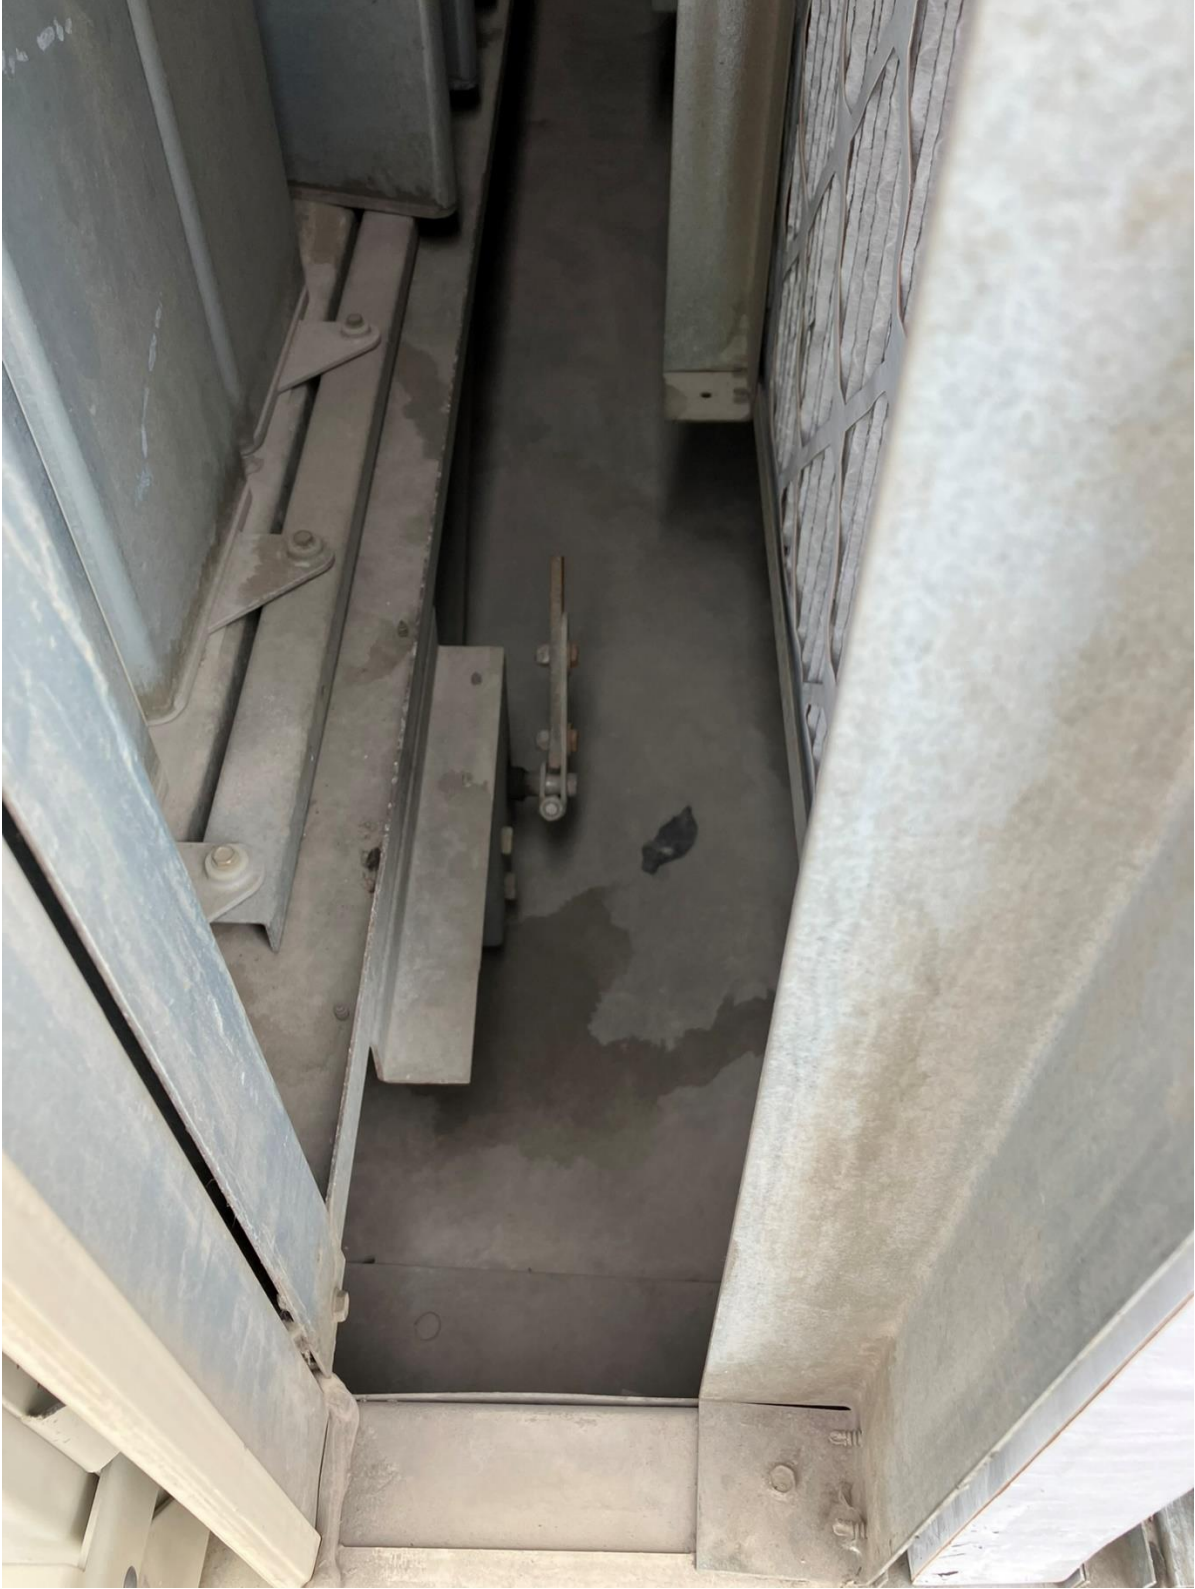
Figure 1: AHU-1 damper manual actuator.

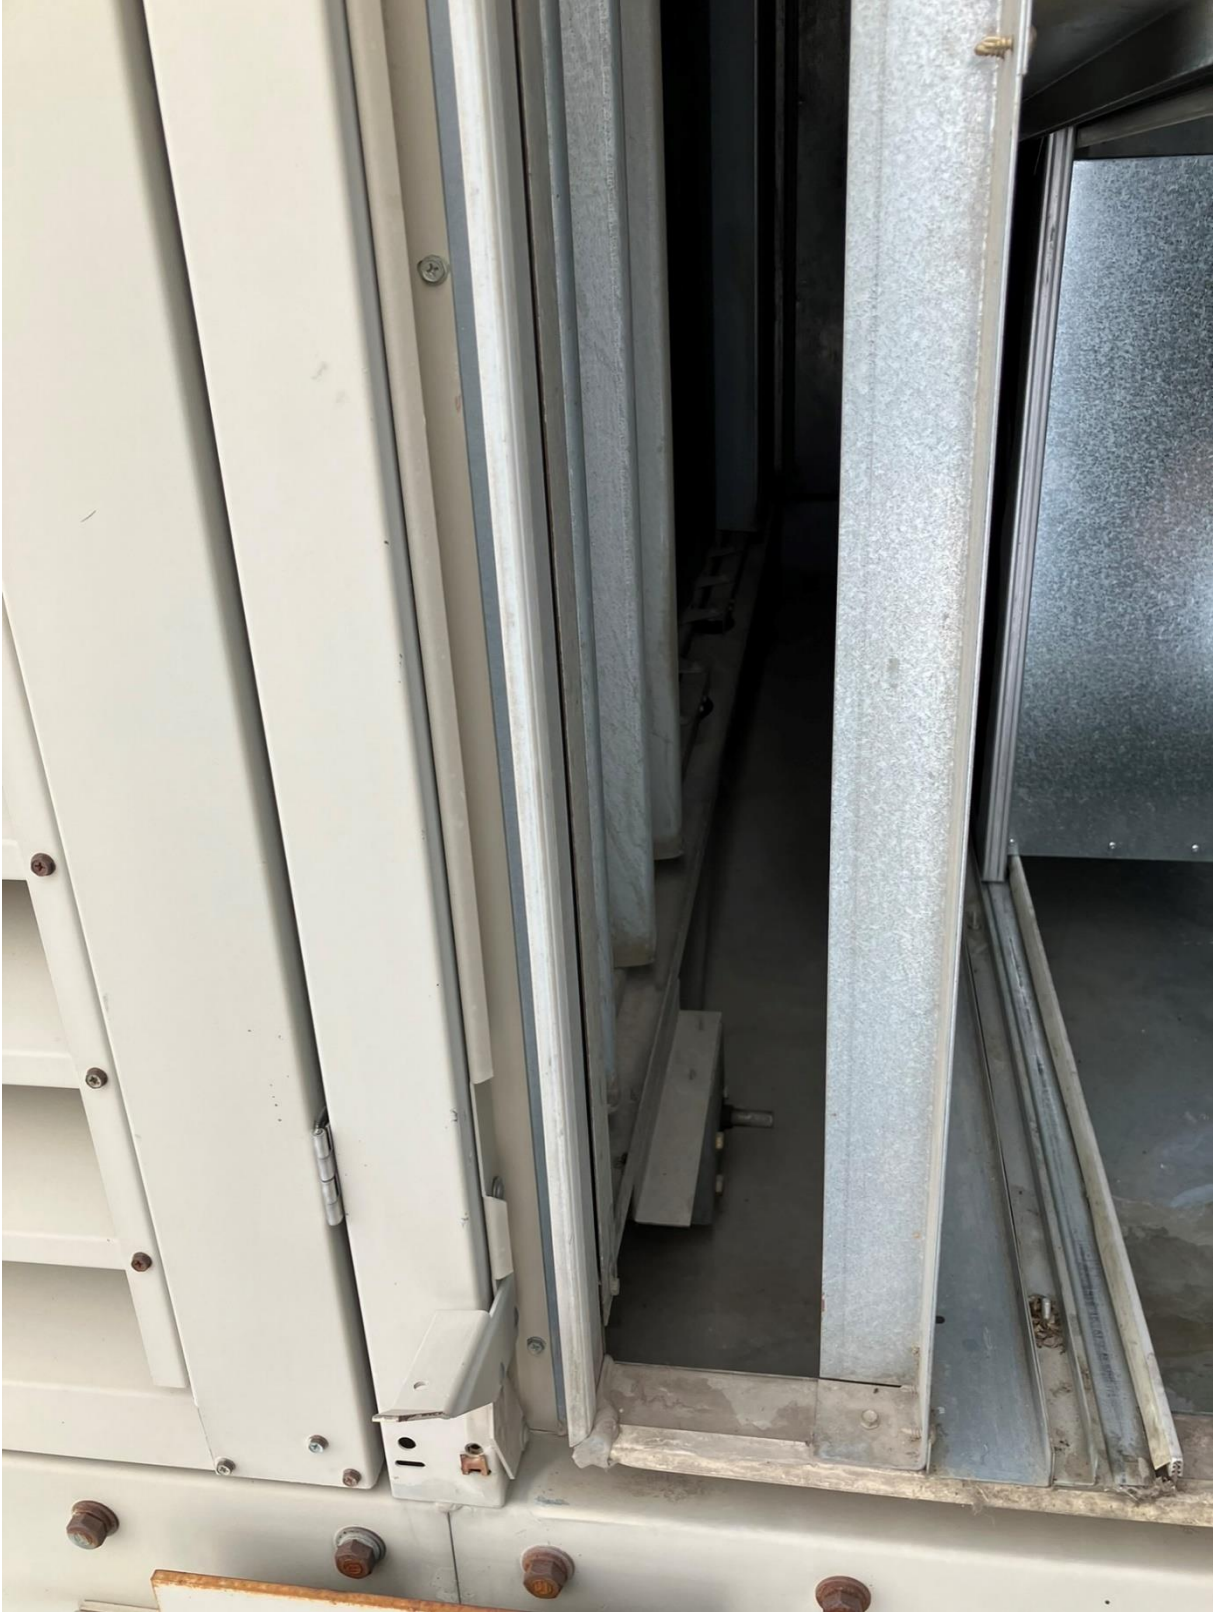
Figure 2: AHU-2 damper manual actuator.

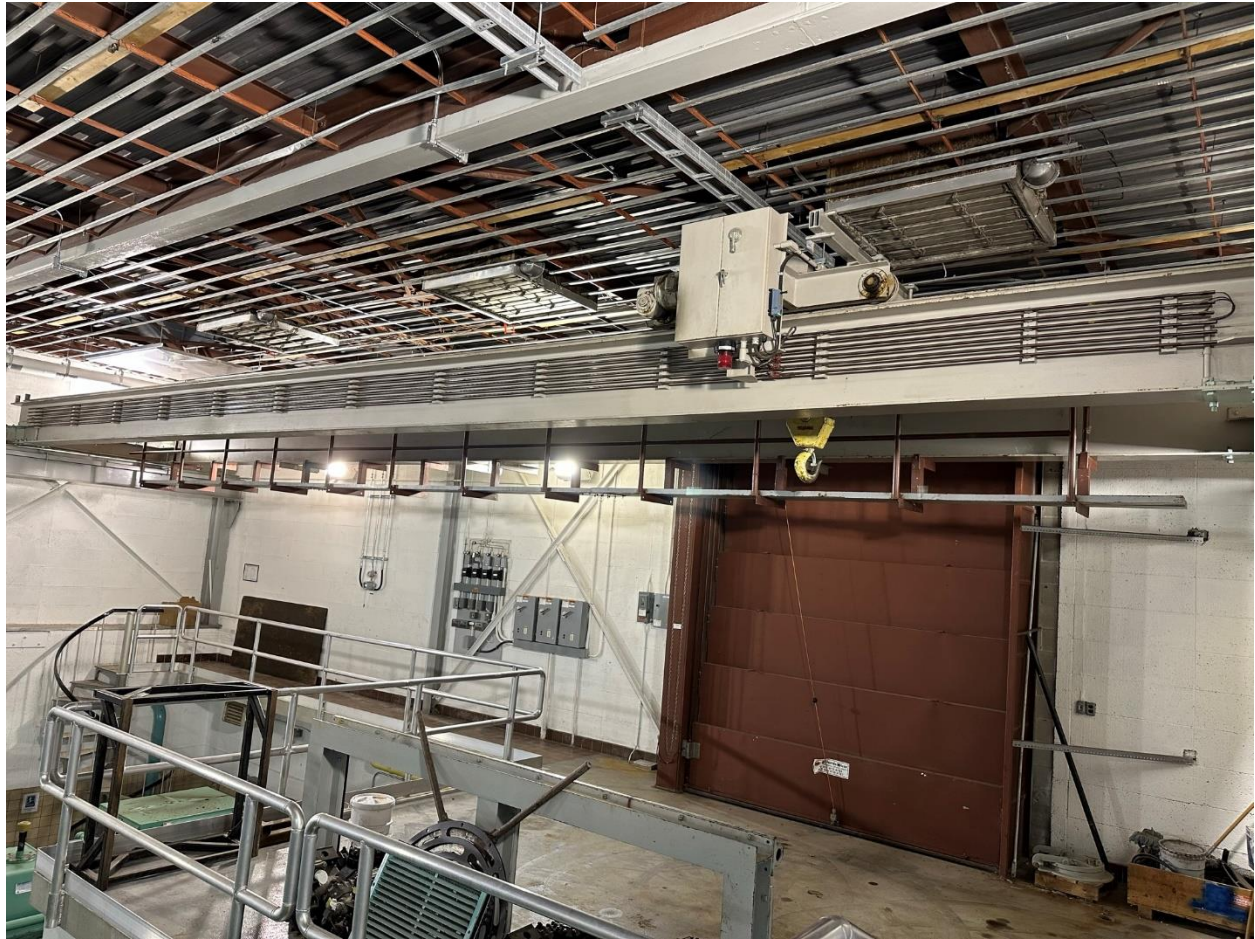
Figure 3: Looking west showing three existing exhaust fan dampers (ceiling), and existing starters, wiring, conduits, pneumatic piping, and control (wall).

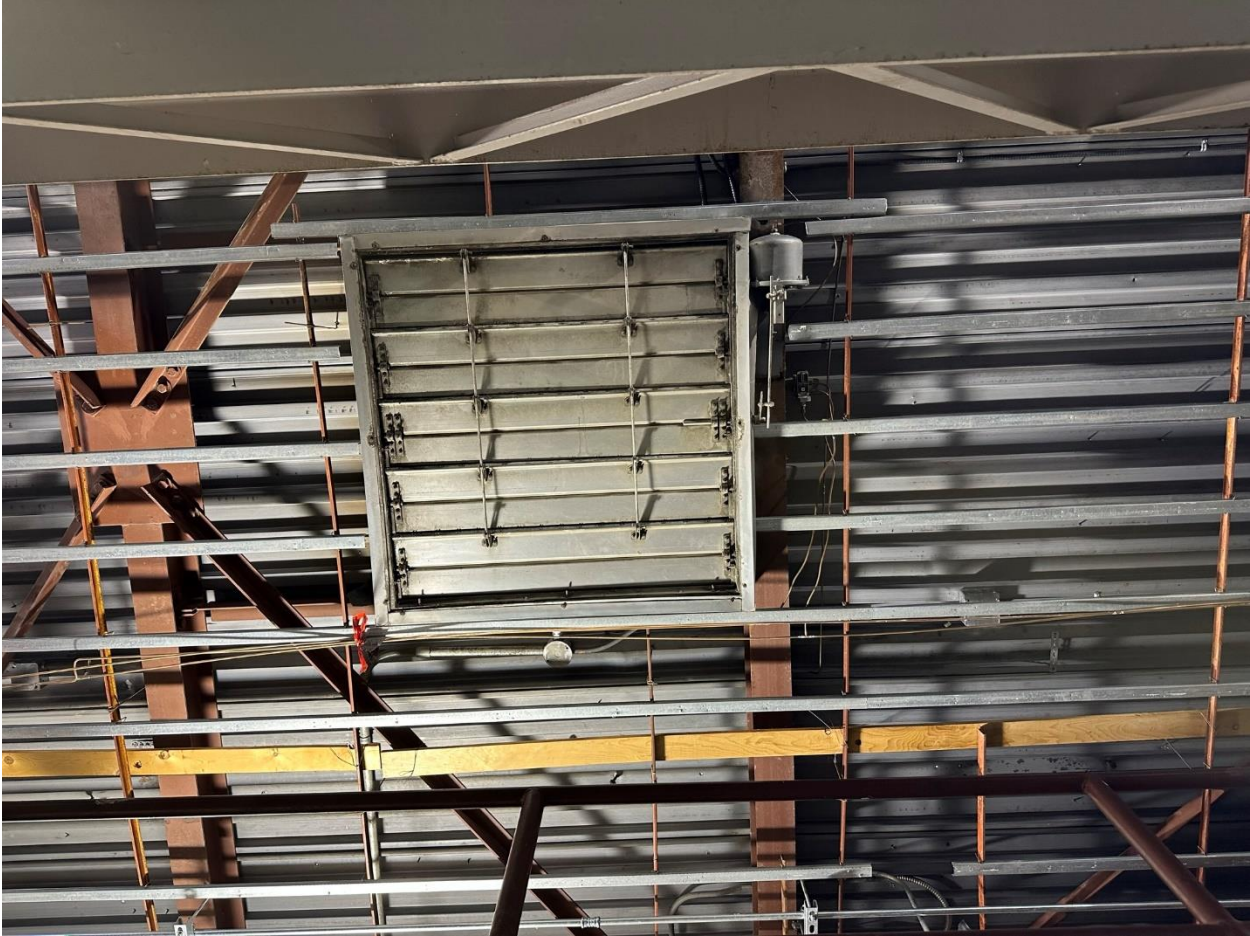
Figure 4: Existing exhaust fan damper and actuator - typical of three.

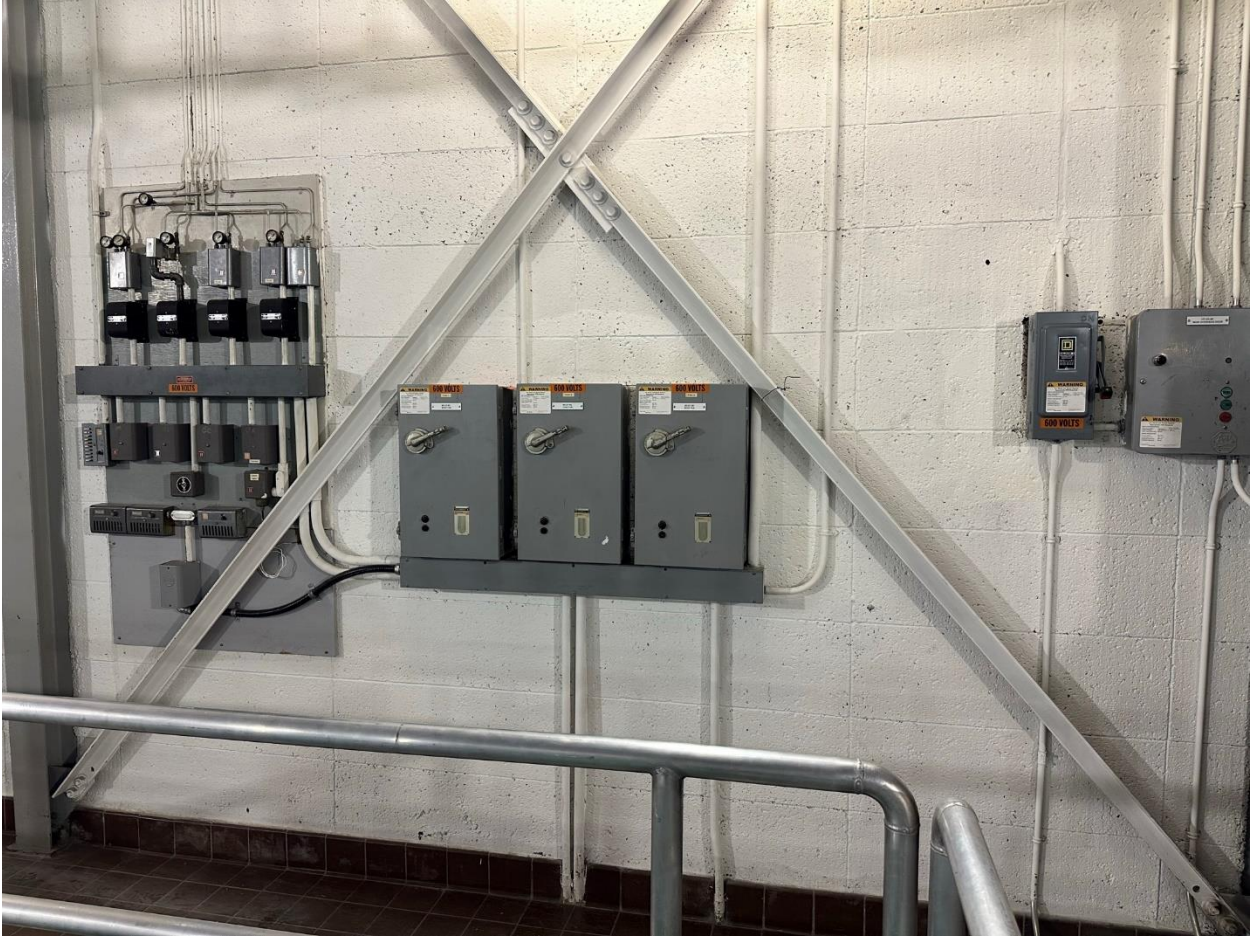
Figure 5: Existing starters, wiring, conduits, pneumatic piping, and control for three exhaust fans.

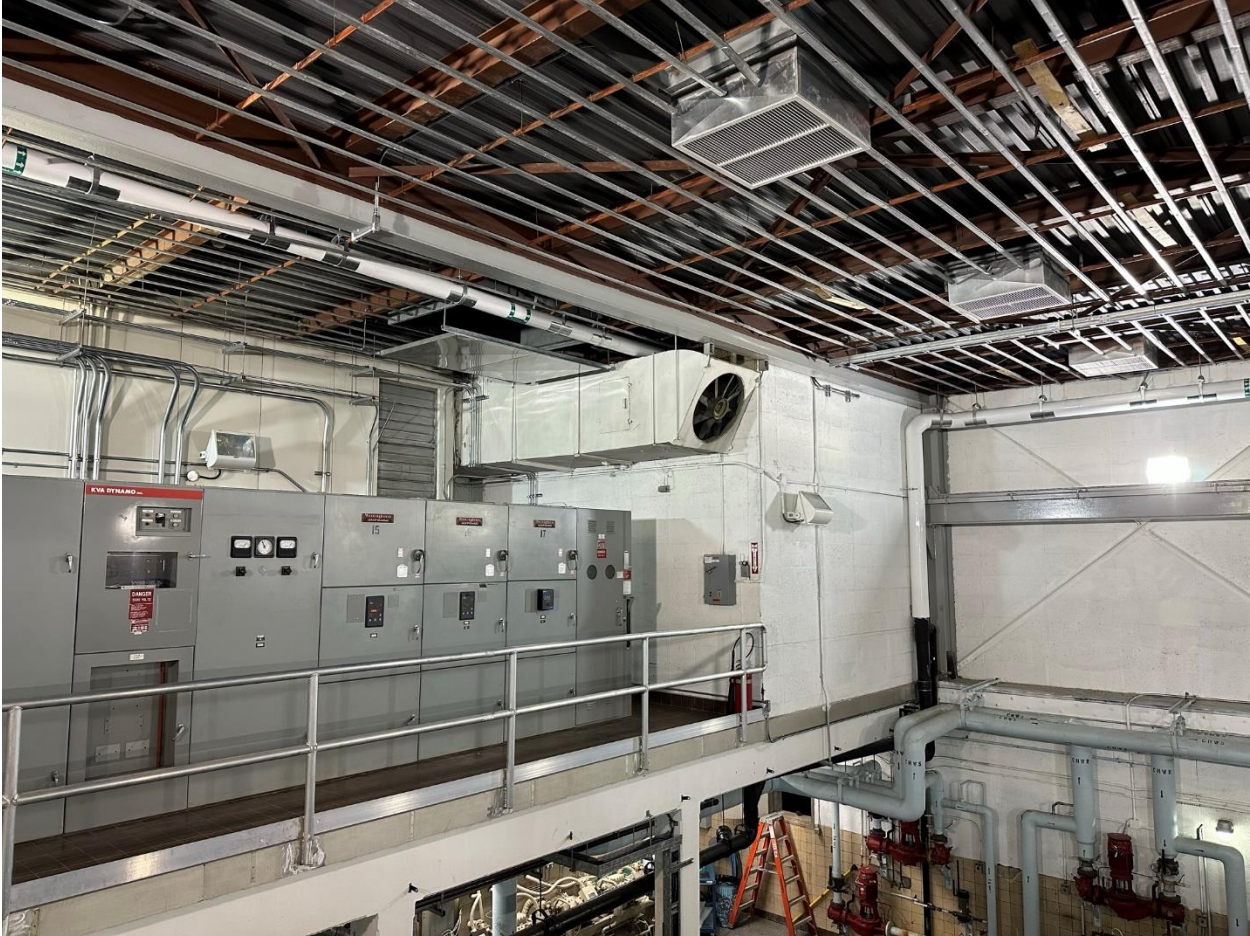
Figure 6: Looking east showing existing supply air fan.

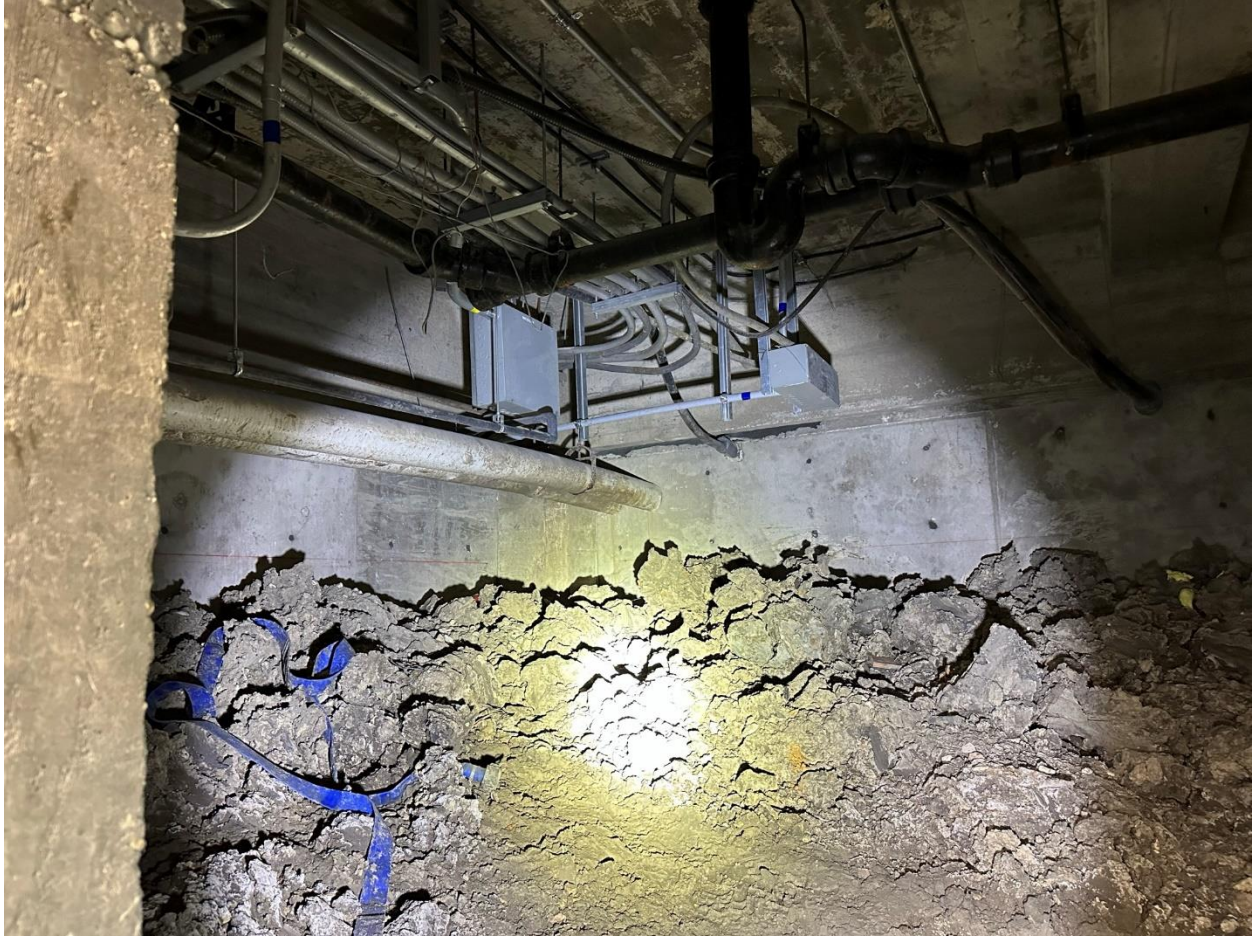
Figure 7: Southeast corner of crawlspace showing existing cooling tower pipes penetrating the grade beam extension.

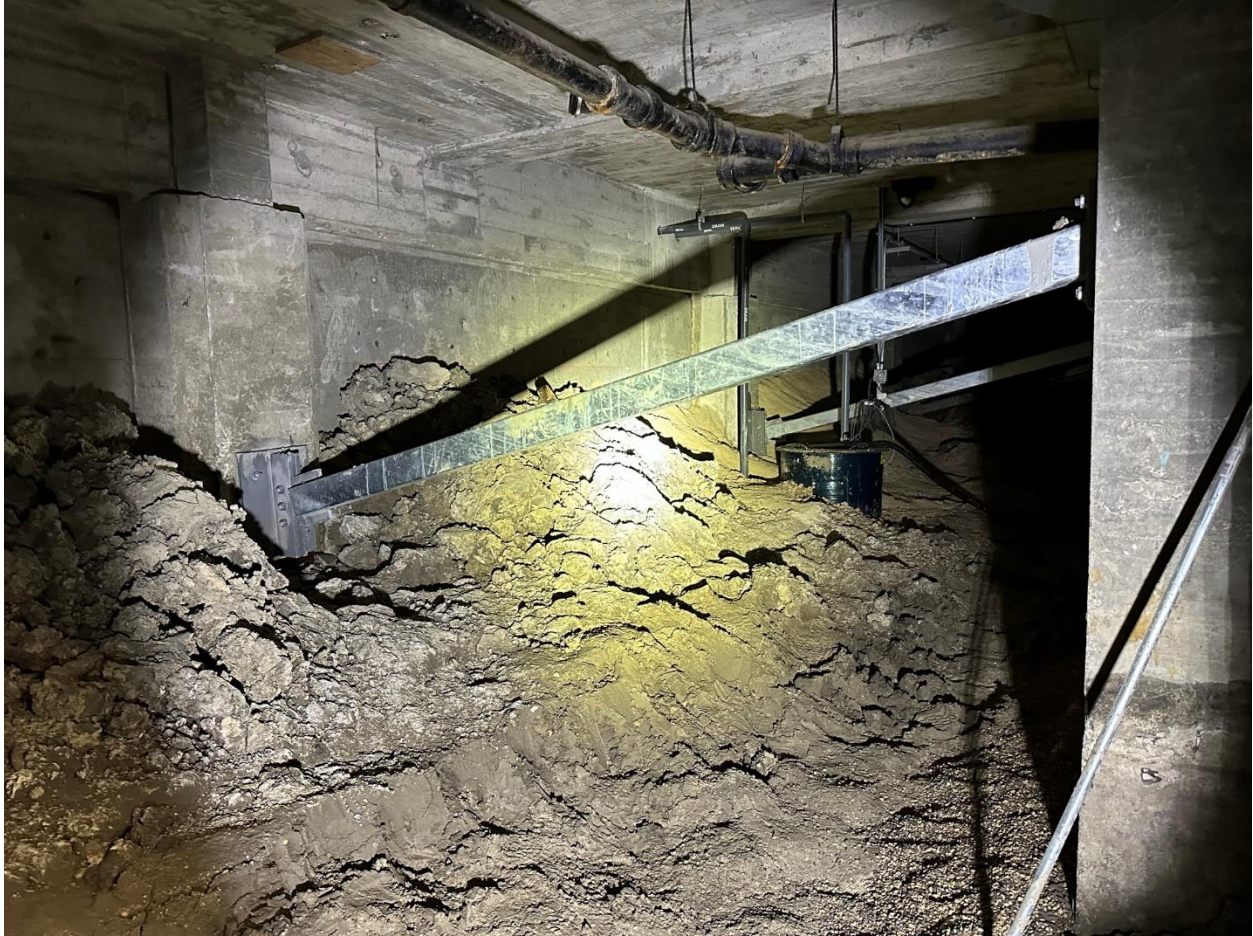
Figure 8: Looking west in crawlspace showing existing sump basin and piping penetrating original grade beam.

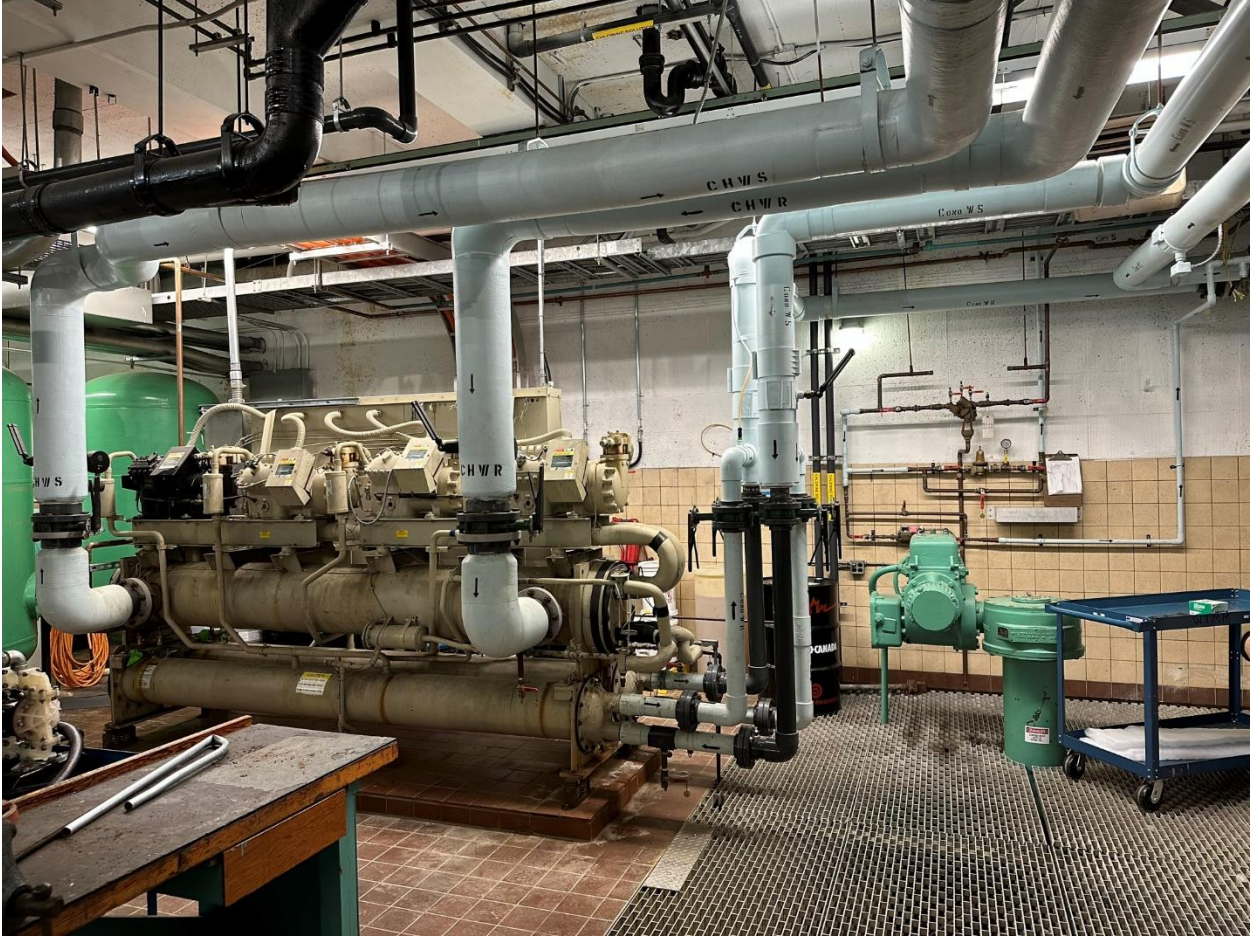
Figure 9: Existing indoor chiller, looking east.

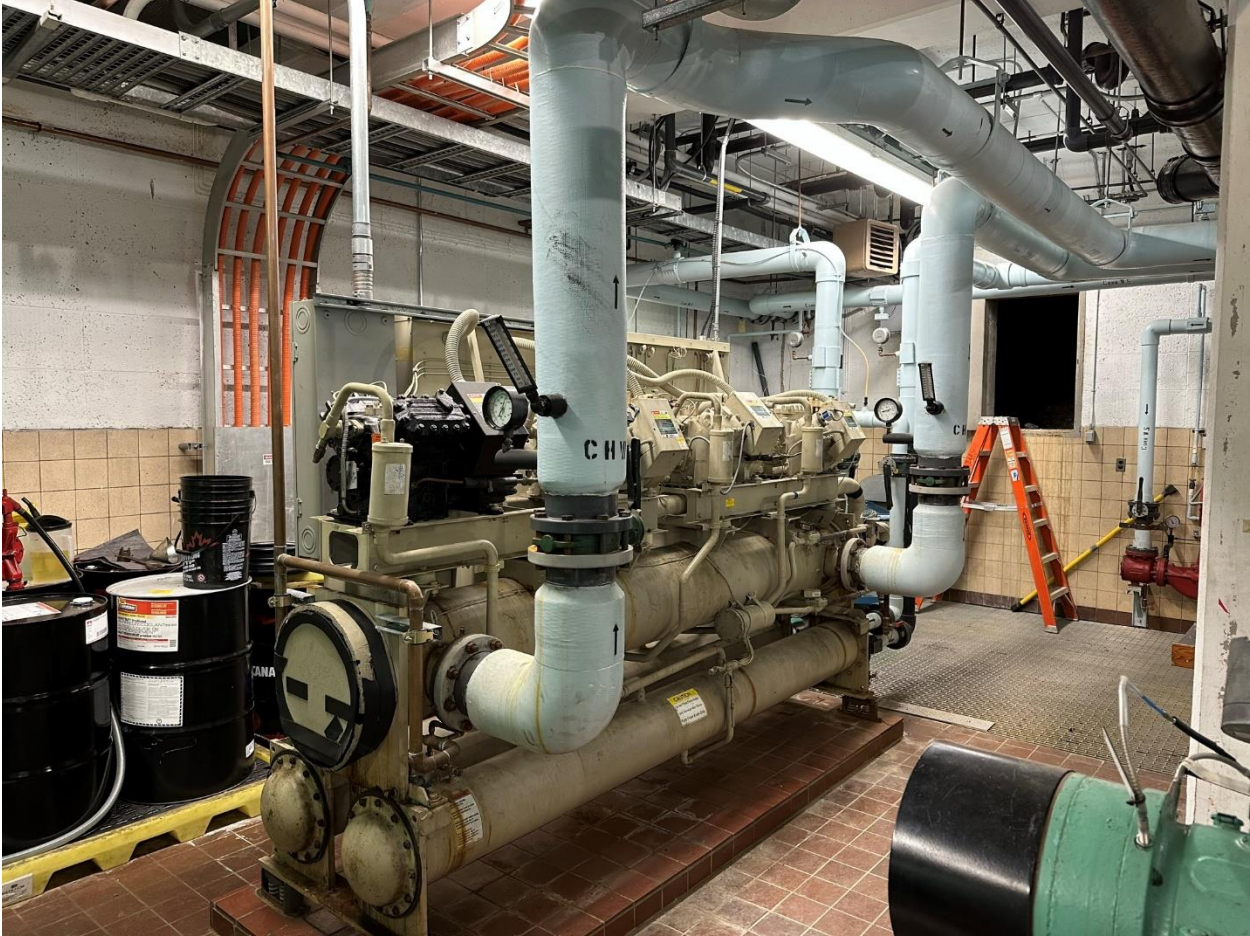
Figure 10: Existing indoor chiller, looking southeast.

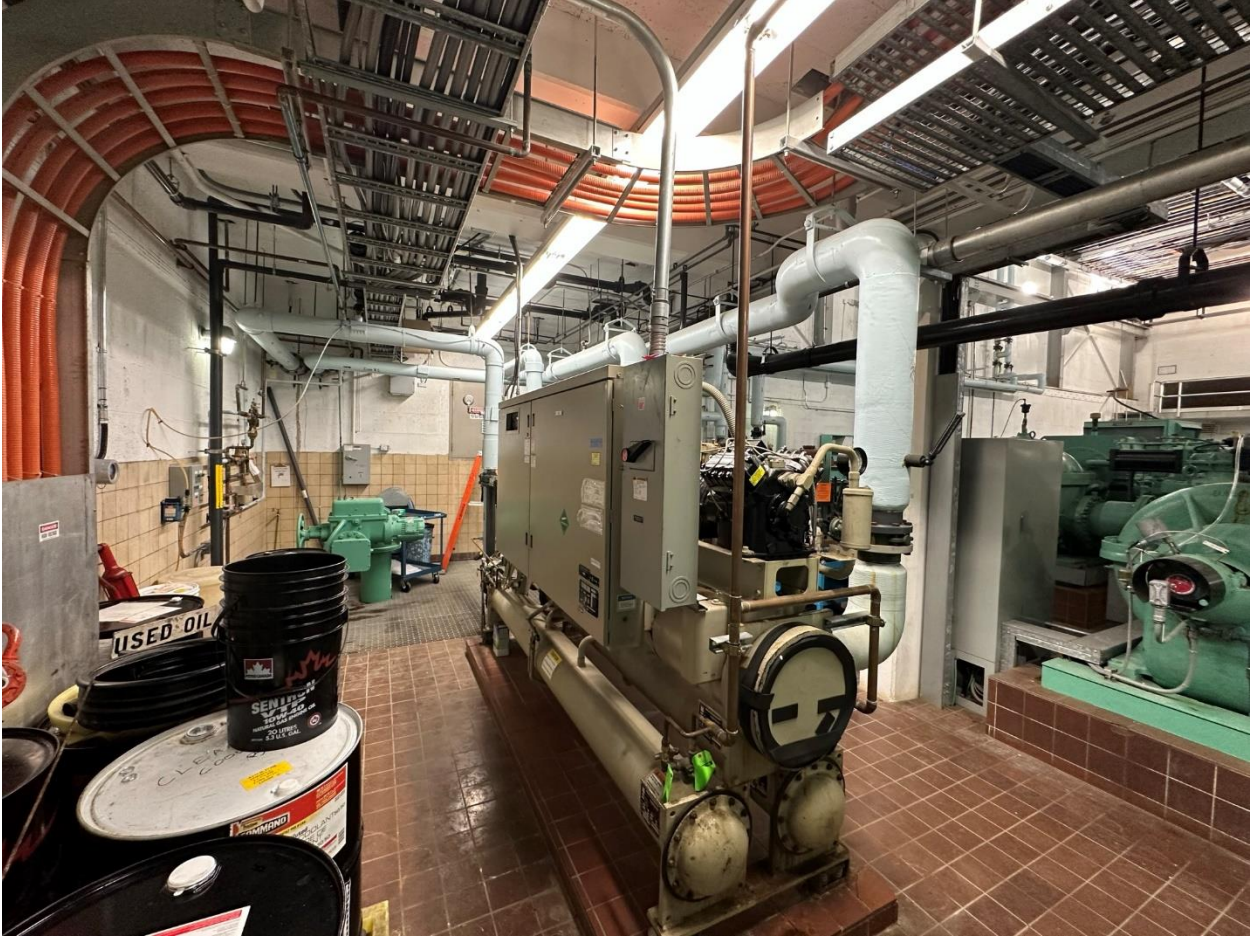
Figure 11: Existing indoor chiller, looking southwest.

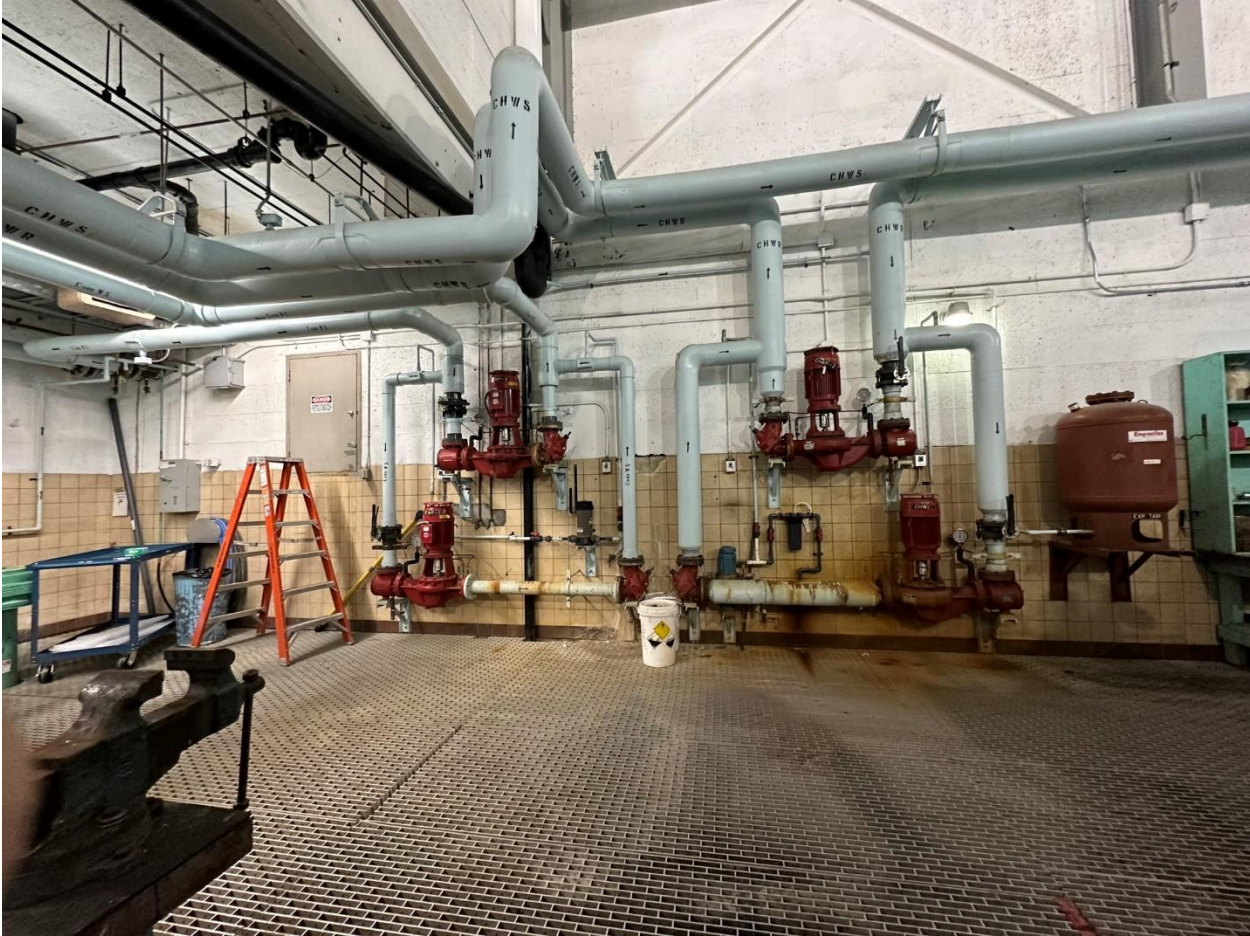
Figure 12: Looking south showing existing chilled water pumps, cooling tower pumps, and expansion tank.

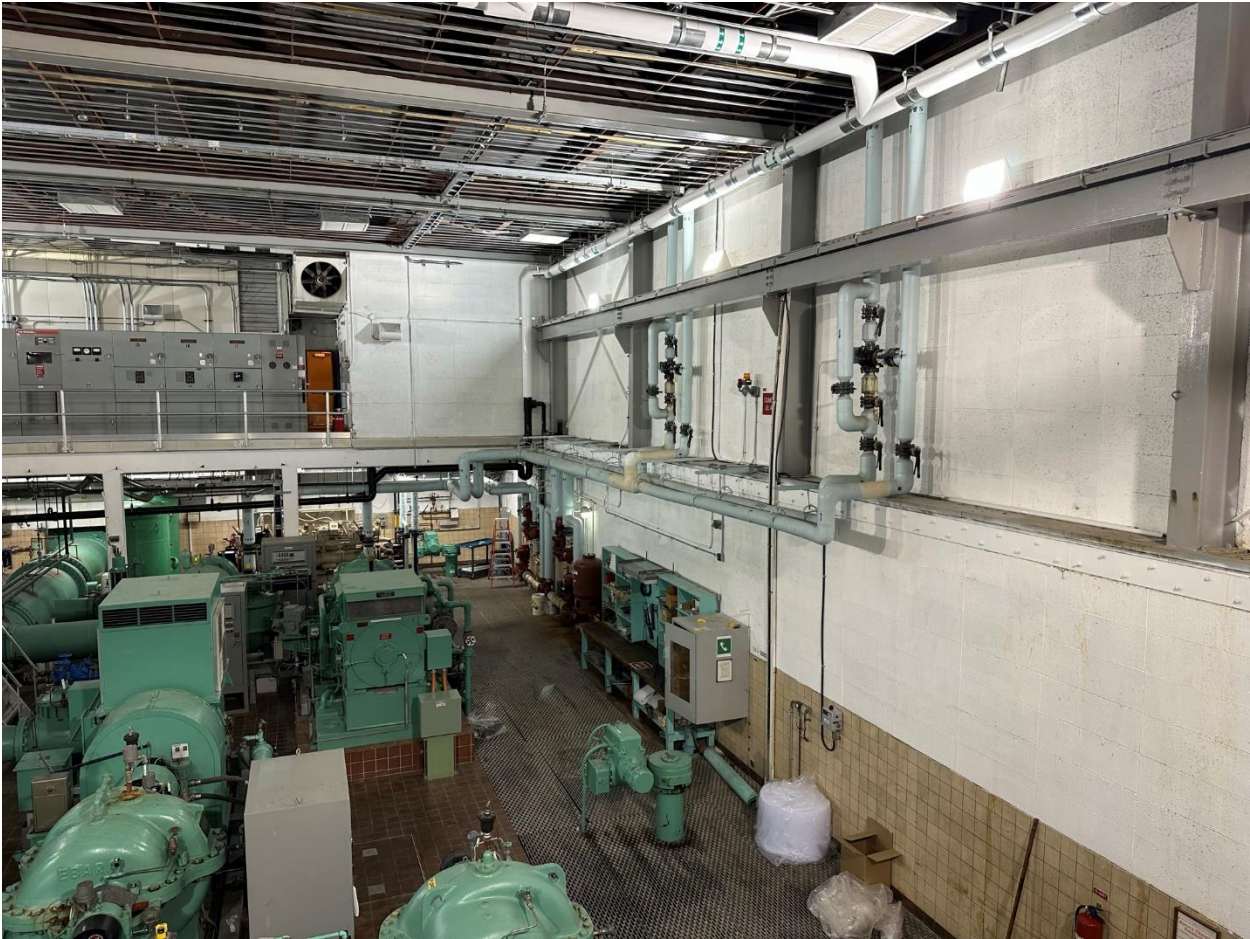
Figure 13: Looking east showing existing chilled water piping up to two rooftop air handling units.

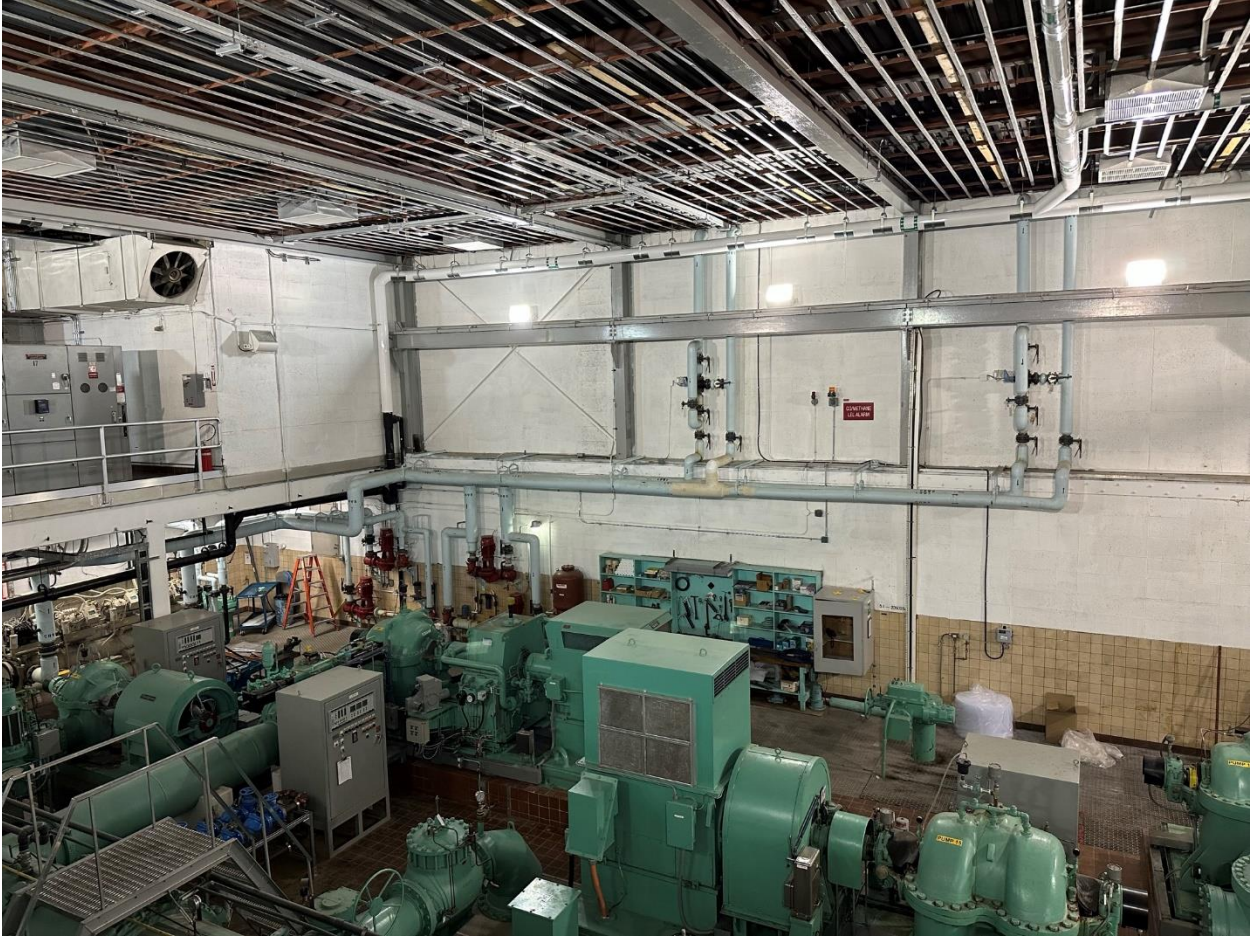
Figure 14: Looking south showing existing chilled water piping up to two rooftop air handling units.

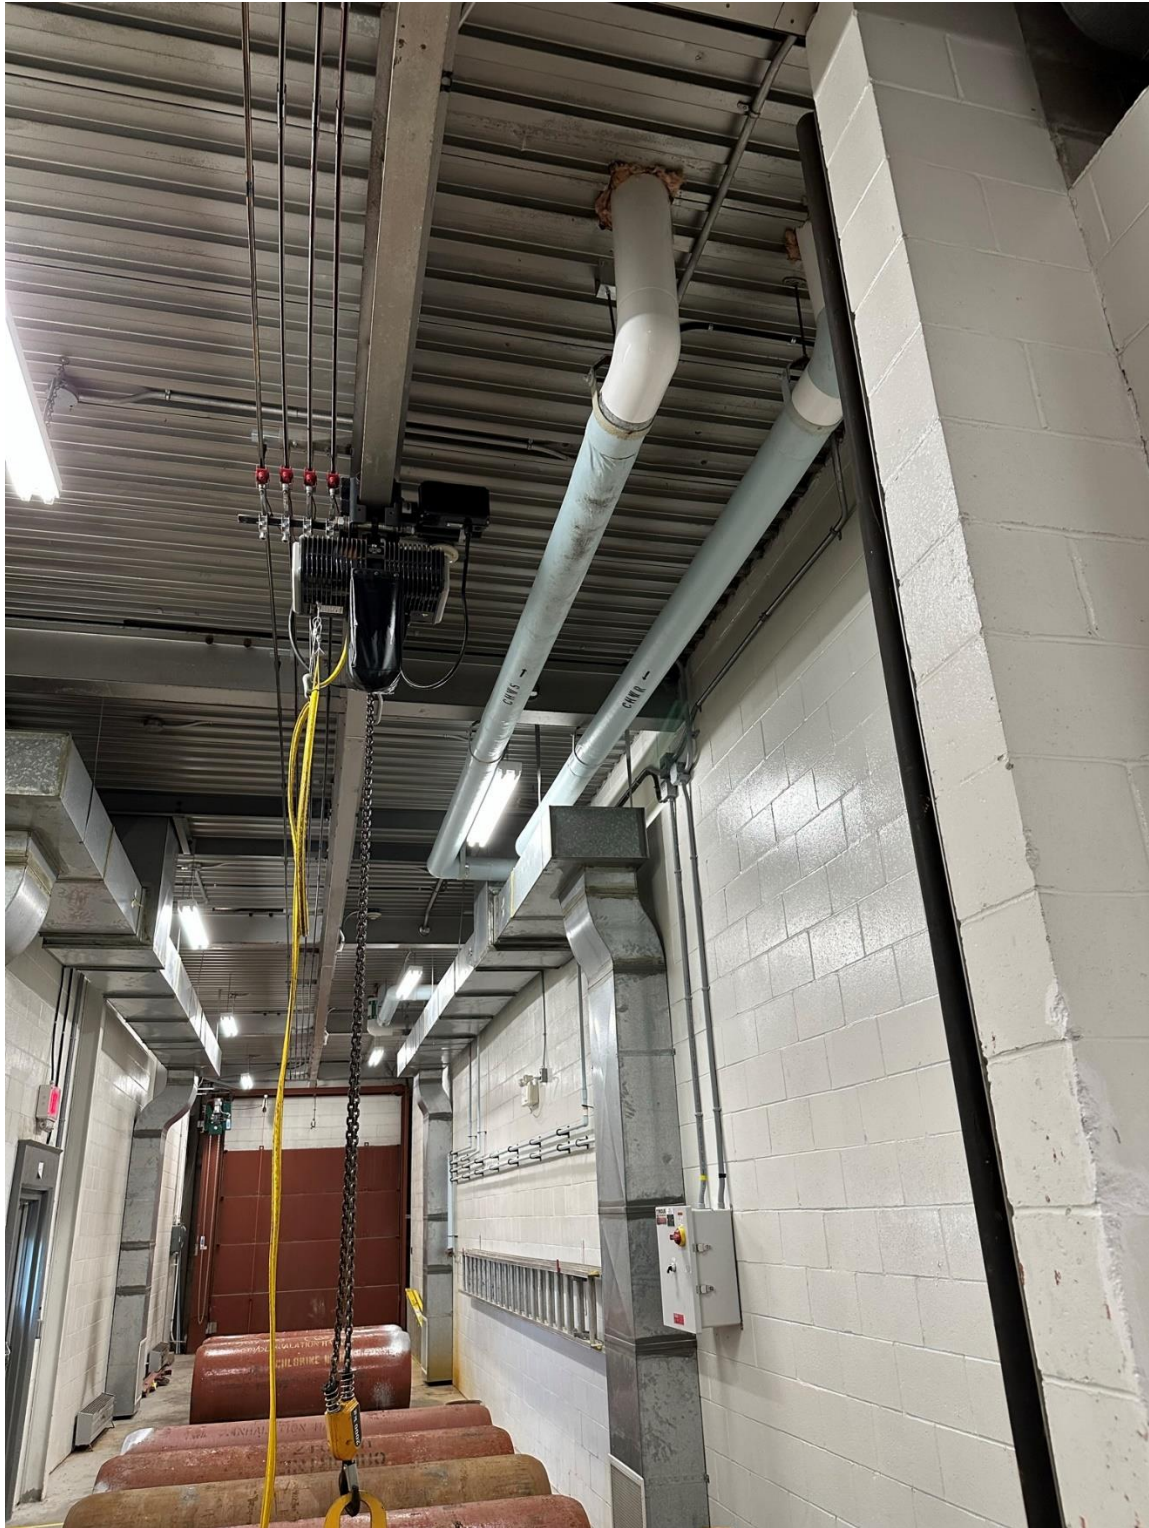
Figure 15: Looking west in the Chlorine Storage room showing existing chilled water piping roof penetrations up to two rooftop air handling units.

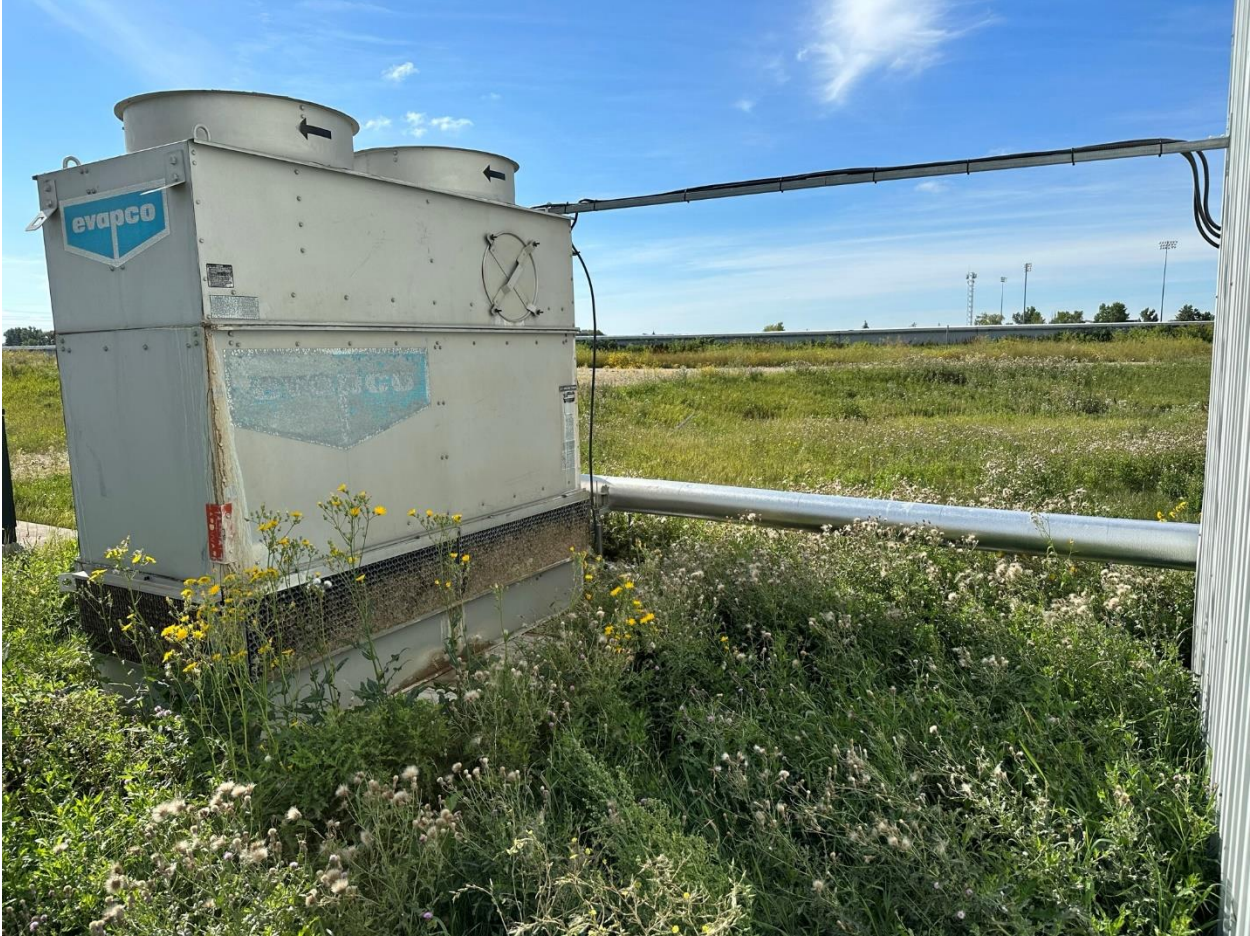
Figure 16: Existing cooling tower.

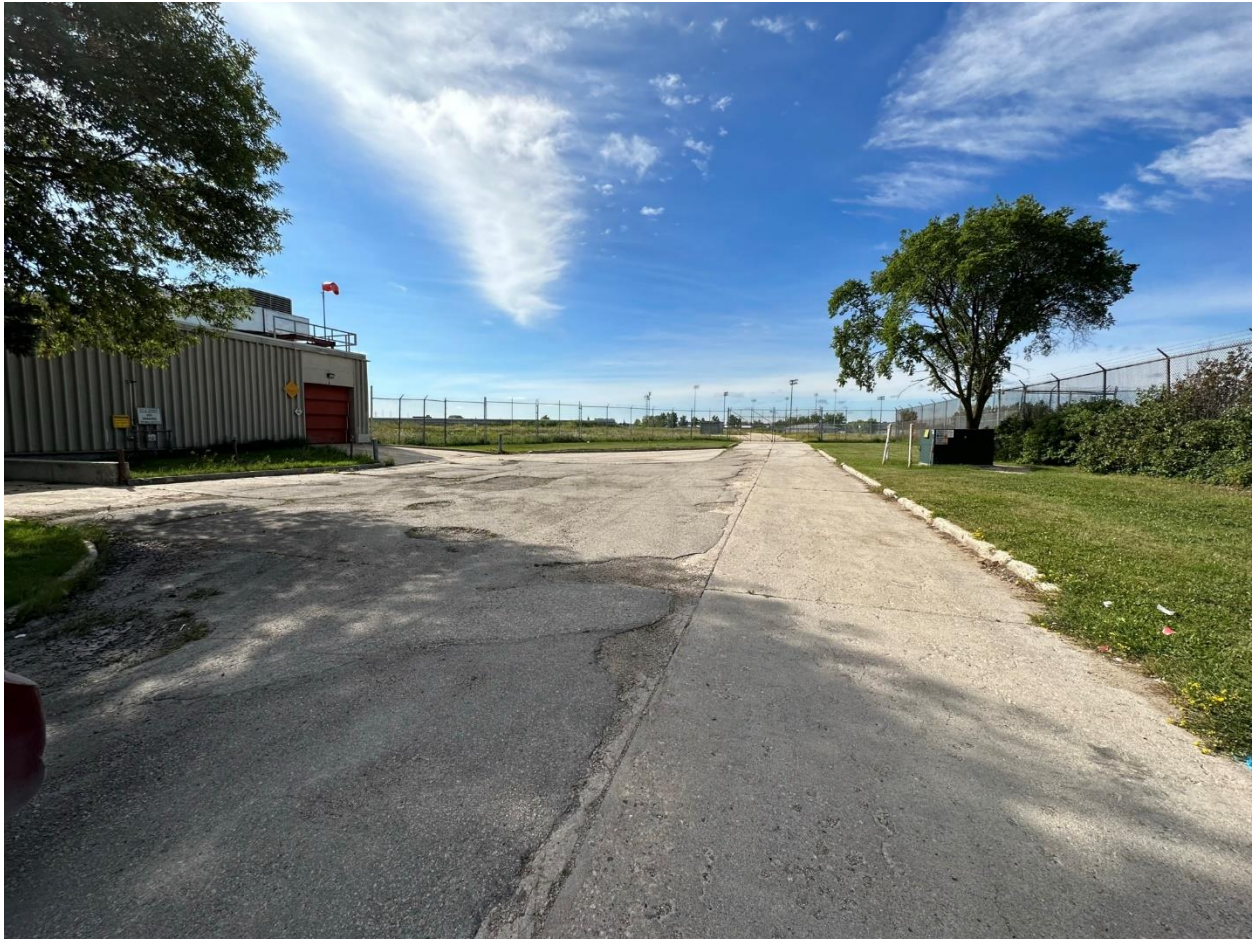
Figure 17: Site access, looking south.
