Appendix E – Site Photos

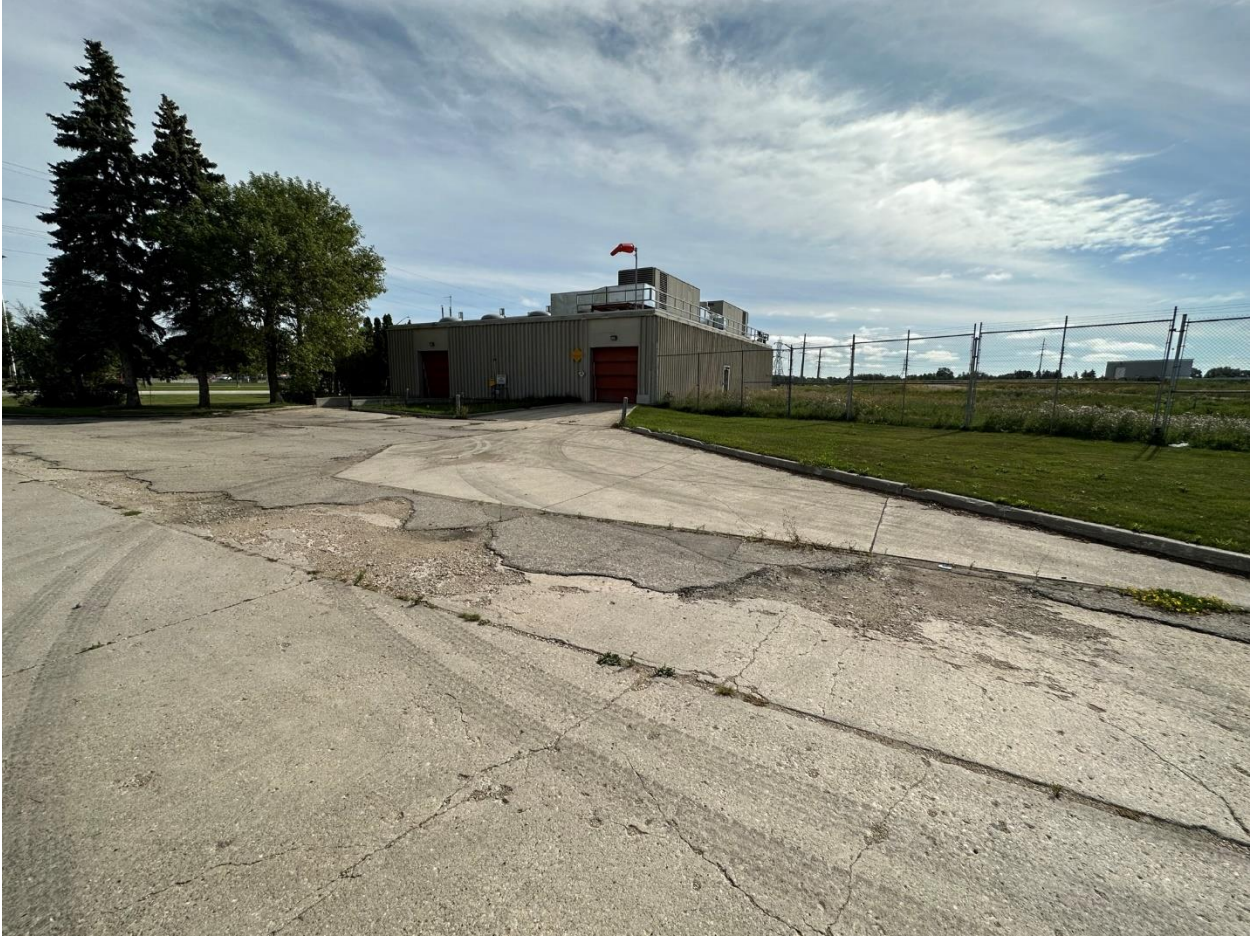
Figure 18: Site access, looking east.

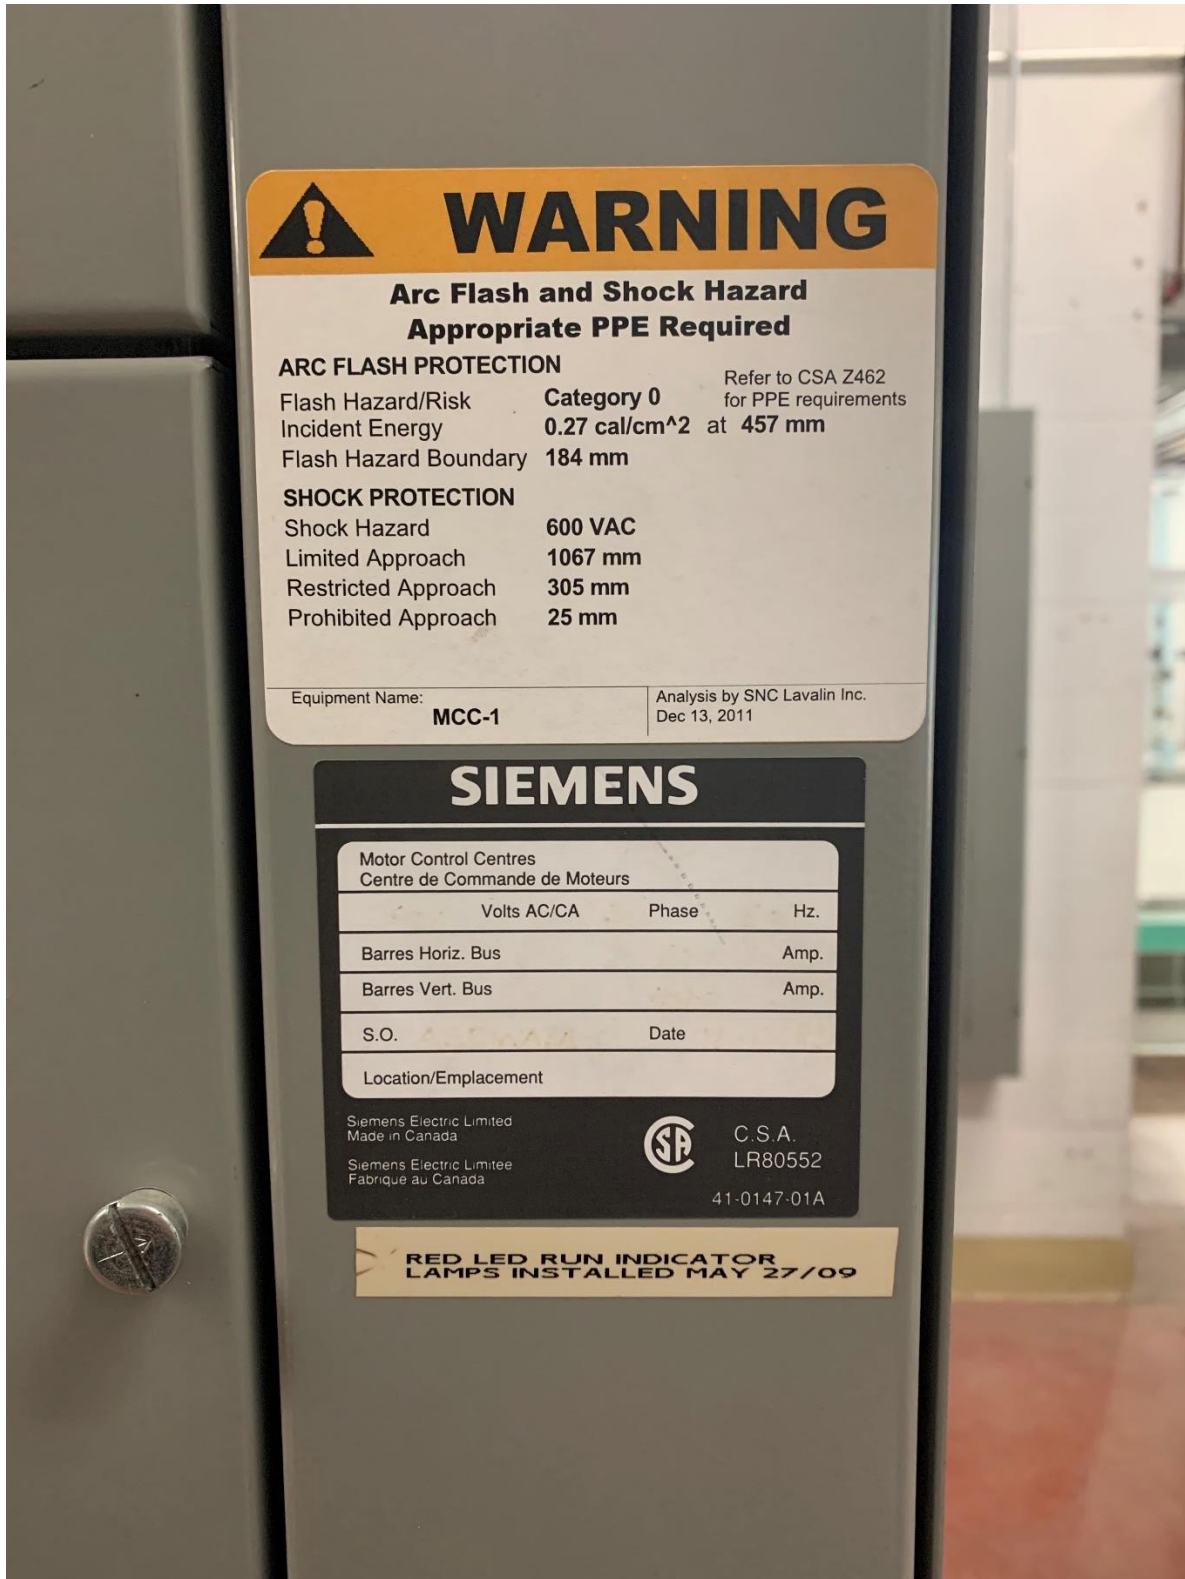
Figure 19: Existing MCC-1 labels.

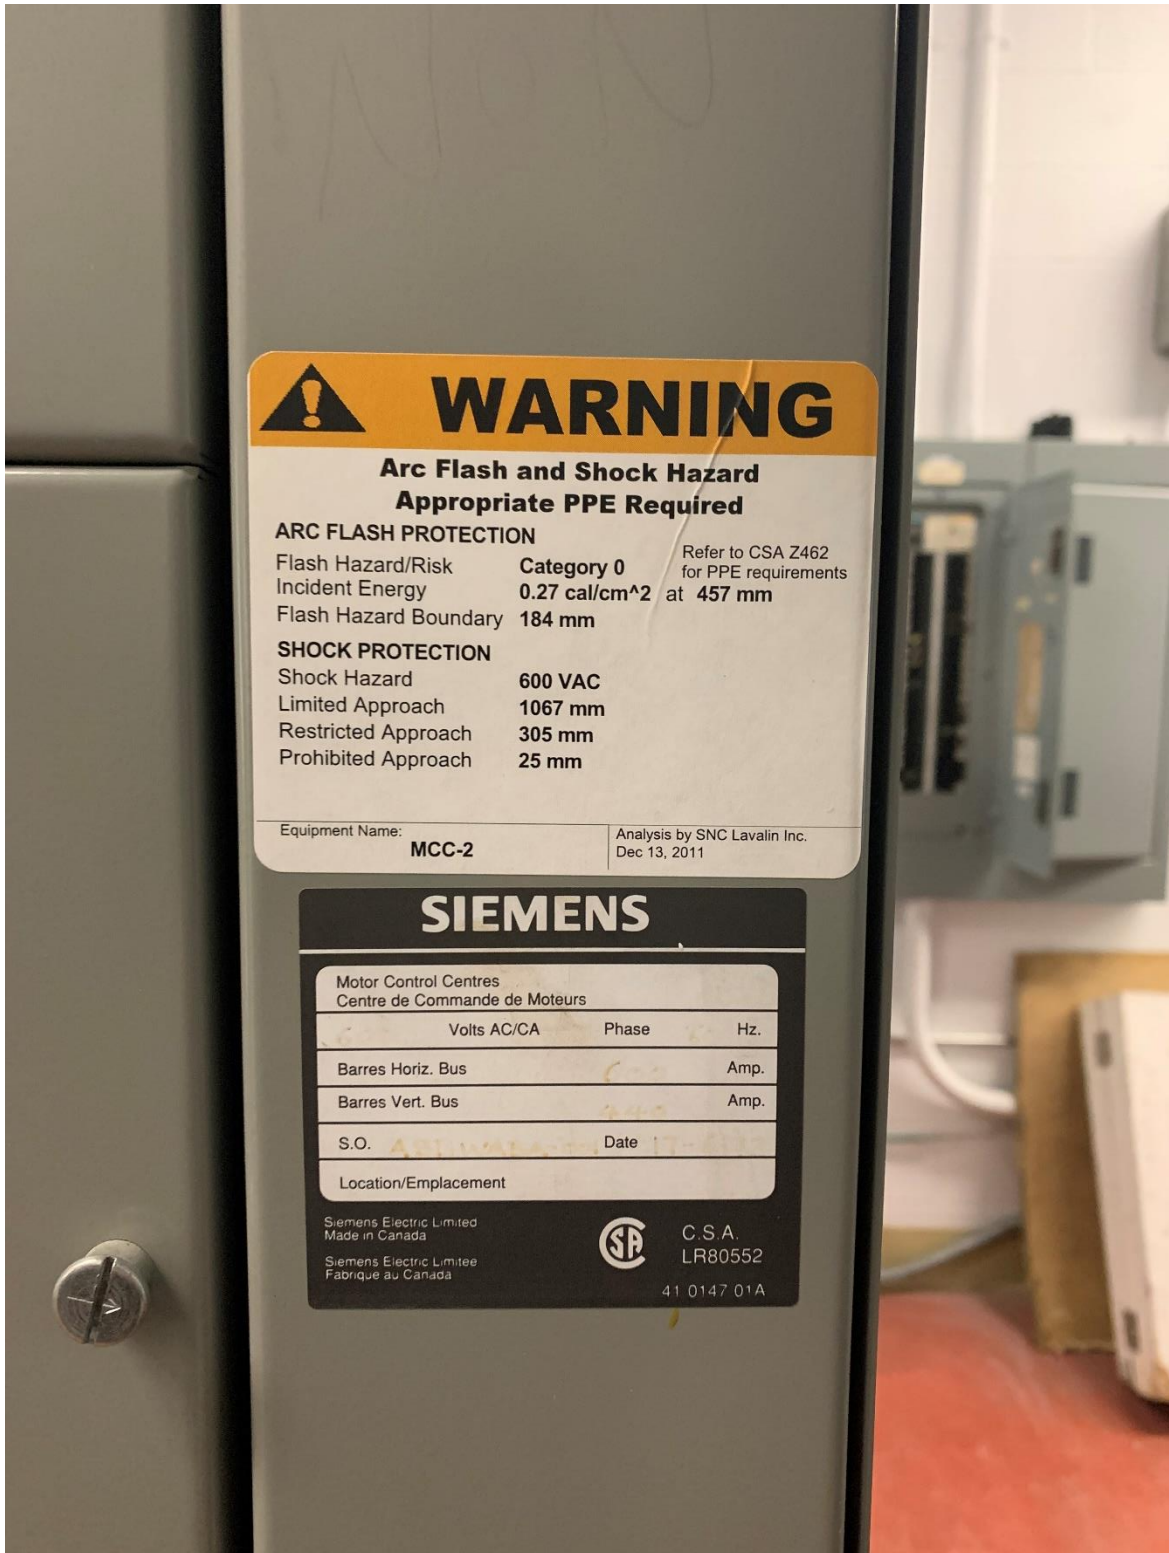
Figure 20: Existing MCC-2 labels.
