ASBESTOS INVENTORY CONTROL

Building Name:	Sargent Park Pool
Building Code:	PI-09
Building Address:	999 Sargent Ave
Inspection Date:	June 8/2010
Inspected By:	Bill Hickey & Nic DeMelo
Construction Date:

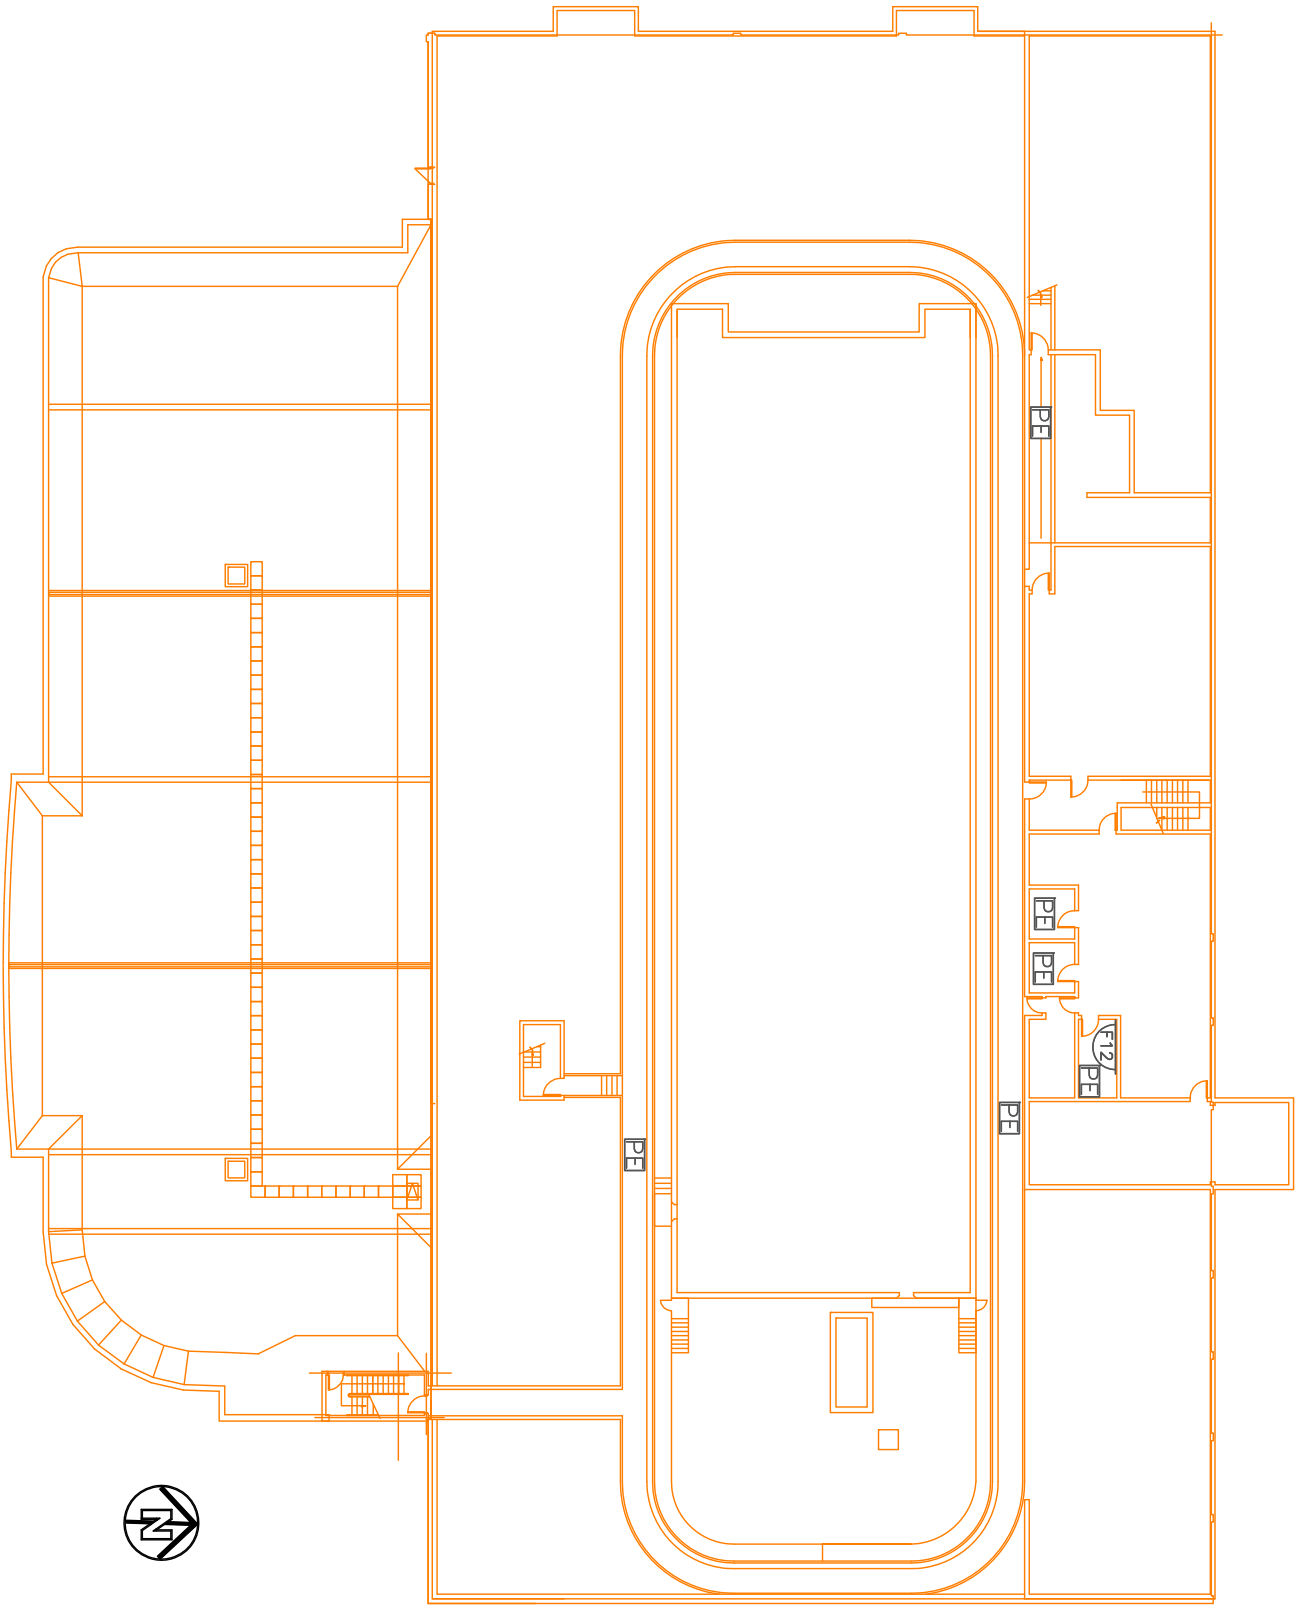
BASEMENT

Asbestos Location	Description	Application Type	Estimated %	Condition	Area Tested	
					Yes	No
All Stucco Ceilings Contain Asbestos (1-2%)						
<u>Basement</u>						
Electrical Room	Pipe Elbows	PW	0%	G	X	
	Duct Insulation	D	0%	G	X	
Pool Engineers Office	Pipe Elbows	PW	0%	G	X	
	Duct Insulation	D	0%	G	X	
	12x12 Floor Tile	F		G	.	X
Electrical Tool Storage Room	Pipe Elbows	PW	0%	G		X
Electrical Chemical Storage Room	Pipe Elbows	PW	0%	G		X
Hot Water Storage Tank Room	Pipe Elbows	PW	0%	NR	X	
	Tank Insulation	TI	0%	G	X	
	East Tank Insulation Tested - 0% Asbestos	TI	0%	G	X	
South Track	Pipe Elbows	PW	0%	G		X
Filtration & Pump Room/Pit	Pipe Elbows	PW	0%	G	X	
North Track	Pipe Elbows	PW	0%	G		X
West Crawlspace	Pipe Elbows	PW	0%	G	X	
<u>Garage</u>						
Corridor Along Track To Garage	Pipe Elbows	PW		G		X
Garage Bathroom	12x12 Floor Tile	F	0%	G	X	
Parks Office	12x12 ceiling Tile	C	0%	NR	X	
Garage Mezzanine	Pipe Elbows	PW	0%	G	X

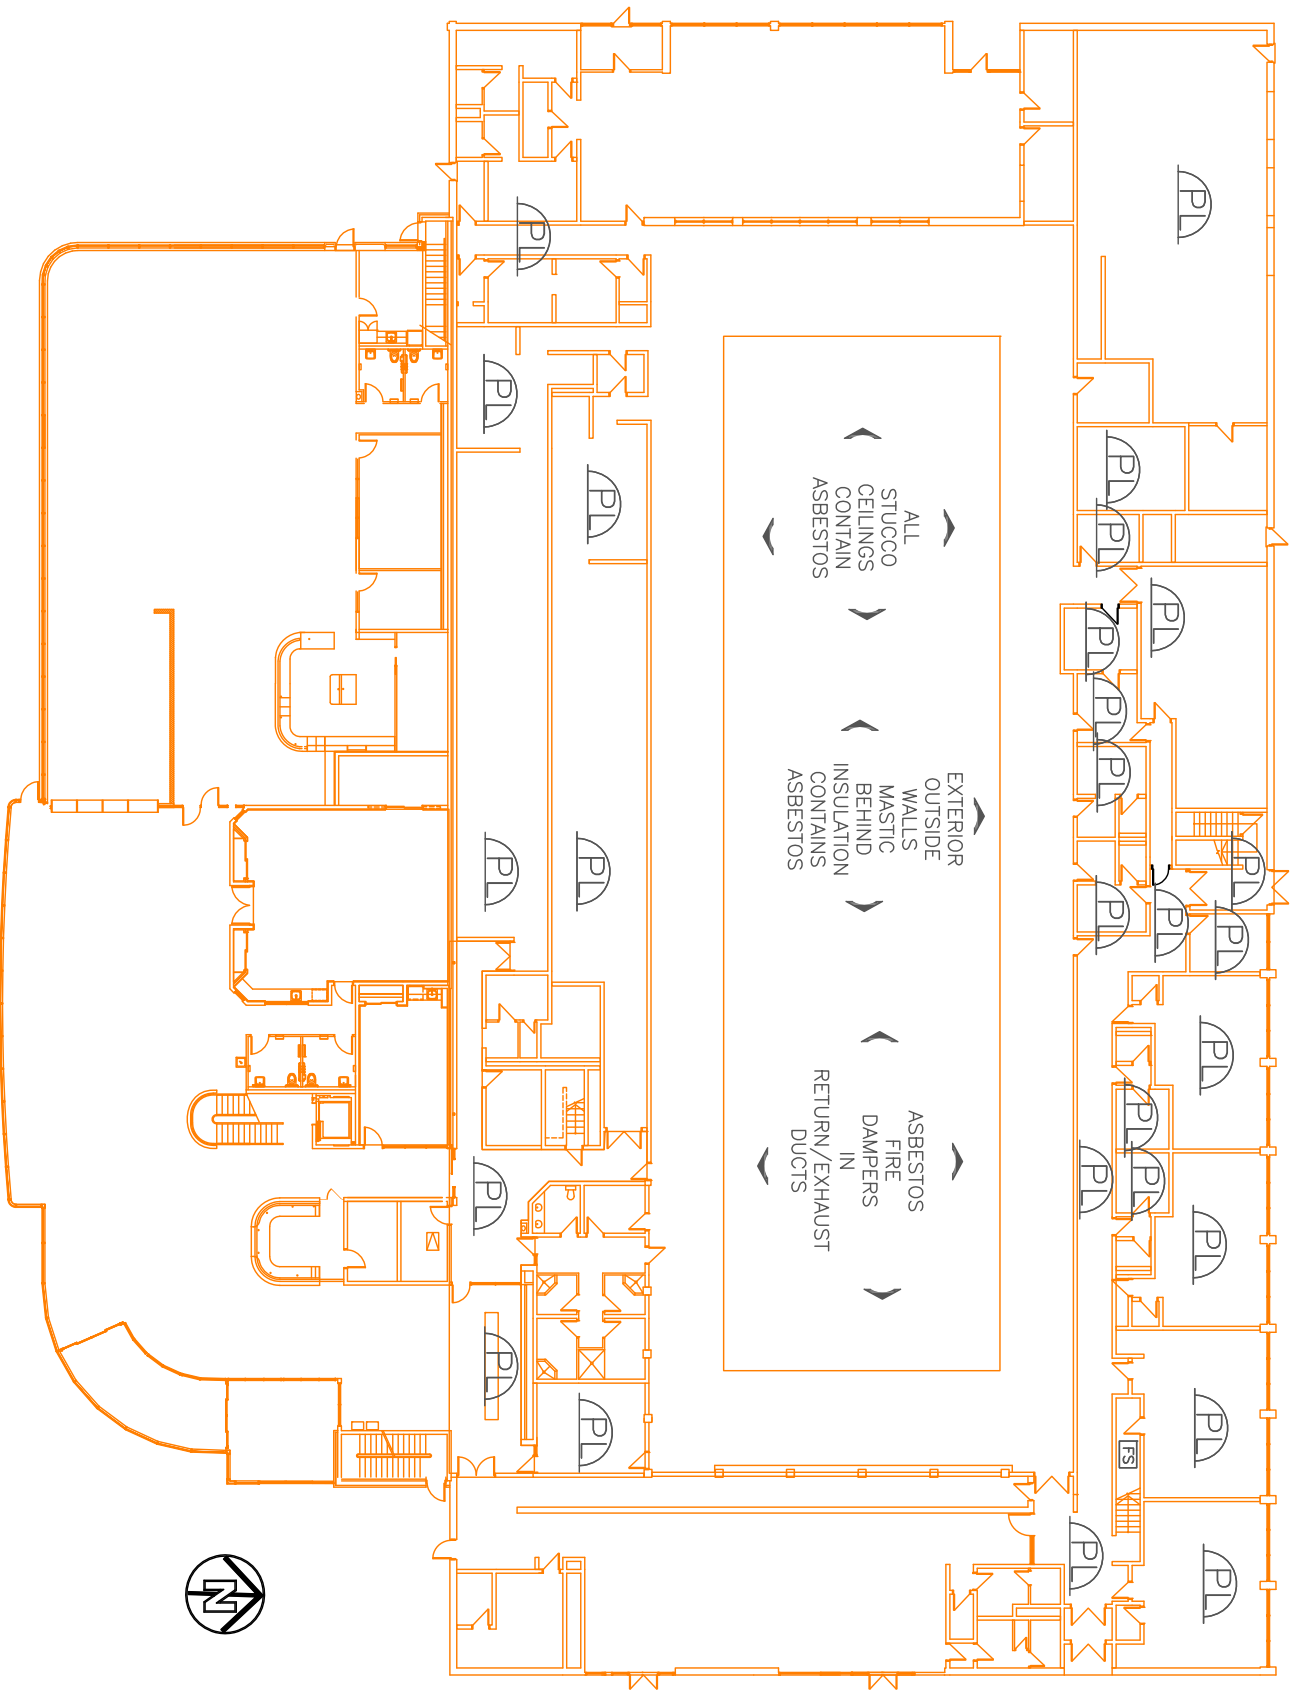
MAIN FLOOR

<u>Main Floor</u>						
All Return/Exhaust Ducts	Contain Asbestos Sheet Fire Dampers	AF		G		X
All Stucco Ceilings Contain Asbestos		PL	1-2%	G	X	
East Side Gym Ceiling	Ceiling Tile	C	0%	G	X	
Room # 2 Closet	Sheet Flooring	FS		G		X

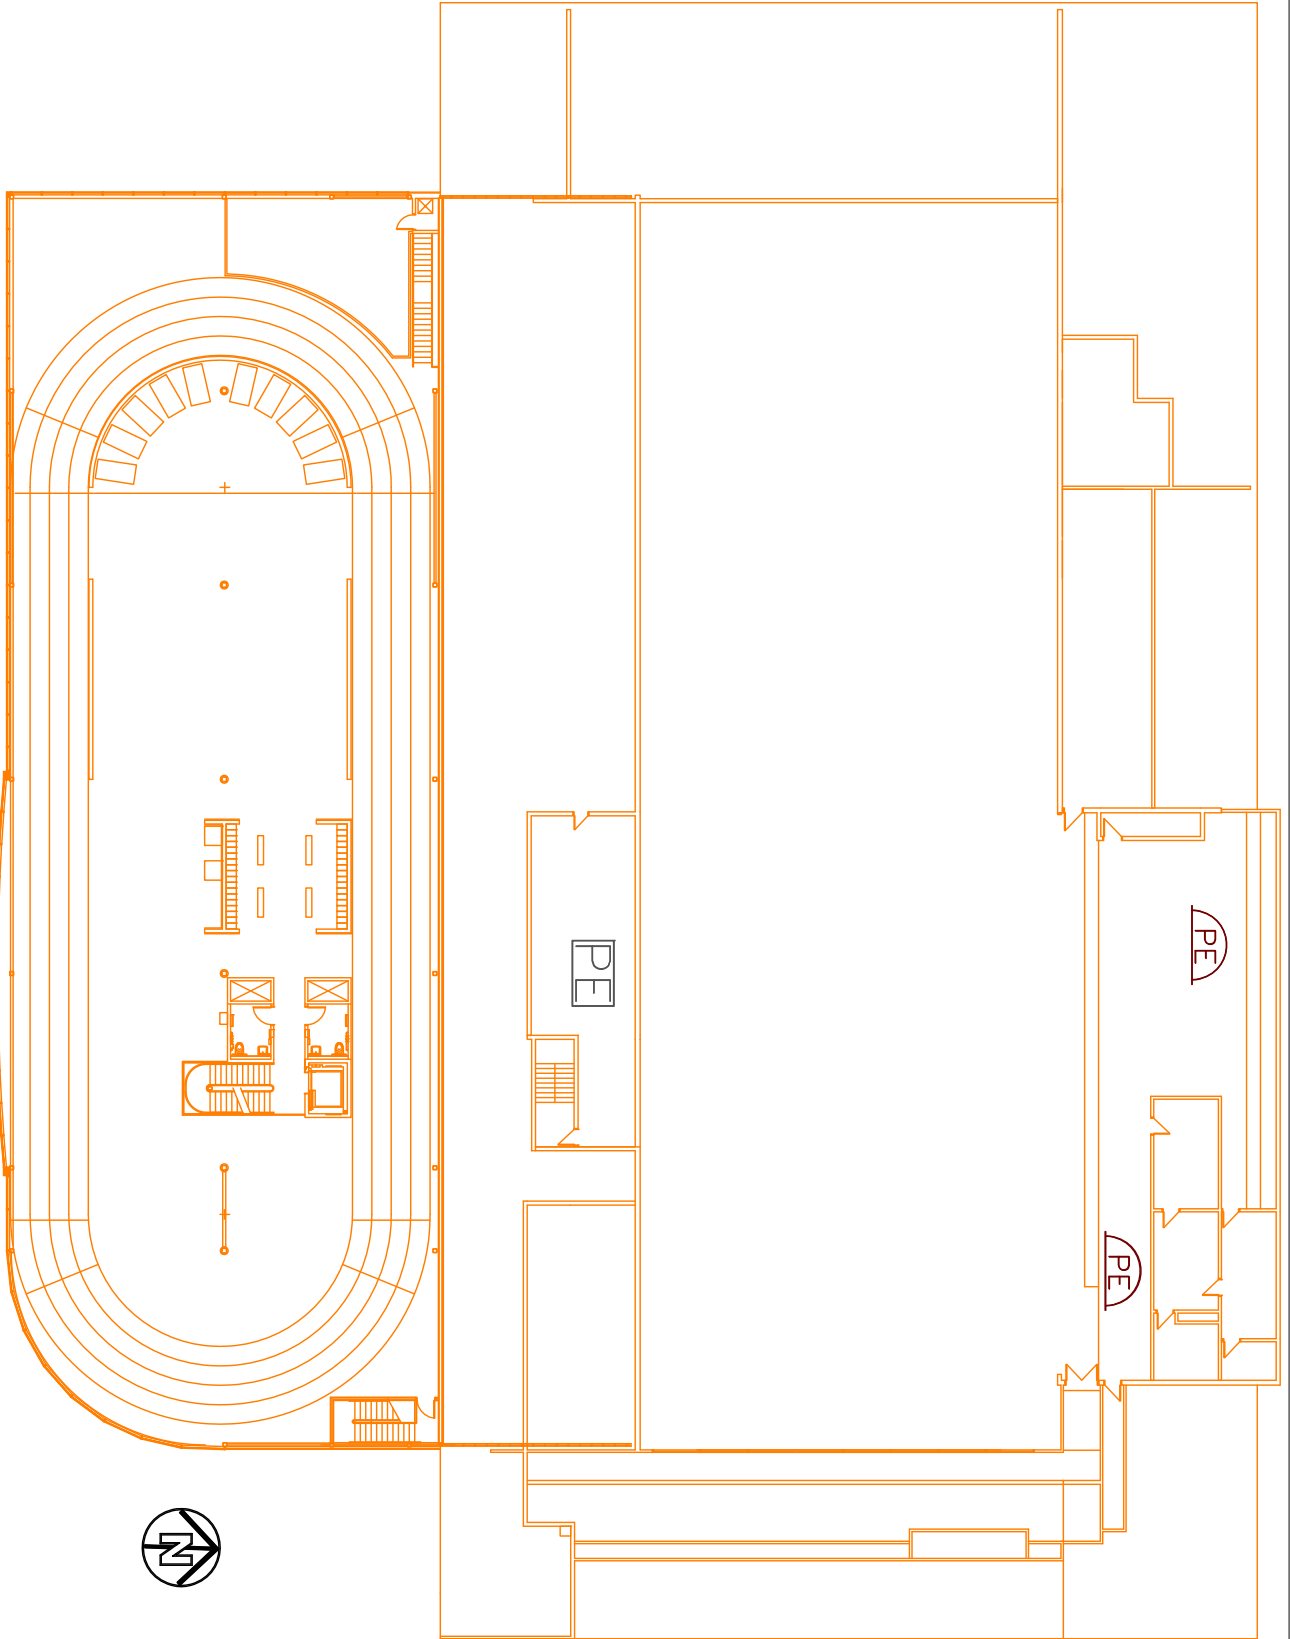
MEZZANINE LEVEL

Asbestos Location	Description	Application Type	Estimated %	Condition	Area Tested	
					Yes	No
Multipurpose room	Scratch Coat Ceiling (Above Metal Ceiling Panels)	C	0%	G	X	
<u>Mezzanine Floor</u>						
All Stucco Ceilings Contain Asbestos		PL	1-2%	G	X	
North Air Handling Room	Spray on Ceiling Ductwork	SO DW	0% 0 %		X X	
North Mezz Lobby & Offices	Ceiling Tile	C	0%	G	X	
North Mezz Above Ceiling Tile	Pipe Elbows & Roof Drains	PW				X
South Mezz Above Ceiling Tile	Pipe Elbows & Roof Drains	PW				X
South Mezz Air Handling Room	Pipe Elbows			R		
North Pool Deck Ceiling	Roof Drains			R		
South Pool Deck Ceiling	Roof Drains			R		
<u>Exterior</u>						
Outside Walls (Behind Insulation)	Mastic	EN	10-20%	G	X	
<ul style="list-style-type: none"> - All vinyl floor tile installed before 1990 may contain asbestos and therefore must be treated as an asbestos containing material - Vermiculite insulation may contain pockets of asbestos, therefore all vermiculite must be treated as an asbestos containing material - There may be asbestos containing materials present that were not located during building inspections - For handling procedures call Central Control 986-2382
