# **NorthEnd Water Pollution Control Centre Storage Tank #5**

## **Concrete and Corrosion Assessment**

*Prepared For: Water & Waste Department – Project Planning and Delivery*

*May, 2010*

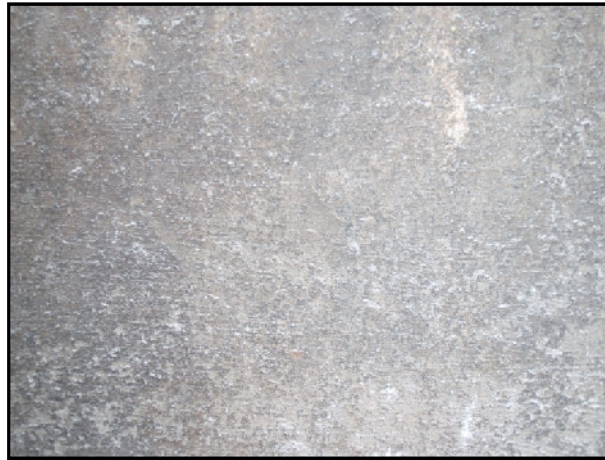
1) Level 1 – 0 to 1.2m:

No loose material, sound  
concrete

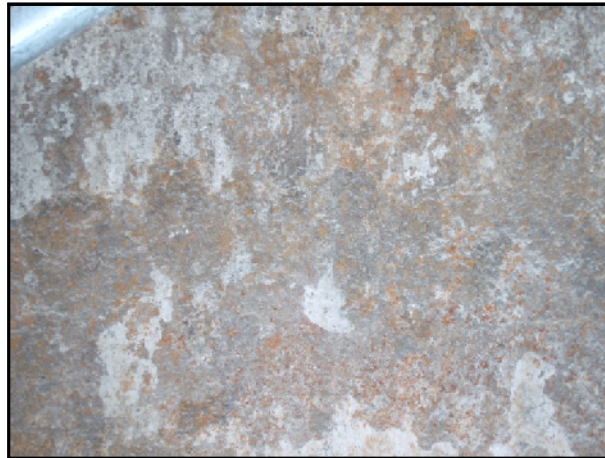
2) Level 2 – 1.2 to 2.7m:

Deposited material, when  
scraped away reveals sound  
concrete, with some loss of  
fines

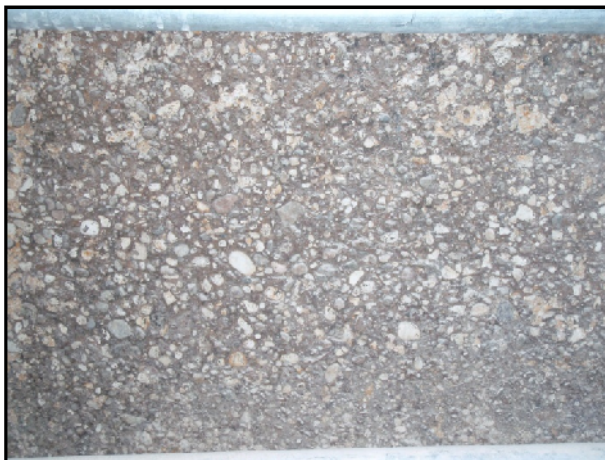
3) Level 3 – 2.7 to 3.6m:

Eroded all surface fines,  
exposed aggregate finish, but  
solid substrate

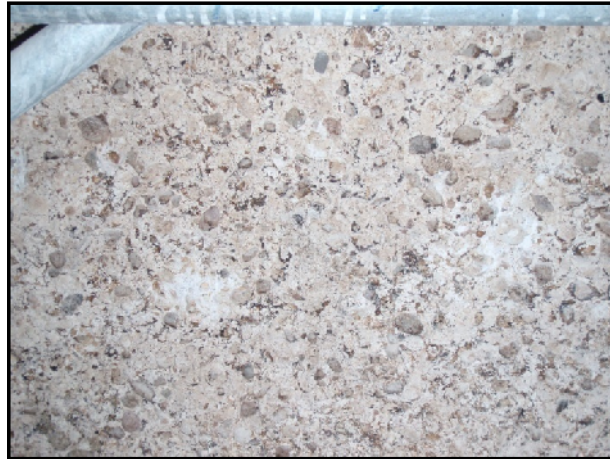
- 4) Level 4 – 3.6 to 5.7m:  
Deterioration increasing with height from eroded surface fines at the bottom to severely decomposed cement paste at the top.

Following surface preparation would be the decision to rebuild the concrete section loss due to the sulphate attack. There may also be an inherent difficulty with the application of a coating on a very uneven surface, namely in Level 4 and 5. The deterioration at these Levels will have left a very roughened surface that may not allow a coating to be installed with without defects. There are some coatings that require a smooth surface for proper installation. This concrete replacement can be either hand applied or with mechanical means such as shotcrete or spray applied mortars. It is recommended that the missing concrete is rebuilt to restore the original structural capacity of the concrete and provide a smooth surface for protective coating or lining system.

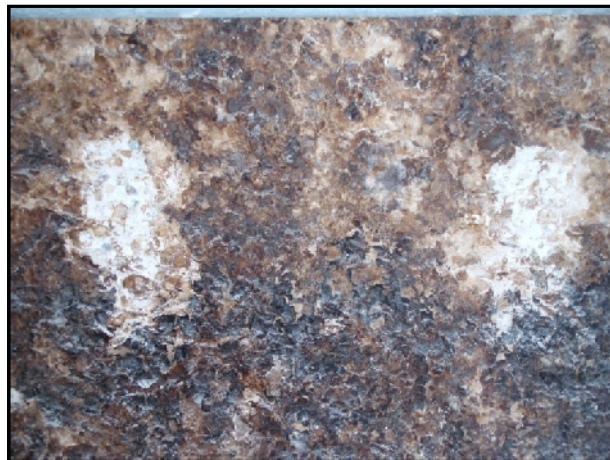
- 5) Level 5 – 5.7 to 7.9m:  
Relatively even deterioration over the height with severely decomposed cement paste throughout. Level is differentiated by dark crusted surface likely from deteriorated coating.

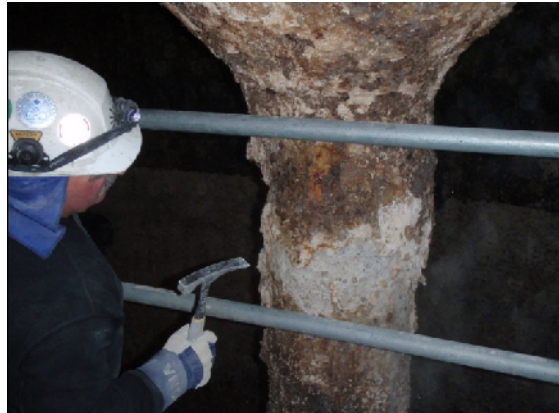
hand, but 15cm rings were scraped at different heights to determine the deteriorated circumferences of the columns. On average, it was measured that the columns had lost nearly 18mm of concrete surface, ranging from 26mm to 19mm. This includes an additional 6mm of depth which would completely remove the softened concrete and expose the sound substrate below.

Ring Scraped on Column

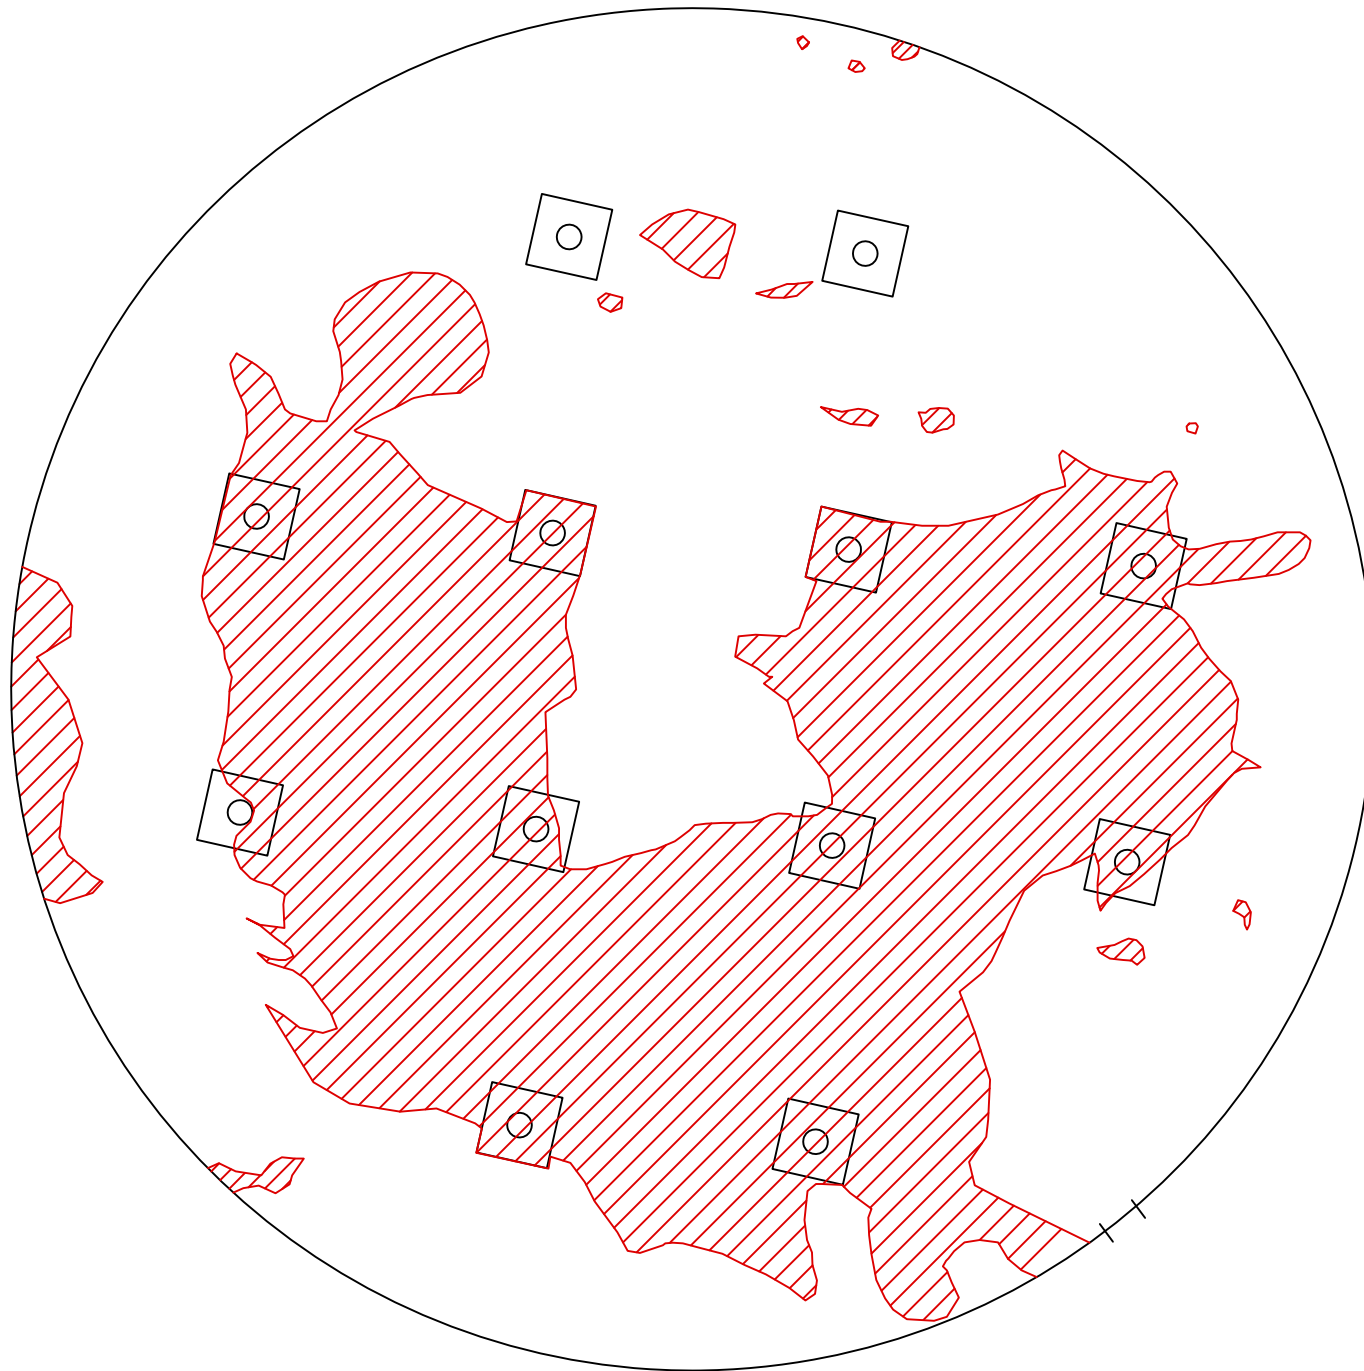
Digestion Tank #5  
Ceiling

Area of  
Concrete Deterioration

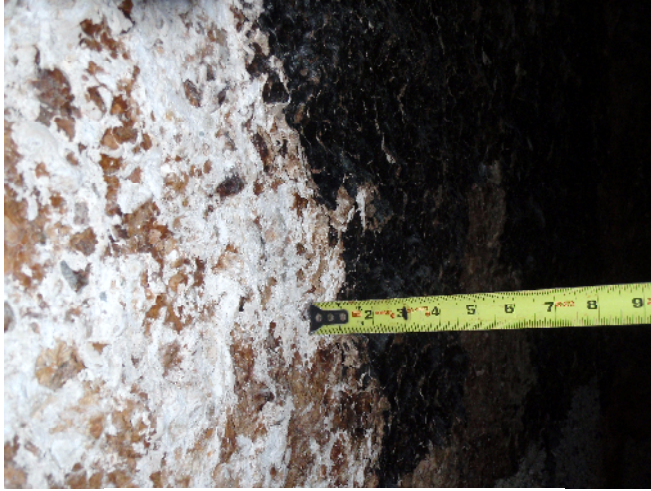
Scraped and Unscraped Level 5

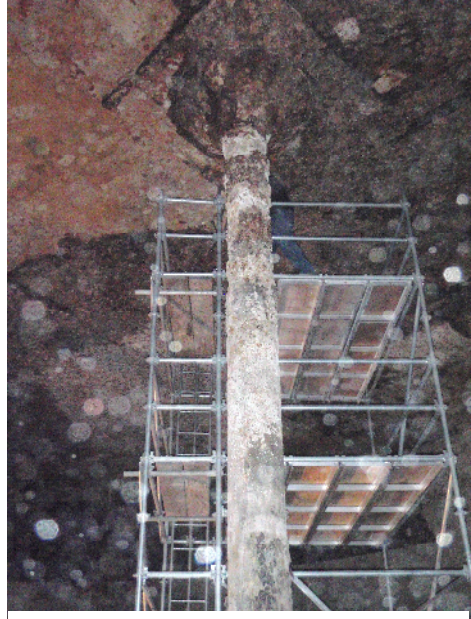
Column with Several Scraped  
Rings for Circumference  
Measurements

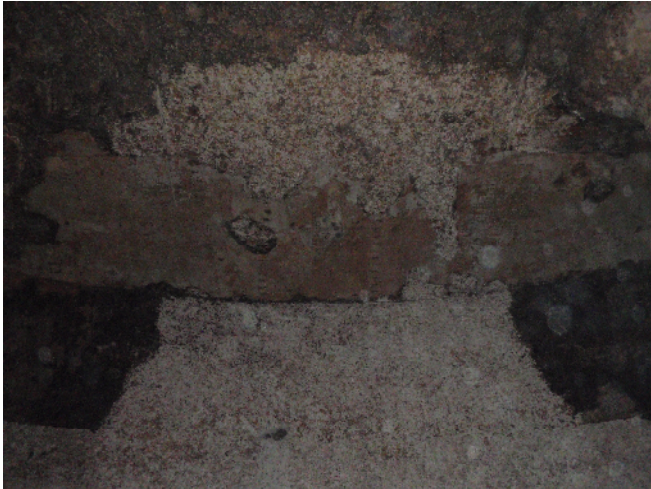
Scraped Section of Ceiling

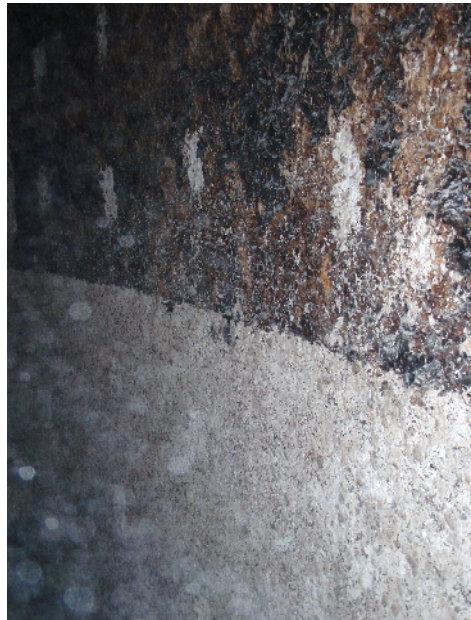
Levels 4 and 5, with Scraped  
Spots for Corrosion Potential  
Measurements

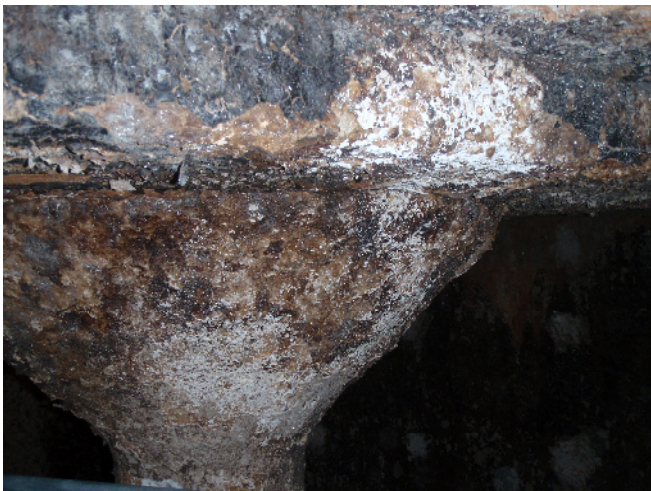
Column Capital with Scraped Edges
