MMM Group Limited
Suite 111-93 Lombard Avenue
Winnipeg, MB R3B 3B1
t: 204.943.3178 | f: 204.943.4948

July 9, 2010

Ref. No. 5509123.101.710

Re: NEWPCC Digester Number 11 – Roof Underside and Wall Interior Condition Assessment

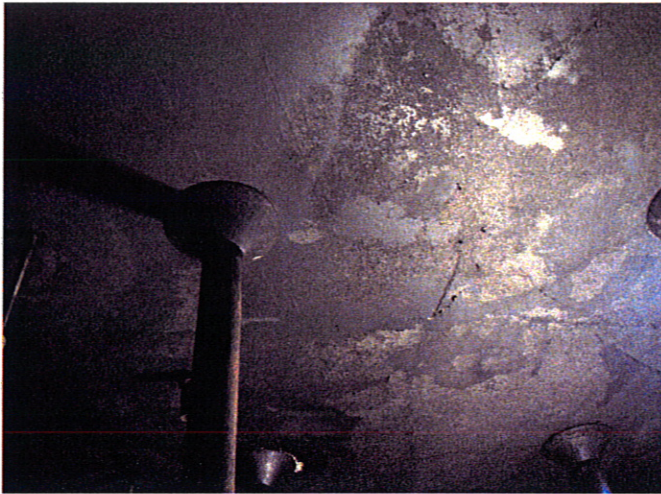
By comparing the cracks observed previously on the top of the roof with those observed from below the roof, it is apparent that many cracks penetrate completely through the slab (see attached crack map sketch). Differences in elevation across a crack were also observed from below the roof slab that mirror those previously observed from above. See Photos 1 and 2 below. This is concerning in that it indicates a failure of the reinforcing steel in this plane.

Photo 1: Cracks on underside of roof slab.

Given the observed condition of the digester roof, we recommend that the roof be replaced or strengthened depending on the results of the next phase of work (design).

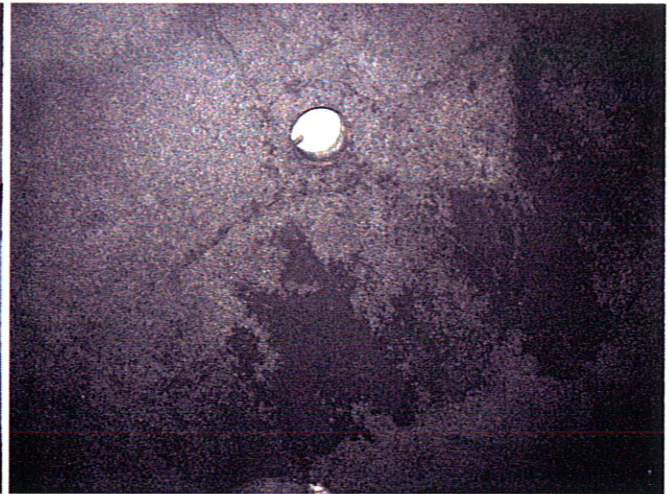
Photo 2: Cracks in roof slab around opening.

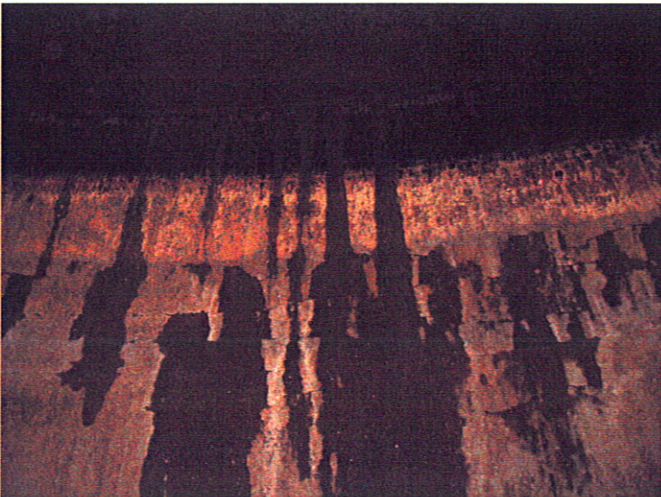
The horizontal cracks on the interior wall of the distiller appear to be old (See Photo 3). Areas of roof membrane and effluent residue are loose with some pieces having fallen to the floor below. The sizes of these pieces are as large as one square foot and up to one inch thick. MMM was informed that the roof pieces fell as a result of pressure washing the bottom of the roof slab. The fallen pieces are all located in patches around the column capitals. Several of the column capitals have minor vertical cracks on the surface. There was no visible damage to any of the columns. See Photo 4.

Photo 3: Horizontal cracks on interior wall.

The cracks in the interior wall of the digester and column capitals should be filled and sealed to ensure water-tightness of the tank. The soundness of the concrete in the column capitals should be tested by sound hammering to determine the extent of damage prior to repair of the roof.

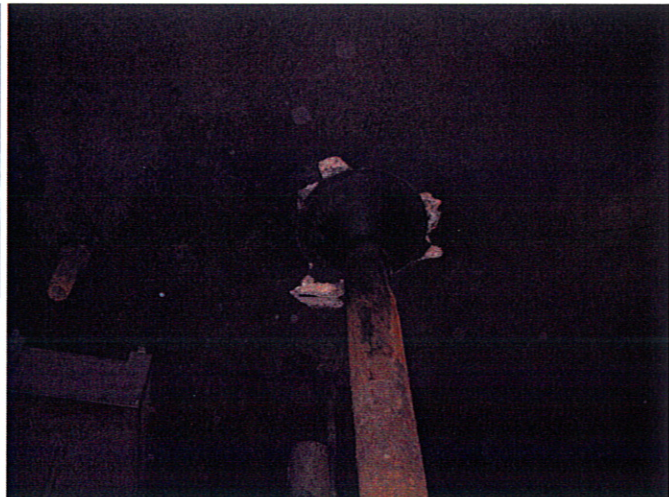
Photo 4: Fallen pieces of roof material around column capitals.

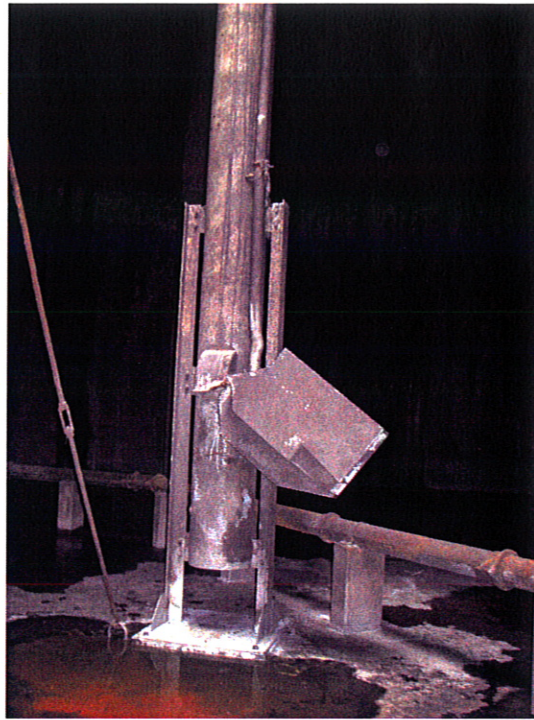
A result of the roof membrane having been raised 0.9 to 1.2m in the centre of the digester, damage to some of the interior equipment that is connected to the roof was observed. See Photo 5.

Photo 5: Damaged internal equipment.
