GEOTECHNICAL REPORT

Geotechnical Report for Corydon Avenue Eastbound

Testhole Location Plan
 Corydon Avenue
 Eastbound Reconstruction
 Lanark Street to Borebank Street

Geotechnical Report for King Edward Street Southbound

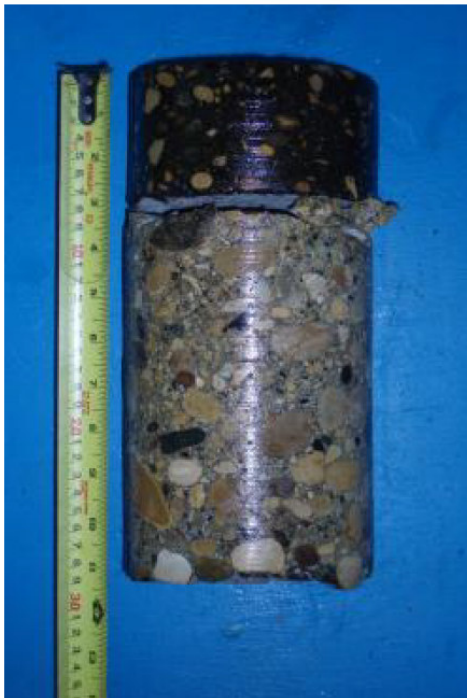
Core sample from Testhole TH3

Asphalt - good condition						
0.1 - 0.3

Concrete - good condition						
0.3 - 0.9

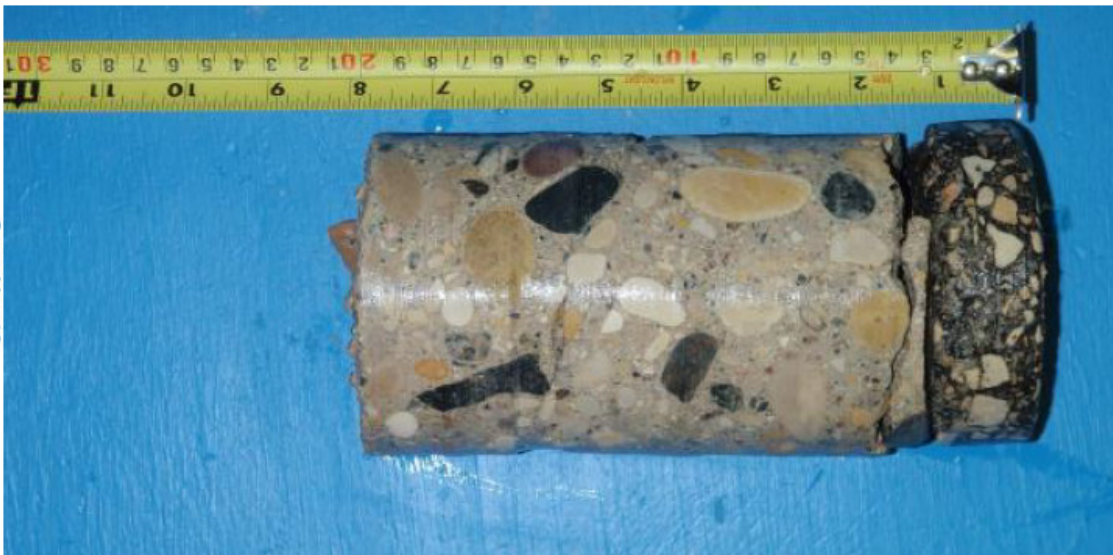
Core No. 16

15	curb lane, 1.7 m from west curb 14628786E, 5530264N	45	190	235	Sound concrete Granular base below pavement structure
16	median lane, 1.6 m from east curb 14628790E, 5530313N	30	170	200	Asphalt pavement not bonded to concrete surface Top 15 mm of concrete shows signs of deterioration Sound concrete below 15 mm Granular base below pavement structure
