## **APPENDIX B – MONTCALM PUMPING STATION HOIST DEVICES AND LIFTING CAPACITIES REPORT**

<b>Station Name:</b>	<u>Montcalm Lift Station</u>
<b>Location of Station:</b>	<u>41 Archibald St.</u>
<b>Date of Inspection:</b>	<u>January 21, 2010</u>
<b>Inspected By:</b>	<u>Damir Muhurdarevic, EIT</u>
<b>Inspecting Firm:</b>	<u>MMM Group Limited (MMM)</u>
<b>Client:</b>	<u>City of Winnipeg – Water and Waste Department</u>

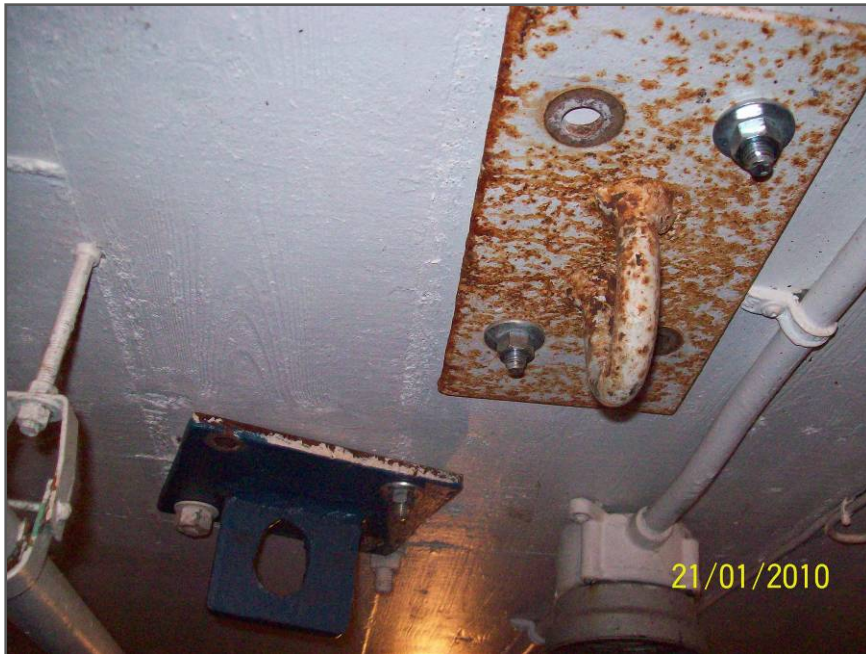
**Photograph No. 1**

The bottom floor pump room contains three (3) eye-shaped hooks fabricated of 19.4mm diameter steel rod, one (1) plate lifting hook hook, and one U shaped hook welded to a plate. Both plates were anchored to the underside of the third floor cast-in-place concrete slab with 12.4mm anchor bolts. Some corrosion appears in the U-shaped hook and its anchor plate, but no loss of sectional area was observed.

Various hooks located in the pump room

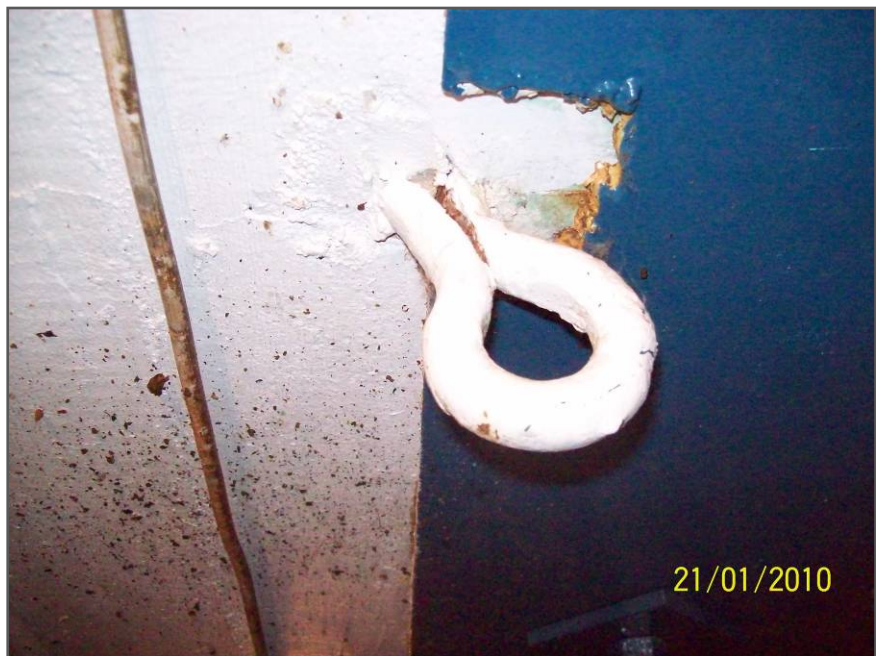
**Photograph No. 2**

Eye-shaped hook located in the pump room (cracked and bent)

Ref.	Description	Priority
4.1	Replace bent and cracked eye-shaped hooks before further use Install stiffeners at shelf angles on S-Beam in the motor room to achieve higher load rating	A
4.2	Paint steel plates and hooks to prevent further corrosion	B

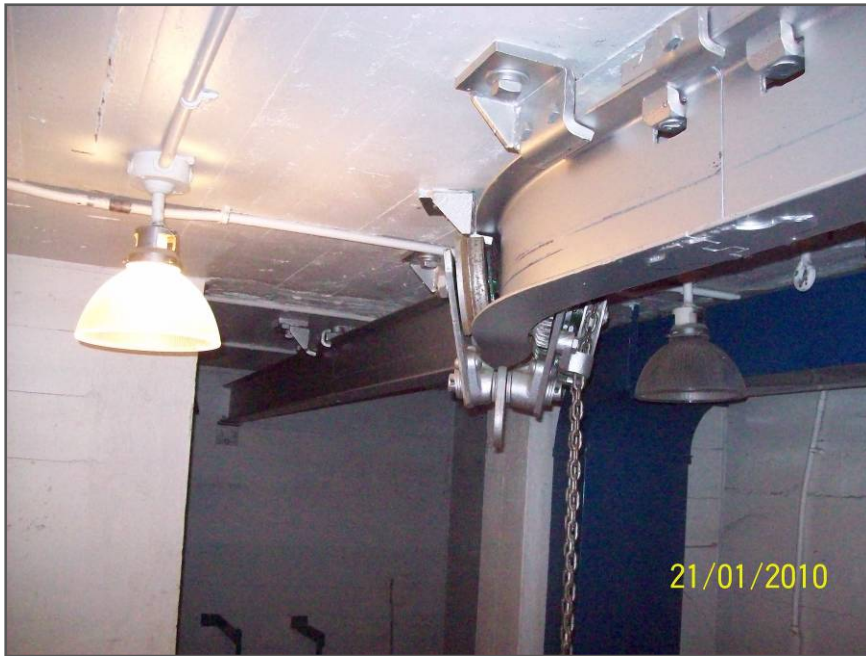
**Photograph No. 3**

The S200x27 beam system on the third floor below ground was analyzed for moment resistance in the beam, tension in the bolts anchored in the concrete slab, the shear resistance and moment resistance in the wall shelf angles. The governing capacity was determined to be 1 ton, which was the moment resistance of the shelf angles, which was assigned as the load rating for the beam system. **The 1.0 ton load rating must be printed on the beam**, as the sliding trolley's posted rating of 2.0 was not accepted

Lifting beam located in the motor room

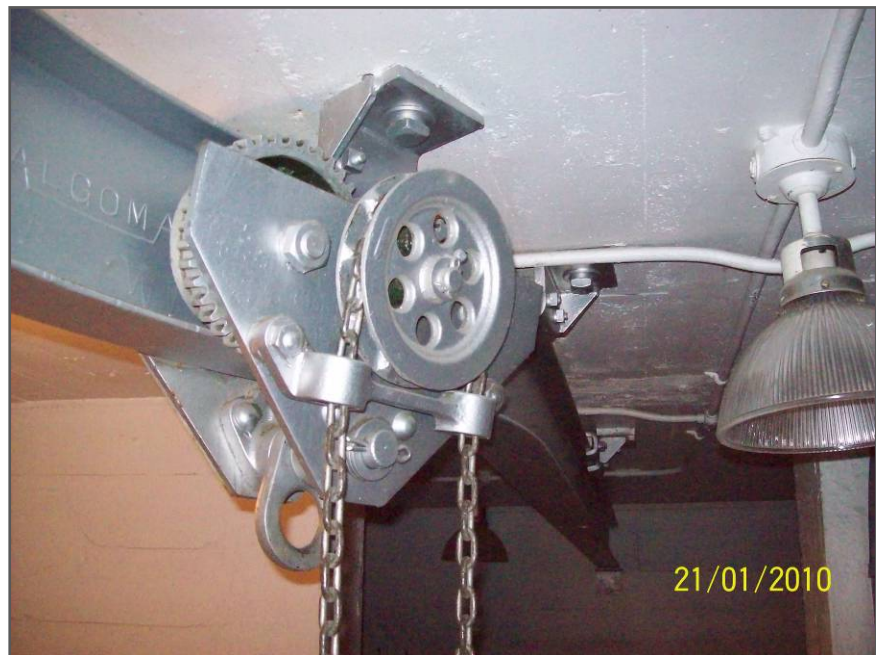
**Photograph No. 1**

Close-up of crane mounted on the lifting beam in Photograph 3

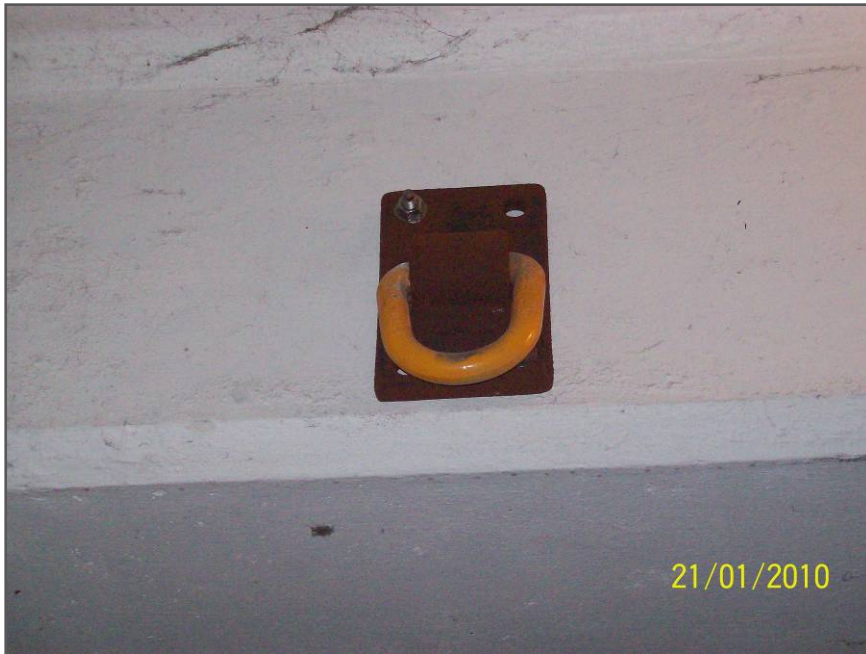
**Photograph No. 5**

The second floor below ground has one (1) U-shaped lifting hook that is attached to a plate that is anchored to a concrete floor beam and one (1) eye-shaped hook, fabricated of 19.4mm diameter steel rod. Some corrosion was observed in the steel plate, but with no loss of sectional area. The motor room on that floor contains four (4) more eye-shaped lifting hooks fabricated of 19.4mm diameter steel rod, and one (1) additional U-shaped lifting hook welded to a steel plate anchored in the concrete, as well as a beam system, which consists of 4 parts of an S200x27 beam. The system spans throughout the entire length of the room, and is supported at the walls with shelf angles that are anchored to the bottom flange of the beam and anchored to the wall with anchor bolts. At two (2) of the three (3) connections between the four (4) parts of the beam there are welds and clamps, and the one (remaining) connection the beam is in two parts and is inserted into one another and clamped as well. Additional supports for the beam are clamps that are holding the beam up and are anchored into the cast-in-place concrete slab in the floor above. There are a total of six (6) of those clamps. The rating of the sliding trolley attached to this S-beam is posted at 2.0 tons.

The U-shaped lifting hook on the second floor below ground was analyzed shear resistance of the bolts, and tension resistance of the hook. The shear resistance of the bolts governed at 3.2 tons. A factor of safety of 3.0 was applied to the beam to yield a **load rating of 1.0 ton**.

Lifting hook on a vertical steel plate, bolted into concrete beam, located on the 2<sup>nd</sup> floor down

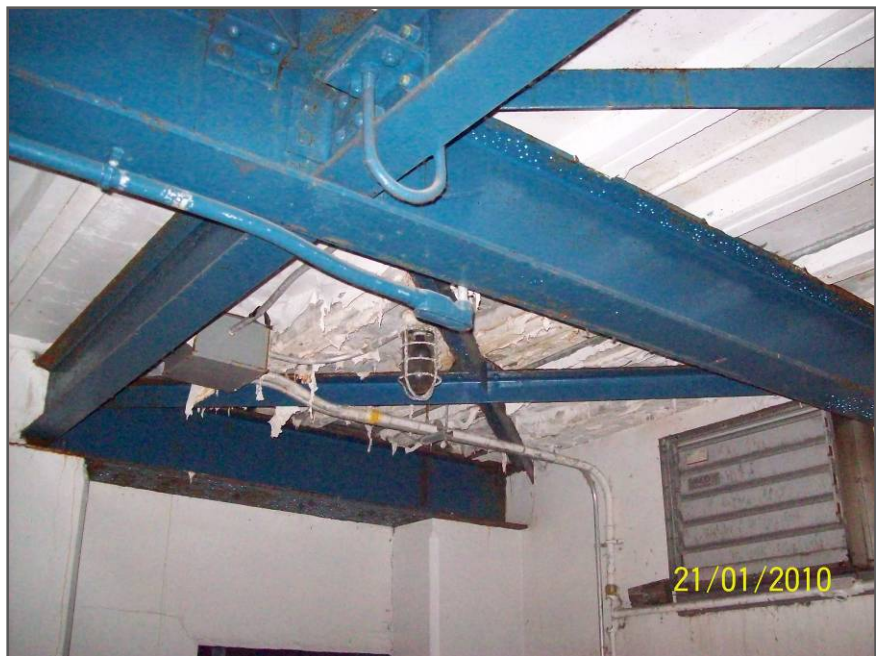
**Photograph No. 6**

The main floor big room has a horizontal truss system with cross bracing. There are three (3) U shaped lifting hooks, fabricated of 19.4mm diameter steel rod, that are connected to an S250x38 beam spanning 2115mm, with double angles bolted on each side of the beam's web. This beam in turn is bolted to a longer beam that spans across the entire width of the room. It is a W310x39 and is 5115mm long.

The horizontal beam truss system was analyzed for the tension resistance of the hooks, the moment resistance in the double angles, moment resistance in the S250x38 beam and the larger W310x39 beam. The moment resistance of the double angles governed at 3.0 tons. A factor of safety of 3.0 was applied to the beam to yield a **load rating of 1.0 ton**.

U-shaped lifting hook bolted to the horizontal truss system located on the main floor

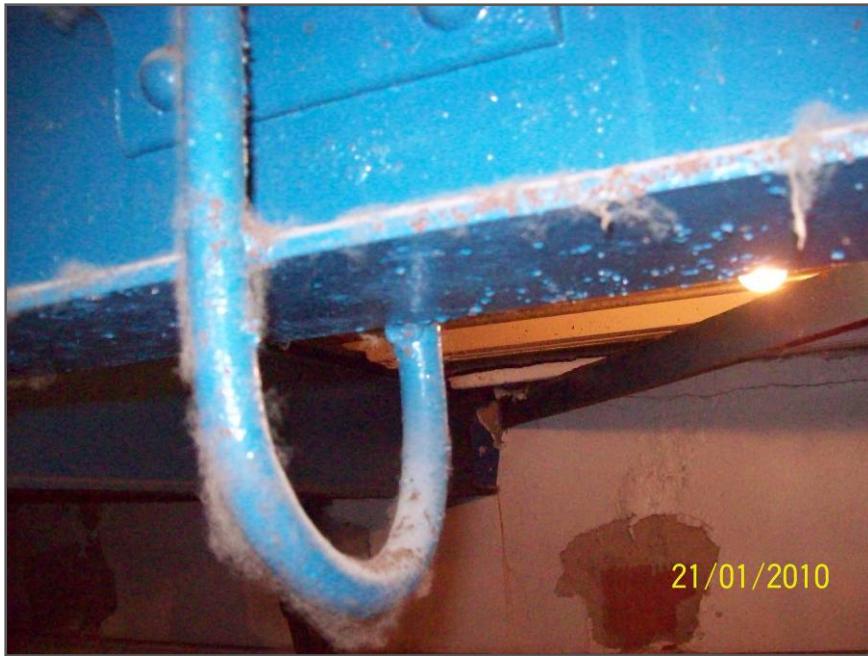
**Photograph No.7**

Close-up of U-shaped lifting hook shown in Photograph No.7

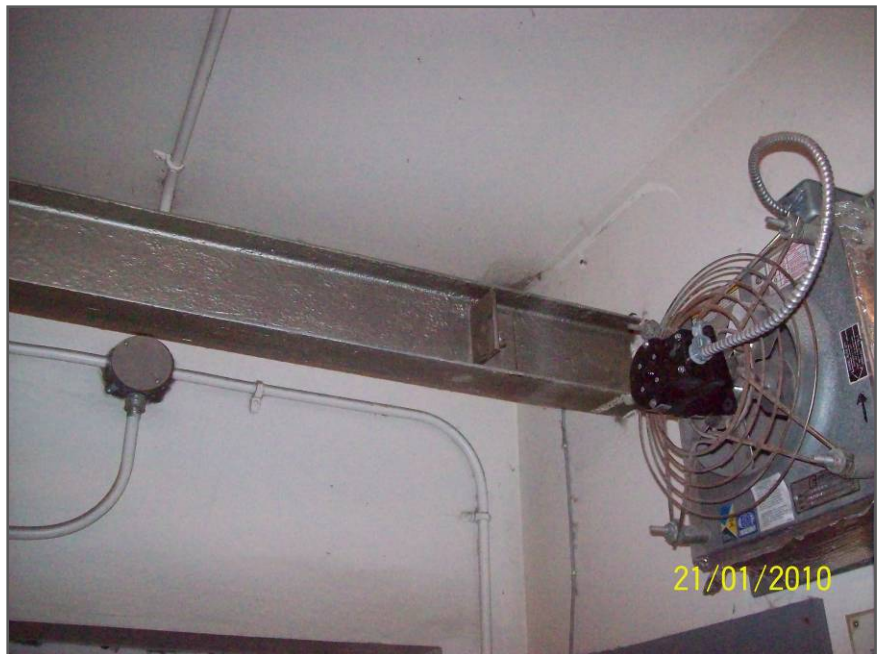
**Photograph No. 8**

The front room on the main floor has a single beam spanning 3000mm across the entire width of the room. It is an S150x19 beam, and its wall connections are not visible, as insulation is exposed. This beam carries a sliding trolley with a ½ ton rating.

The lifting beam in the front room on the main floor was analyzed for moment resistance which was determined to be 3.0 tons. A factor of safety of 3.0 was applied to the beam to yield a **load rating of 1.0 ton**.

Lifting beam located on the main floor, in the front room
