OSBORNE BRIDGE
2009 CONDITION SURVEY
Winnipeg, Manitoba

Prepared By:
TBT Engineering Limited
110 Paramount Road
Winnipeg, Manitoba, R2X 2W3

October 14, 2009

Project No. 09-571

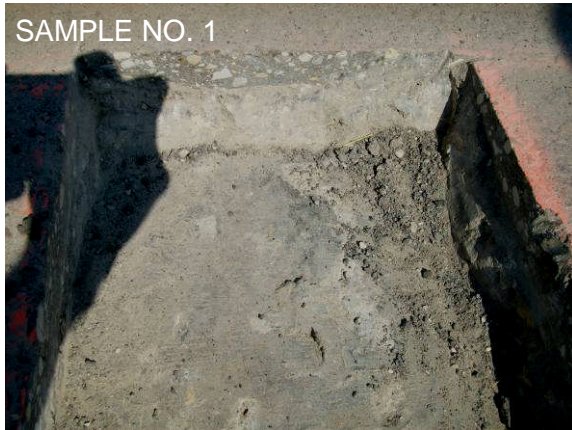
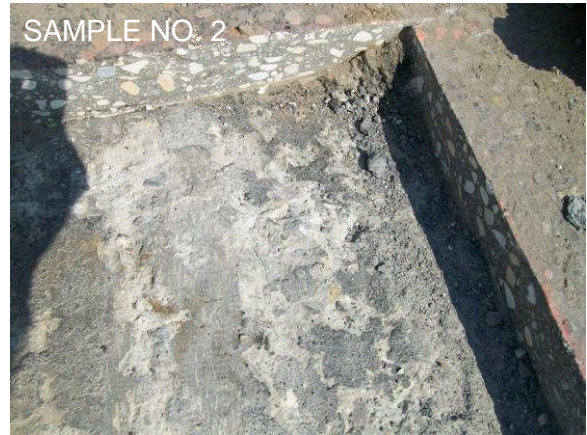
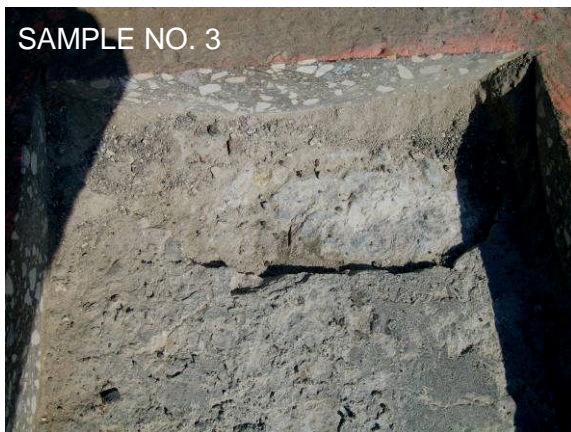
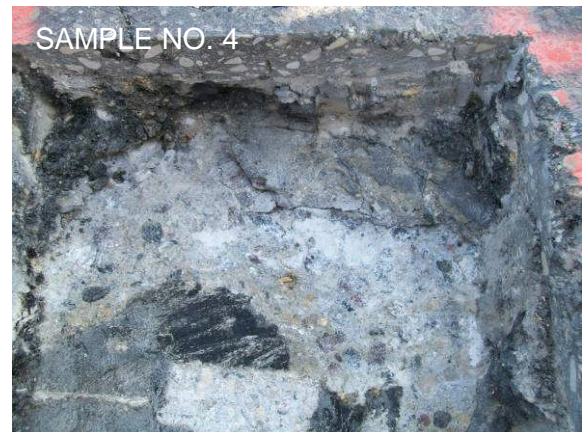
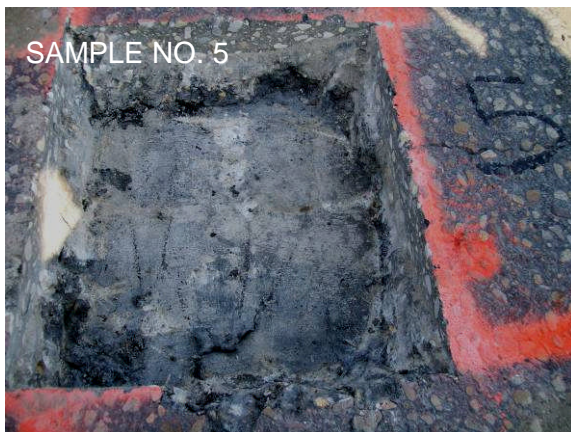
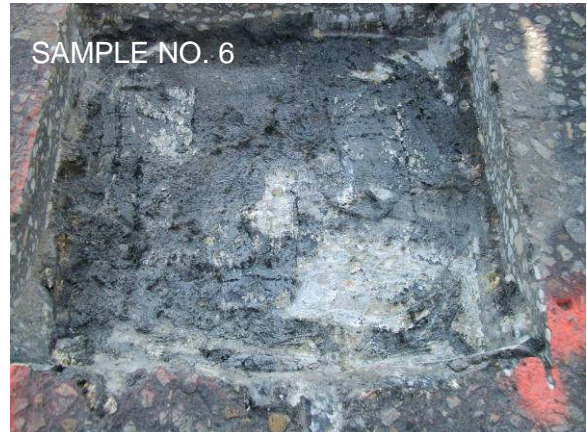
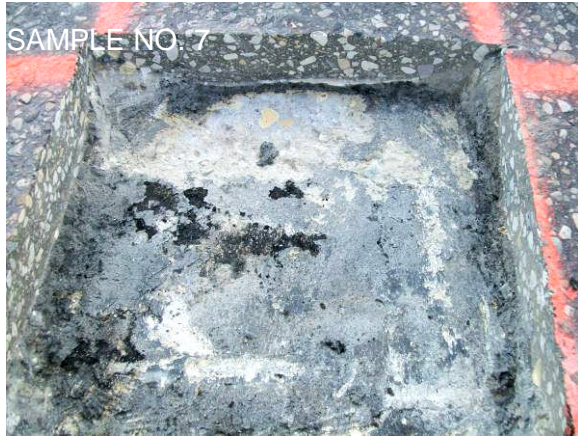
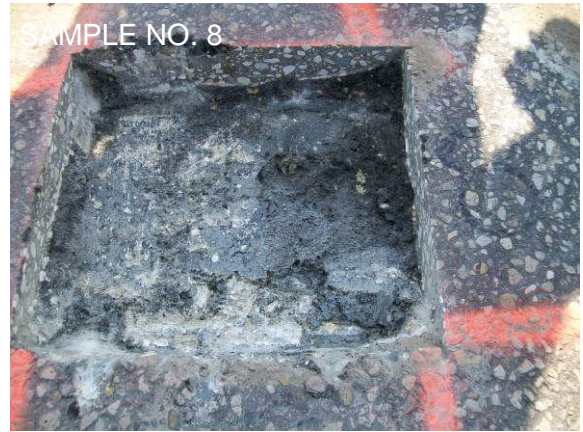
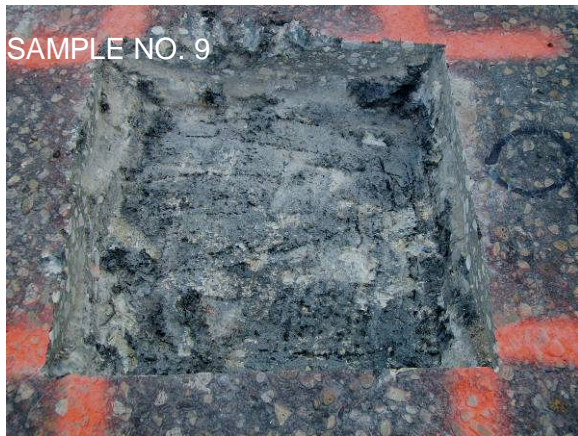
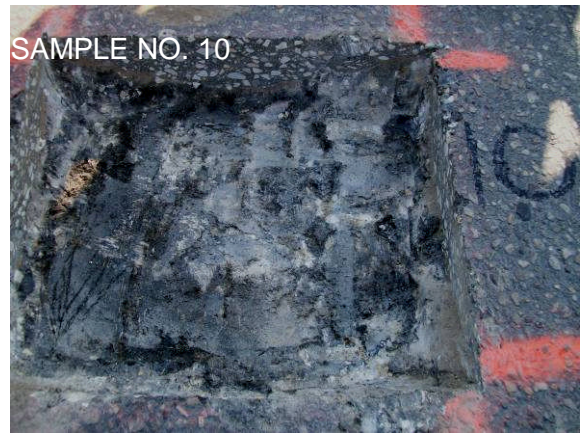
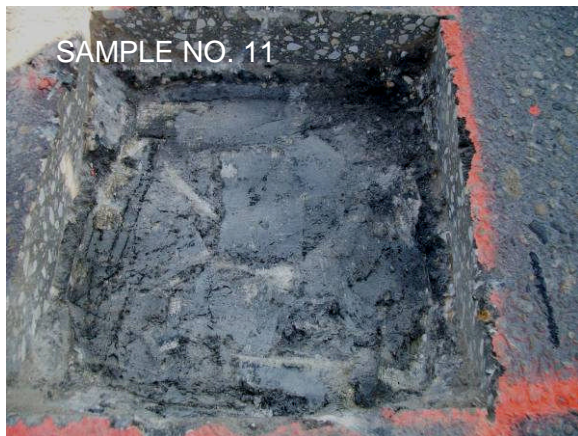
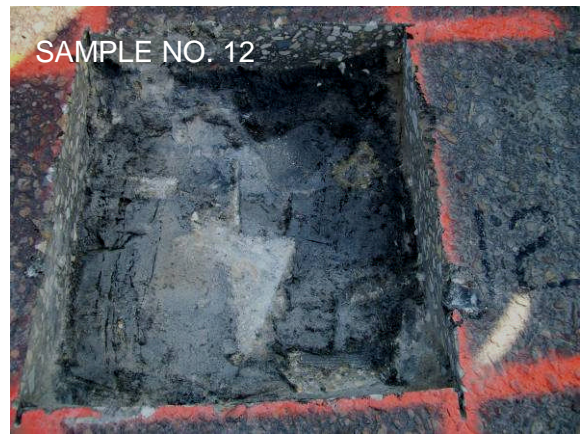
PHOTOS OF SAWN SAMPLES

No evidence of moisture was observed in the surface of the concrete deck beneath the asphalt pavement. Concrete distress in the form of delamination and cracking was observed at the sawn locations in the north bound curb lane (Sawn Sample No. 1 to 3) and at one location at the northbound median lane (Sawn Sample No. 7). It was observed that the bottom surface of the asphalt samples recovered from these locations were covered with approximately 15 to 20% concrete from the underlying deck ranging from 5 to 15 mm in depth. Sound concrete surfaces were observed after removal of asphalt pavement sawn samples from the southbound lanes of the bridge deck. The thickness of the asphalt pavement taken during pavement sawing ranged from 52 to 91 mm with an average value of 73 mm. The depths of concrete cover over the reinforcing steel at these locations ranged from 38 to 49 mm with an average value of 44 mm.

Sample No.	Sample Location	Asphalt Pavement Thickness (mm)	Concrete Cover (mm)	Remarks
1	Northbound lane, 15 m from south expansion joint	75	40	bottom surface covered with 15% substrate concrete ranging from 5 to 15 mm in depth.
2	Northbound lane, 49 m from south expansion joint	52	45	bottom surface covered with 10% substrate concrete ranging from 3 to 8 mm in depth
3	Northbound lane, 105 m from south expansion joint	68	42	bottom surface covered with 15% substrate concrete ranging from 5 to 15 mm in depth
4	Northbound lane, 30 m from south expansion joint	82	38	horizontal crack was observed in the concrete deck
5	Northbound lane, 78 m from south expansion joint	85	47	sound concrete surface
6	Southbound lane, 108 m from south expansion joint	60	41	Sound concrete surface
7	Southbound lane, 46 m from south expansion joint	65	45	bottom surface covered with 20% substrate concrete ranging from 5 to 15 mm in depth

8	Southbound lane, 75 m from southbound lane	69	46	sound concrete surface
9	Southbound lane, 15 m from south expansion joint	74	49	sound concrete surface
10	Southbound lane, 98 m from south expansion joint	85	46	sound concrete surface
11	Southbound lane, 64 m from south expansion joint	91	43	sound concrete surface
12	Southbound lane, 31 m from south expansion joint	74	45	sound concrete surface, evidence of minor spalling was observed.
Average		73	44

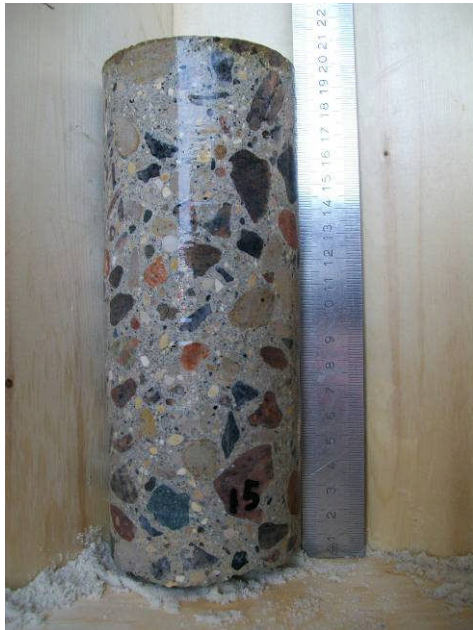
SPAN 1
Core No. 15

Core No.	Location	Thickness (mm)	Compressive Strength (MPa)
15	span 1, northbound lane	188 (full depth)	44.9
5	span 3, northbound lane	162	35.0
1A	Span 2, southbound lane	125	61.4
12	Span 4, southbound lane	125	64.7

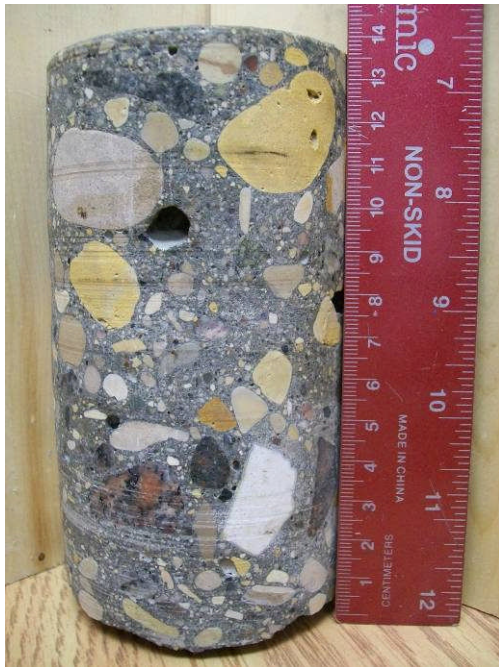
PIER 1

Core No.	Location	Thickness (mm)	Compressive Strength (MPa)
Pier 1	North Pier, south face, 2m above waterline,	130	57.1
Pier 2	Centre Pier, north face, 2m above waterline	145	66.0
Pier 3	South Pier, north face, 2m above waterline	120	51.5

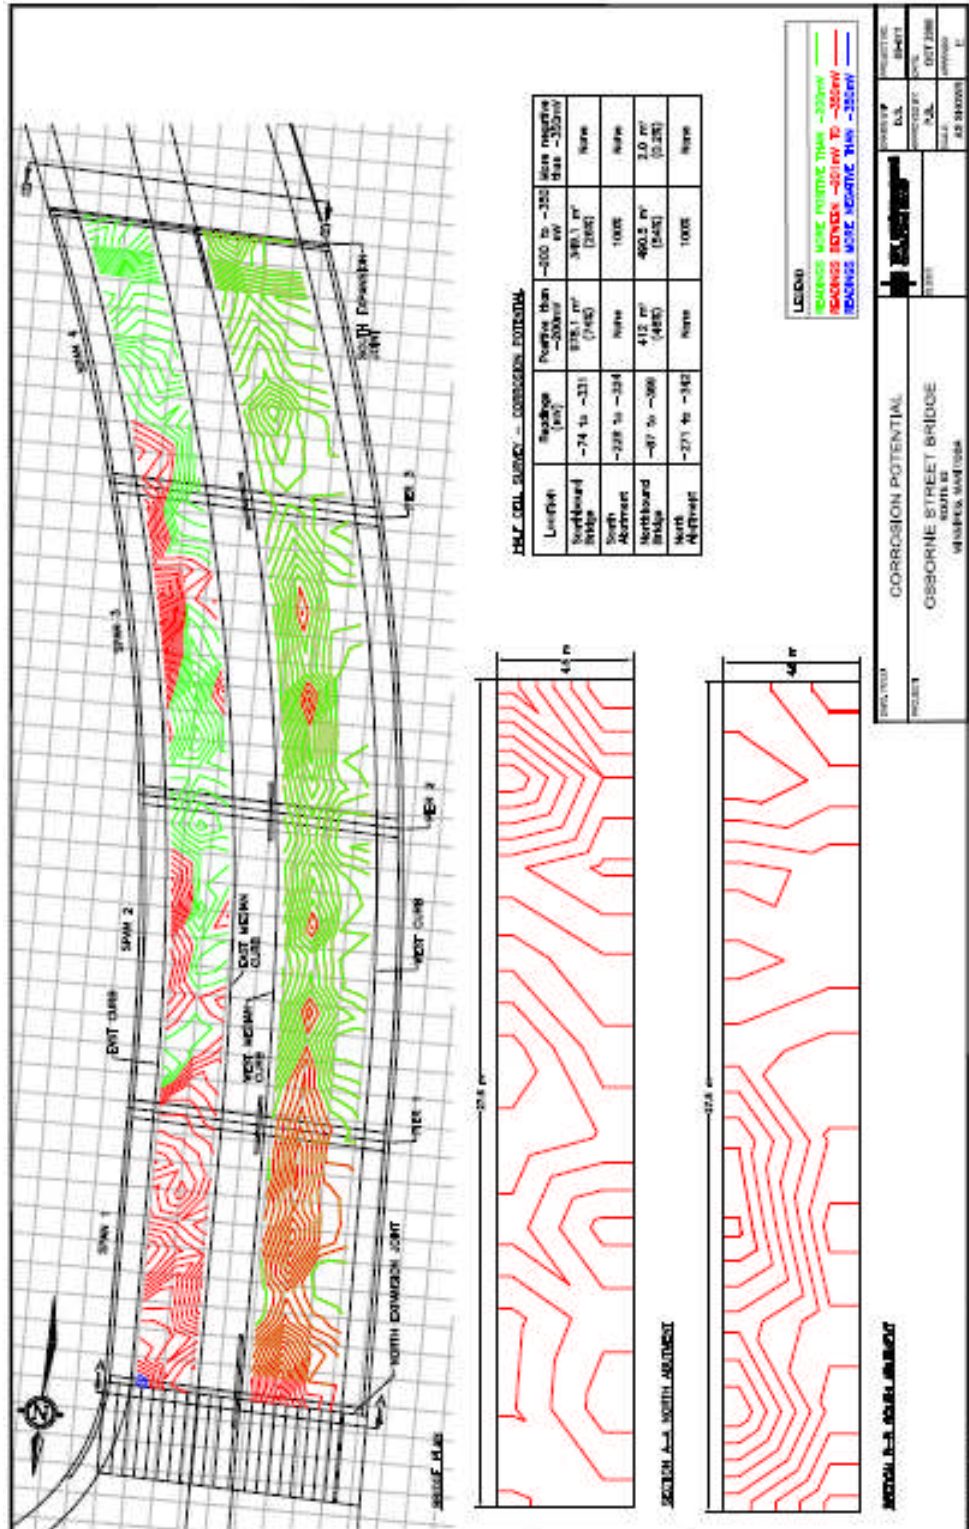
APPENDIX E
HALF CELL SURVEY - CORROSION POTENTIAL

The corrosion potential measurements obtained from the southbound lane bridge ranged from -74 to -331 mV with an average of -171 mV. The corrosion potential measurements obtained from the northbound lane bridge ranged from -87 to -389 mV with an average value of -218 mV. According to ASTM C876, corrosion potential can be evaluated as follows:

Based upon our corrosion potential survey for the southbound bridge, the test data indicates a greater than 90% probability that no reinforcing steel corrosion is occurring in that area at the time of measurement. A total of 978.1 m² or 74% of the deck area has corrosion potentials more positive than -200 mV. The deck area that has corrosion potentials between -200 mV and -350 mV was determined to be 349.3 m² or 26%. However, based on visual observations, isolated corrosion and delamination are present on the bottom side of the bridge.

The corrosion potential measurements for the northbound bridge indicate corrosion activity of the reinforcing steel in much of the deck area is uncertain. A total of 412 m² or 46% of the deck area has corrosion potentials more positive than -200 mV. The deck area that has corrosion potentials between -200 mV and -350 mV was determined to be 490.5 m² or 54%. A small section having an area of 2 m² area near the north end indicated a corrosion probability exceeding 90%. Based on visual observation, corrosion and delamination are present on the bottom side of the bridge.

The corrosion potential measurements obtained from the south abutment ranged from -228 mV to -324 mV with an average value of 276 mV. The abutment area that has corrosion potentials between -200 mV and -350 mV was determined to be 124 m² or 100%.

The corrosion potential measurements obtained from the north abutment ranged from -271 mV to -342 mV with an average value of 307 mV. The abutment area that has corrosion potentials between -200 mV and -350 mV was determined to be 124 m² or 100%. The test data obtained from both abutments indicates that corrosion activity of the reinforcing steel in that area is uncertain.

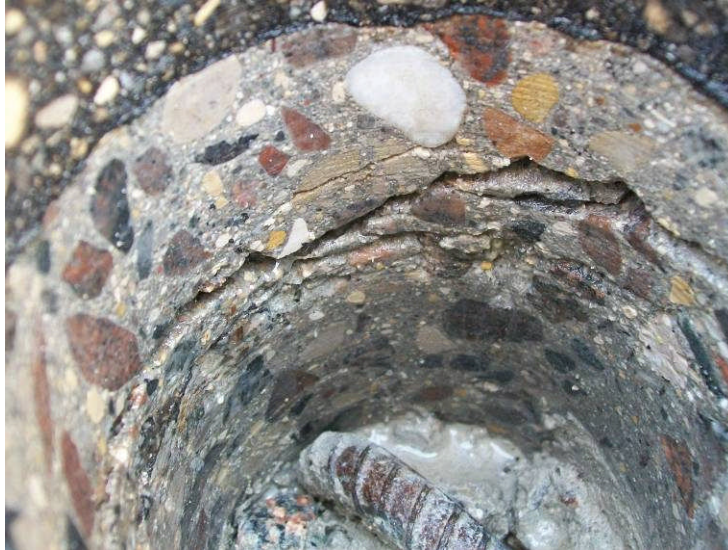
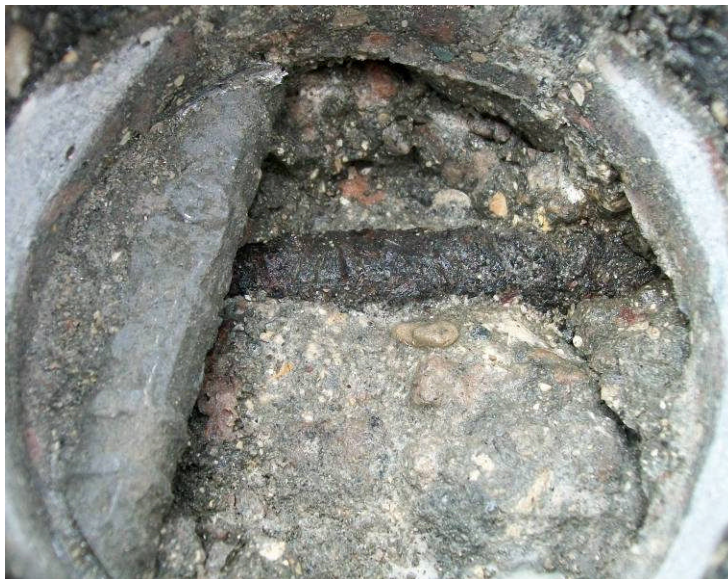
CONDITION OF EXPOSED REBAR ON THE NORTHBOUND LANE

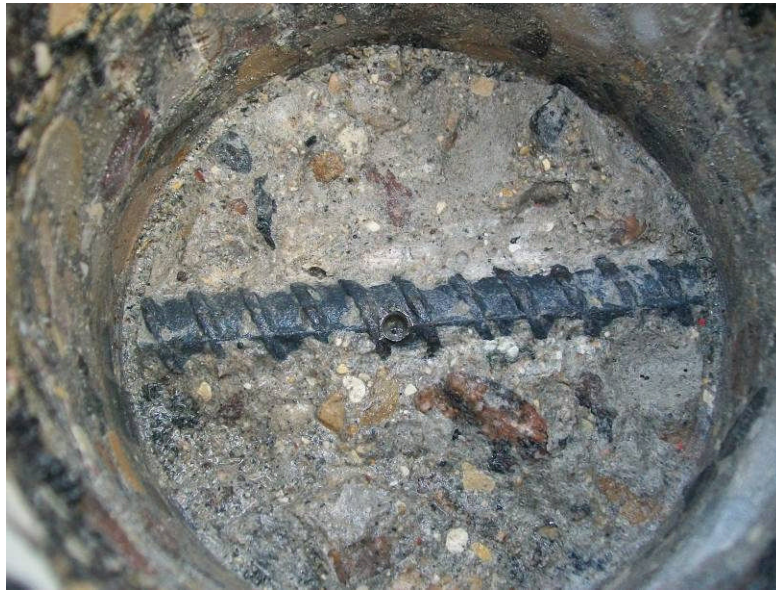
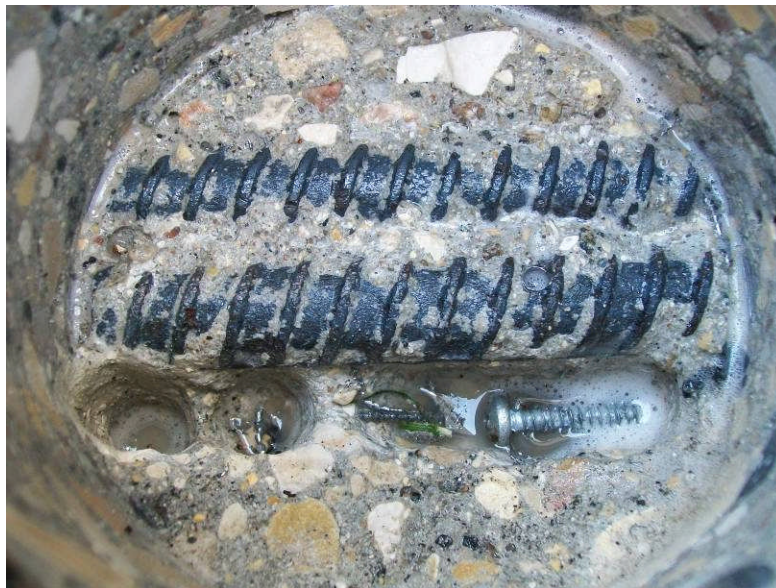
CONDITION OF EXPOSED REBAR ON THE SOUTHBOUND LANE

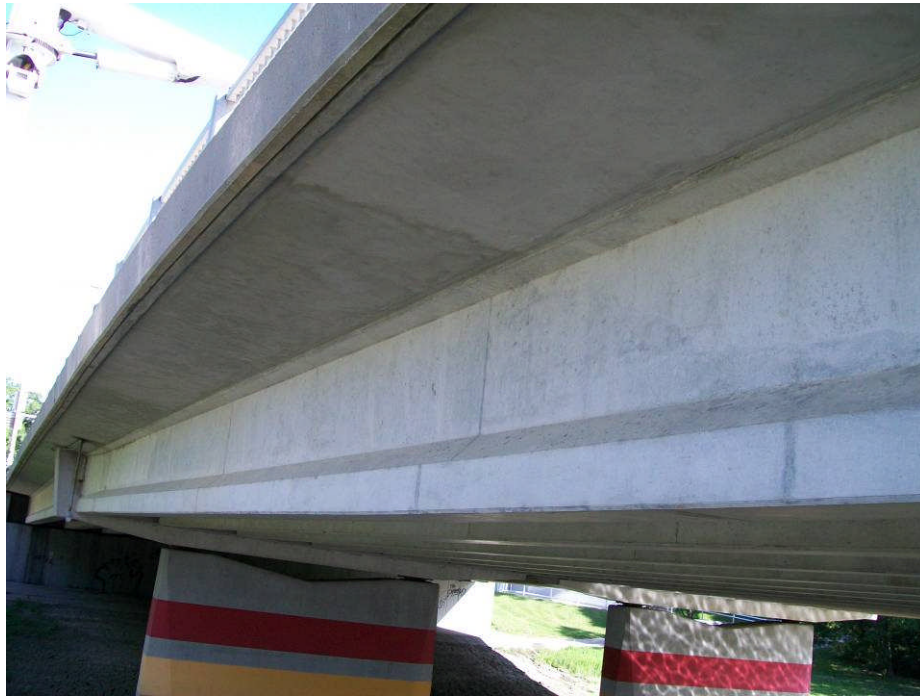
SOUTHBOUND BRIDGE WEST SOFFIT

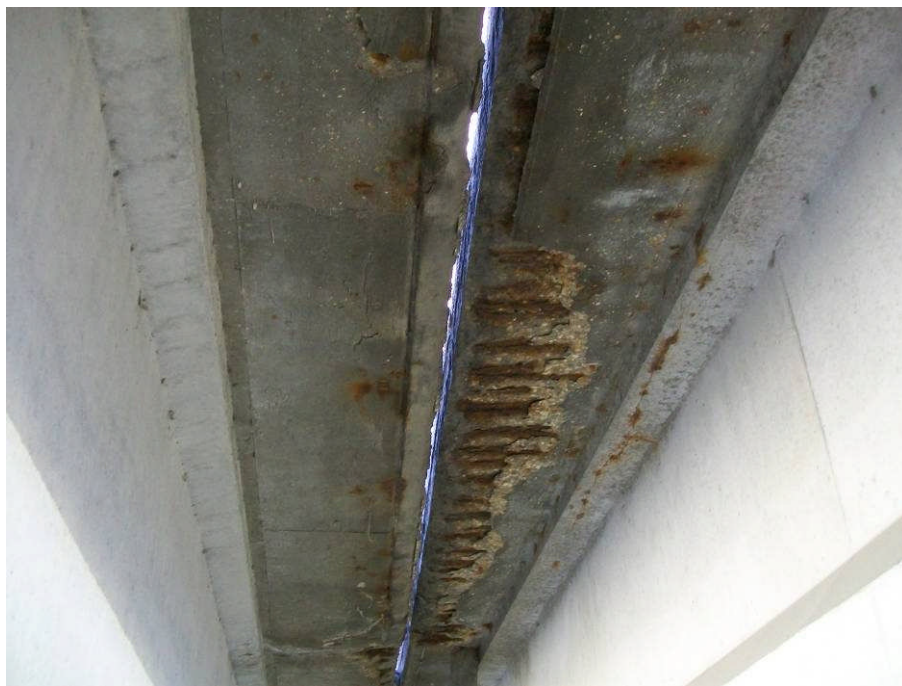
NORTHBOUND BRIDGE EAST SOFFIT

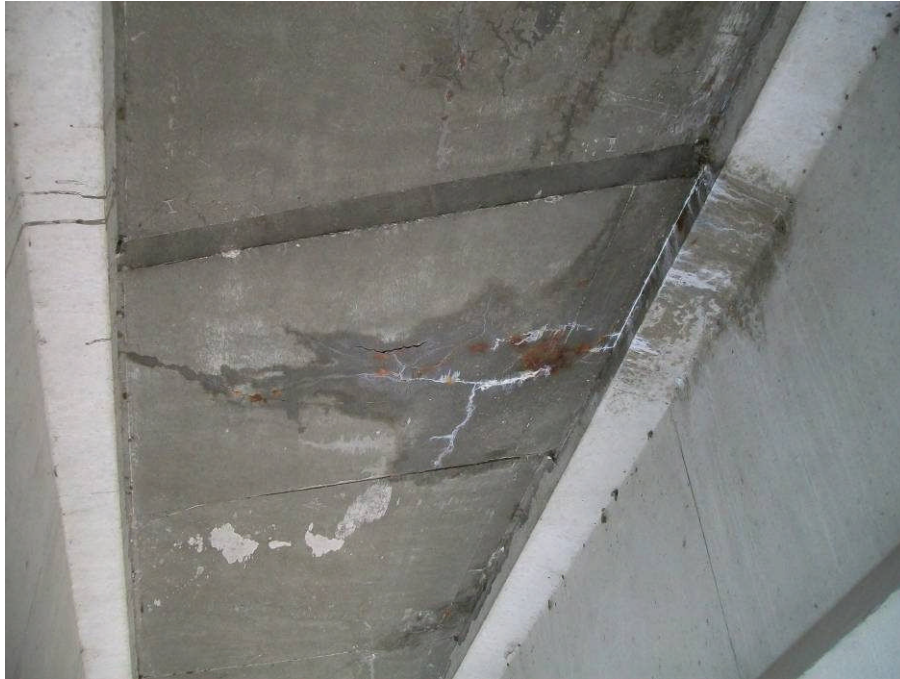
EFFLORESCENCE OBSERVED ON THE UNDERSIDE
OF THE EAST SIDE OF THE NORTHBOUND BRIDGE

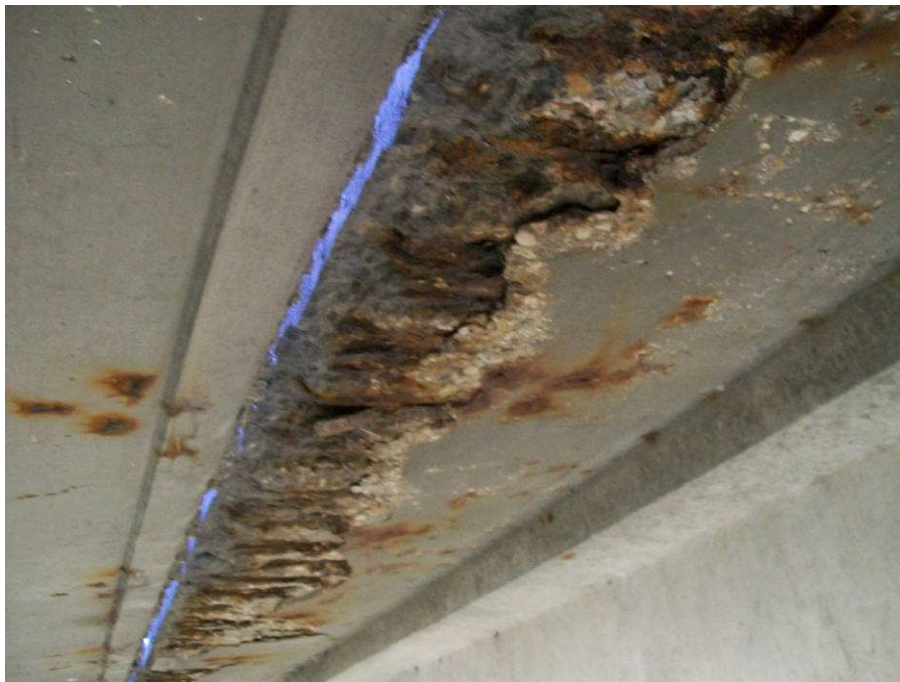
HEAVY CORROSION AND DELAMINATION OBSERVED ON THE WEST SIDE
OF THE NORTHBOUND BRIDGE

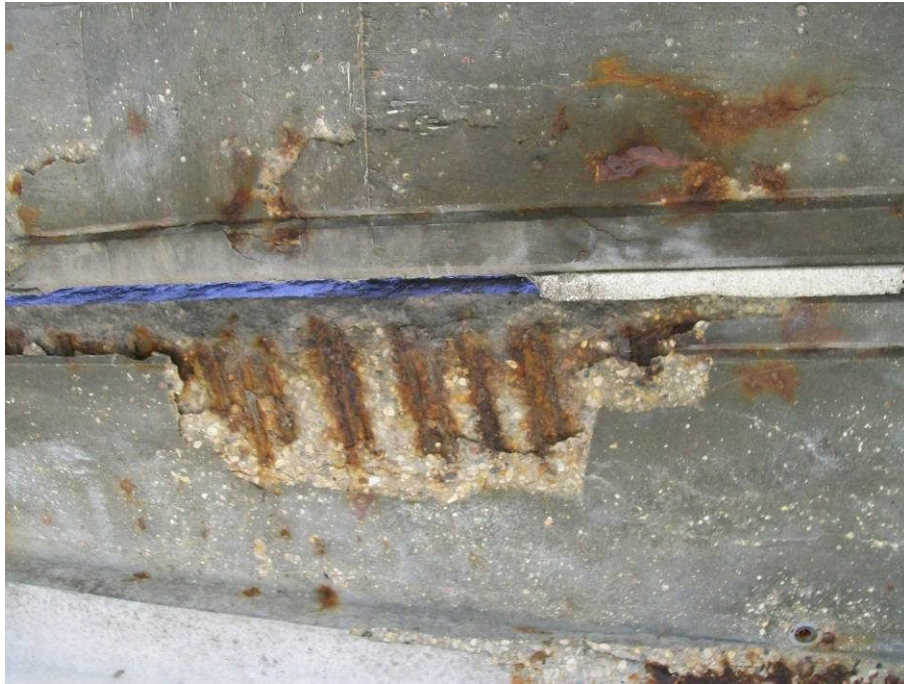
ISOLATED CORROSION AND DELAMINATION OBSERVED ON THE EAST SIDE OF THE SOUTHBOUND BRIDGE

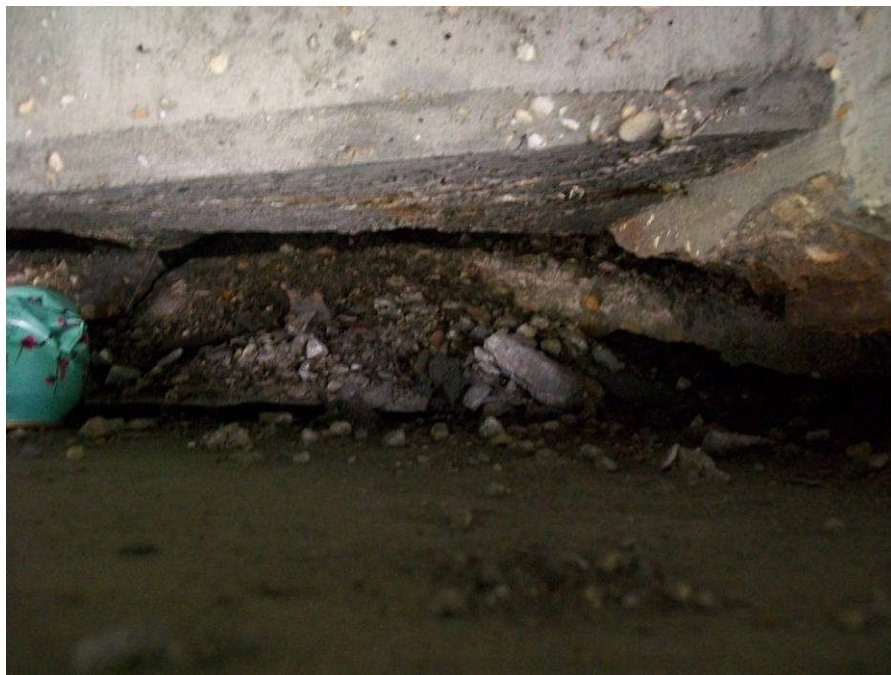
The chloride content obtained from the core sample taken from the south abutment seat (Core No. 10) significantly exceeded the threshold value of 0.15% at all depths.

CONDITION OF THE SOUTH ABUTMENT SEAT

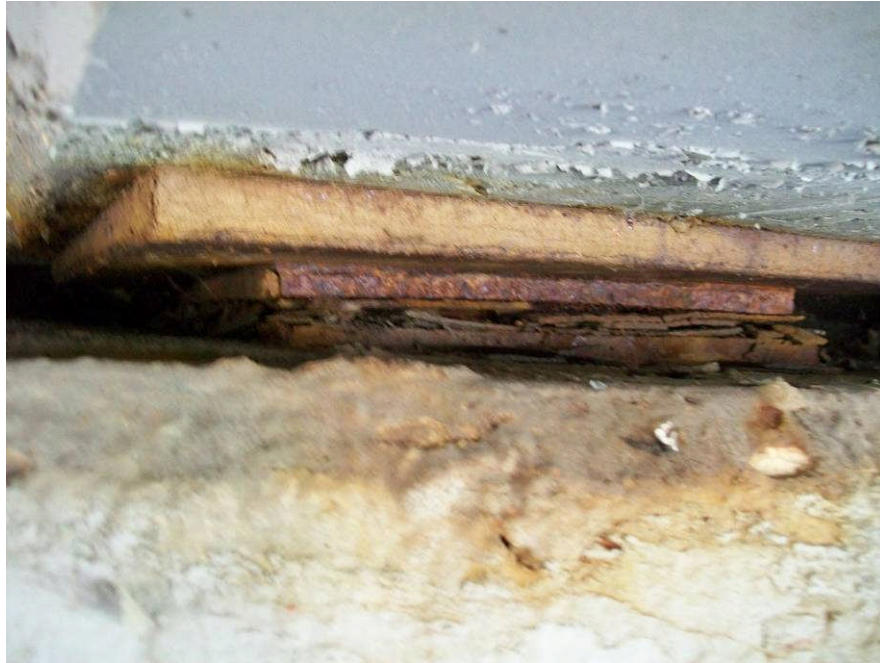
CONDITION OF THE BRIDGE BEARING ON THE NORTH ABUTMENT

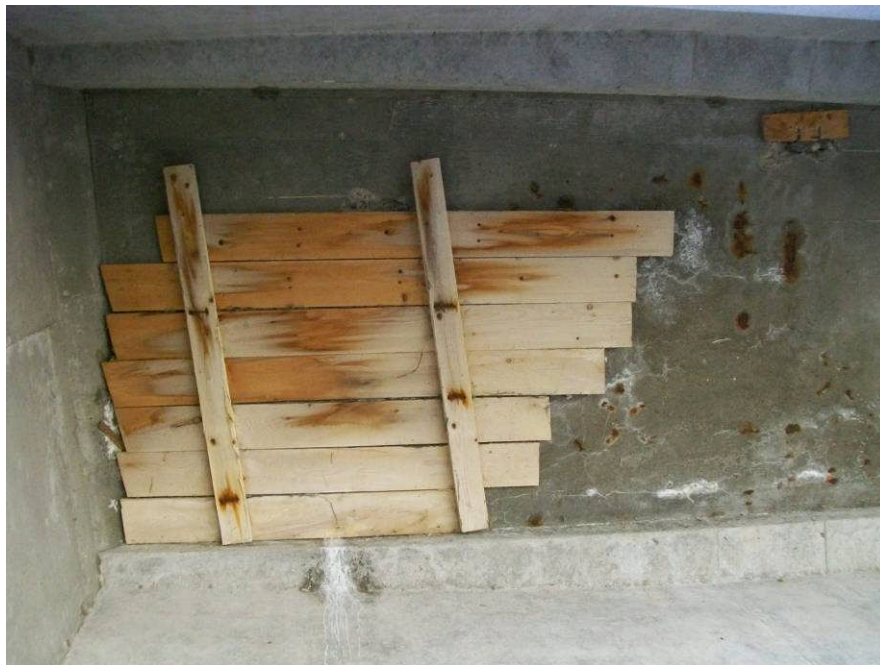
EVIDENCE OF PREVIOUS FULL DEPTH REPAIR
