# **GEOTECHNICAL REPORT**

# GEOTECHNICAL INVESTIGATION RESIDENTIAL STREETS RECONSTRUCTION WINNIPEG, MANITOBA

21 January 2015

Amec Foster Wheeler File No. WX17565R1

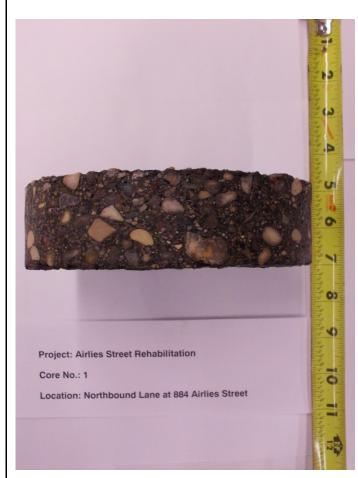
- C01 indicated asphalt over concrete rubble. This location was not subsequently drilled and the depth of rubble was not determined.
- C02 indicated concrete with no asphalt overlay. Since the street was covered in approximately 10 cm of compacted snow and ice during the coring, no visual assessment of the pavement surface was made.
- C03 and C04 showed asphalt over a concrete pavement structure.

**Photo 1:** C01: Northbound lane at 884 Airlies Street, 1.0 m from curb

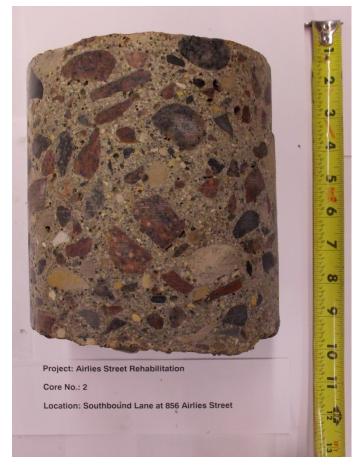
**Photo 2:** C02: Southbound lane at 856 Airlies Street, 1.0 m from curb

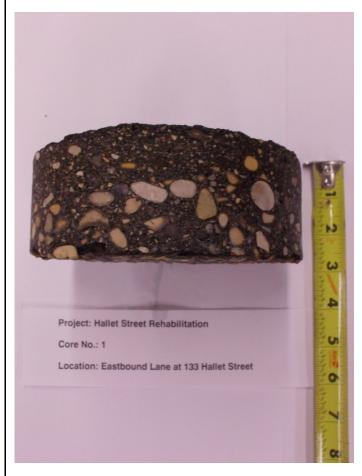
- C01 indicated asphalt over a gravel base. It is possible that there was additional concrete below the gravel base. This location was not subsequently drilled and the depth of gravel was not determined.
- C02 indicated concrete with no asphalt overlay. Since the street was covered in approximately 10 cm of compacted snow and ice during the coring, no visual assessment of the pavement surface was made.
- C03 showed asphalt over a concrete pavement structure.
- C04 showed asphalt over concrete rubble over weathered but intact concrete.

**Photo 1:** C01: Eastbound lane at 133 Hallet Street, 0.9 m from curb

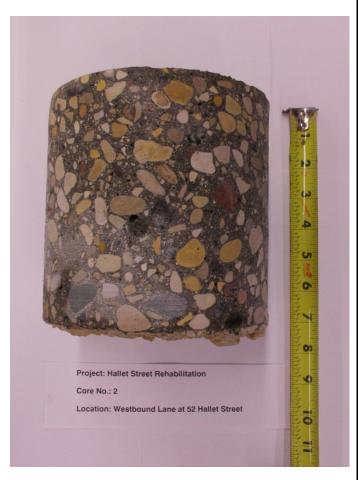
**Photo 2:** C02: Westbound lane at 52 Hallet Street, 1.0 m from curb
