APPENDIX E – ASBESTOS INVENTORY

- AR-03 – Civic Centre Arena
- PI-05 - St. James Civic Centre Pool
- RC-22 - St. James Civic Center

Building Name:	Civic Centre Arena (also see PI-05 & RC-22)	Inspection Date:	April 29, 2015
Building Code:	AR-03	Inspected By:	Ryan Matthews & James Neufeld
Building Address:	2055 Ness Avenue	Construction Date:	1967

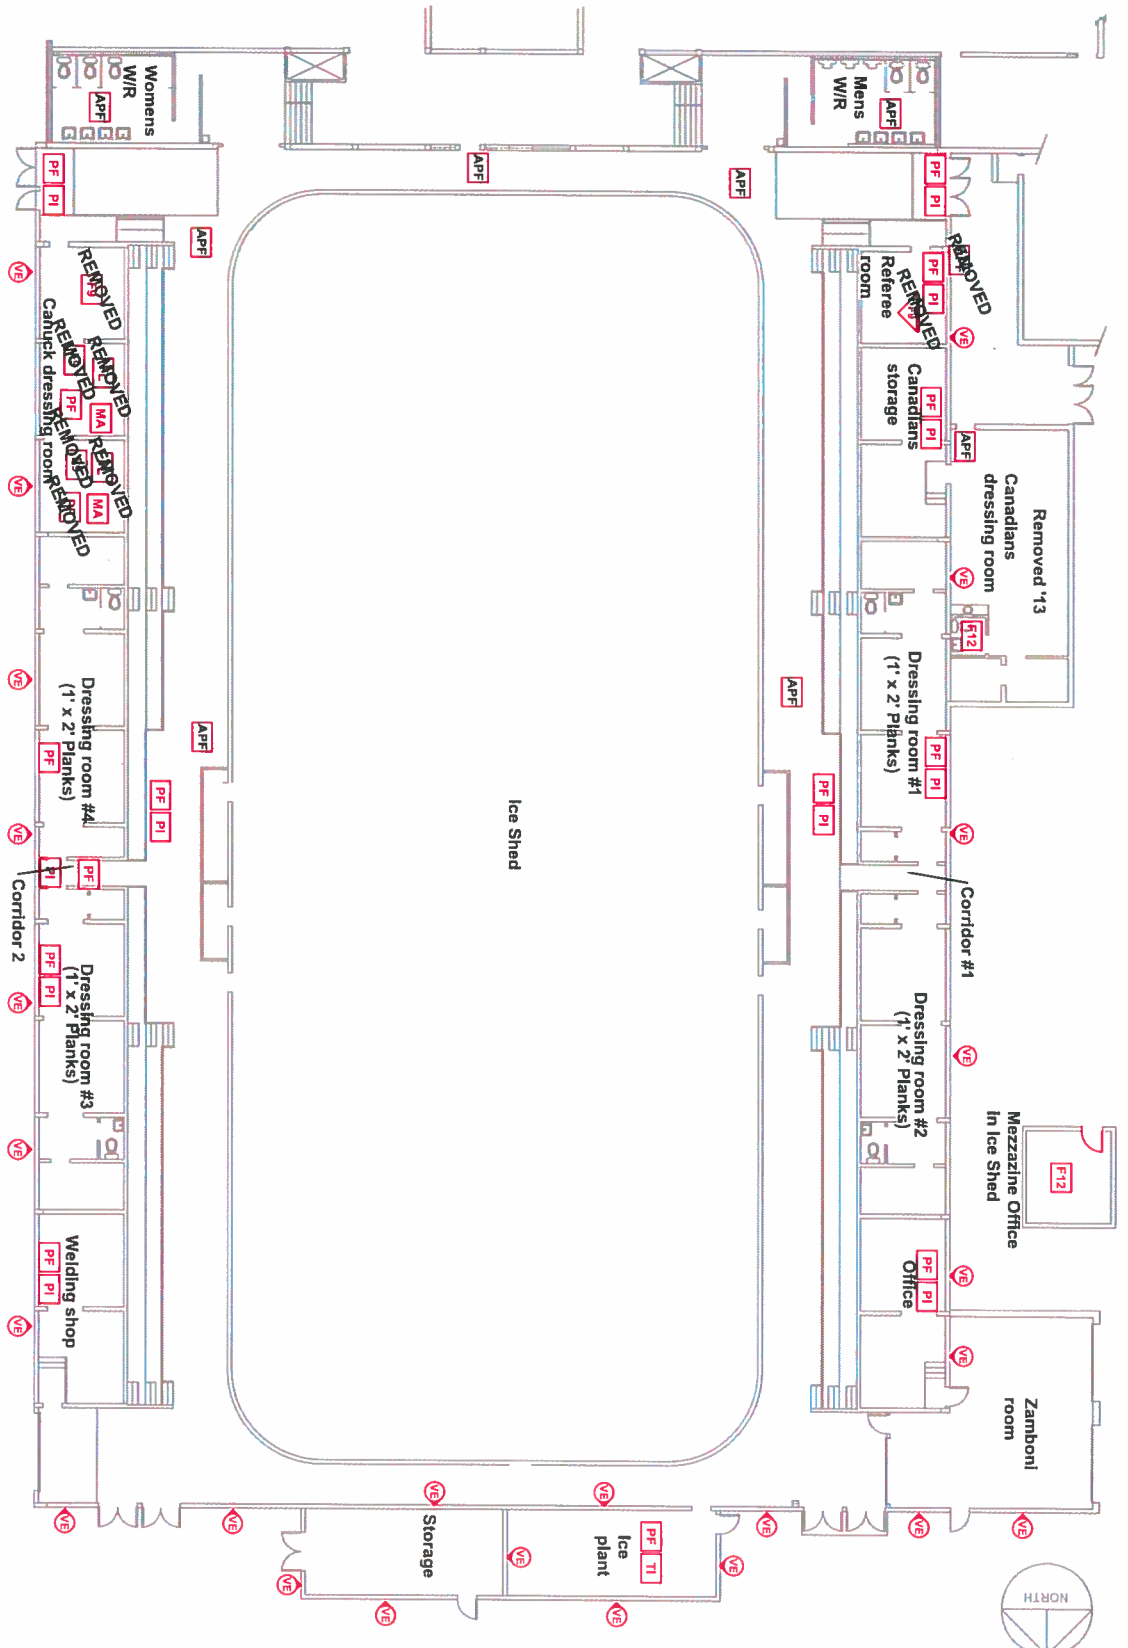
AR-03

Material Location	Material Description	Drawing Label	Material Condition	Testing Status	Date M/Y	Test %	Est. %
Men's Washroom & Entrance	Asphalt Plank Floor (1 x 4)	APF	Needs Repair				5
Women's Washroom & Entrance	Asphalt Plank Floor (1 x 4)	APF	Needs Repair				5
Ice Shed	Asphalt Plank Floor (1 x 4)	APF	Good	TESTED	Oct/'12	5	
	Pipe Insulation	PI	Good				
	Pipe Fitting Insulation	PF	Good				
Mezzanine Office in Ice Shed	12x12 Floor Tile	F12	Needs Repair	TESTED	Jan/'13	3	
Referee room	9x9 Floor Tile - Under rubber mats	F9	Removed				
	Pipe Fitting Insulation	PF	Good				
	Pipe Insulation	PI	Good				
Dressing room #1	Pipe Fitting Insulation	PF	Good				
	Pipe Insulation	PI	Good				
	Asphalt Plank Floor (1 x 2 Planks)			TESTED	Oct/'12	0	
Dressing Room # 2	Asphalt Plank Floor (1 x 2 Planks)						0
	Pipe Fitting Insulation	PF	Good				
West stands	Pipe Insulation	PI	Good				
	Pipe Fitting Insulation	PF	Good				
Office	Pipe Fitting Insulation	PF	Good

Pipe Insulation	PI	Good				
Ice plant	Pipe Fitting Insulation (Blue foam)	PF	Good				
	Pipe Insulation (Blue foam)	PI	Good				
Welding shop	Pipe Fitting Insulation	PF	Good				
	Pipe Insulation	PI	Good				
Dressing room #3	Pipe Fitting Insulation	PF	Good				
	Pipe Insulation	PI	Good				
Dressing room #3	Asphalt Plank Floor (1 x 2 Planks)			TESTED	Nov/'12	0	
	Pipe Fitting Insulation	PF	Good

Material Location	Material Description	Drawing Label	Material Condition	Testing Status	Date M/Y	Test %	Est. %
Dressing room #4	Pipe Insulation Asphalt Plank Floor (1 x 2 Planks)	PI	Good	TESTED	Dec/'11	0	0
Corridor #2	Pipe Fitting Insulation	PF	Good				
	Pipe Insulation	PI	Good				
East stands	Pipe Fitting Insulation	PF	Good				
	Pipe Insulation	PI	Good				
South arena corner @ east exit	Pipe Fitting Insulation	PF	Good				
	Pipe Insulation	PI	Good				
South arena wall @ west exit	Pipe Fitting Insulation	PF	Removed		Dec/'10		
	Pipe Insulation	PI	Removed		Dec/'10		5
Canadians dressing room	Asphalt Plank Floor (1 x 4 Planks)	APF	Good				
	9x9 Floor Tile	F9	Removed 10/12	TESTED	Dec/'11	15	
Canucks dressing room	Mastic (on underside of floor tiles)	MA	Good	TESTED	Dec/'11	3	
	Leveling compound (under floor tiles)	FL	Removed 10/12	TESTED	Dec/'11	2	
	Pipe Fitting Insulation	PF	Removed				
Zamboni room	Stucco - Ceiling		Good	TESTED	Dec/'10	0

Stucco - Walls		Good	TESTED	Dec/'10	0	
Concrete block walls	Contains Vermiculite Insulation (Which May Contain Asbestos)	VE	Good				
Common wall between ice shed & lobby	Randomly Inspected & Appear To Be Empty (Do Not Contain Vermiculite Insulation)

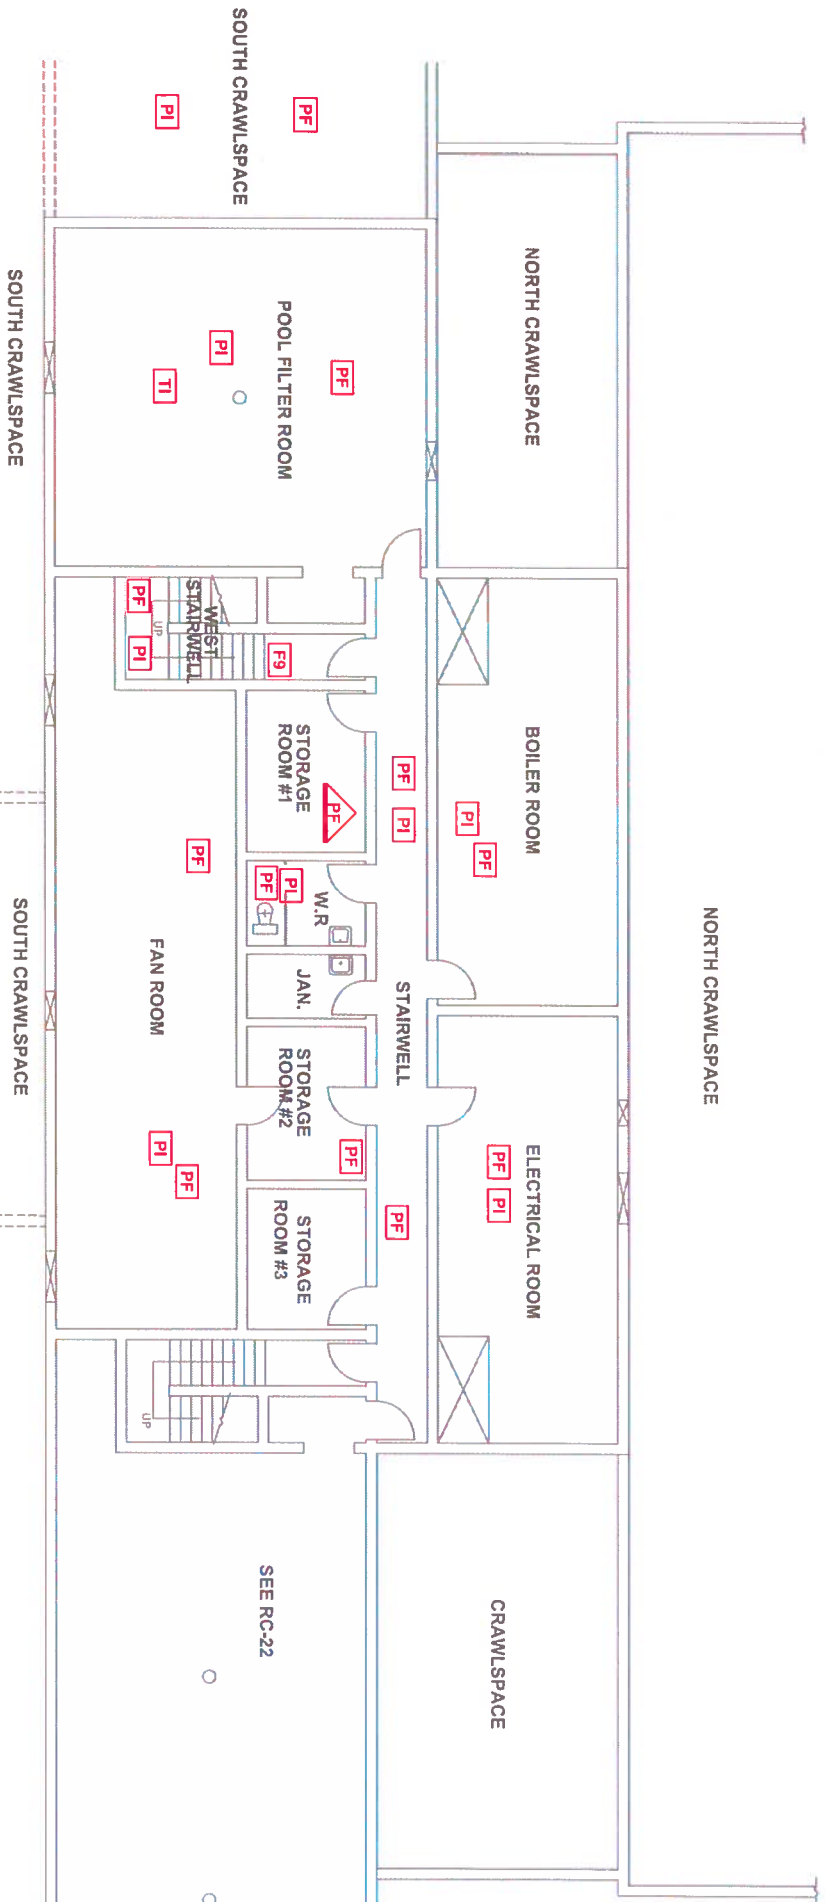
Northwest storage room	Pipe Insulation - Appears to be Older Fibreglass	PI	Good				0
	Pipe Insulation - Above Ceiling	PI	Good				
West stairwell	Pipe Fitting Insulation	PF	Good				2-5
	Pipe Fitting Insulation	PF	Good				
Pool Area	9x9 Floor Tile	F9	Good				
	Stucco - Walls	ST	Good	TESTED	Jan/13	0	
Basement							
Pool filter room	Pipe Fitting Insulation	PF	Good				
	Pipe Insulation	PI	Good				
	Tank Insulation	TI	Good	TESTED	Dec/'11	10	
	Pipe wrap mastic			TESTED	Feb, 14	0

Material Location	Material Description	Drawing Label	Material Condition	Testing Status	Date M/Y	Test %	Est. %
Hallway	Pipe Fitting Insulation	PF	Good				
	Pipe Insulation	PI	Good				
Washroom	Pipe Fitting Insulation	PF	Good				
	Pipe Insulation	PI	Good				
Boiler room	Pipe Fitting Insulation	PF	Needs Repair	TESTED	Dec/'10	2-5	
	Pipe Insulation	PI	Good				
Electrical room	Pipe Fitting Insulation	PF	Good				
	Pipe Insulation	PI	Good				
Storage room #2	Duct Insulation	DI	Good	TESTED	Dec/'10	0	
	Pipe Fitting Insulation	PF	Good				
Fan room	Pipe Fitting Insulation	PF	Good				
	Pipe Insulation	PI	Good				
South crawlspace	Pipe Fitting Insulation	PF	Good				
	Pipe Insulation	PI	Good				
West Storage Room	Mastic - Duct	MA	Good	TESTED	Dec/'11	30	
	Pipe Fitting Insulation	PF	Good				
North crawlspace	NO ASBESTOS						
	9x9 Floor Tile	F9	Good				
West stairwell	Pipe Fitting Insulation	PF	Good				
	Pipe Insulation	PI	Good

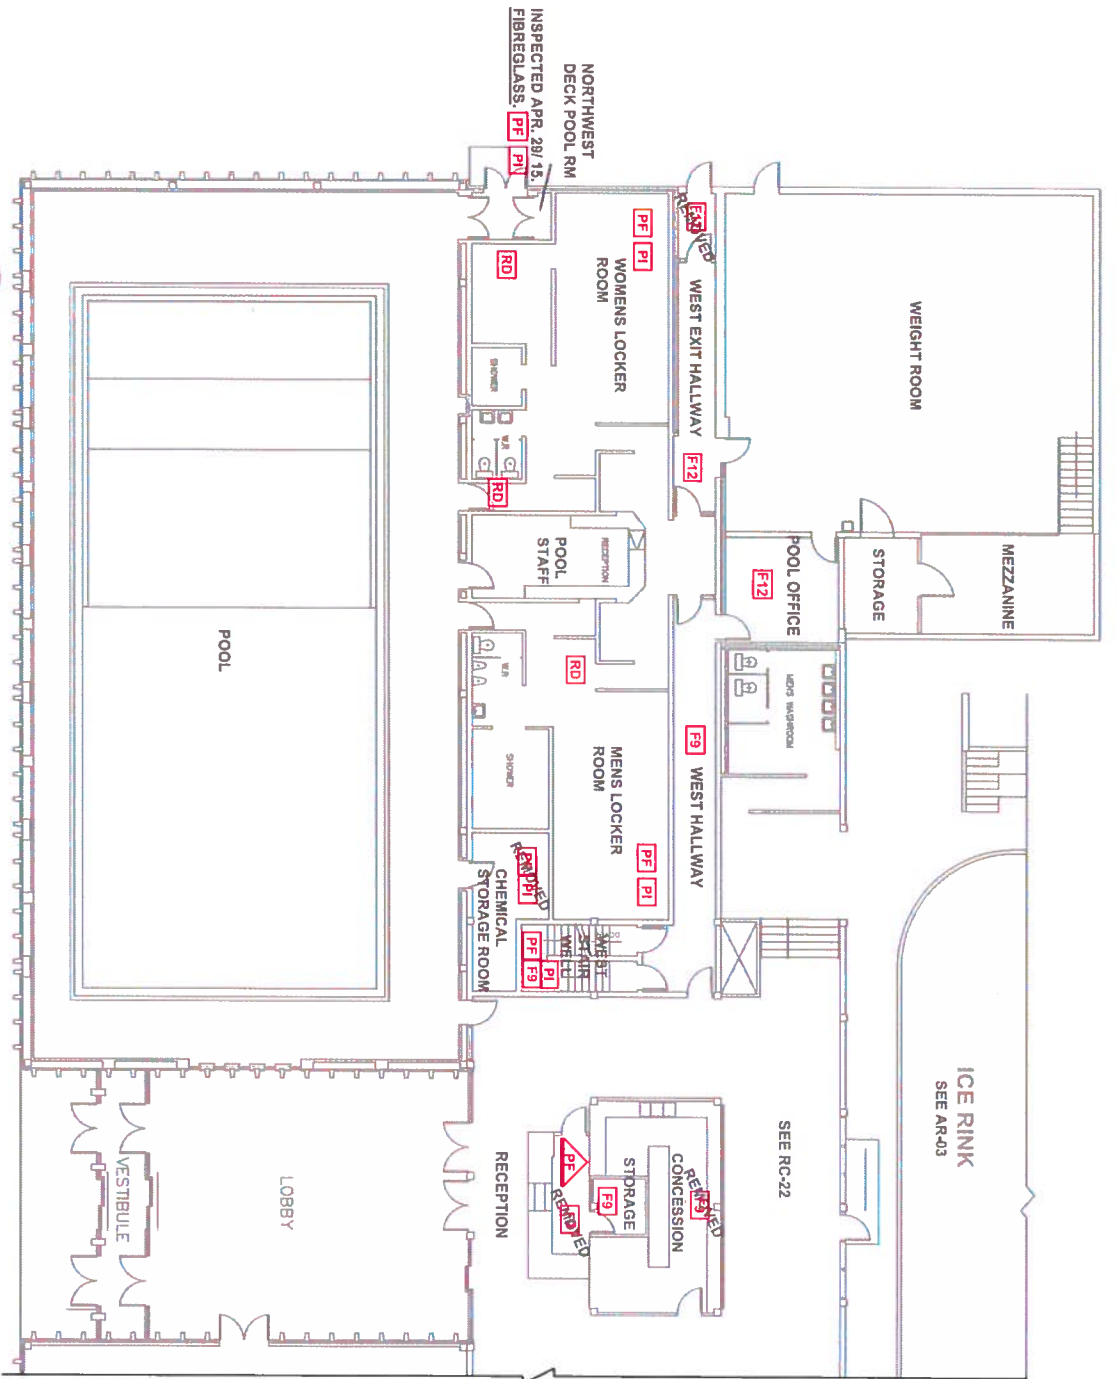
Main floor

Material Location	Material Description	Drawing Label	Material Condition	Testing Status	Date M/Y	Test %	Est. %
Main Floor							
Reception area	Pipe Fitting Insulation - Above Ceiling	PF	Good				2-5
Reception storage room	9x9 Floor Tile	F9	Good				
Consession stand	9x9 Floor Tile	F9	Removed 7/10				2-5
West hallway	Pipe Fitting Insulation - Above Ceiling	PF	Good				
Pool office	9x9 Floor Tile	F9	Good				
West exit hallway	12x12 Floor Tile	F12	Good				
West exit hallway entry	12x12 Floor Tile	F12	Removed	TESTED	Dec/'10	0	
Weight room	Duct Insulation	DI	Good				
Mens locker room	Pipe Fitting Insulation	PF	Good				2-5
Womens locker room	Pipe Insulation	PI	Good				
	Pipe Fitting Insulation	PF	Good				2-5
	Pipe Insulation	PI	Good				
	Roof Drain	RD	Needs Repair				
	Pipe Fitting Insulation	PF	Removed		Aug/'11		2-5
Chemical storage	Pipe Insulation	PI	Removed		Aug/'11		
	Pipe Fitting Insulation - Appears to be Older Fibreglass	PF	Good				0

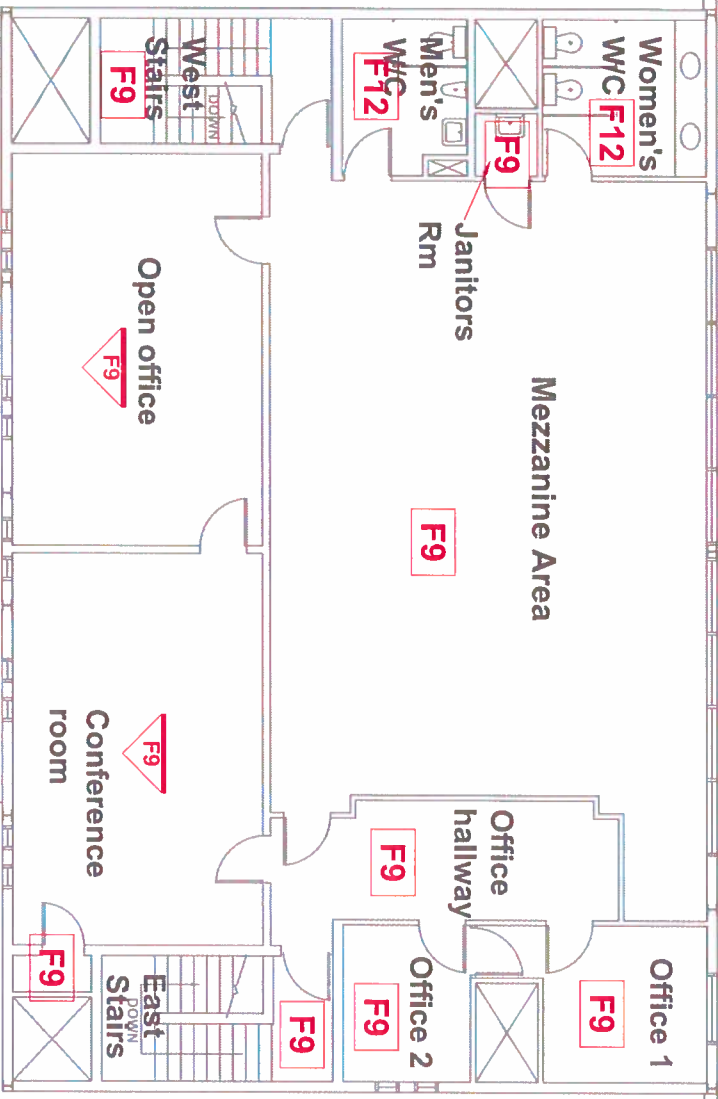
Material Location	Material Description	Drawing Label	Material Condition	Testing Status	Date M/Y	Test %	Est. %
Office #2	9x9 Floor Tile	F9	Good				
Mezzanine area	9x9 Floor Tile	F9	Good				
Open office	9x9 Floor Tile - Under Carpet	F9	Good				
Conference room	9x9 Floor Tile - Under Carpet	F9	Good				
Men's washroom	12x12 Floor Tile	F12	Good				
Janitor's room	9x9 Floor Tile	F9	Good				
West stairwell landing	9x9 Floor Tile	F9	Needs Repair				
Women's washroom	12x12 Floor Tile	F12	Good				
Basement							
	9x9 Floor Tile	F9	Good				
	Pipe Fitting Insulation	PF	Good				
East stairwell	Pipe Insulation	P1	Good				
	Pipe Fitting Insulation - Above Ceiling	PF	Good				
Meeting room	12x12 Floor Tile - new						
	Pipe Insulation - Above Ceiling	P1	Good				
Storage room 1	no asbestos located						
Storage room 2	no asbestos located						
Storage room 3	no asbestos located

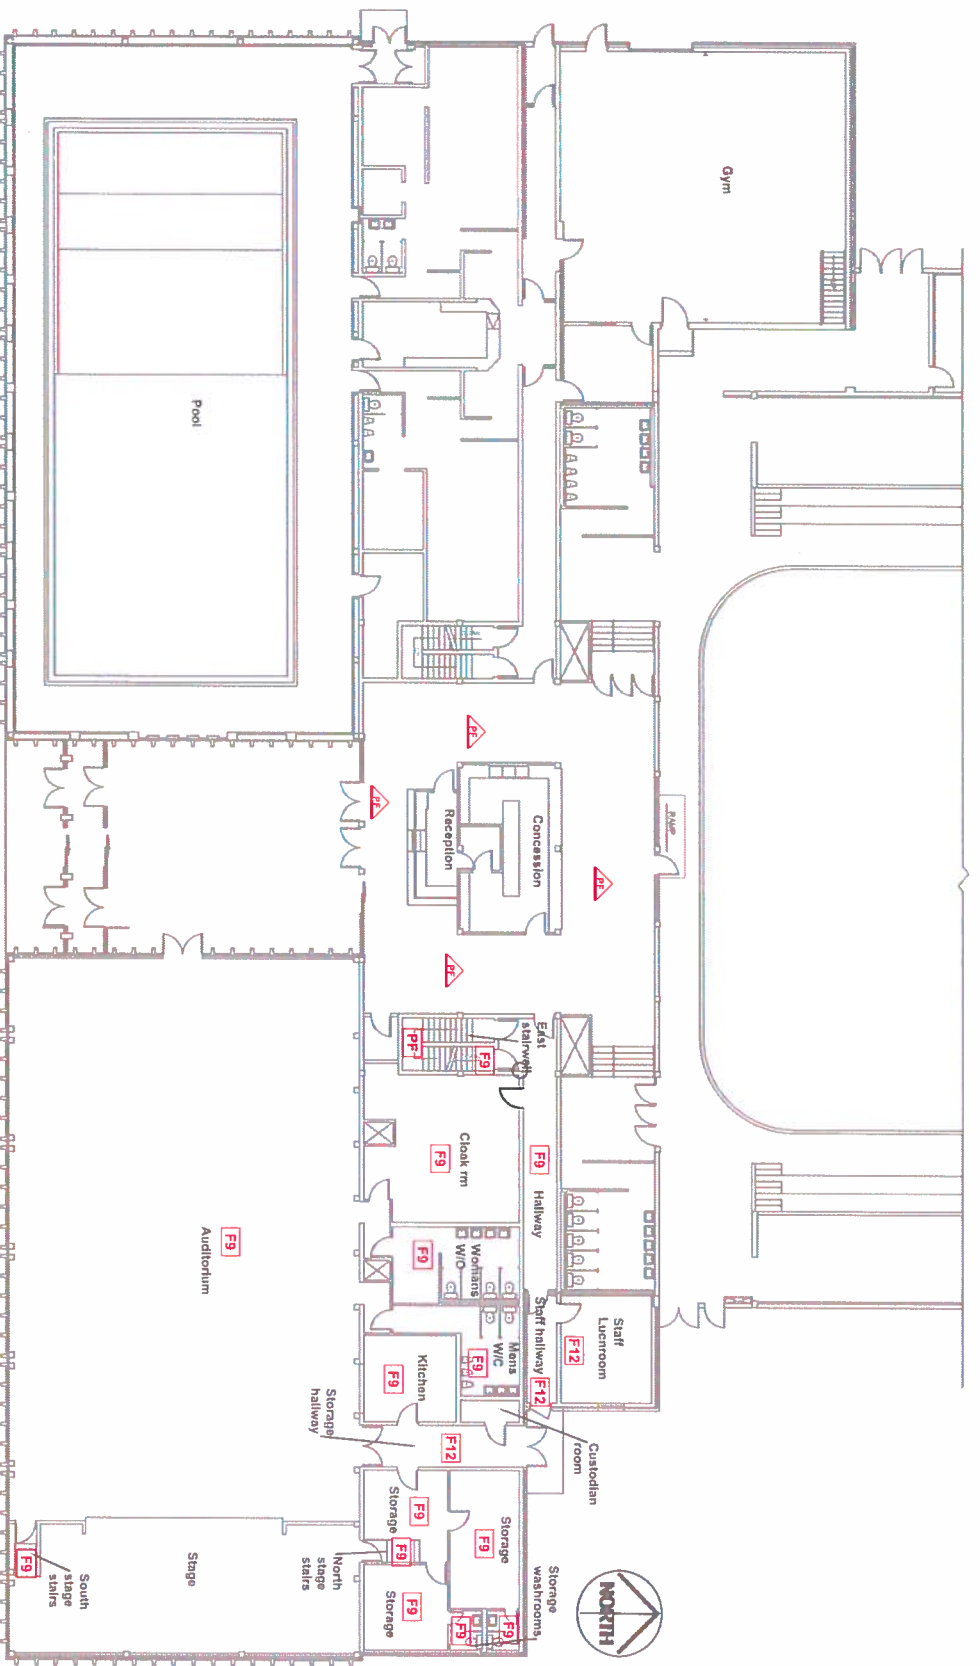
Material Location	Material Description	Drawing Label	Material Condition	Testing Status	Date M/Y	Test %	Est. %
Main Floor							
Reception Area	9x9 Floor Tile	F9	Removed				
Reception Storage Rm	9x9 Floor Tile	F9	Good				
Concession	Pipe Fitting Insulation - Above Ceiling	PF	Good				
	9x9 Floor Tile	F9	Removed				
Staff Lunchroom Hallway	12x12 Floor Tile	F12	Good	TESTED	Apr'15	0%	
Staff Lunchroom	12x12 Floor Tile	F12	Good	TESTED	May'14	5	
Staff Hallway	9x9 Floor Tile	F9	Good				
Cloak room	9x9 Floor Tile	F9	Good				
Auditorium	9x9 Floor Tile (Mastic) Spray On Insulation	F9 SO	Good Good	TESTED	Dec'10	2-5	
Mens washroom	9x9 Floor Tile	F9	Good				
Women's washroom	9x9 Floor Tile	F9	Good				
Kitchen	9x9 Floor Tile	F9	Good				
Storage hallway	12x12 Floor Tile						
Custodian room	12x12 Floor Tile						
Storage rooms x 3	9x9 Floor Tile	F9	Needs Repair	TESTED	Mar'14	0	
North & South stage stairs	9x9 Floor Tile	F9	Good

South Stage wall	Stucco - Walls	ST	Good				
Storage washrooms x 2	9x9 Floor Tile	F9	Good				
East stairwell up to second flr	9x9 Floor Tile	F9	Good				
	Pipe Fitting Insulation	PF	Good	TESTED	Dec'10	Trace	
Second Floor							
East stairwell landing	9x9 Floor Tile	F9	Good				
	Stair Tread/ Nosing						
Office hallway	9x9 Floor Tile	F9	Good	TESTED	Apr'15	0%	
Office #1	9x9 Floor Tile	F9	Good
