1.0 LIFT STATION INFORMATION

Station Name:	<u>Olive Lift Station</u>
Location of Station:	<u>Assiniboine Crescent east of Olive Street</u>
Date of Inspection:	<u>February 10, 2010</u>
Inspected By:	<u>Damir Muhurdarevic, EIT</u>
Inspecting Firm:	<u>MMM Group Limited (MMM)</u>
Client:	<u>City of Winnipeg – Water and Waste Department</u>

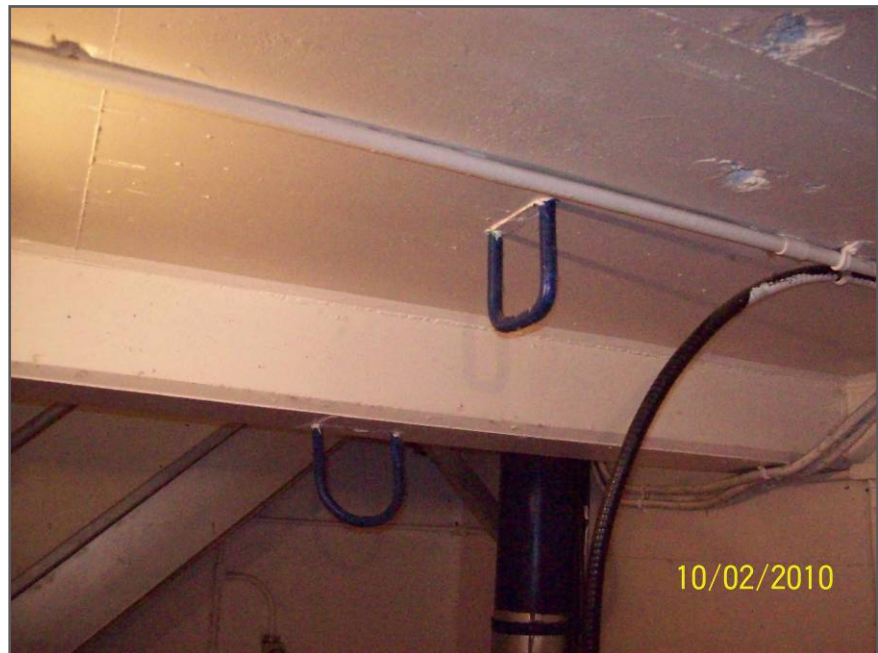
Photograph No. 2

The combination chamber on the first floor below ground and the motor room on the second floor below ground each have four (4) U-shaped lifting hooks that are fabricated of 19.4mm diameter steel rod and are embedded into the underside of the main and first floor cast-in-place concrete slabs. During the inspection it was observed that one of the hooks in the motor room on the second floor below ground is bent.

All U-hooks were analyzed for pullout resistance of and the tension resistance of the hooks. The thickness of the roof and floor slabs was not observed and therefore the embedment length of the hooks was only estimated. The slabs were estimated to be 200mm thick and an embedment length of 150mm was used. The governing factor in the hooks was the pullout resistance, which was calculated to be 6.8 tons. A factor of safety of 4.5 was applied to the hooks to yield a load rating of 1.5 tons. The one (1) bent hook located in the motor room was not rated for safe use and was recommended to be replaced.

Various lifting hooks embedded in the ceiling, located in the motor room (U-shaped hook bent)

Ref.	Description	Priority
4.1	Replace bend U-shaped lifting hook located in the motor room	A
