# Lead Abatement Procedures and Inspection Report

## 845 Sargent Ave

## **Inspection Report with Lead Abatement Procedures**

**LOCATION:** 845 Sargent Ave  
Winnipeg, Manitoba

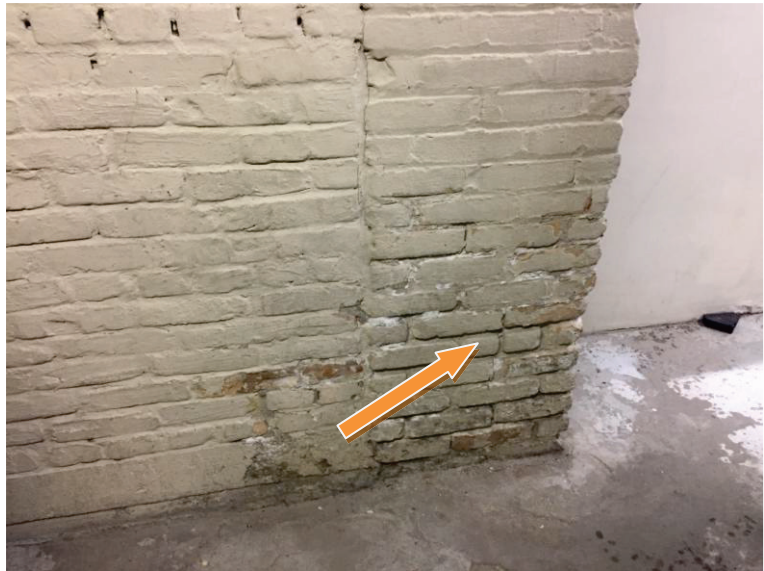
### Photo 1

There were seven samples of paint taken from throughout the basement area of the building. Samples were analyzed with a reportable limit of 0.010% w/w and a single sample was positive for lead content, with a result of 0.012% w/w lead (Pb). This sample was reportedly taken of paint on the wall in the drying room in the south-west portion of the basement.

Reported location of the paint sample that was found to contain 0.012% w/w lead (EMC Lab L67178-1).

This is the wall in the drying room located in the SW corner of the basement.

Based on sample result of <0.5% w/w, lead-based paints (LBPs) are not present in the area.

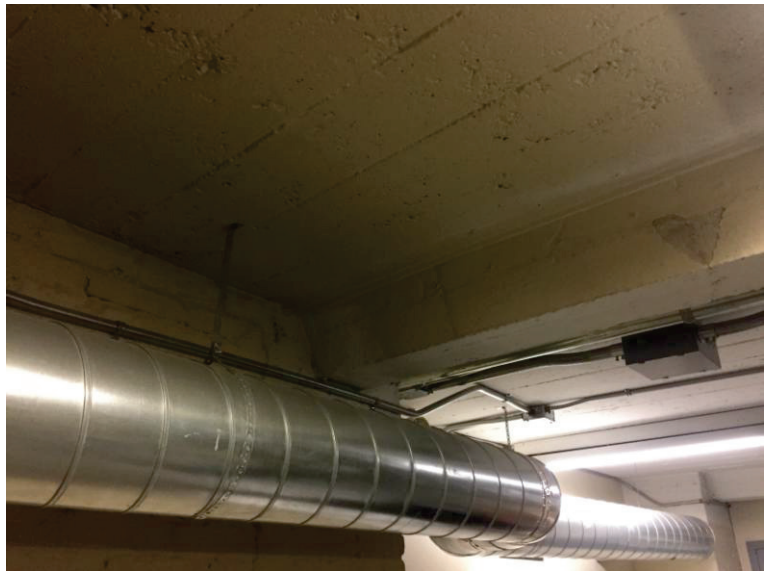
### Photo 2

The ceiling in the drying room.

A sample of paint applied to ceiling (EMC Lab L67178-2) was found to contain <0.010 %w/w lead (Pb).
