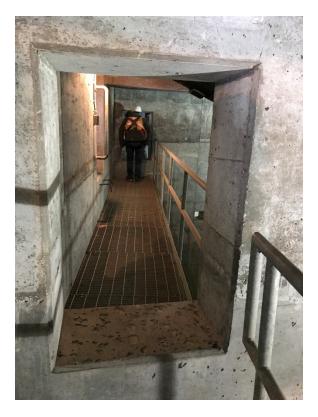
Site 1 – North abutment looking west, typical abutment access hole.

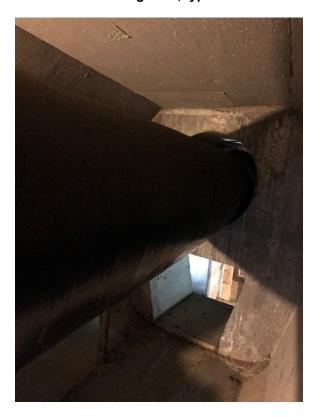
Site 1 – 500 mm FRM at south abutment wall, typical access hole in box girders.

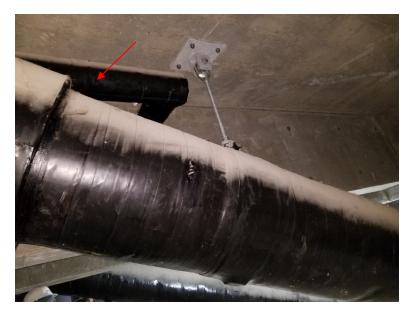
Site 1 – North abutment looking west, air release piping.

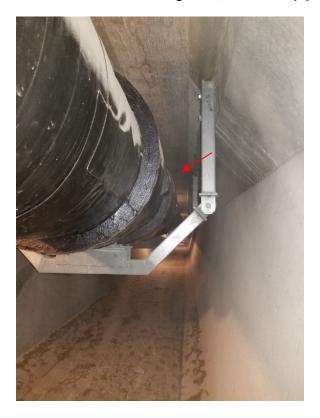
Site 1 – 500 mm FRM, expansion joint in box girder.

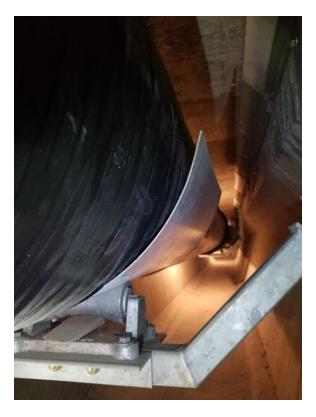
Site 1 – Typical roller support and weight distribution plate.

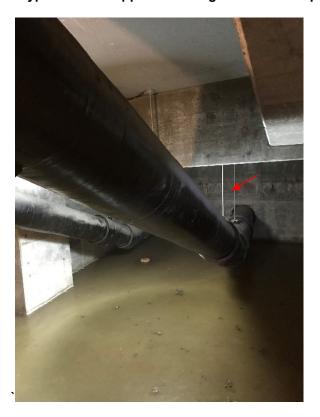
Site 1 – South abutment chamber looking south, wall penetration, hanger supports, elbow and couplers.

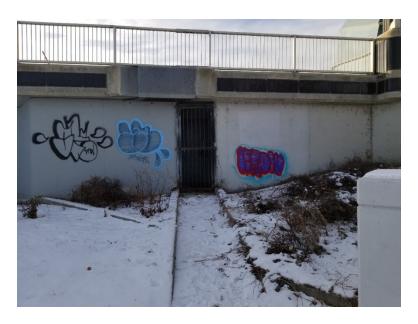
Site 2 – West abutment access door looking south.

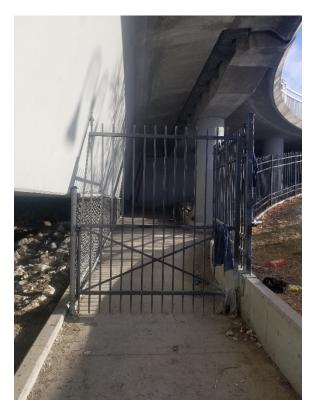
Site 2 – East abutment access gate and door looking east.

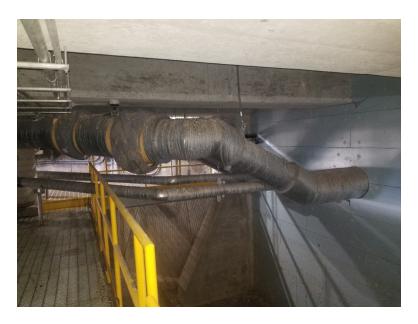
Site 2 – West abutment piping looking south, expansion joints, pipe hanger, and welded joints.

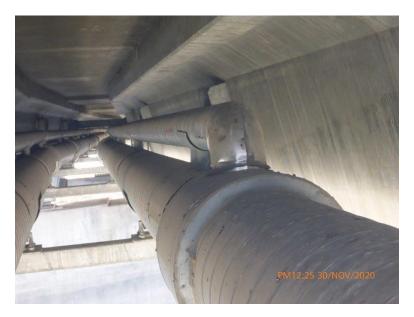
Site 2 – Air release connection at mid span of bridge, looking west.

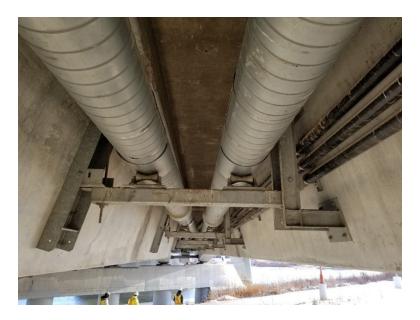
Site 2 – West river bank looking east.

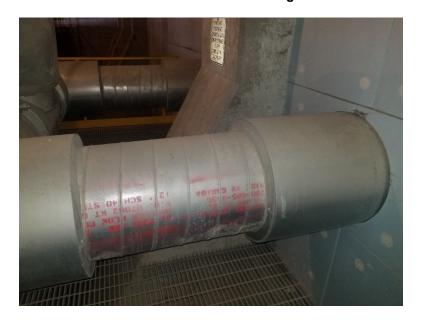
Site 2 – East abutment looking north, pipe wall penetrations.

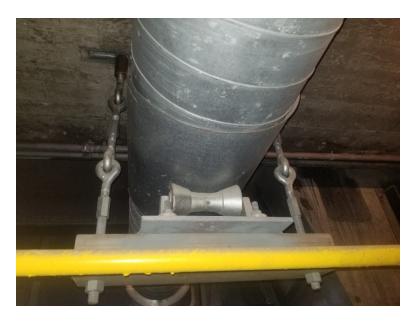
Site 2 – East abutment looking west, pipe roller support.

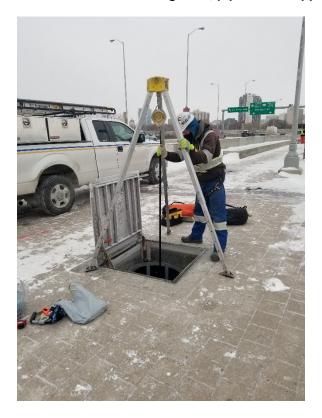
Site 3 – Typical sidewalk access hatch.

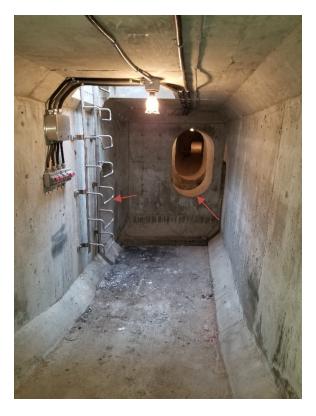
Site 3 – Hatch access girder looking west, pier access hole (west), bridge girder access hole (south).

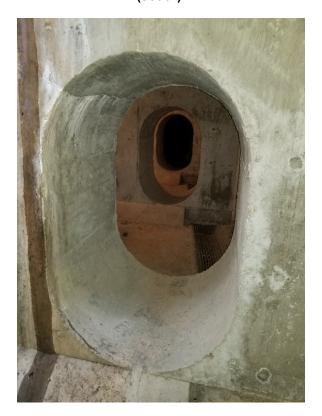
Site 3 – Typical bridge girder access holes looking south.

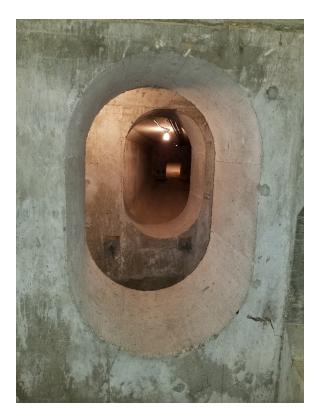
Site 3 – Typical bridge pier access hole looking west.

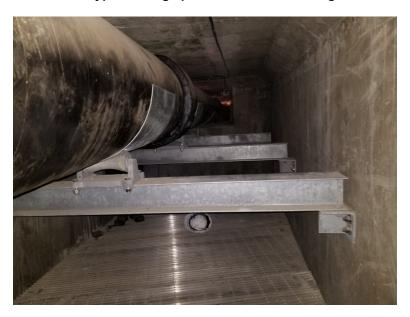
Site 3 – Force main piping and typical inspection platform at bridge piers.

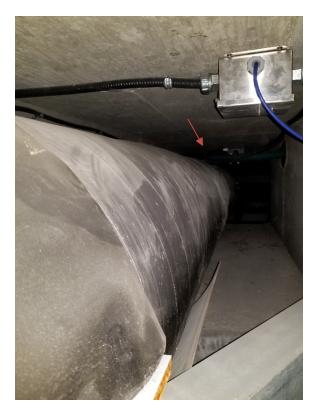
Site 3 – Air release tap within bridge pier looking west.

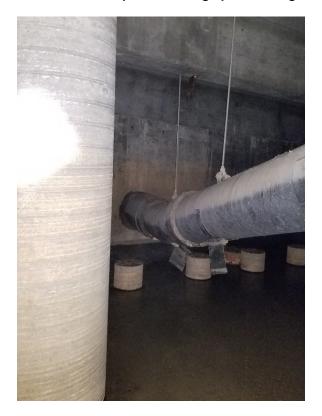
Site 3 – North abutment looking northeast, wall penetration, elbow, couplers, expansion joint, and hanger supports.

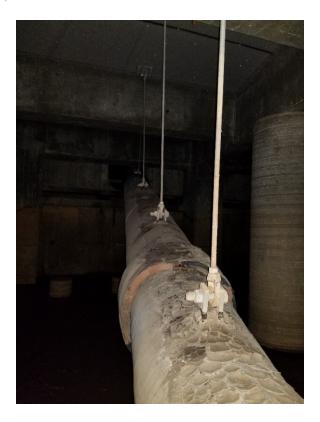
Site 3 – North abutment piping looking east.

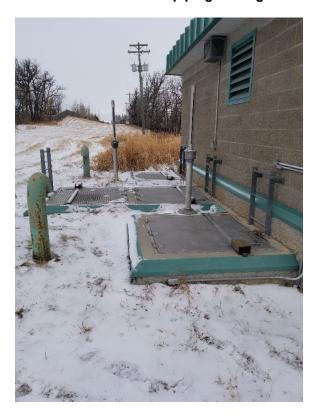
Site 5 – Wet wells at pumping station, looking north.

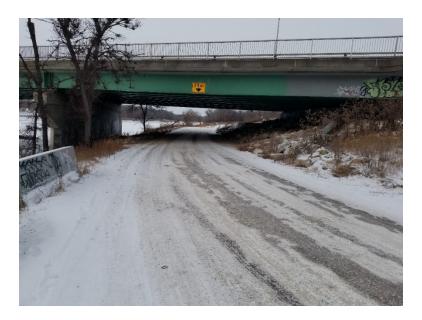
Site 5 – Bridge overpass on Oxbow Bend Rd, looking west.

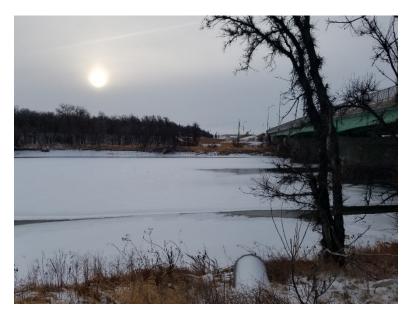
Site 5 – North bank looking south.
