## **CITY OF WINNIPEG**

WASTEWATER LIFT STATION CONDITION ASSESSMENT PHASE II

Document VII: Metcalfe Lift Station Assessment

Date: March 16, 2020  
City File No.: S-1095  
MPE Project No.: 8400-001-00

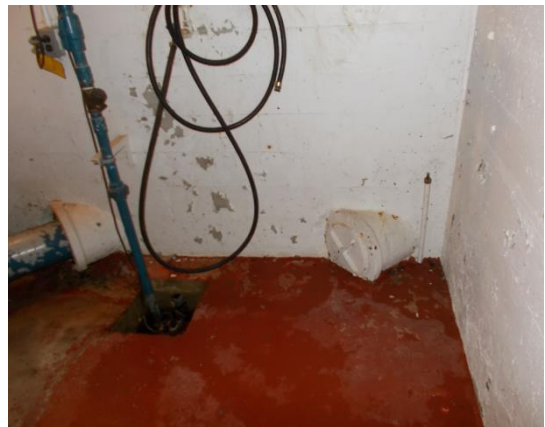
The Metcalfe Lift Station foundation consists of a cast-in-place concrete wet well/dry well configuration. The concrete dry well acts as the primary foundation for the lift station building with the wet well cast against the north side. The concrete base slab finish is worn and paint is flaking off, but it remains in "Good" condition with no structural concerns. The sump pit is functional with good floor slope for drainage to the sump

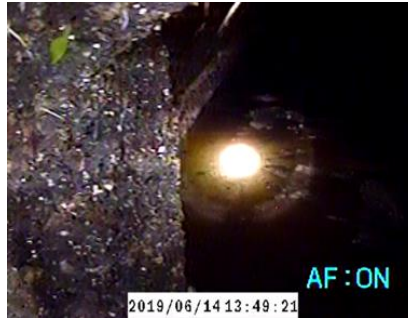
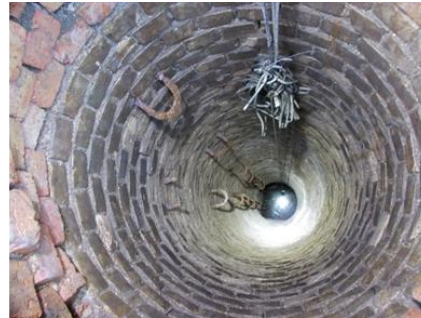
The wet well chamber is aged and deteriorating. The walls showed indications of deterioration of the paste, and

there is evidence of infiltration and root presence. The wet well should be replaced.

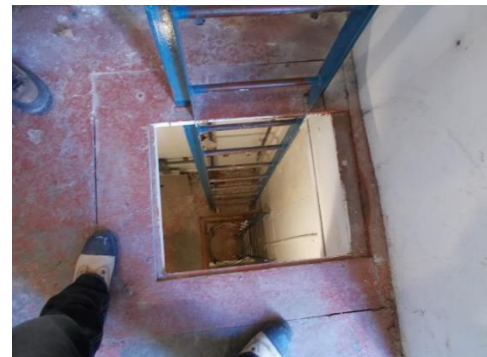
The ladders in the Metcalfe Lift Station are a **safety concern**. The upper ladder does not have a proper landing and dismounts directly over another penetration. There are no guard rails around the openings and ladders are aged and corroded. The ladders are supported in some places by slotted wood infills.

The hatches in the station are square, unhinged, and the lids are subject to falling through the openings. There are no safety guard rails in place around the hatches.

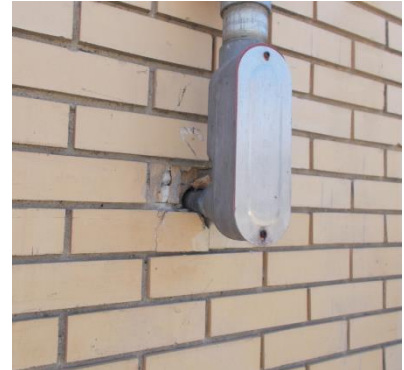
The drawings indicate that superstructure is composed of brick-faced haydite block. The masonry is broken and cracked around an electrical penetration. This compromises the envelope and should be sealed. The metal door is aging but is still fit for use. A metal grate covers an exhaust penetration but is insufficient in shape or size to protect the penetration properly.

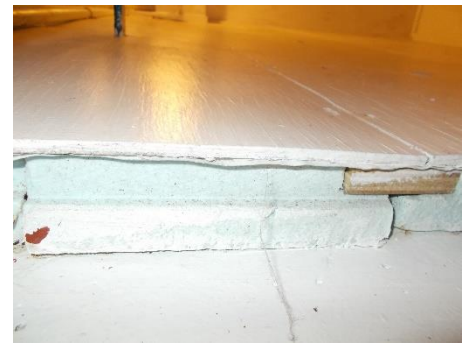
Insulation was added to the superstructure post initial construction. The rigid insulation board, vapour barrier, and painted plywood liner were properly installed and provide a suitable insulation and building envelop system for the station.

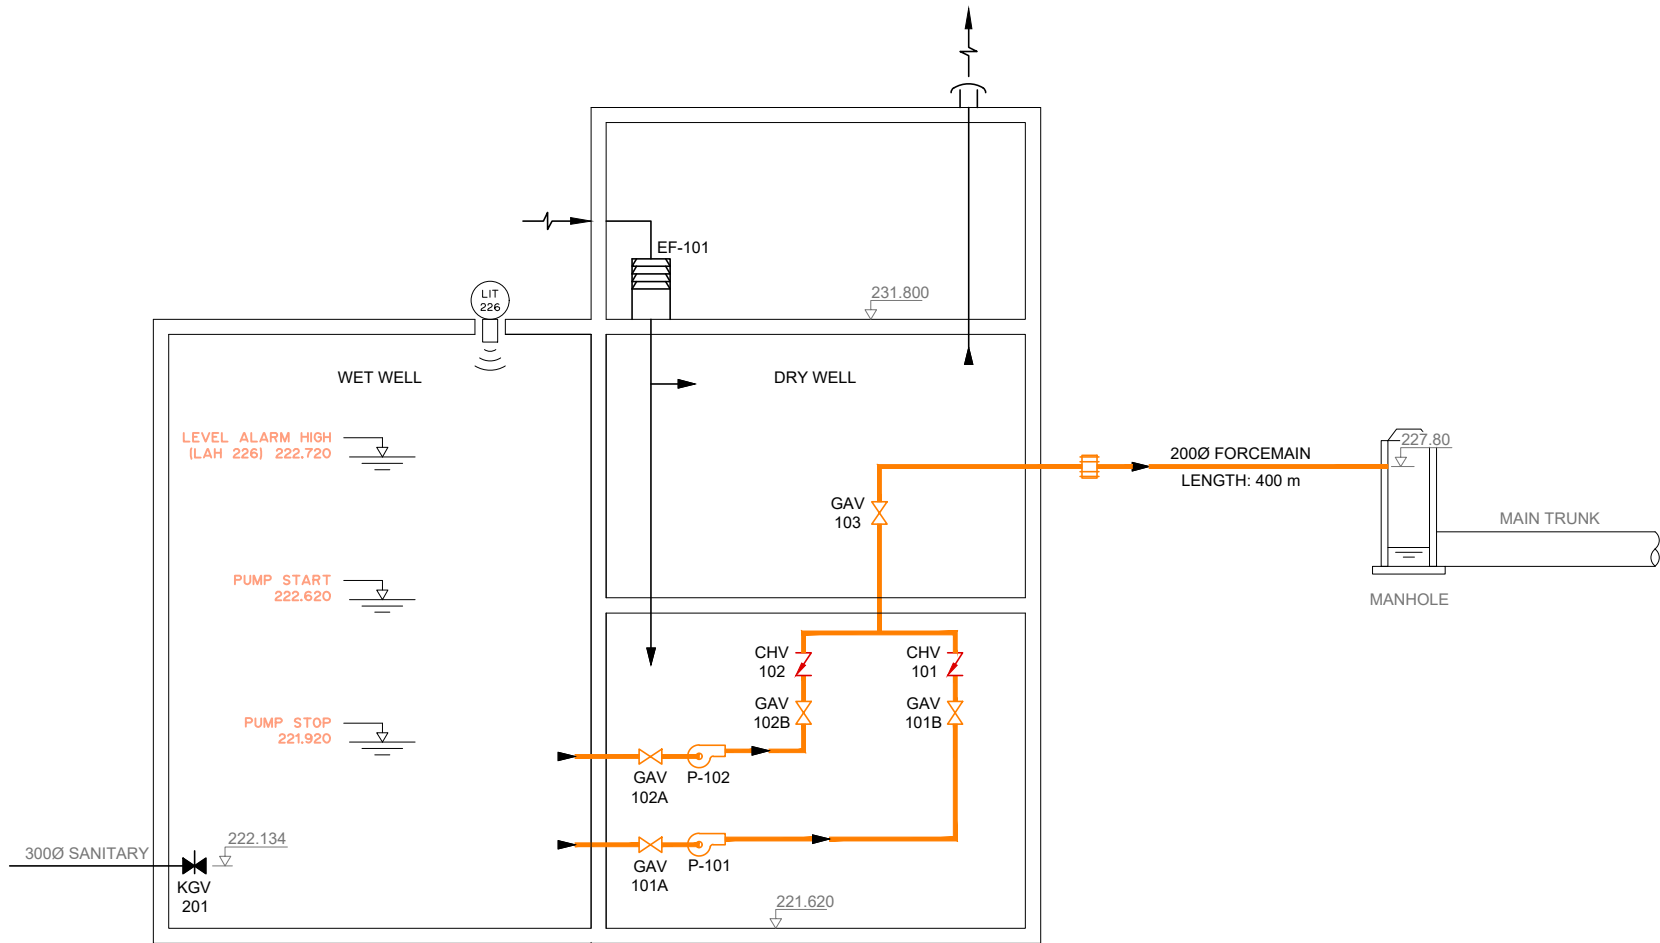
LIFT STATION ASSESSMENTS 2018-2019  
 METCALFE  
 CONDITION ASSESSMENT SUMMARY

Figure 7.1 provides a graphical summary of the condition assessment of the mechanical components of the Metcalfe Lift Station.

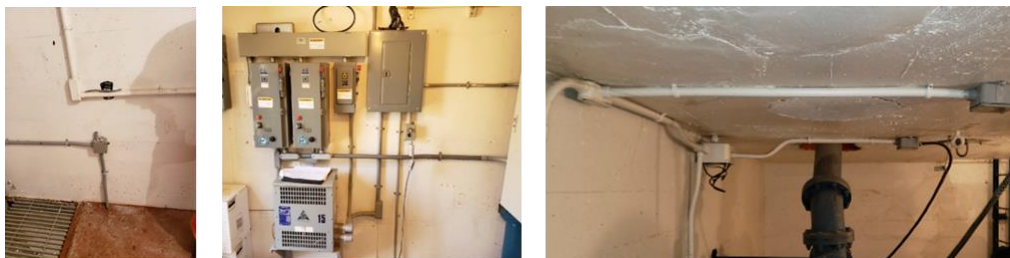
The wiring style in the Metcalfe Lift Station is primarily run using RPVC throughout all levels of the dry well. Conduit does not meet Zone 2 requirements. Additionally, conduit fitting covers have been removed and not replaced once work was complete.
