CITY OF WINNIPEG

WASTEWATER LIFT STATION CONDITION ASSESSMENT PHASE II

Document II: St. Charles Lift Station Assessment

Date: March 16, 2020

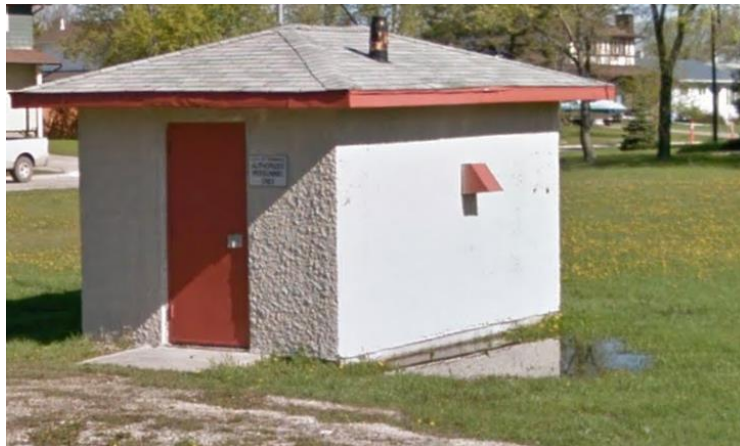
St. Charles Site Grading – Google Maps

Due to snow cover during the inspection, the site grading conditions were not able to be observed. A Google Maps – Street View image, however, reveals ponding against the side of the structure. Landscaping consists of a large grass area kept mowed.

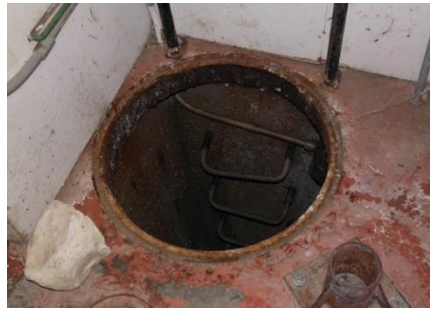
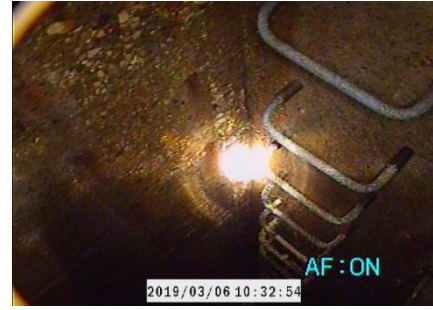
The wet well access is located within the lift station building resulting in potential for H₂S to enter the building. This can cause an unsafe work environment, and lead to aggressive corrosion in the

building components. A bolt down gas-tight hatch would help eliminate this issue; however, the close proximity to the wall would require additional modifications for proper installation. Relocating the access to the exterior of the building is recommended for Code compliance.

Access to the well is not recommended in any condition unless full harnessing and safety protocol is followed. The ladder rungs are not suitable for usage.

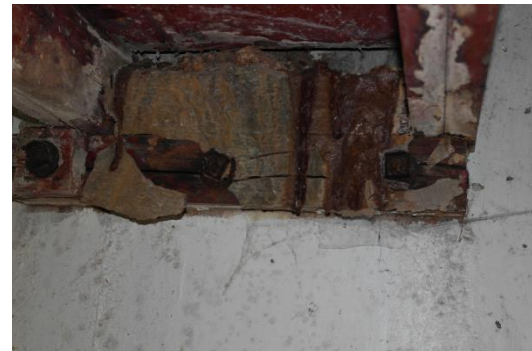
During the inspection, MPE was unable to assess the superstructure components due to the cladding installed. The drawings provided by the City indicate the structure was built using YTONG Autoclaved Concrete Blocks. The drawings also indicate the structure originally had two windows on the west side. These appear to have been removed and possibly filled in. The configuration is durable. The subgrade concrete walls and base slab appear to be in “fair” condition, though the finishes are deteriorating.

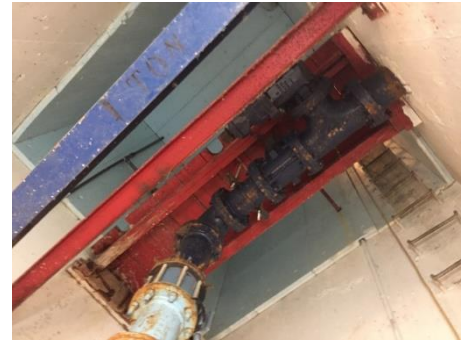
The plywood interior finishes are aged and should be replaced with the next renovation. Equipment pads appear to be in “Good” condition. Two mid-level cross beams (painted red), are show signs of corrosion. The beams were used to support the bearings of a historical extended pump shaft. The shaft has since been removed and consideration should be made for the removal of the beams.

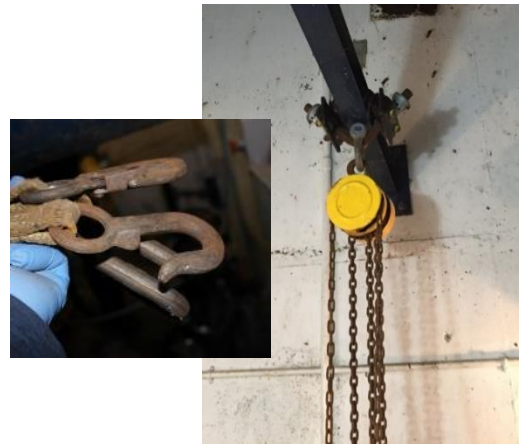
The lower level hoist is aging and corroding and the monorail is showing some signs of corrosion as well. The hooks used for this hoist are missing latches and are not code compliant. It is unable to deliver equipment to the exterior of the building. Future renovations should consider upgrading the hoist system and including a roof-access hatch for equipment removal.

MPE was unable to obtain a copy of the third party monorail and hoist certification.

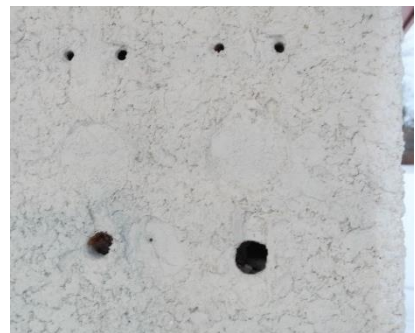
The stucco siding has several holes that are primarily on the east and north sides of the building. The holes on the north side have been covered by a plate and bolt; however, the covering is imperfect and will not properly seal the envelope. The asphalt shingle roof is aging and in need of replacement.

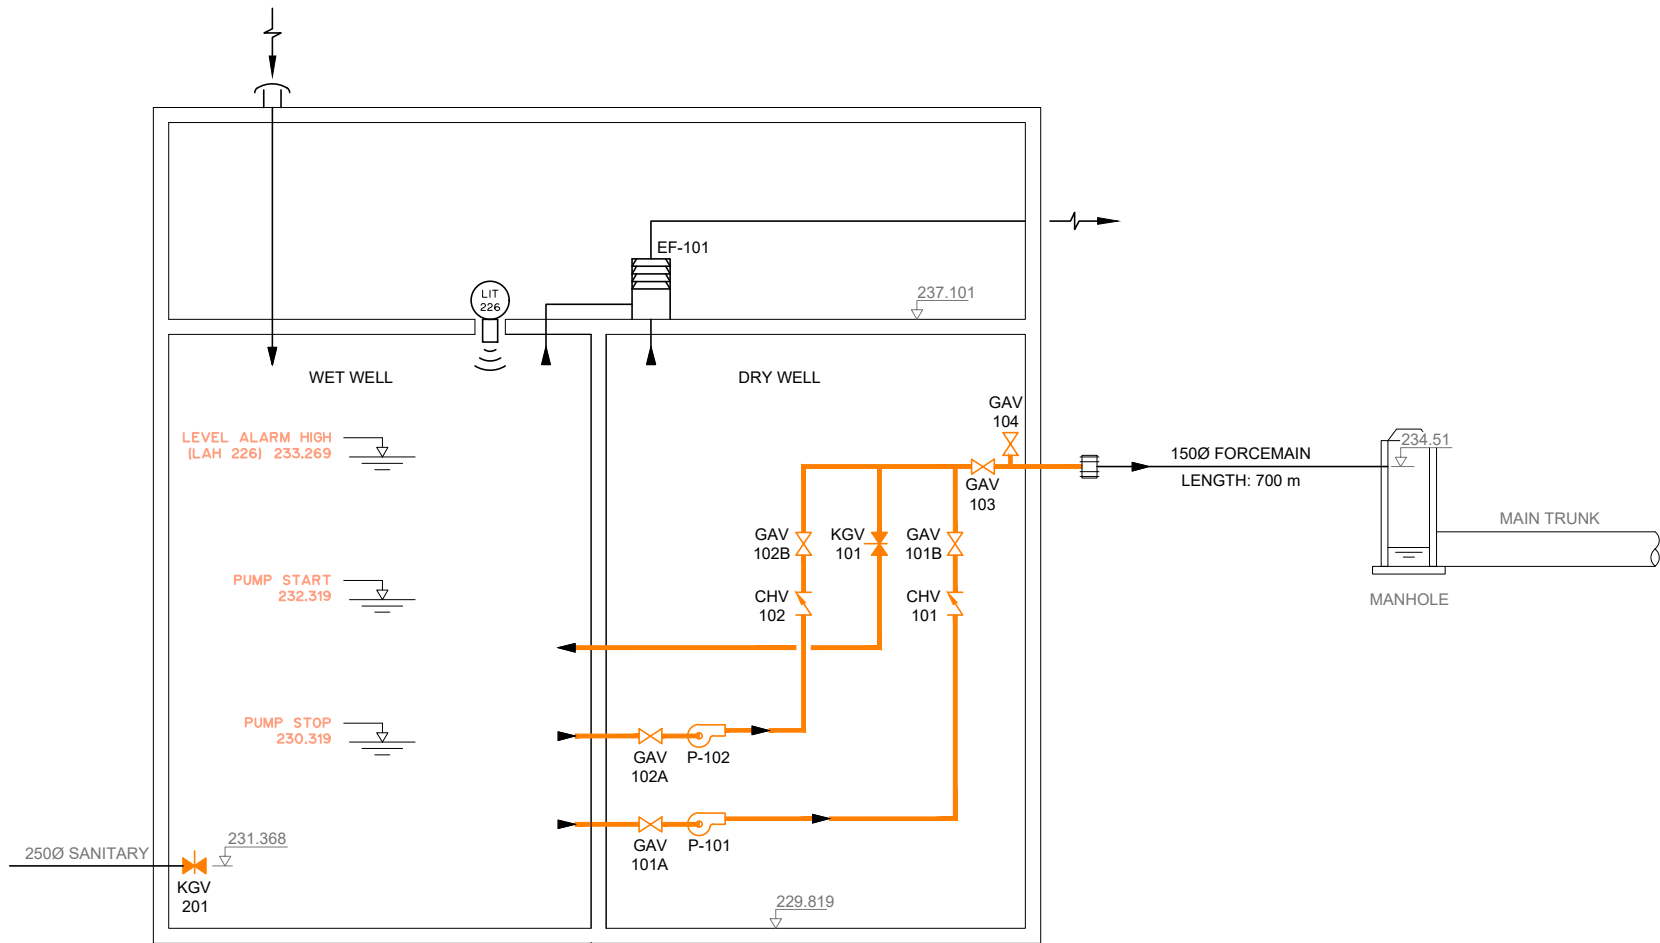
ST. CHARLES
 CONDITION ASSESSMENT SUMMARY

Figure 7.1 provides a graphical summary of the condition assessment of the mechanical components of the St. Charles Lift Station.

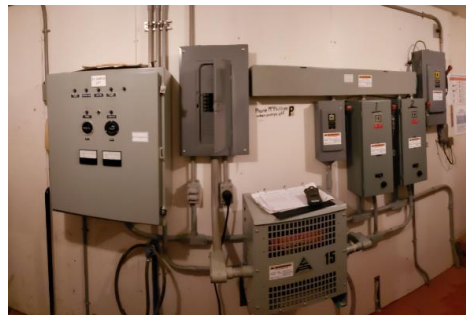
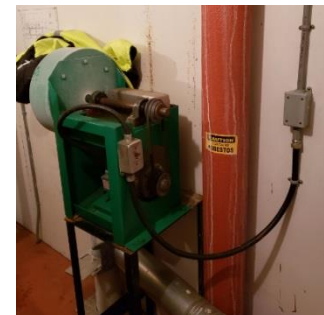
The wiring style in St. Charles Lift Station is primarily run using RPVC with minor amounts of threaded rigid, and Teck within the lift station. RPVC does not meet Zone 1 requirements.
