POOL HEATING AND VENTILATION SYSTEM ASSESSMENT

**CINDY KLASSEN POOL - 999 SARGENT AVENUE
PHASE I STUDY - PROJECT NO. 2015-089**

KGS Group 17-0107-019
May 2018

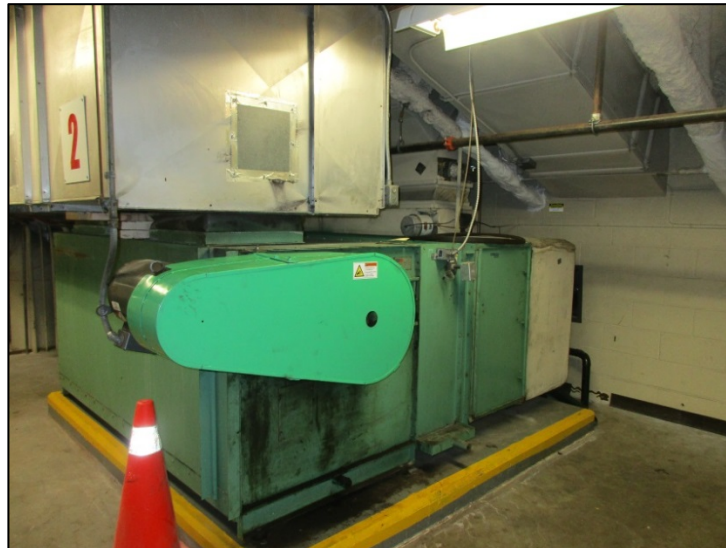
PHOTO 1
EXISTING AIR HANDLING UNIT – AH-2

Air handling unit AH-2 is located in the south mechanical room provides heating and ventilation to the south portion of the pool. It is original to the building and approximately 42 years old. It has been operating beyond the 30 year normal life expectancy of an air handling unit. The unit consists of a supply fan section and a coil section (for a future coil). There is a built up mixing section at the return connection side of the unit with pneumatically actuated return and outdoor air dampers. The actuators appear to be in poor condition with bent actuator rods. The supply air coming out of this unit is heated using a remotely mounted 75 kW electric coil located in the basement. The City staff indicated that the heating coil has been replaced over time.

This unit receives outdoor air either directly from an outdoor air intake duct or through the solar wall. (Solar wall can pre-heat outdoor air using the solar energy during daytime.) The solar wall was originally installed in 2005 on the upper portion of the south facing wall of the pool building. The original solar drawings indicate it has an air flow capacity of 15,000 CFM. During the 2007 renovation it was moved to the upper portion of the south facing wall of the new addition. A long intake duct is installed to take air from the solar wall back to air handling unit AH-2.

(Note: The 2007 architectural drawings called for the relocation of the solar wall however the mechanical drawing did not show the solar wall or the intake duct. It is assumed that the intake duct was added by addendum or change order, but did not get added to the drawings. There is no documentation to indicate that AH-2 system was re-balanced or properly commissioned after the solar wall relocation.)

Some of the issues noted on the solar wall system are as follows:

- AH-2 may not have adequate fan power to overcome the pressure losses through long duct that connects AH-2 to the relocated solar wall. (The 2007 air balancing report had no data on AH-2; therefore it is assumed that air flow through the solar wall was never measured).

- There is an existing motorized damper on the solar wall duct where it connects to the normal outdoor air duct; however whether there is a damper on the outdoor air duct could not be confirmed.
- The spiral solar wall duct in the fitness area does not have any external duct insulation. As the original construction drawings do not show this duct, whether there is any internal insulation within the duct could not be confirmed. (The City staff indicated that there used to be water or condensation coming through the seams of the spiral duct. The seams were sealed to prevent this. The duct would have to be cut open to verify if there is any internal insulation).

It is recommended that the City retain the services of an air balance contractor to measure air flow rates of the solar wall. The results from the air balance report can be utilized to properly re-commission the solar wall.

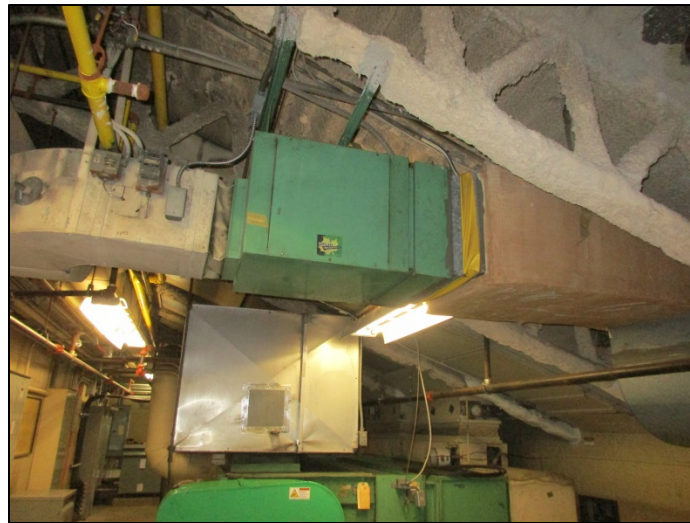
PHOTO 5
AIR HANDLING UNIT AH-5

Air handling unit AH-5 appears to be a built up unit consisting of a fan with an inlet filter, electric heating coil(s) and what appears to be a built up mixing box. According to the drawings this unit supplies 750 CFM to the family change area and Room M:84.

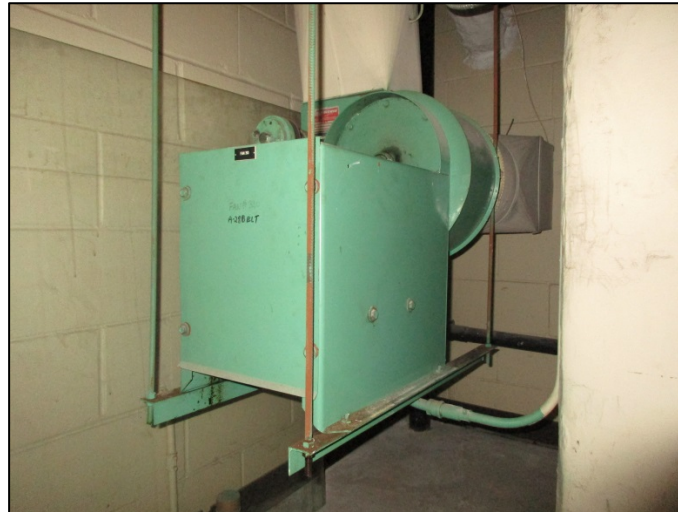
PHOTO 6
FAN 310

Fan F-6 exhausts air from the family change area. (The original drawings identify this fan as F-6, however the physical tag on the unit state Fan 310.) This is a belt driven centrifugal exhaust fan with an air flow capacity of 750 CFM. It is original to the building and therefore approximately 42 years old. The exterior of the fan appears to be in average condition. Normal life expectancy of a fan of this type is about 35 years, however it can operate beyond that based on good maintenance.

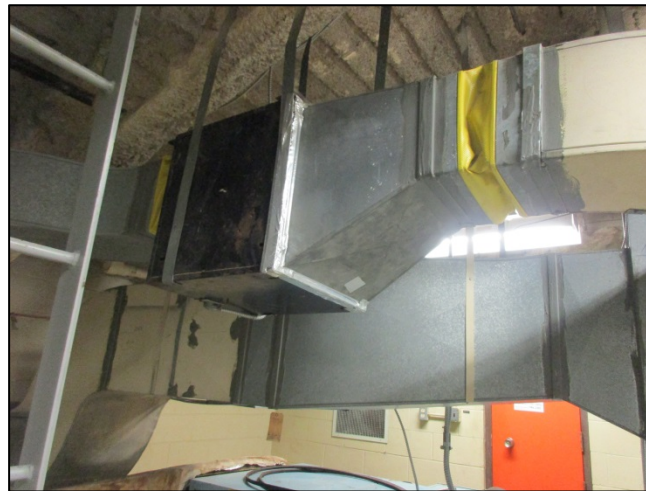
**PHOTO 7
FAN (NO TAG)**

This fan has no identification tag or name plate data (See Photo 7 below). From the exterior, it appears to be a direct drive inline centrifugal unit. It is on one of the duct branches originating from air handling unit AH-3. The fan is not shown in the original drawings, therefore it is assumed to be installed after the original construction. The duct branch supplies a single grille with a 275 CFM airflow rating located at the entrance/reception area of the original building. (The 2007 renovation drawings identify this area as Corridor 108). As the installation of this fan is not documented, its' intended purpose is unclear. It can be assumed that the air flow into the original building entrance/reception area may have been inadequate. As the reception area is now located in the new addition, this fan may no longer be needed.

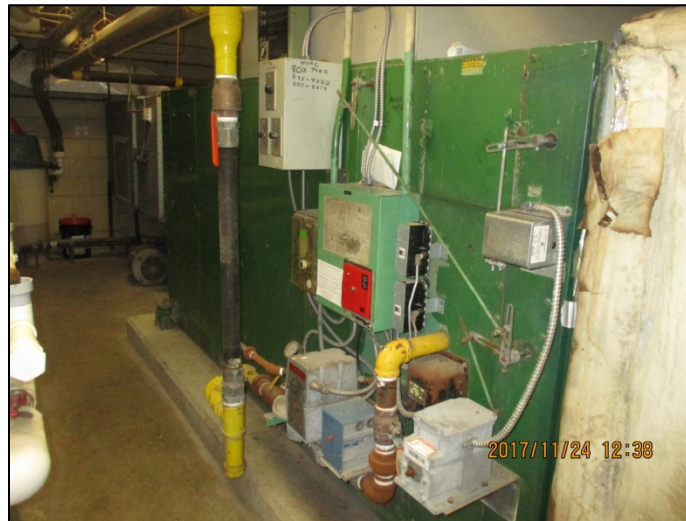
PHOTO 8
AIR HANDLING UNIT AH-1

Air handling unit AH-1 is a direct fired natural gas air handler. The direct fire burner is located in the outdoor air section of the unit before the return air duct connections. The unit has a total air flow capacity of 15,000 CFM. The unit is original to the building and approximately 42 years old. It has been operating beyond its' 30 year normal life expectancy. The unit is in poor condition and said to have frequent breakdowns. Furthermore, the unit as installed does not comply with current CSA B149.1 code. There is no provision in the code that allow direct fired burners to be installed in air handling unit that have return air. (The reason is to prevent carbon monoxide (CO) poisoning. CO is created due to incomplete combustion.) Due to the unit being non-code compliant, it requires immediate replacement.

Two replacement options are considered and presented below. Option 1 is to replace the existing unit with an indirect natural gas fired outdoor air handling unit. Option 2 is to replace existing unit with an indoor hydronically heated air handling unit.

In this option the existing air handling unit would be replaced with a new outdoor air handling unit. The new unit would be located on a concrete pad at ground level. It would have two indirect fired natural gas heating sections, one for normal space heating and one outdoor air heating. The total air flow of the unit would be 15,000 CFM to match the existing air flow rate. The unit would have capacity to bring in 3,500 CFM (50% of the total ventilation requirement of the pool) in the winter. The new unit would have a heated maintenance vestibule to facilitate maintenance and repair in the winter. It would not have air conditioning or mechanical dehumidification as the existing pool is not air conditioned or mechanically dehumidified. (Proposed location of the unit is shown in Figure 2 in Appendix A).

Due to humid air returning from the pool, there is a possibility of condensate forming within the mixing section of the new air handling unit. To mitigate this, the mixing section would be equipped with a drip pan. A condensate removal pump would have to be provided to remove any condensation that collects in the drip pan. The condensate would be pumped to a drain in the north mechanical room. The outdoor portions of the piping would have to be insulated and heat traced to prevent freezing in the winter.

In this option the air handling unit would be replaced with a new hydronically heated air handler. (This would be similar to the other air handling units in the north mechanical room). The air handling unit would have two heating coils, one space heating and one for outdoor air heating.

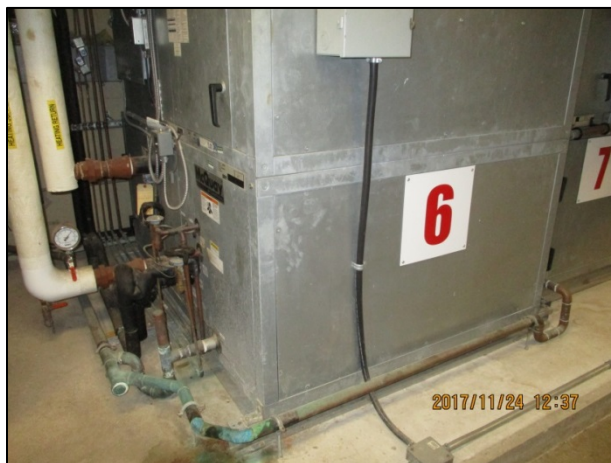
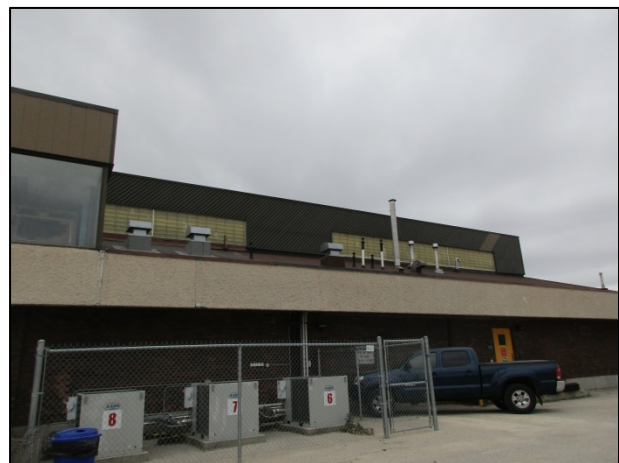
PHOTO 9
AIR HANDLING UNIT AH-6 AND REMOTE CONDENSING UNIT

Air handling unit AH-6 serves the north side second floor spectator area and offices. It has hydronic (hot water) heating and mechanical (DX) cooling. The remote condensing unit associated with AH-6 is located outside at ground level. The air handling unit and the associated remote condensing unit are installed in 2007 and currently 10 years old. The units appear to be in good condition and with good maintenance can last up to another 20 years.

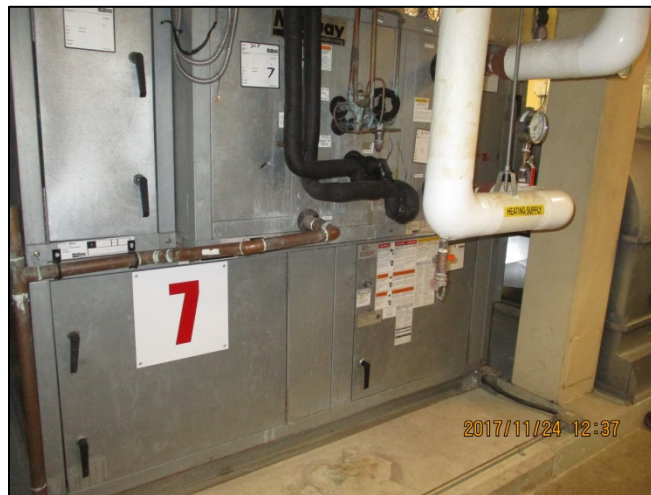
PHOTO 10
AIR HANDLING UNIT AH-7

Air handling unit AH-7 serves the main floor areas identified as Club Rooms. Similar to AH-6 system, it has hydronic (hot water) heating and mechanical (DX) cooling. The remote condensing unit associated with AH-7 is located outside at ground level. The air handling unit and the associated remote condensing unit are installed in 2007 and currently 10 years old. The units appear to be in good condition and with good maintenance can last up to another 20 years.

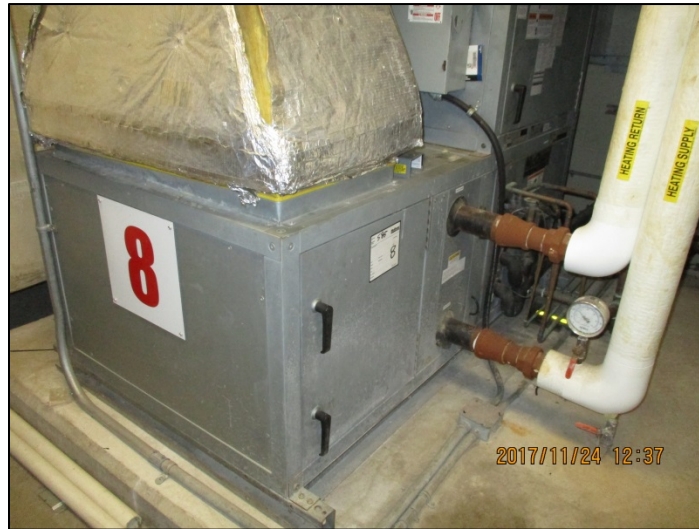
PHOTO 11
AIR HANDLING UNIT AH-8

Air handling unit AH-8 serves the main floor area identified as Exercise Room. Similar to AH-6 and 7 systems, it has hydronic (hot water) heating and mechanical (DX) cooling. The remote condensing unit associated with AH-8 is located outside at ground level. The air handling unit and the associated remote condensing unit are installed in 2007 and currently 10 years old. The units appear to be in good condition and with good maintenance can last up to another 20 years.

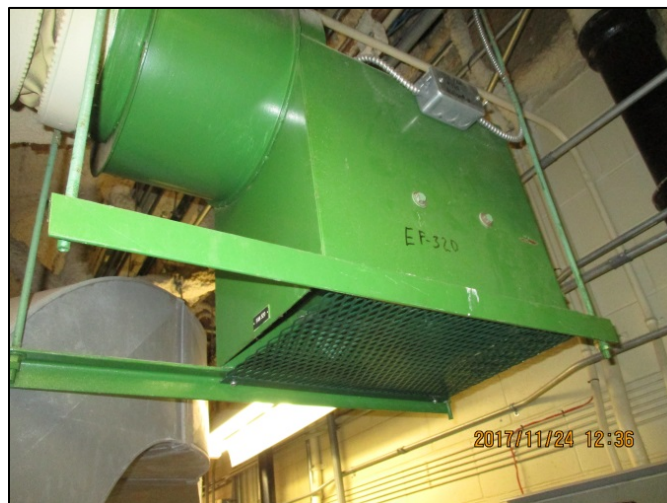
PHOTO 12
FAN 320

This fan serves the staff locker rooms located on the north side of the main floor. The fan is original to the building and therefore 42 years old. The exterior of the fan appears to be in good condition. Normal life expectancy of a fan of this type is approximately 35 years, however with good maintenance can operate beyond the normal life expectancy.

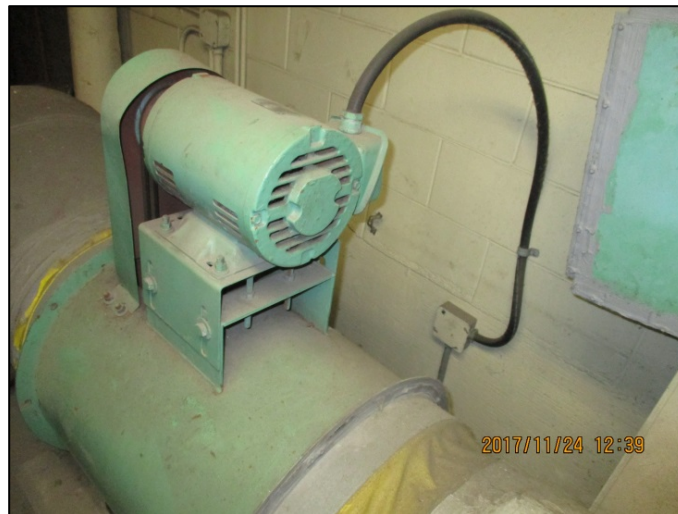
PHOTO 13
FAN F-11

This is a 7000 CFM axial fan supplying air to the “Vault Room” located in the basement. Its’ function appears to be providing cooling for electrical equipment located within the vault. This fan is original to the building and approximately 42 years old. It appears to be in average condition. Normal life expectancy of a fan of this type is approximately 35 years, however with good maintenance can operate beyond the normal life expectancy.

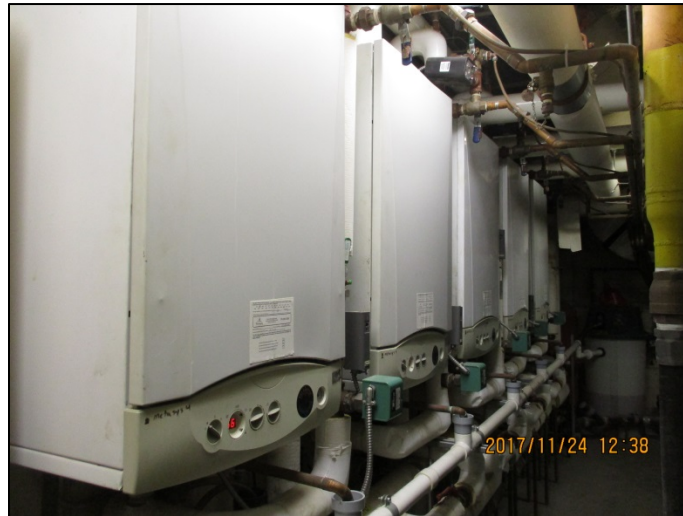
**PHOTO 14
BOILERS**

The boilers are installed in 2007 and currently 10 years old. These boilers appear to be residential units which are used in a commercial application. In a residential application these boiler would have approximately 20 year life span. However, the normal life may be considerably reduced in a commercial application. Most likely these boilers would require replacement within the next five years.

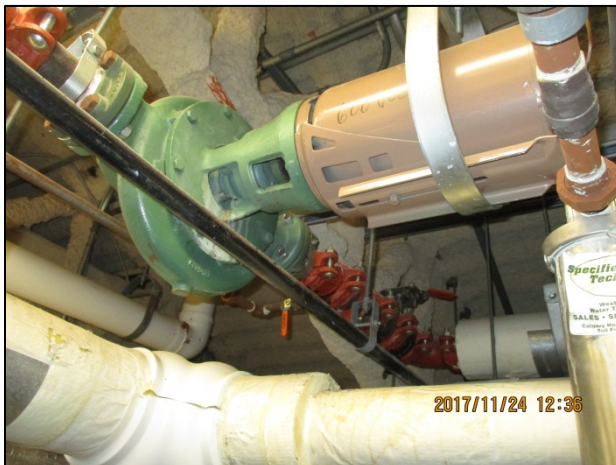
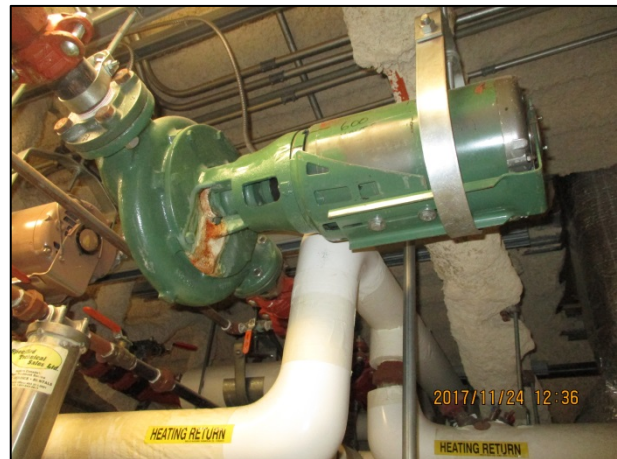
**PHOTO 15
PUMPS**

The circulation pumps are installed in 2007 and currently 10 years old. Both pumps rust stains perhaps indicative of a leak at some point. One of the pump motors appears to have been replaced. Typical life expectancy of a circulation pump is 25 years. However these pumps may have a reduced life due to various failures. The maintenance history of the pumps should be reviewed to see if there are any ongoing failures.

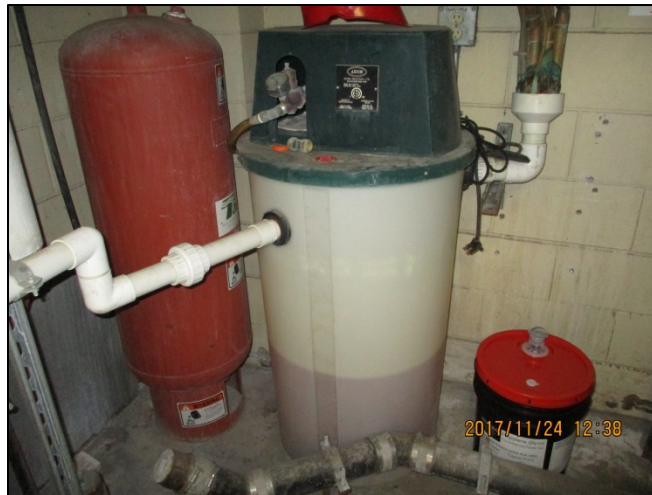
PHOTO 16
SYSTEM FEEDER

The hydronic system feeder is installed in 2007 and currently 10 years old. It appears to be in average condition. A normal life span of a system feeder is approximately 25 years. (Note: The unit was not plugged into the wall outlet at the time of the site visit.)

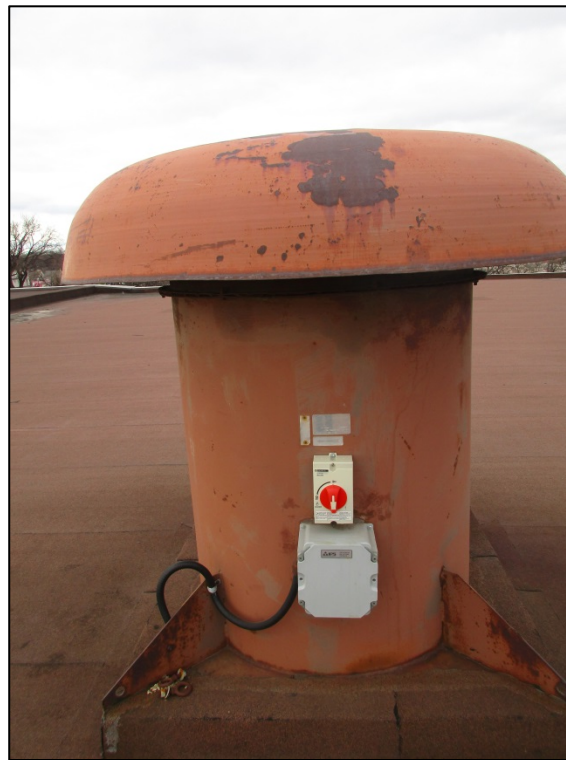
PHOTO 17
FAN (TYP)

Fans F-1, F-2, and F-3 are original to the building and currently 42 years old. Fans F-1 and F-2 exhaust the pool and are rated at 15,000 CFM each. Fan F-3 rated at 5,900 CFM exhausts the locker rooms. All three fans have rusted housing and appear to be in poor condition. It was indicated that the fan motors required replacement from time to time. The fans have been operating beyond their normal 35 year lifespan.

According to site staff, fans F-1 and F-2 operated continuously with a total exhaust rate of 30,000 CFM. The ventilation requirement of the pool and deck per current code (ASHRAE 62.1) is only 7,500 CFM. The current exhaust rate is four times higher than the required rate. Heating costs can be significantly reduced in the winter if the exhaust rates reduce to minimum rate of 7,500 CFM. This can be achieved using variable frequency drives (VFD). The VFD's will allow

the exhaust rate to be increased in the summer time to provide cooling and de-humidification. (**Note:** Exhaust fan F-3 rate cannot be varied as it is exhausting the men's and women's change rooms at the rate required by code.)

It is recommended that exhaust fans EF-1, EF-2, and EF-3 be replaced at the same time as the direct fired air handling units AH-1 and AH-3.

The existing exhaust fans F-1, F-2 and F-3 will be replaced with similar type of fans. The new fans would have appropriate coatings suitable for handling high humidity and chlorine compounds found in swimming pool air. Fans F-1 and F-2 would be variable frequency drive (VFD) controlled, whereas F-3 would operate at constant speed. Fans F-1 and F-2 would have air flow capacity of 15,000 CFM each. Fan F-3 would be 6,000 CFM.

The new control strategy for F-1 and F-2 would differ from the existing. The new strategy is to operate one fan constantly at the minimum required ventilation rate of 7,000 CFM. The fans would be programmed to modulate the exhaust rate between 7,000 and 30,000 CFM as required to control space temperature or humidity when outdoor air conditions permit. (The outdoor air / return air dampers in AH-1 and AH-2 would also be modulated to bring in the amount of air being exhausted by the fans.) This would result in considerable amount of cost savings (mainly outdoor air heating costs and also reduced power consumption by the fans).
