City of Winnipeg - 8" & 12" Steel lines

Condition Assessment Report, Standard Analysis

PICA – Pipeline Inspection & Condition Analysis Corporation
(a subsidiary of Russell NDT Holdings Ltd.)

**PICA Project:
WPG 12-8007**

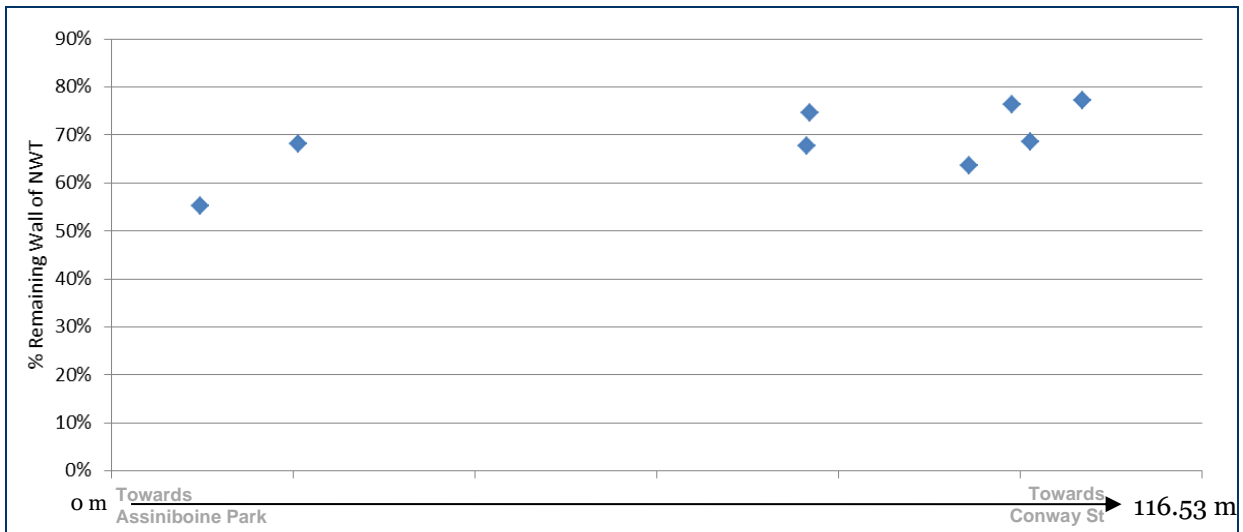
In the 8-in line, no pipes were found with a remaining wall thinner than 50% of nominal. The identified wall loss regions in the 8-in line were measured to have local remaining wall thicknesses ranging from 55% to 77% of nominal.

Figure 1: Distribution of local wall loss indications expressed in [%remaining wall of NWT] in pitting regions along the 8-in Assiniboine Park Siphon.

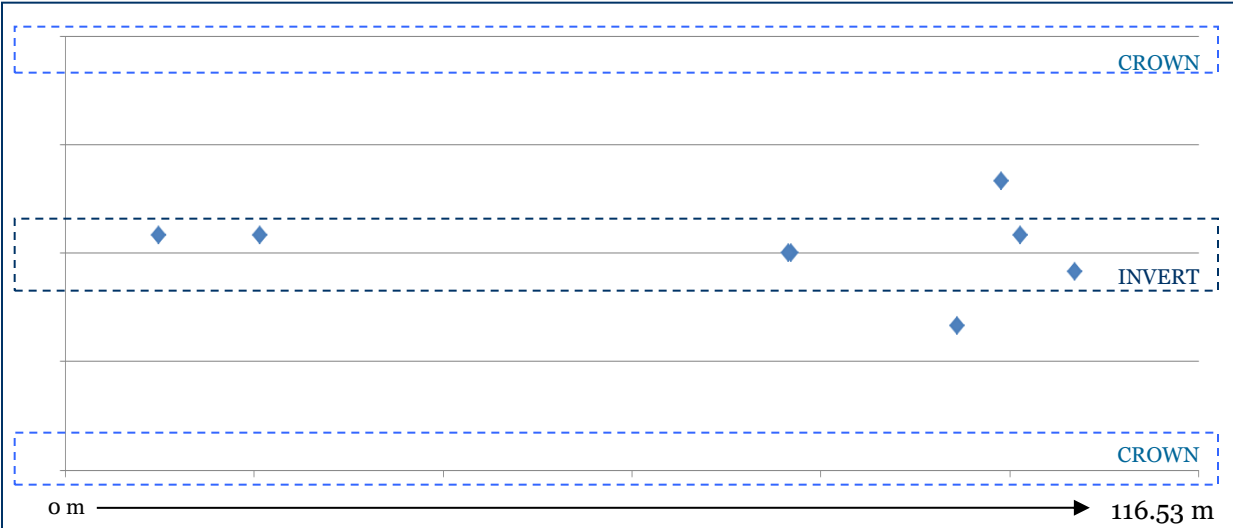
Figure 2: Circumferential distribution of pitting regions along the 8-in Assiniboine Park Siphon.

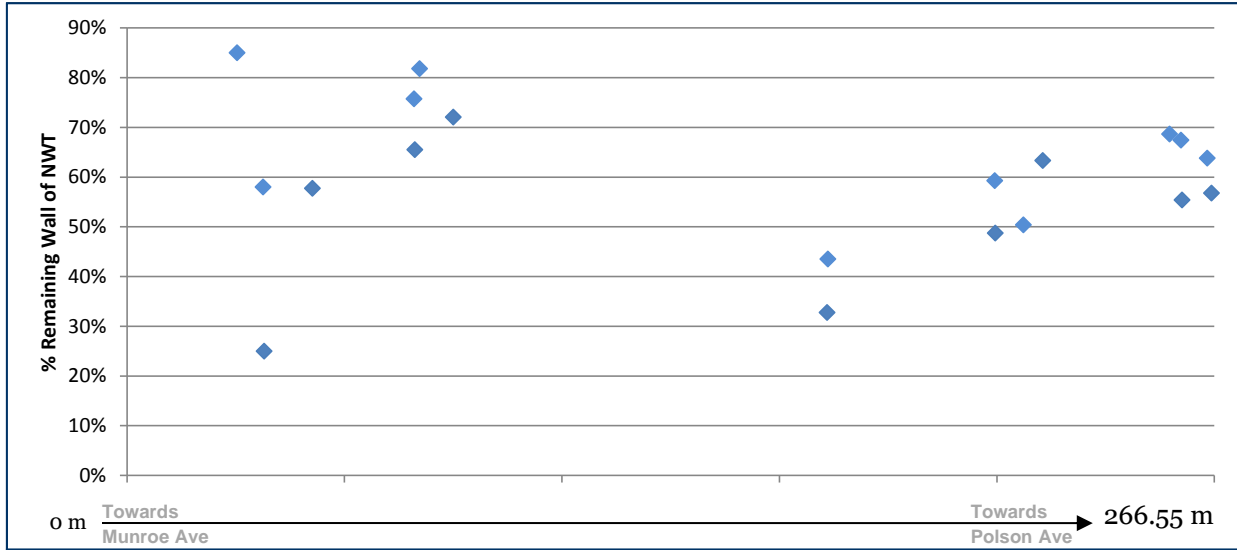
In the 12-in Munroe-Polson Siphon, a total of 22 wall loss regions were identified in 10 of 23 analyzed pipe sections. The wall loss regions have a local remaining wall thickness ranging from 24% to 85%. Eight (8) pipes (out of 23) were found with localized areas where the minimum wall is thinner than 50% of nominal.

Figure 3: Distribution of local wall loss indications expressed in [%remaining wall of NWT] in pitting regions along the 12-in Munroe-Polson Siphon.

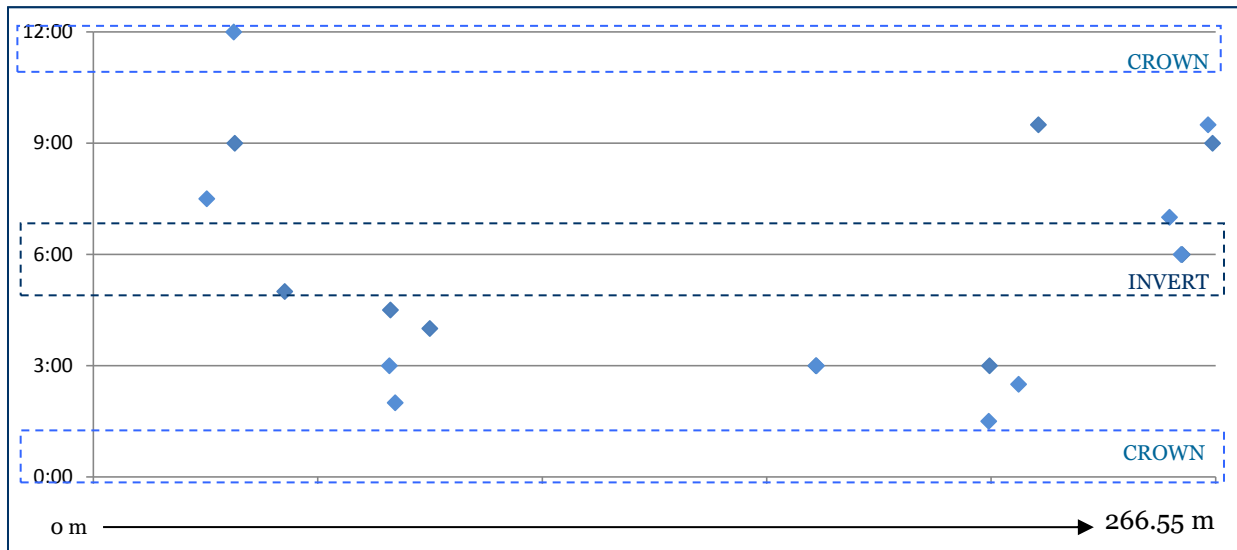
Figure 4: Circumferential distribution of pitting regions along the 12-in Munroe-Polson Siphon.

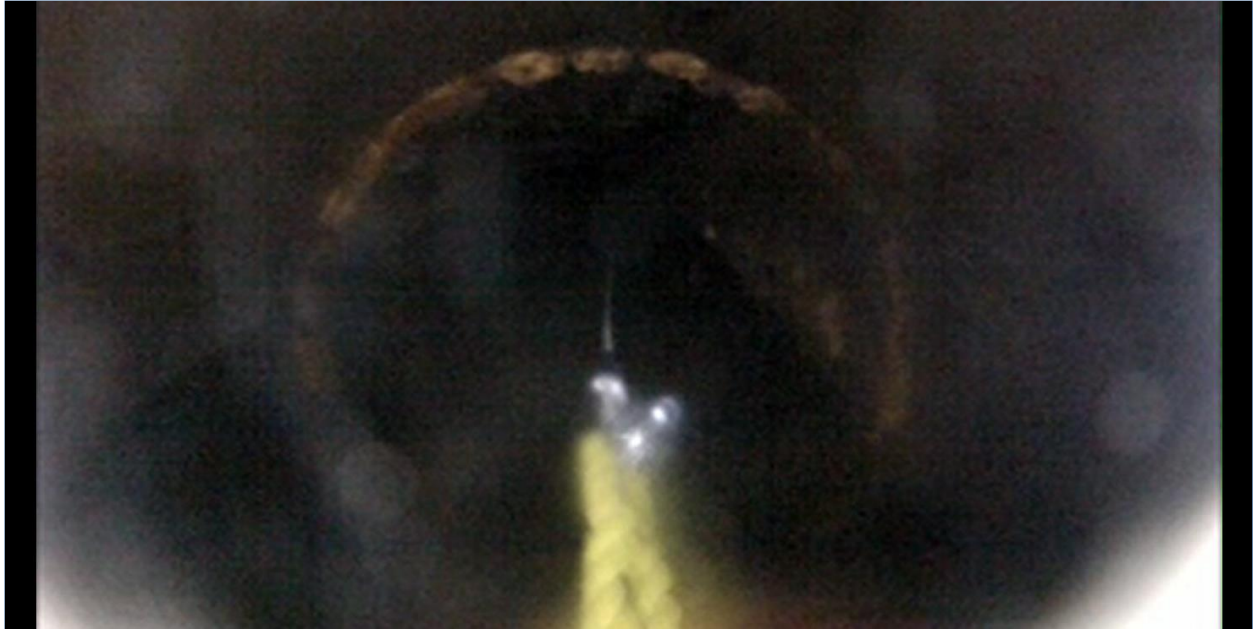
Figure 6a: A sample image of the tuberculation extent captured during PICA's foam pig proving run. The image was extracted from PICA's video recording footage of the proving run.

The extent of tuberculation, in PICA's experience is not unusual and not necessarily indicative of poor line condition. Since the video showed that the liner in between the joints was generally in good shape, it was decided to continue the inspection effort. However, it was first necessary to remove the tuberculated rings

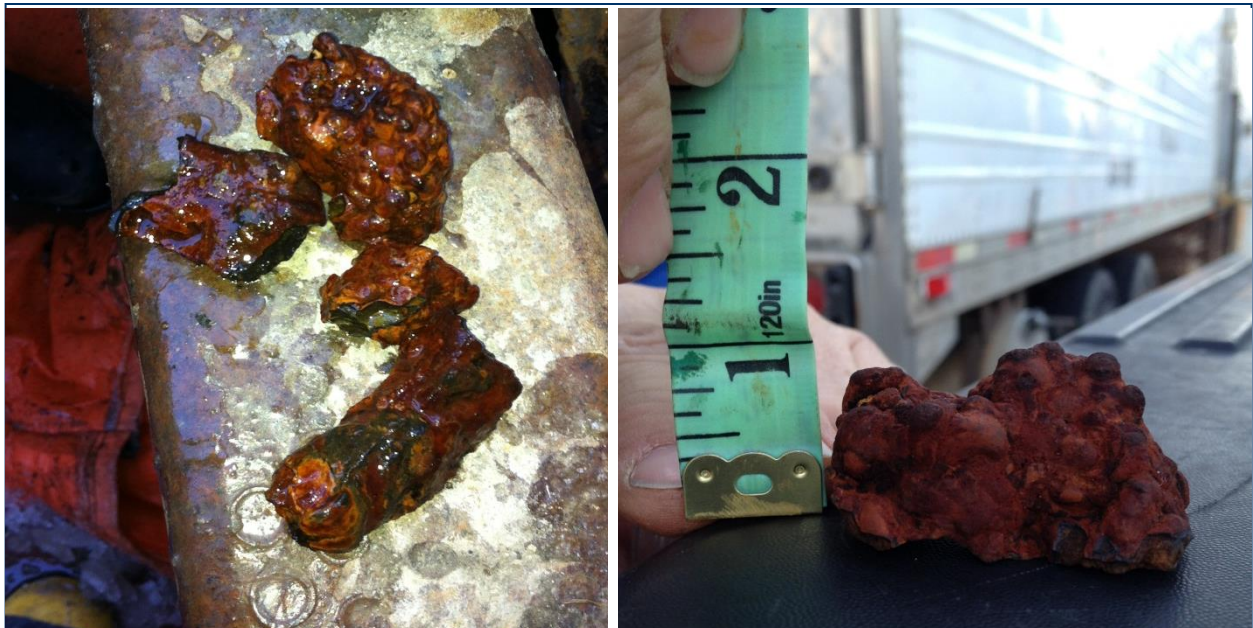
Figure 6b: Tubercle samples collected during the PICA's foam pig proving run.

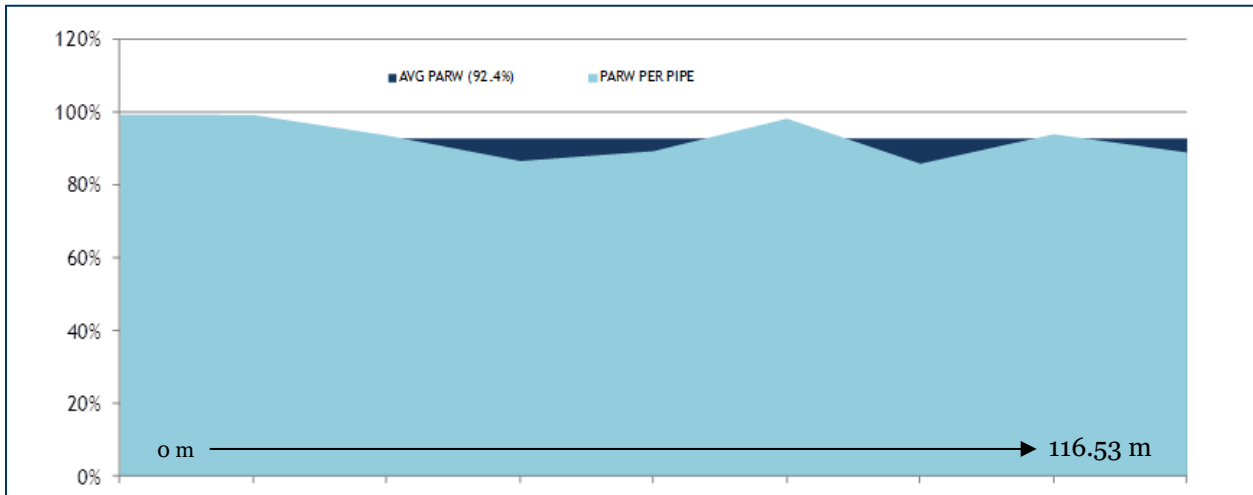
Figure 7: Pipe Average Remaining Wall (PARW) for each inspected pipe in the 8-in line.

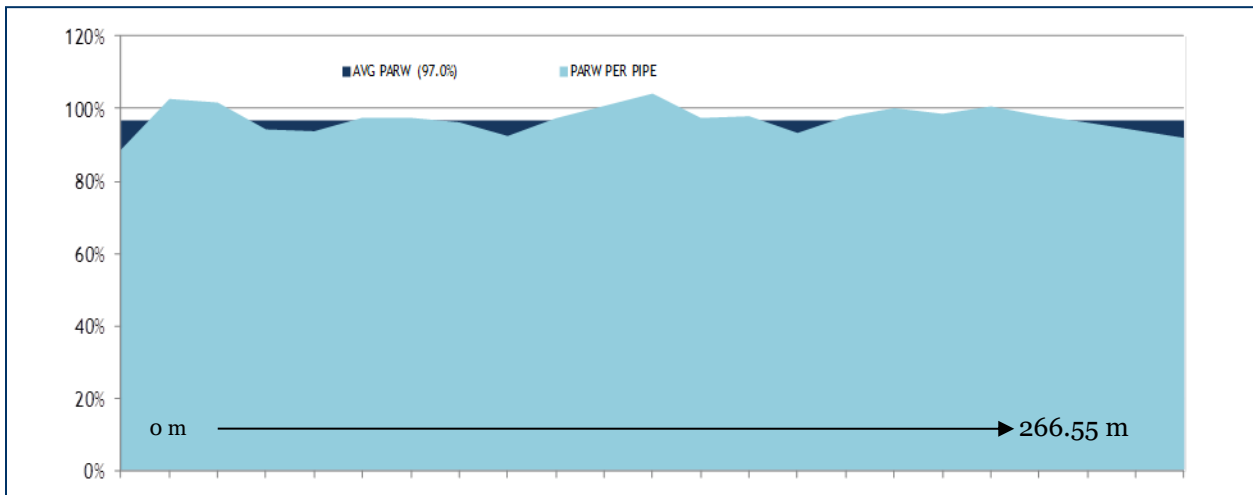
Figure 8: Pipe Average Remaining Wall (PARW) for each inspected pipe in the 12-in line.

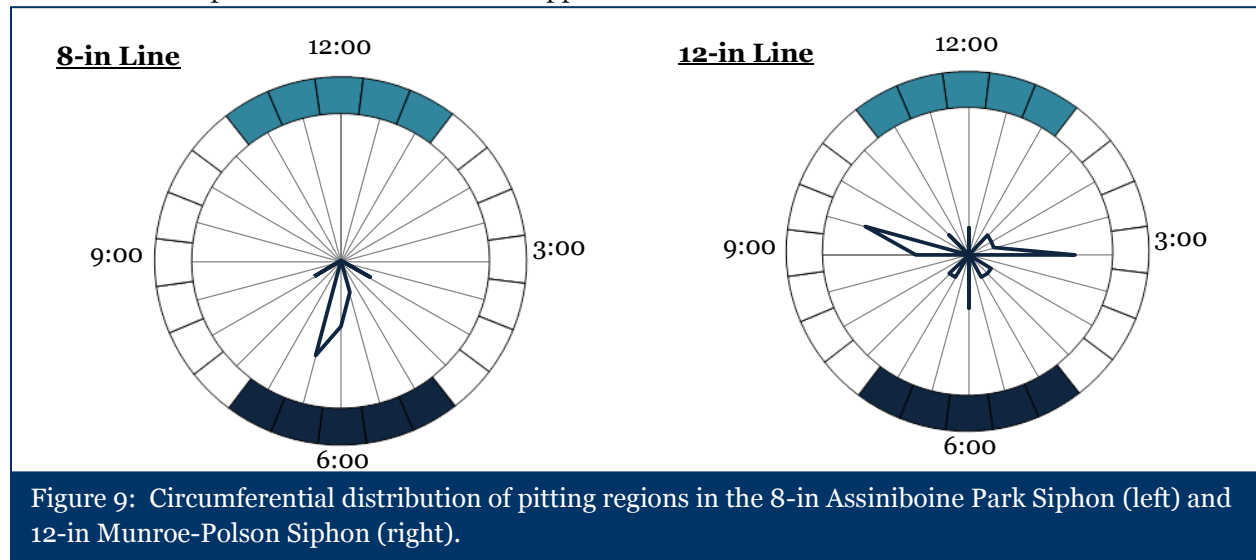
Figure 9 shows the distribution of reported pits as a function of clock position. In the 8-in line, detected pitting regions are all distributed in the lower half of the pipe with 75% at the invert (dark blue) and 25% along the mid-line (white). In the 12-in line, detected pitting regions appear to be mostly (77%) located along the mid-line (white), followed by 18% at the invert and 5% at crown.

Figure 9: Circumferential distribution of pitting regions in the 8-in Assiniboine Park Siphon (left) and 12-in Munroe-Polson Siphon (right).

If the City of Winnipeg chooses to excavate any of these wall loss locations, PICA should be contacted to provide dig maps. Additionally, sharing verification results with PICA can allow us to fine tune defect calibration and update the wall loss table in Appendix E.

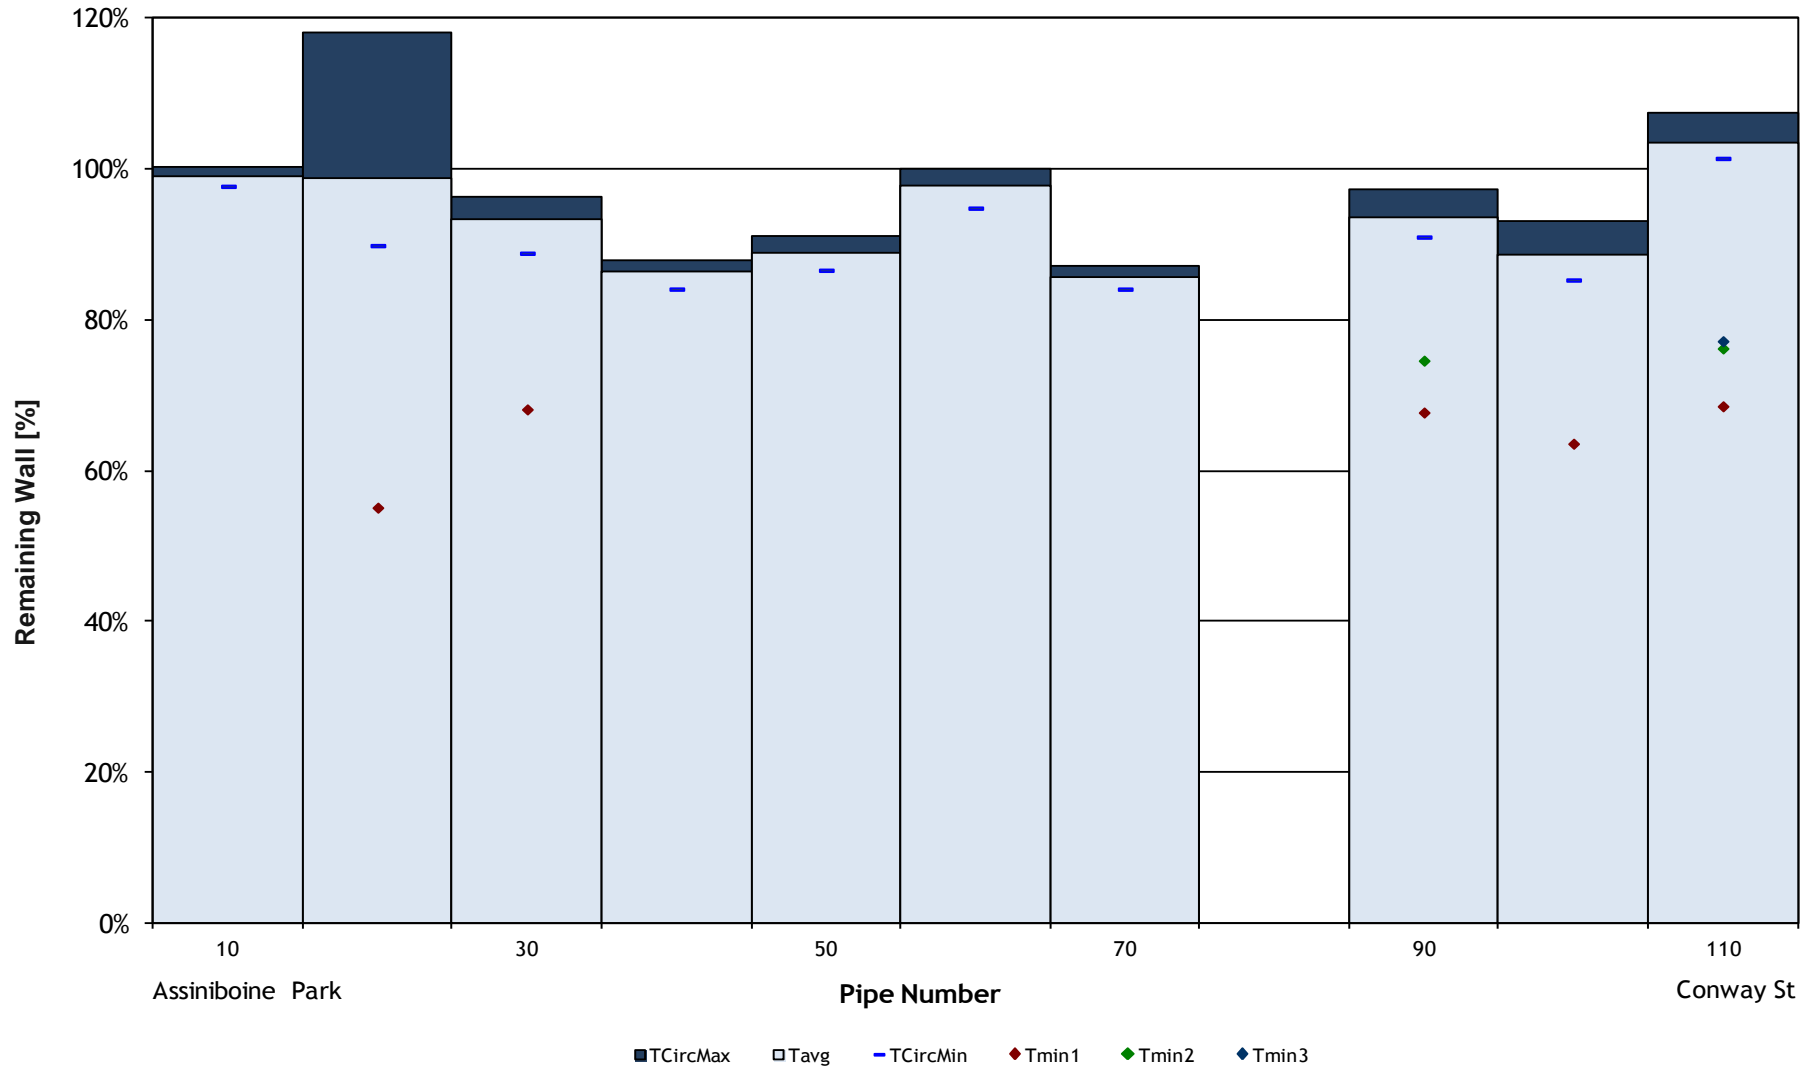
8-inch line (Assiniboine to Conway)

The RFT analysis of the 8-in Assiniboine Park Siphon identified a total of eight wall loss regions in 5 of 10 analyzed pipe sections. The wall loss regions in the 8-in line have local remaining wall thickness ranging from 55% to 77%. Pipe 0020 possesses the most severe wall loss region at 55% RW. Pipe 0110 possesses the worst cluster of wall loss regions (69%, 76% and 77% RW).

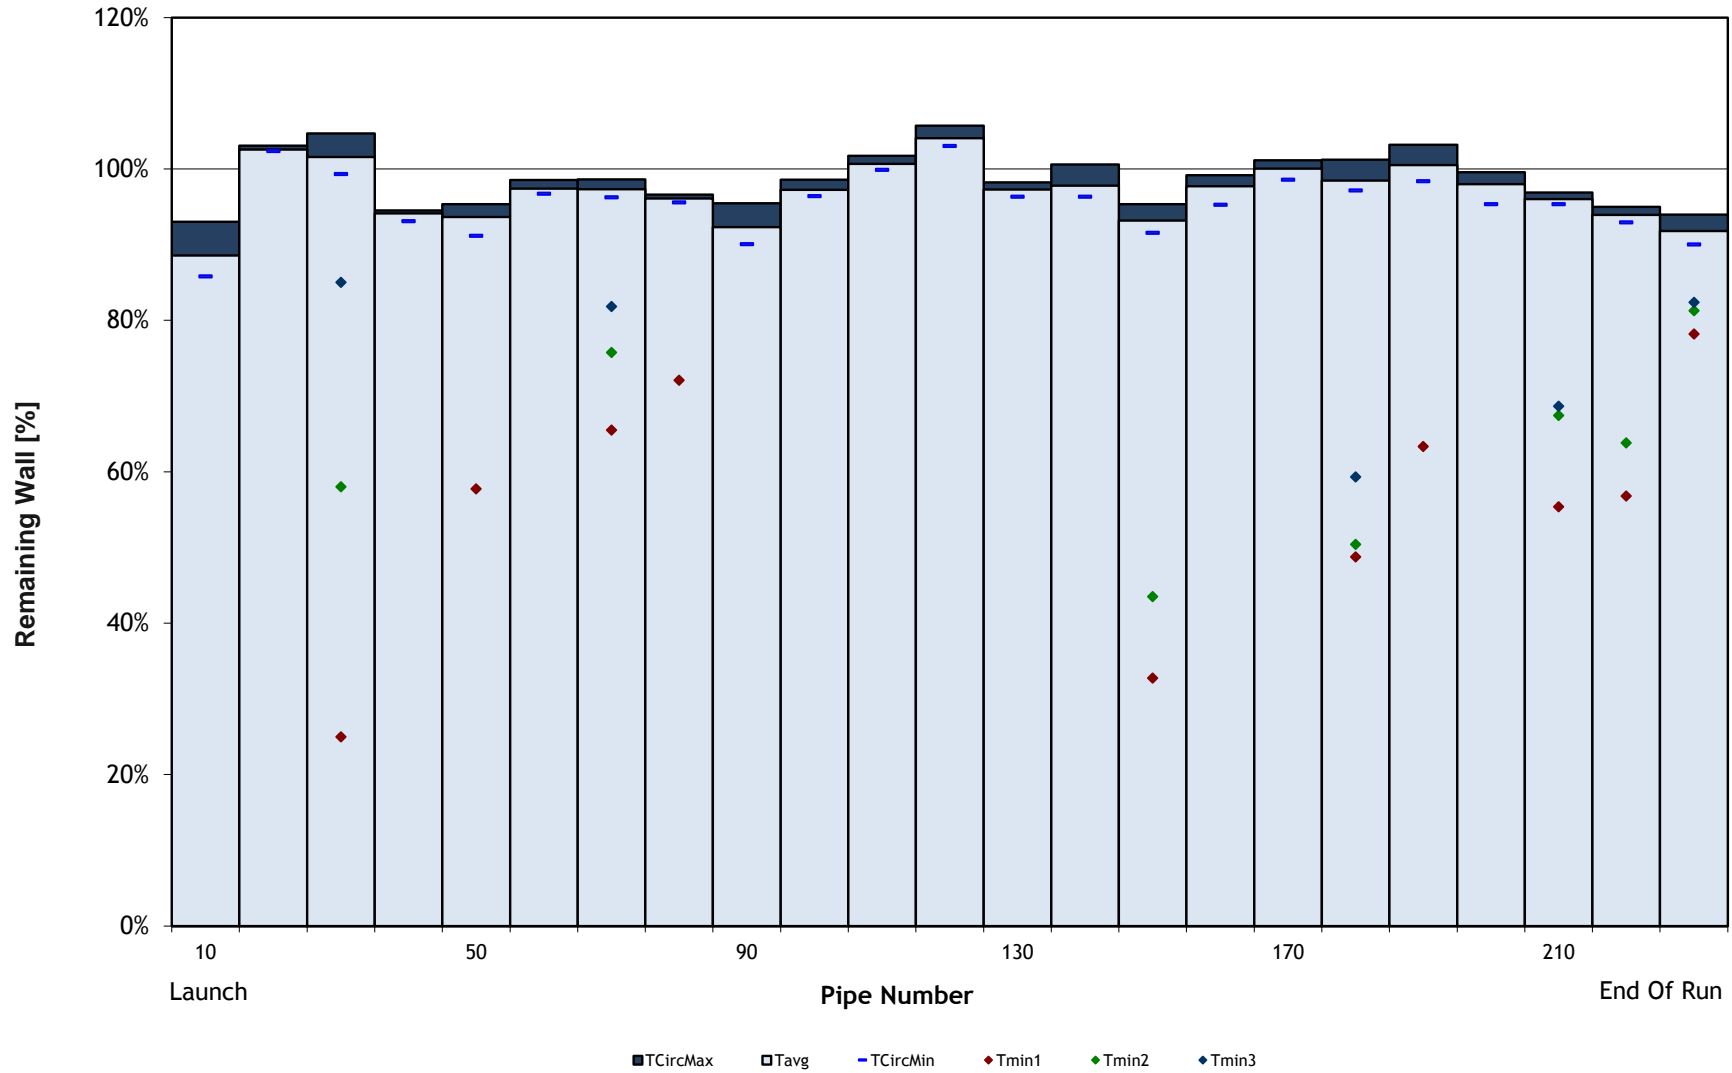
City of Winnipeg - 12-inch line (Munroe to Polson)

In the 12-in Munroe-Polson Siphon, a total of 22 wall loss regions were identified in 10 of 23 analyzed pipe sections. The wall loss regions in the 12-in line have local remaining wall thickness ranging from 25% to 85%.
