APPENDIX 'C'

Photo Log

APPENDIX 'C' – PHOTO LOG

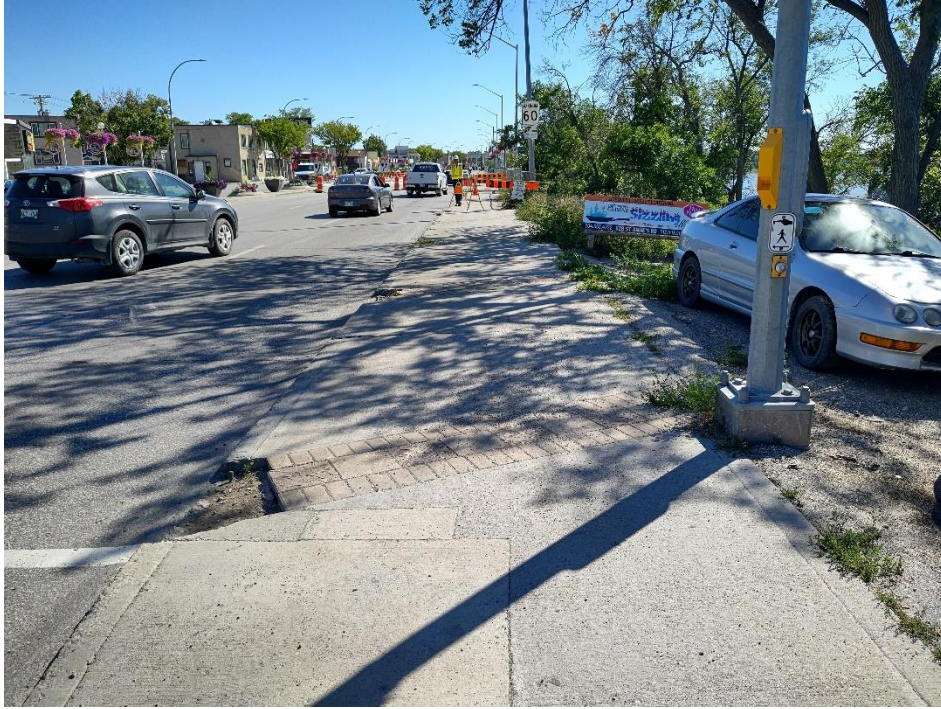
Photo 1: Looking south on St. Mary's from Vivian intersection (August 31, 2022)

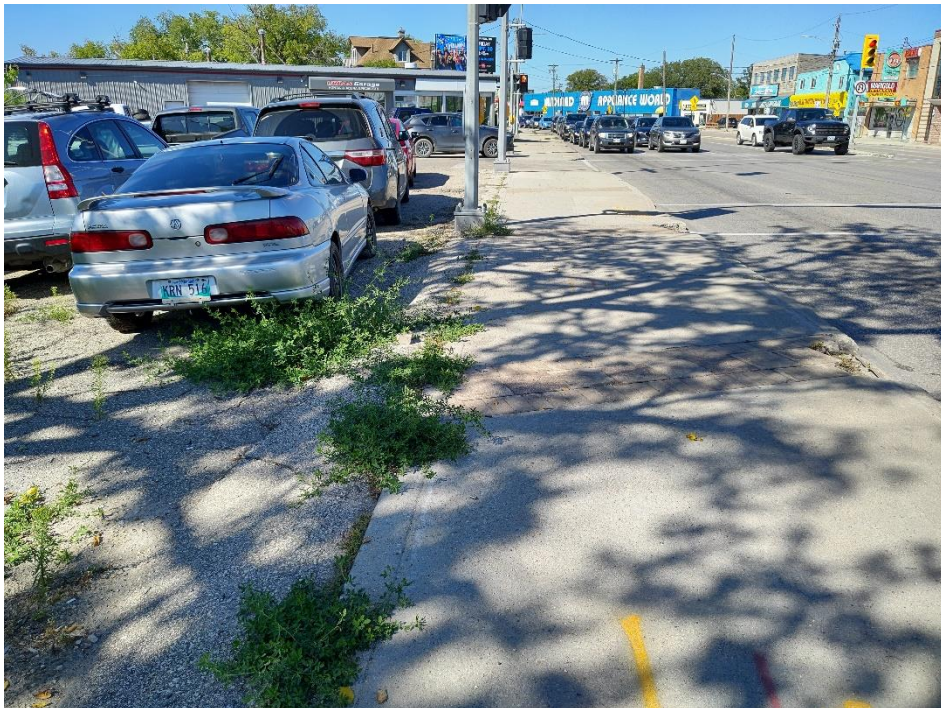
Photo 2: Looking north on St. Mary's from Vivian intersection (August 31, 2022)

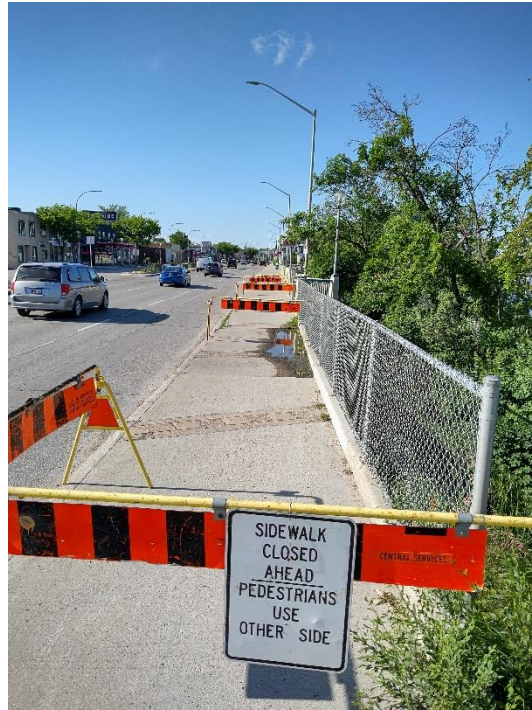
Photo 3: Looking south on St. Mary's at closed sidewalk segment (July 12, 2022)

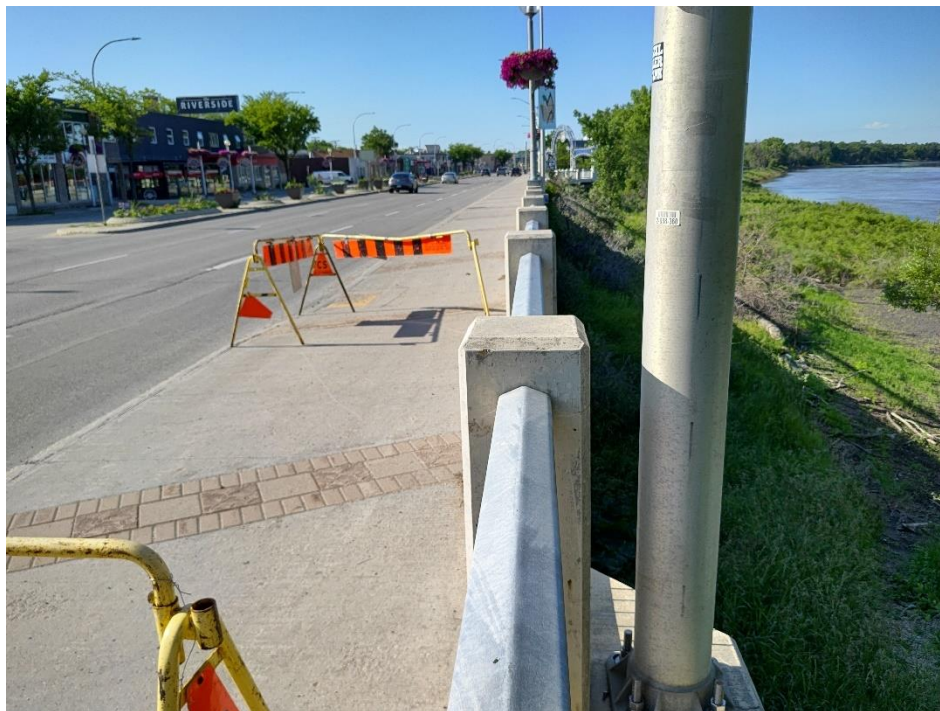
Photo 4: Looking upstream at the top of bank near the upstream edge of the project area (July 12, 2022)

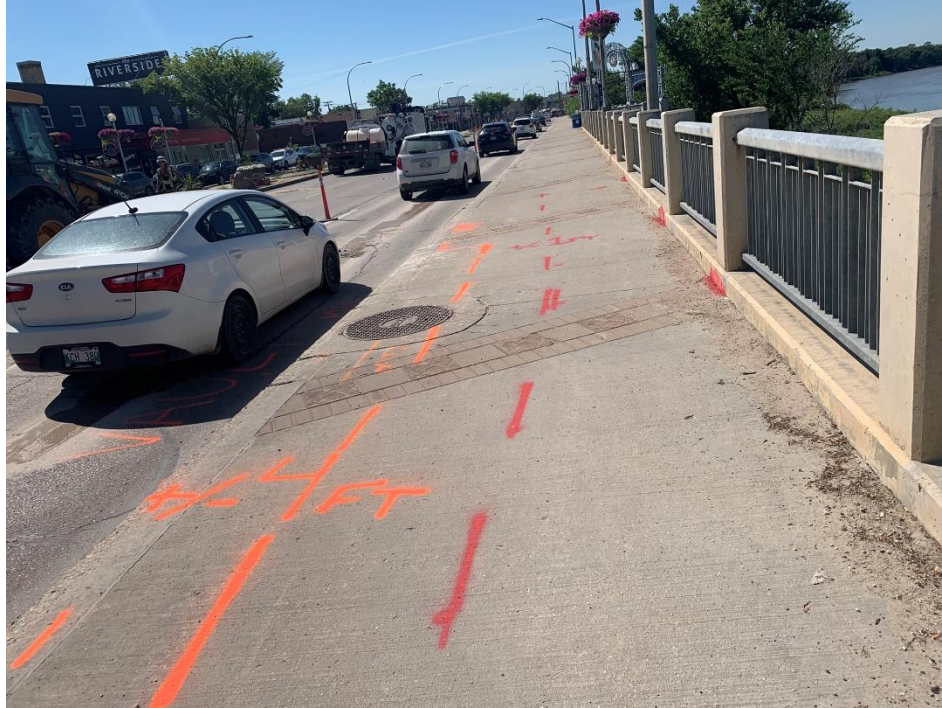
Photo 5: Looking south on St. Mary's. Utilities marked out on sidewalk (July 29, 2022)

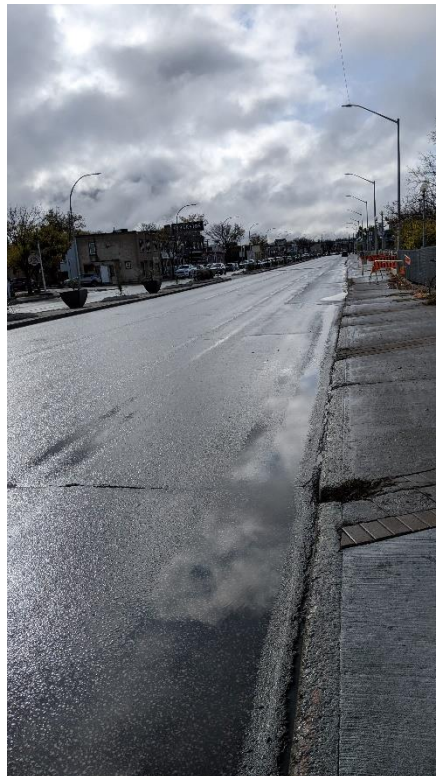
Photo 6: Looking south on St. Mary's at closed sidewalk segment after a rain event. CB at failure not low spot with ponding occurring in gutter (October 14, 2022)

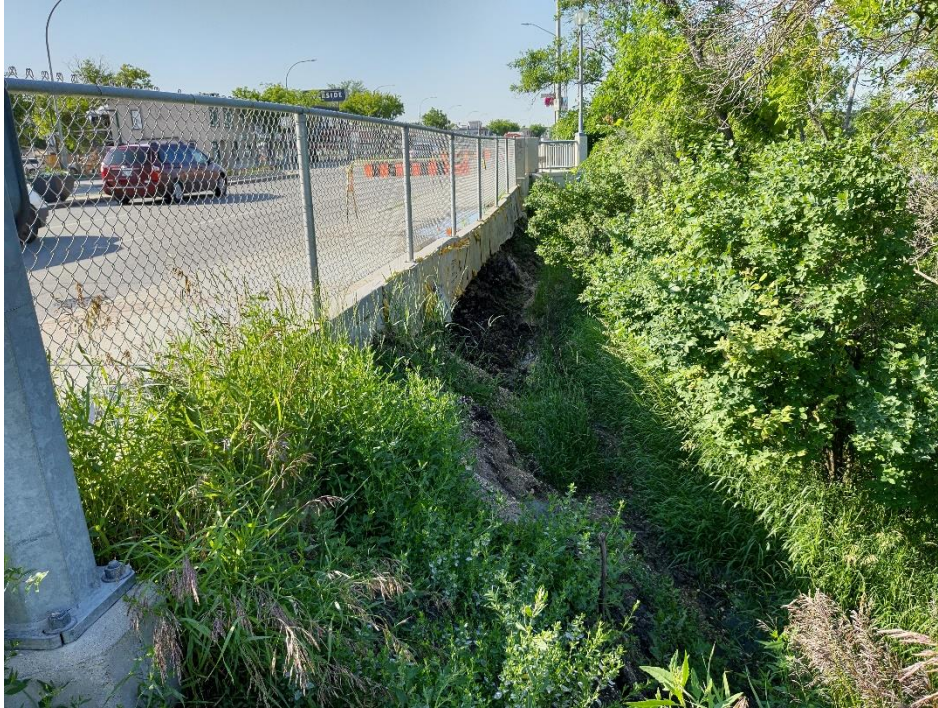
Photo 7: Looking south on St. Mary's at closed sidewalk segment. Significant undermining (July 12, 2022)

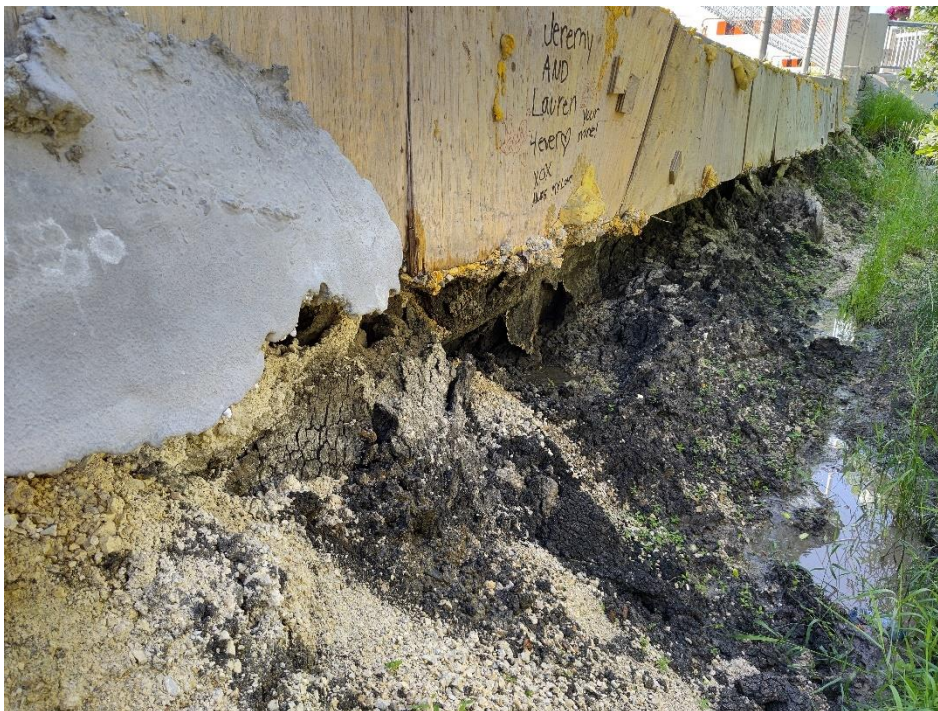
Photo 8: Close-up view of upper bank failure undercutting the sidewalk (July 12, 2022)

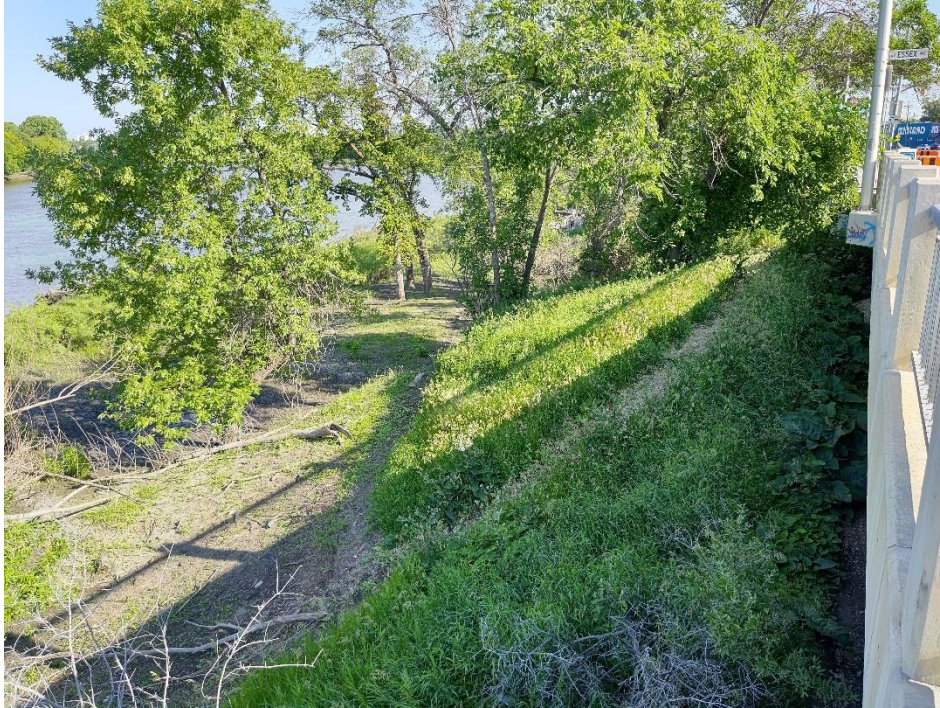
Photo 9: Looking downstream at the top of bank near the upstream edge of the project area (July 12, 2022)

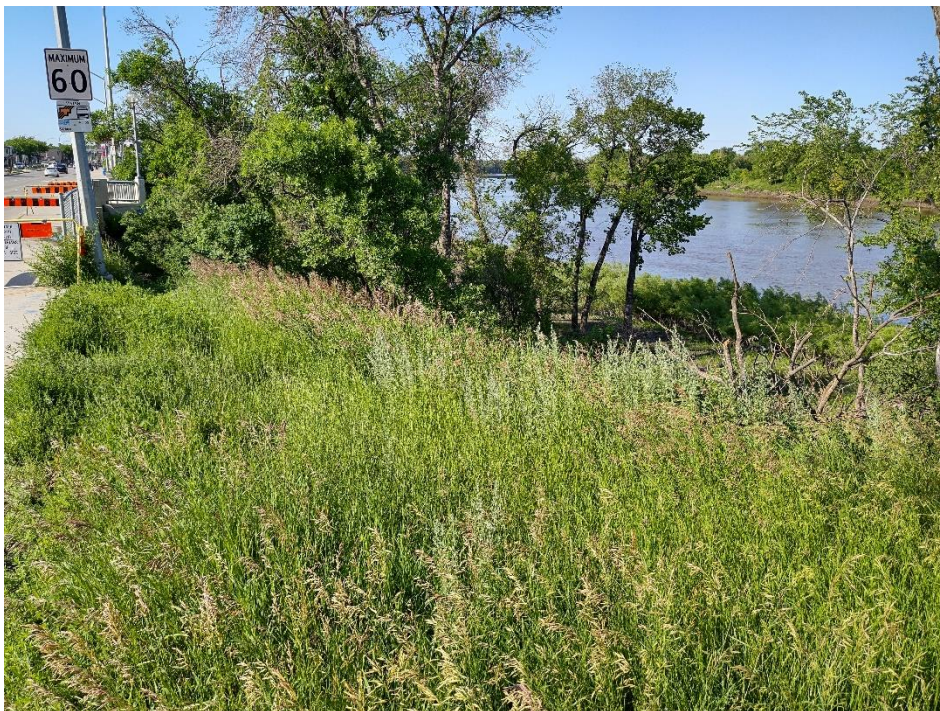
Photo 10: Potential site access. Looking upstream at the top of the bank showing the barricaded failed sidewalk (July 12, 2022)

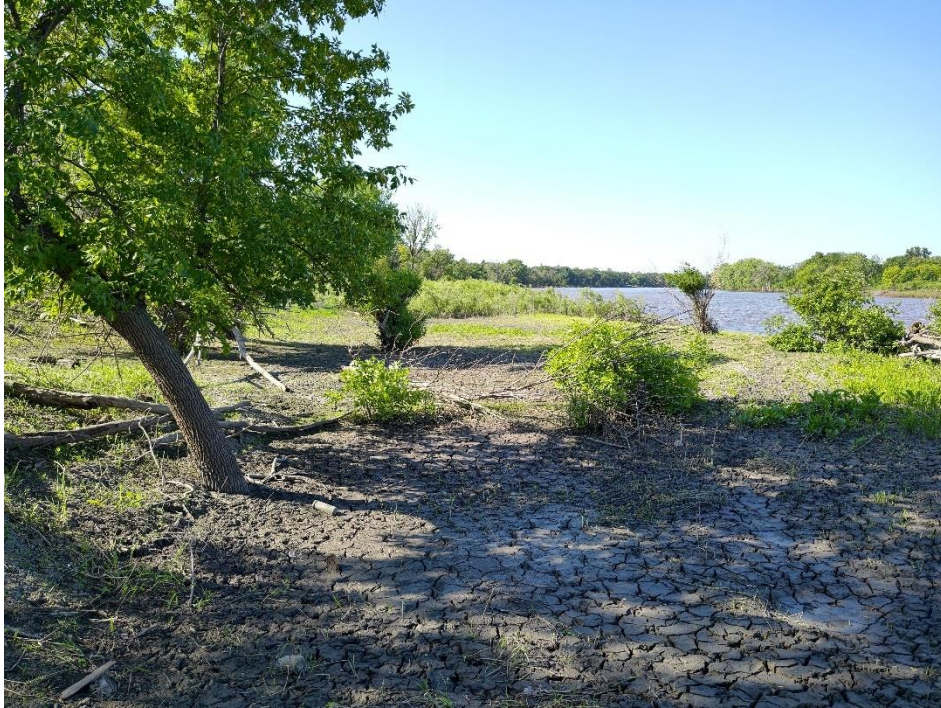
Photo 11: Looking upstream at mid-bank (approx. OHWM) near the upstream edge of the project area (July 12, 2022)

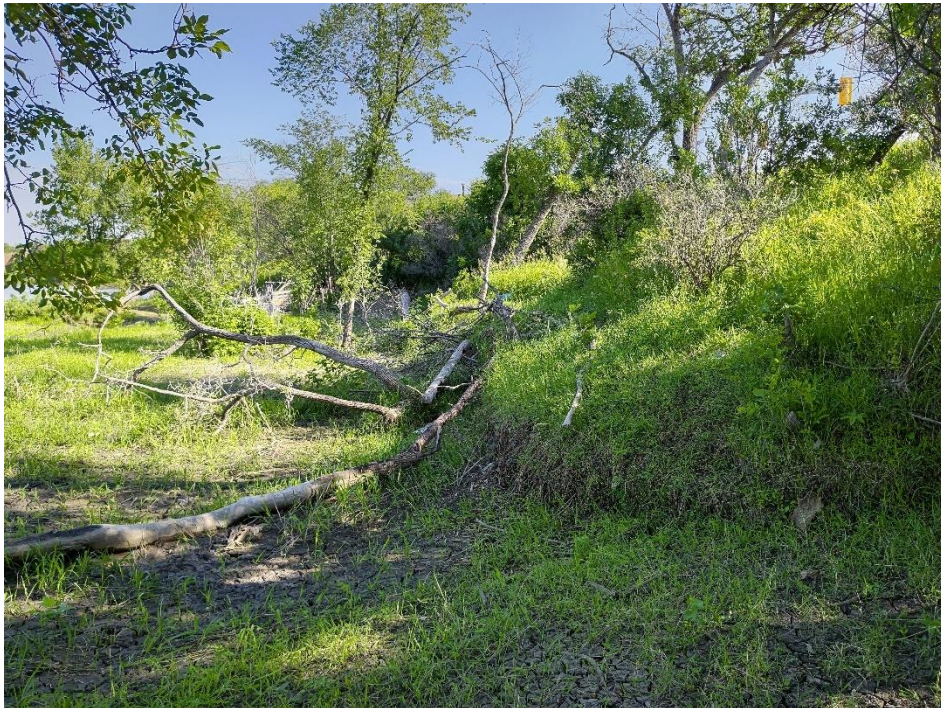
Photo 12: Looking downstream at mid-bank (approx. OHWM) near the middle of the project area (July 12, 2022)

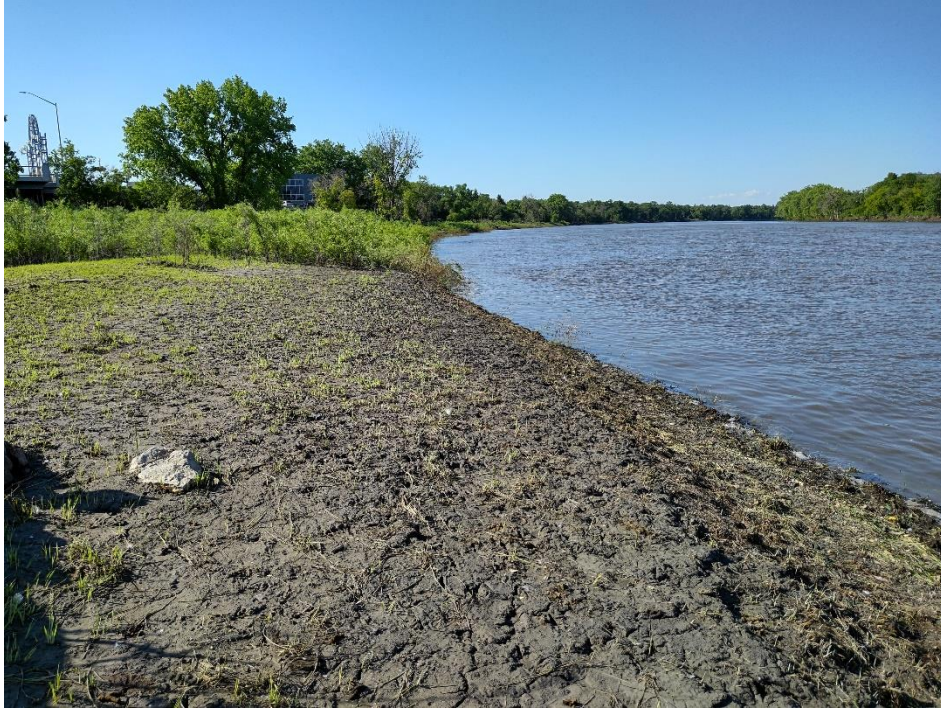
Photo 13: Looking upstream at toe of bank (water approx. 224 m) near the upstream edge of the project area (July 12, 2022)

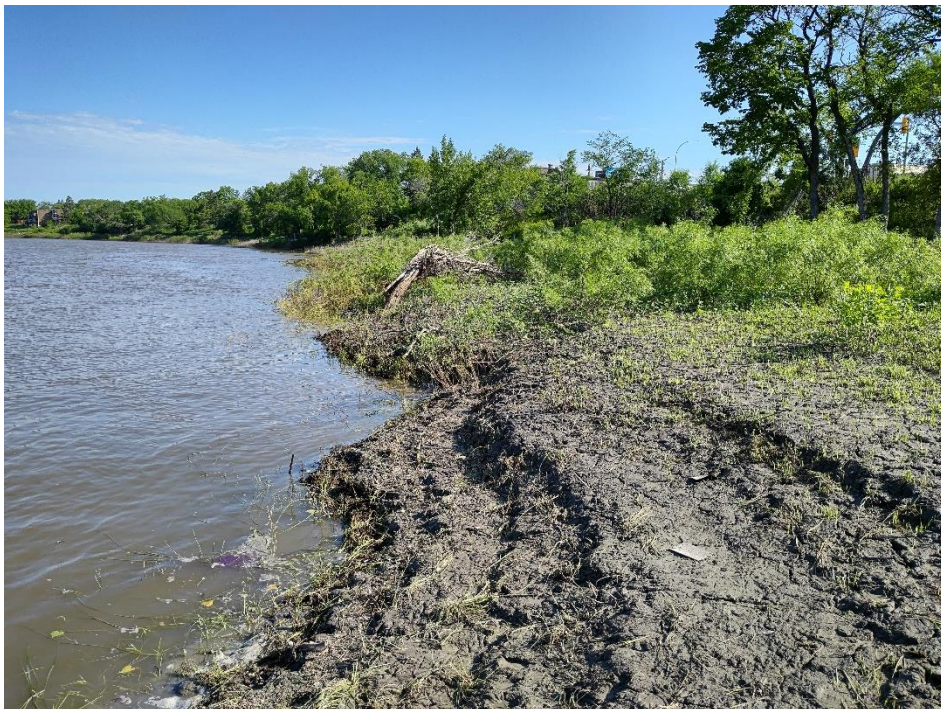
Photo 14: Looking downstream at toe of bank (water approx. 224 m) near the upstream edge of the project area (July 12, 2022)

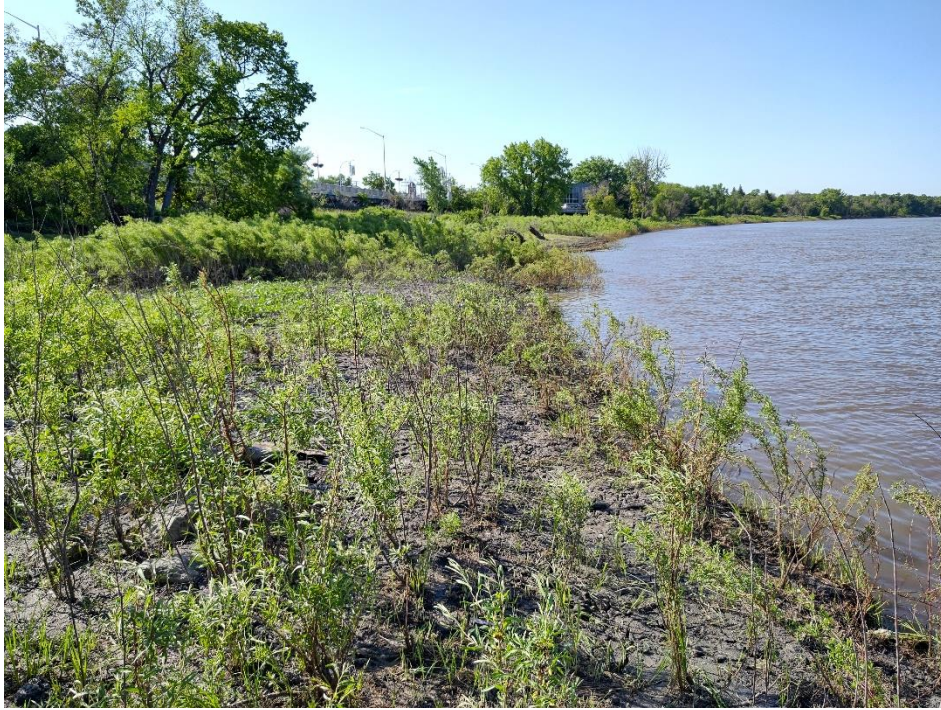
Photo 15: Looking upstream at toe of bank (water approx. 224 m) near the downstream edge of the project area (July 12, 2022)

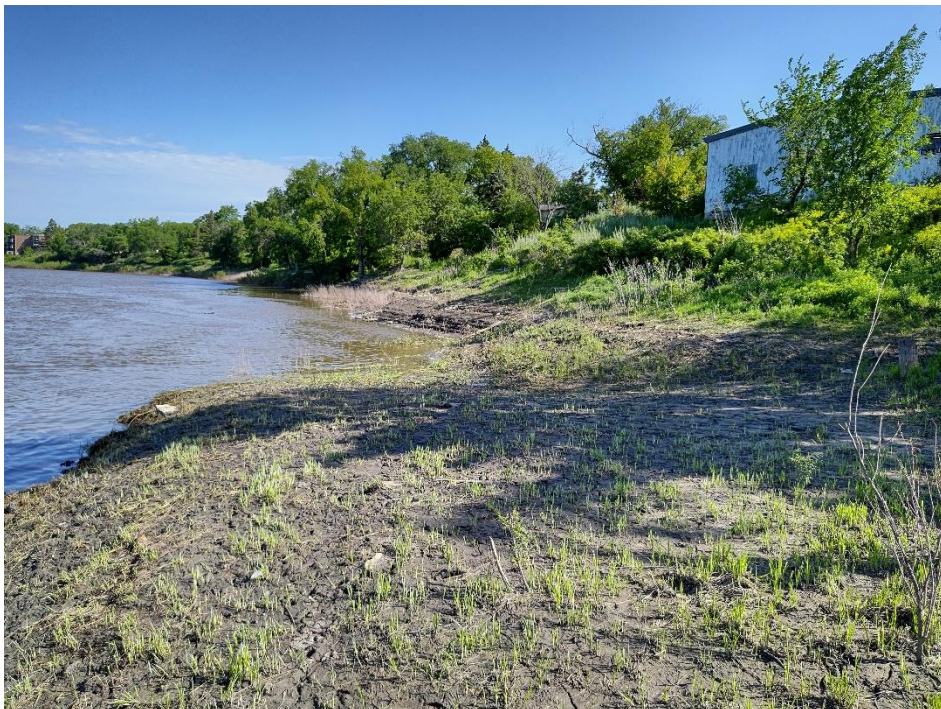
Photo 16: Looking downstream at toe of bank (water approx. 224 m) near the downstream edge of the project area (July 12, 2022)

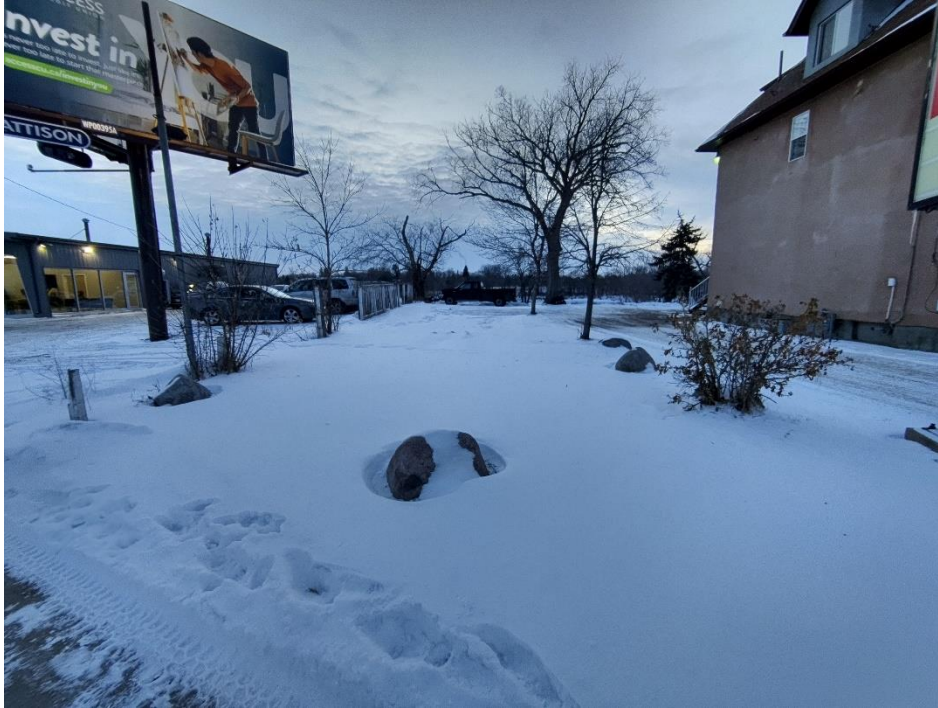
Photo 17: Location of top of construction access ramp at 480 St. Mary's Road. (December 1, 2022)

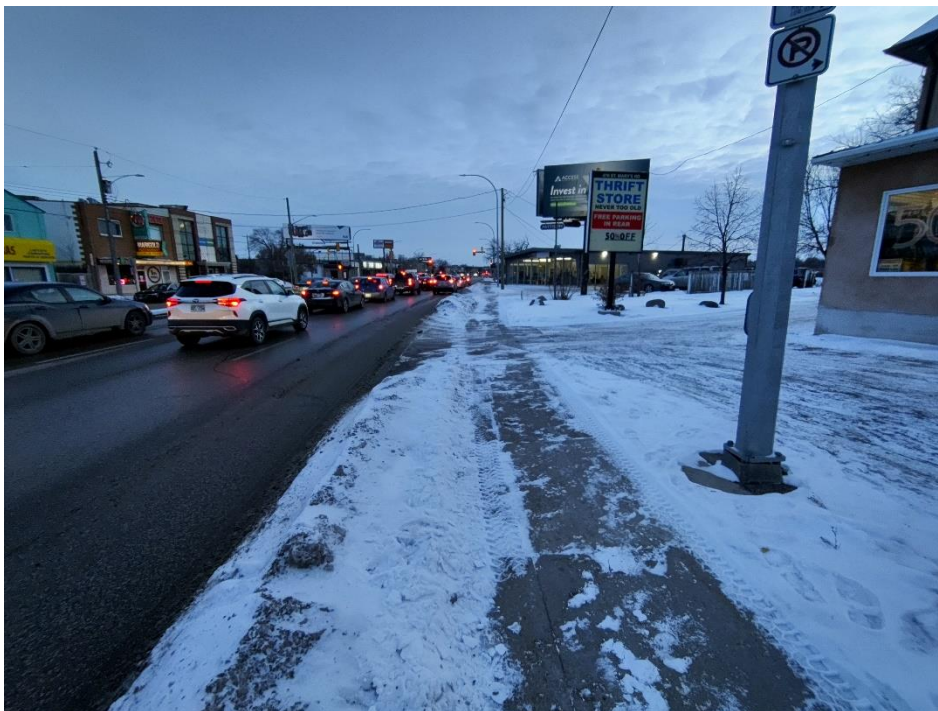
Photo 18: Looking south near top of construction access ramp. Caution must be exercised around existing signs and utilities (December 1, 2022)

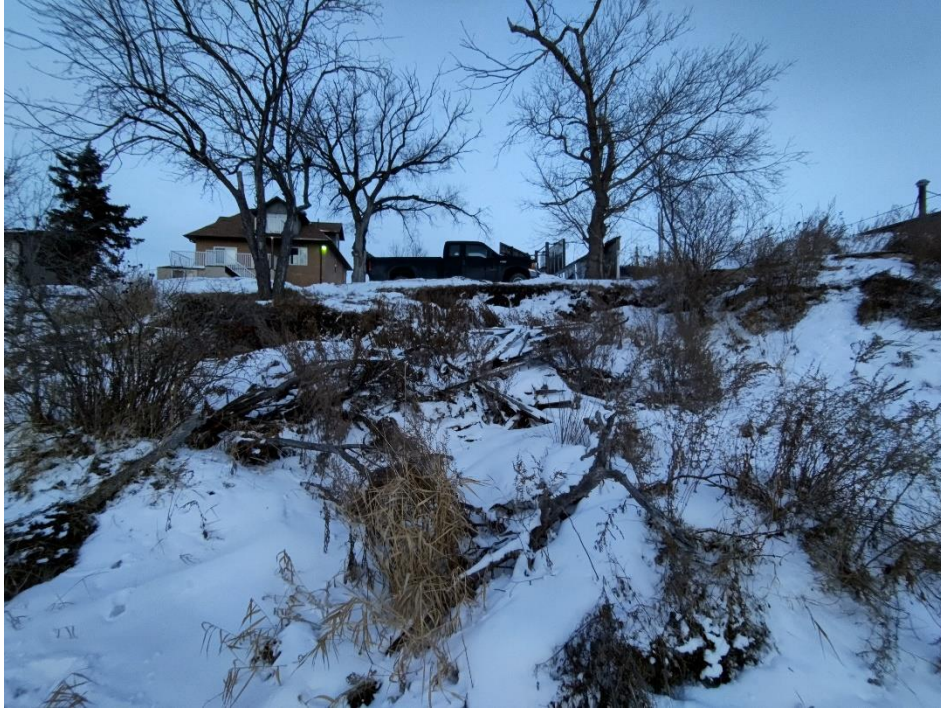
Photo 19: Looking upslope from bottom of construction access ramp. Site must be secured with fencing. Refer to tree protection specifications. (December 1, 2022)

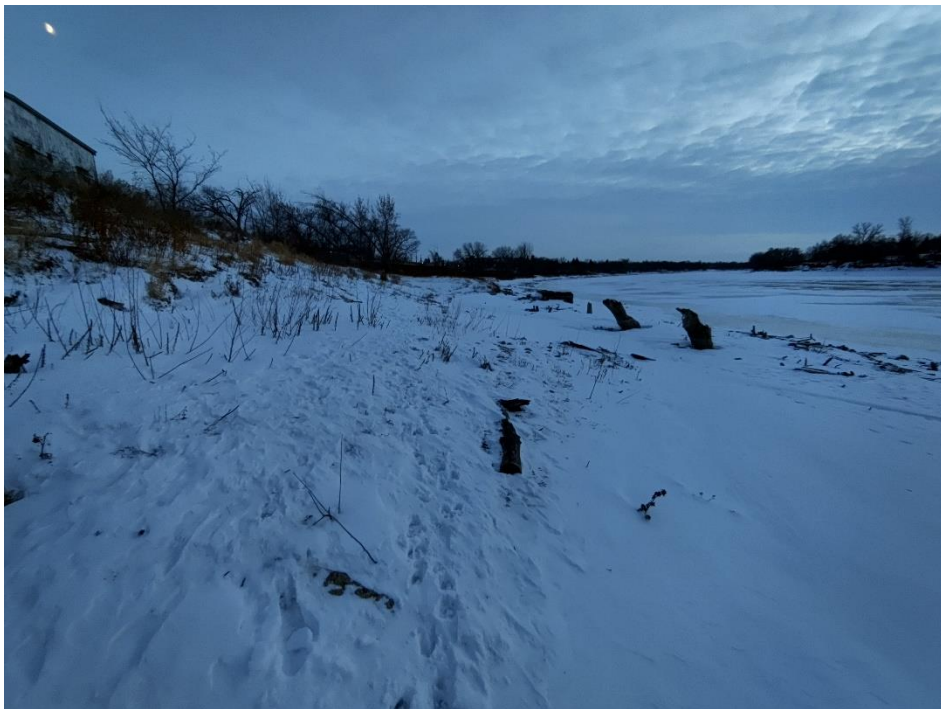
Photo 20: Looking upstream from bottom of construction access ramp. (December 1, 2022)

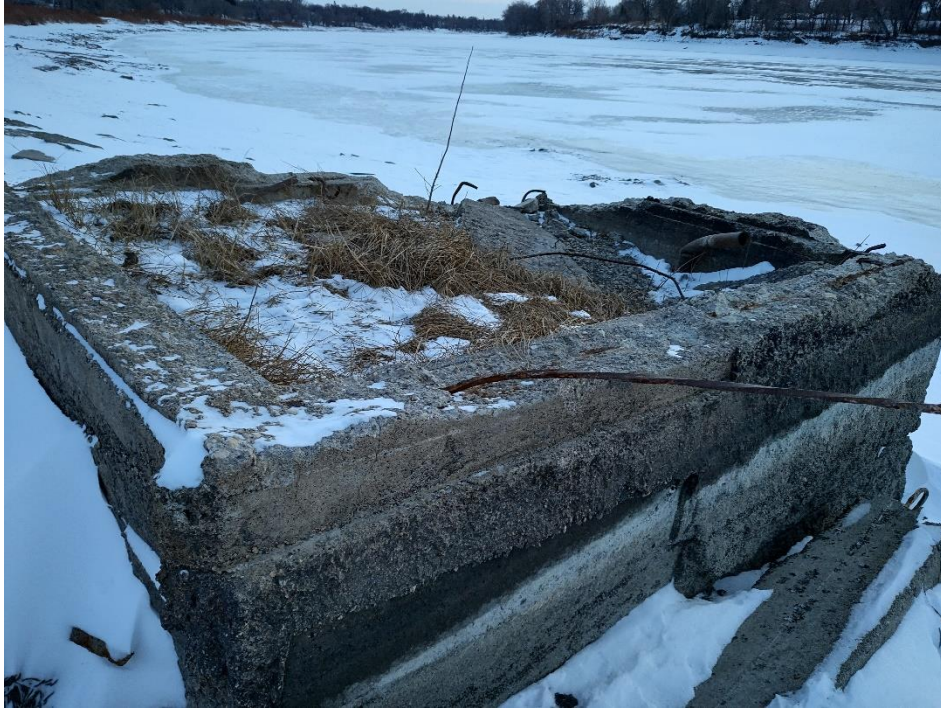
Photo 21: Old concrete block (to be removed) marks the downstream limit of riprap (refer to drawings for details). (December 1, 2022)

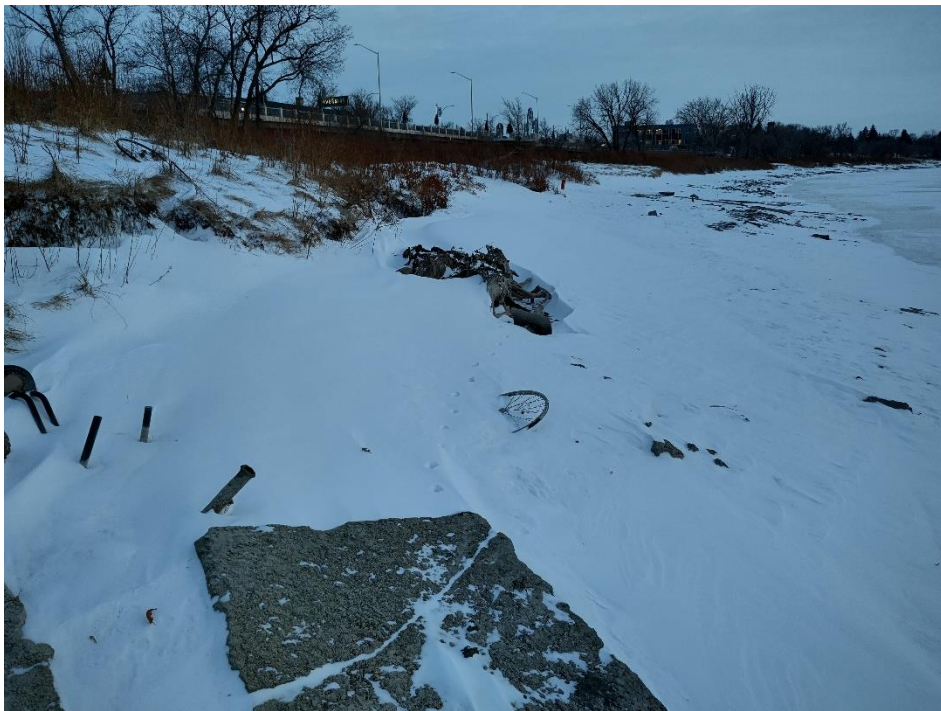
Photo 22: Looking upstream from old concrete block (to be removed). (December 1, 2022)

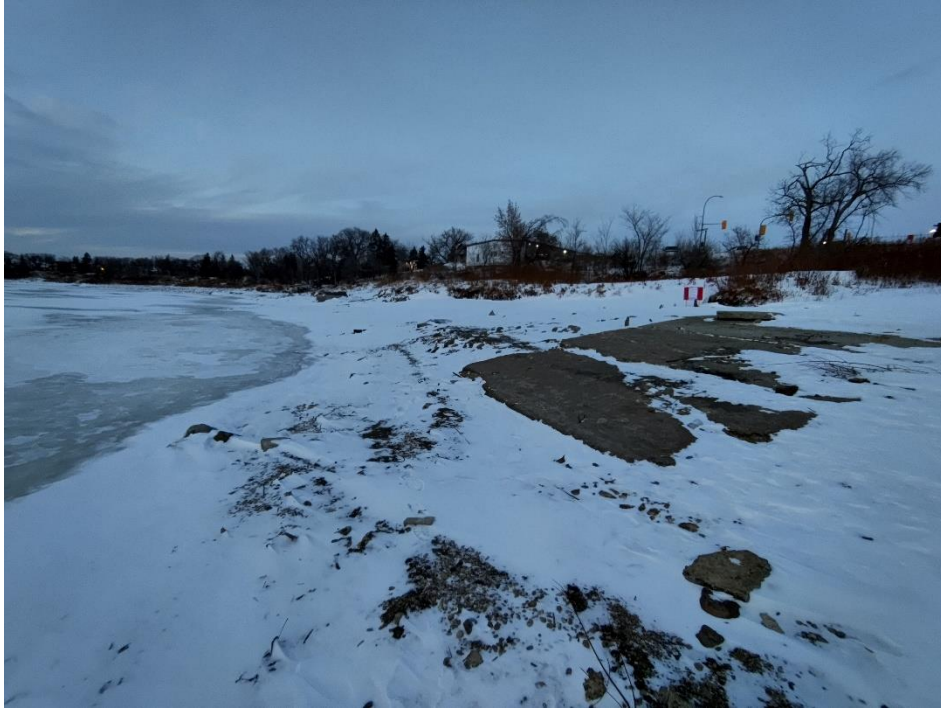
Photo 23: Looking downstream from concrete slab (old boat launch to be removed) . (December 1, 2022)

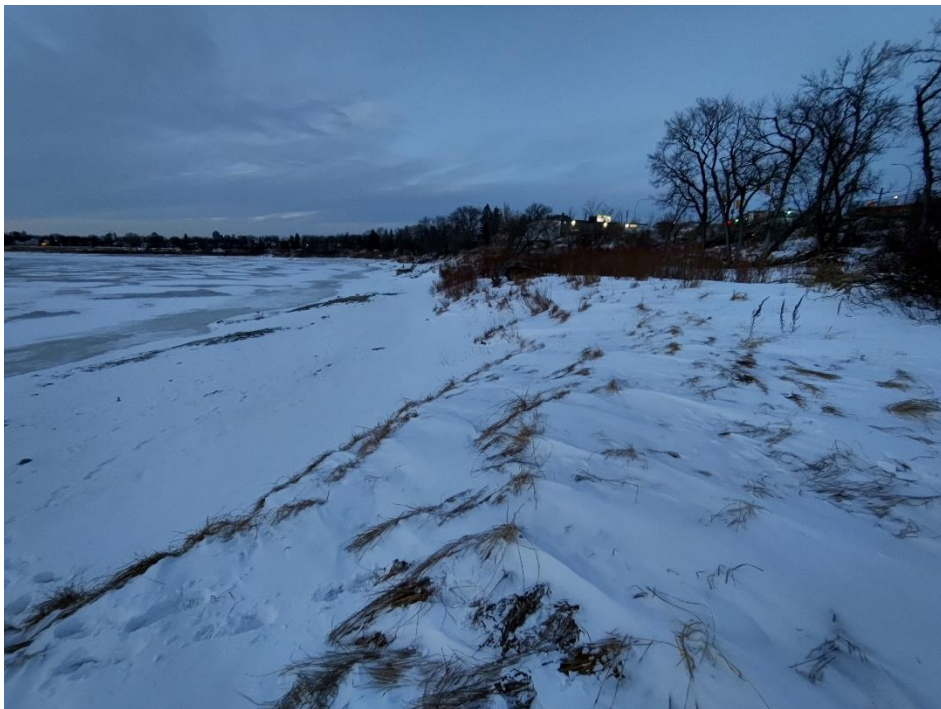
Photo 24: Looking downstream at toe of riverbank (water approx. 222 m) (December 1, 2022)
