May 1, 2015

File No. 14-0107-036

RE: Alexander Dock  
Inspection and Condition Assessment, Final – Rev 0

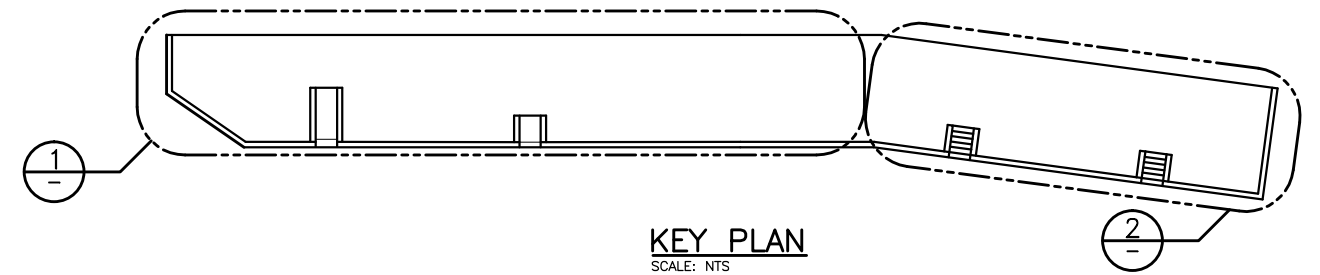
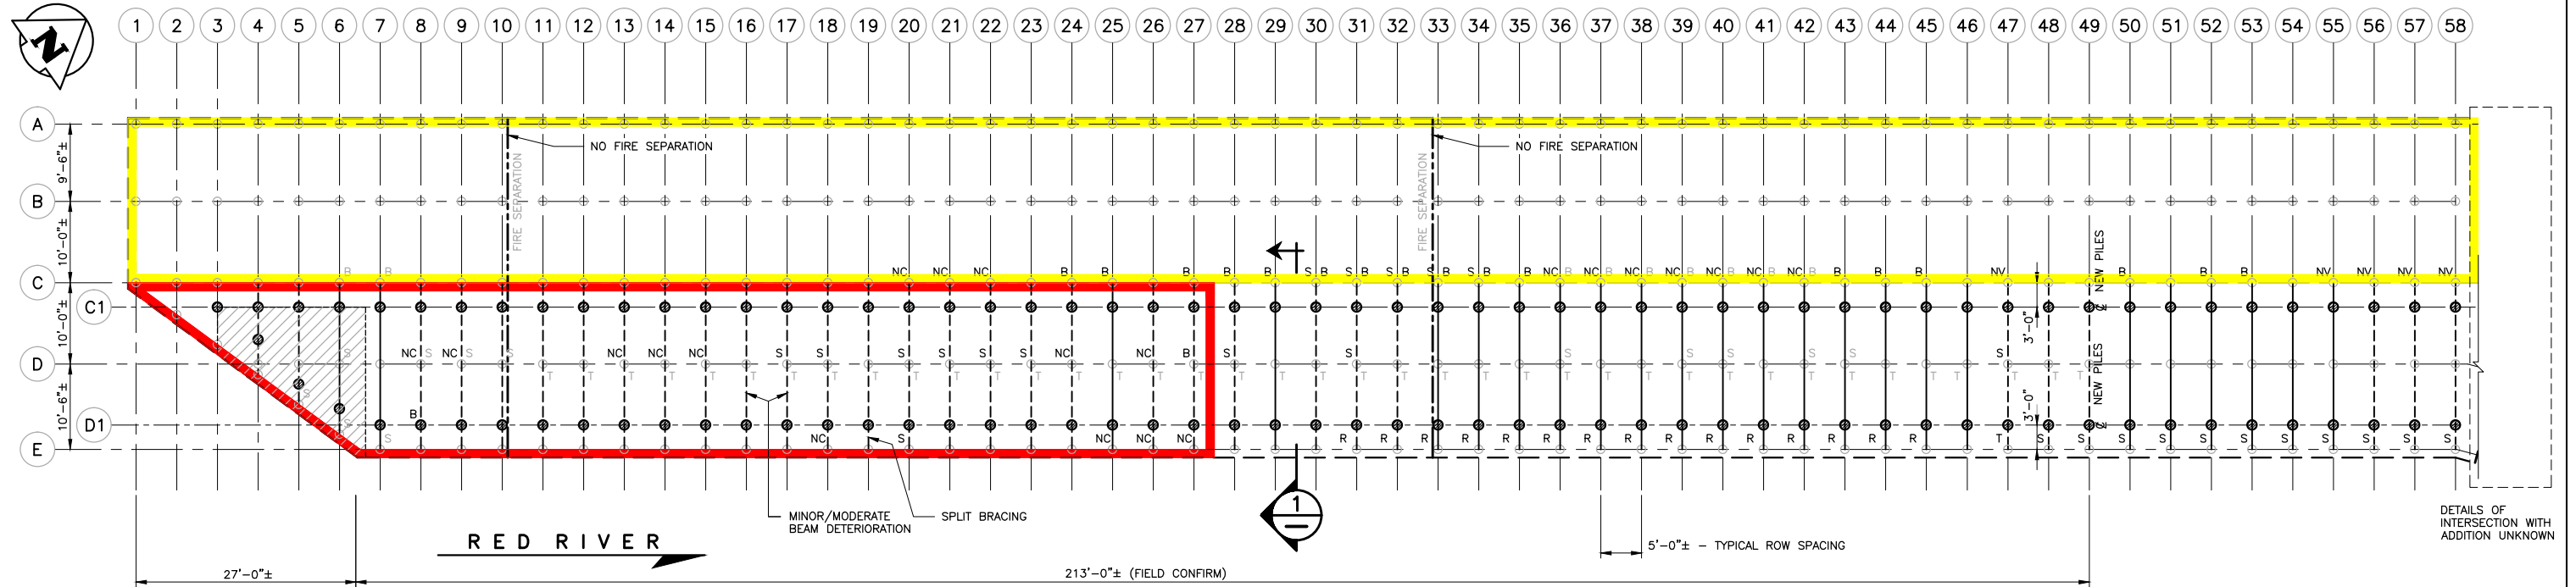
A	15/02/27	ISSUED FOR INFORMATION	RM
NO.	YY/MM/DD	DESCRIPTION	BY
REVISIONS / ISSUE			
<b>KGS GROUP</b> CONSULTING ENGINEERS		THE CITY OF WINNIPEG PLANNING AND PROPERTY DEVELOPMENT DEPT.	
ALEXANDER DOCK			
CONDITION ASSESSMENT PLAN			
FEBRUARY 2015		FIGURE 1	
			REV: <b>A</b>

The visual inspection of the structure was performed by Mr. N. Kyriakopoulos, P.Eng. The inspection was planned in two stages with the top side assessment to be completed in late fall of 2014, before winter snow would cover the large deck surface and a second underside inspection to be conducted once river levels dropped to seasonal lows and riverbank ground freezing allowed safe access. The inspection of the top surface of the timber deck and waterside skirting of the Alexander Dock was performed on November 5, 2014. The inspection of the accessible areas of the underside of the timber deck and substructure was performed on February 6, 2015. Figure 1 summarizes the assessment observations for the underside inspection.

deterioration in wet conditions. The approximate lengths of deterioration are provided in Figure 1.

In general, the original timber piles were in poor to severely deteriorated condition while the timber piles installed during the 2004 rehabilitation were still in good condition. The dock structure is supported on 451 timber driven piles as shown on Figure 1. Of these, only 164 are visible for inspection. 287 of the 451 are mostly or entirely encased in the riverbank and not accessible for a condition assessment. Of the 164 piles inspected, approximately 55% are no longer supporting the structure as intended with a summary of compromised condition as follows:

- Photo 21 displays the typical condition of the piles installed after the 2001 KGS Group report and the 2004 rehabilitation work.
- Several piles were found to be significantly inclined (Photo 22). These piles are marked with a "T" on Figure 1.
- Several piles were also found to be split, to varying degree. Photo 23 displays a typical split pile. These piles are marked with a "S" on Figure 1.

- If no corrective actions are taken to rectify the deficient areas, the City of Winnipeg should consider closing off the dock structure. The City of Winnipeg may consider the implementation of "loading lanes" for riverboat operation that could be cordoned off on the dock, such that the deteriorated areas outlined on Figure 1 are not accessible. The location and details of access corridors would require further evaluation.

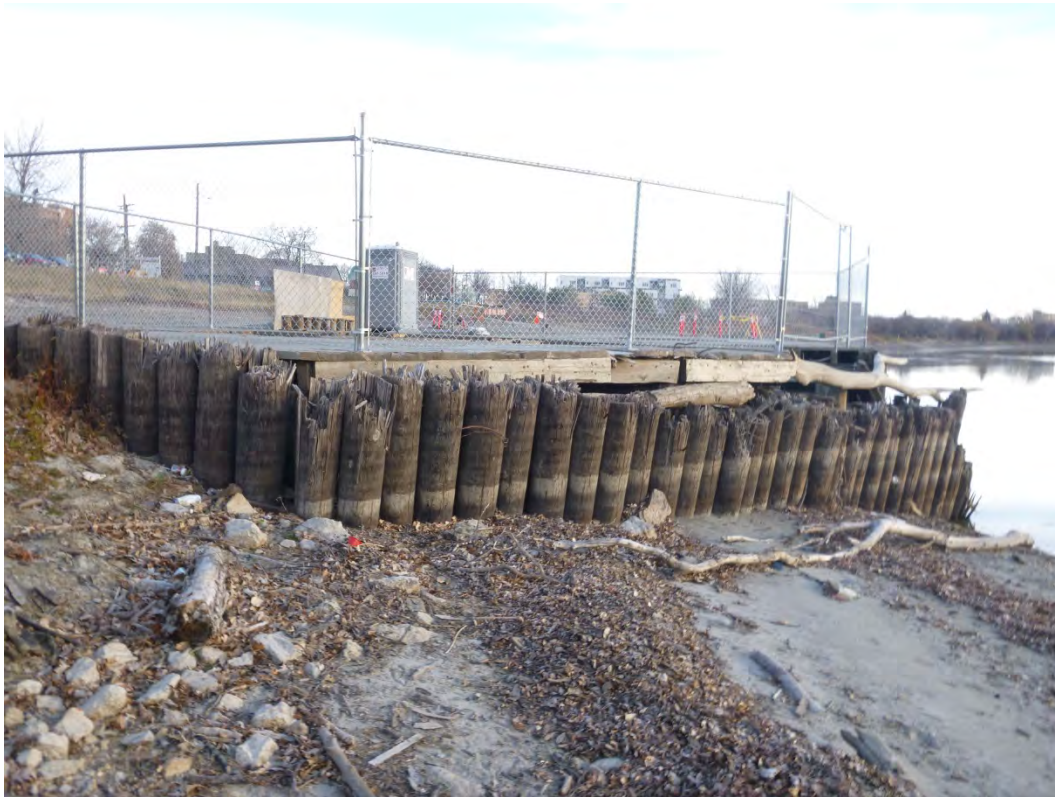
- Photo 1 displays the extent of the ice damage on the upstream end of the dock. This portion of the structure is severely damaged.
- Photo 2 is an overview of the waterside skirting along the structure. It can be seen that large areas of the waterside skirting has been damaged due to river-ice impact and long term

**Photo 1 – South waterside skirting damage due to river ice**

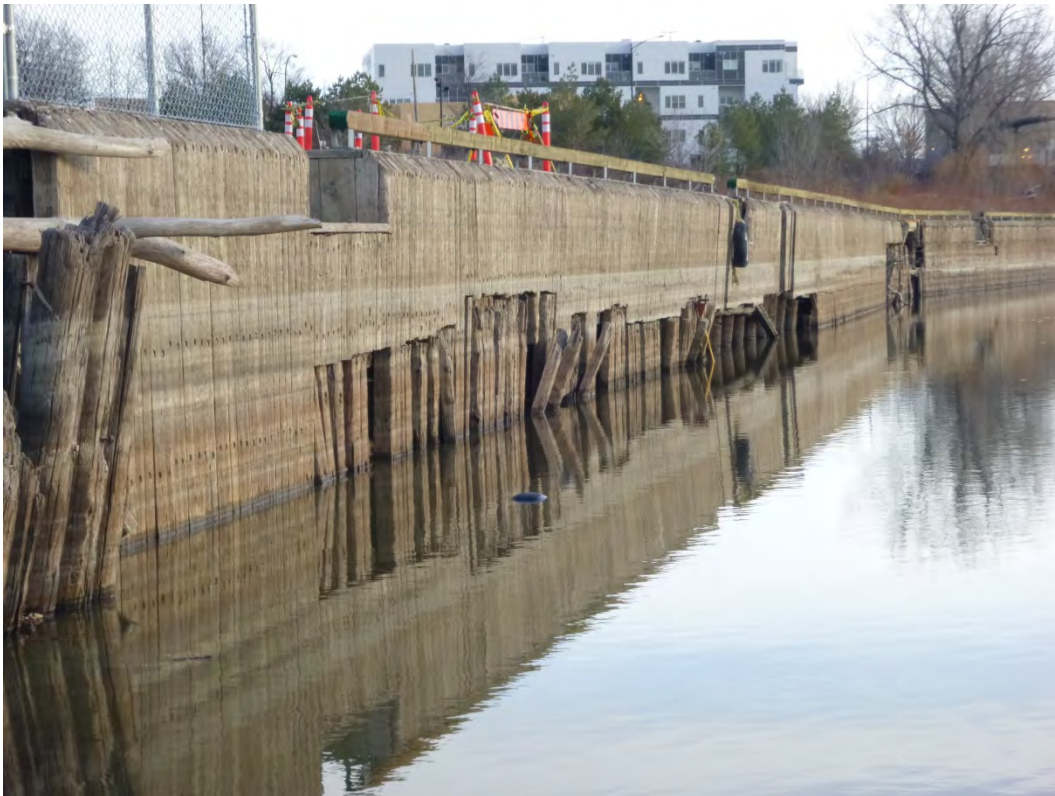
**Photo 2 – East waterside skirting damage due to river ice erosion**

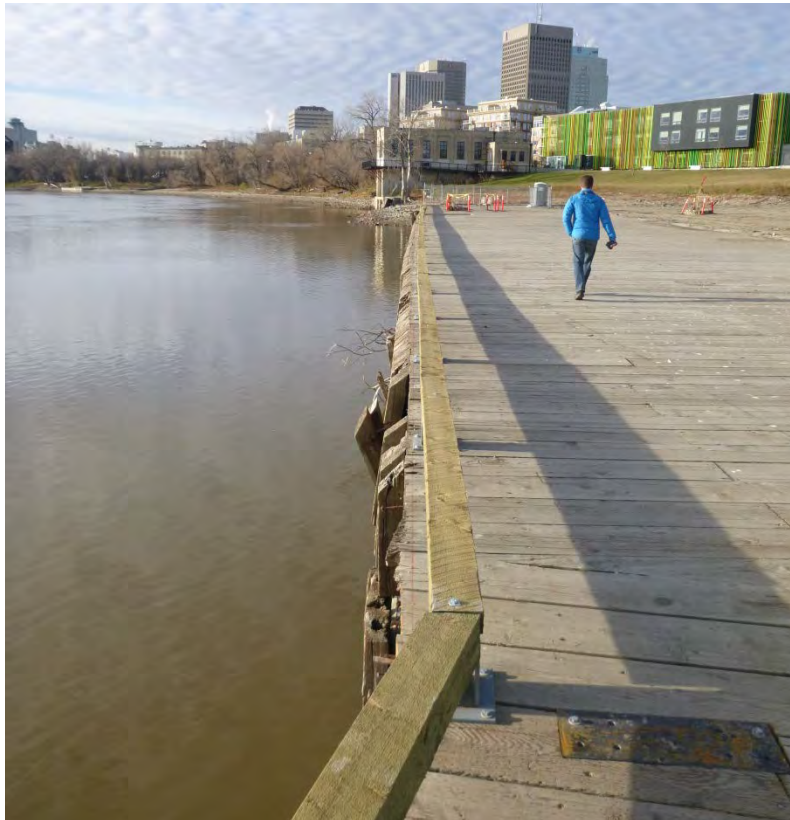
- Photo 3 shows the general deflection (or bulging) near the middle of Section 1, likely the result of historical riverbank movement. This movement was noted in previous reports and does not appear to have visibly advanced since the dock structure was last rehabilitated. However, due to the tolerance of the wood structure construction and damage to localized areas, meaningful survey of the structure alignment to compare with the previous assessment was not possible.
- Photo 4 displays the extent of the ice damage along the South half of the skirting.
- Photo 5 shows the North face of Section 2 with damage in the upper left corner, likely the result of long term rot and disintegration.

**Photo 3 – Longitudinal view of Section 1 skirting showing horizontal deflection**

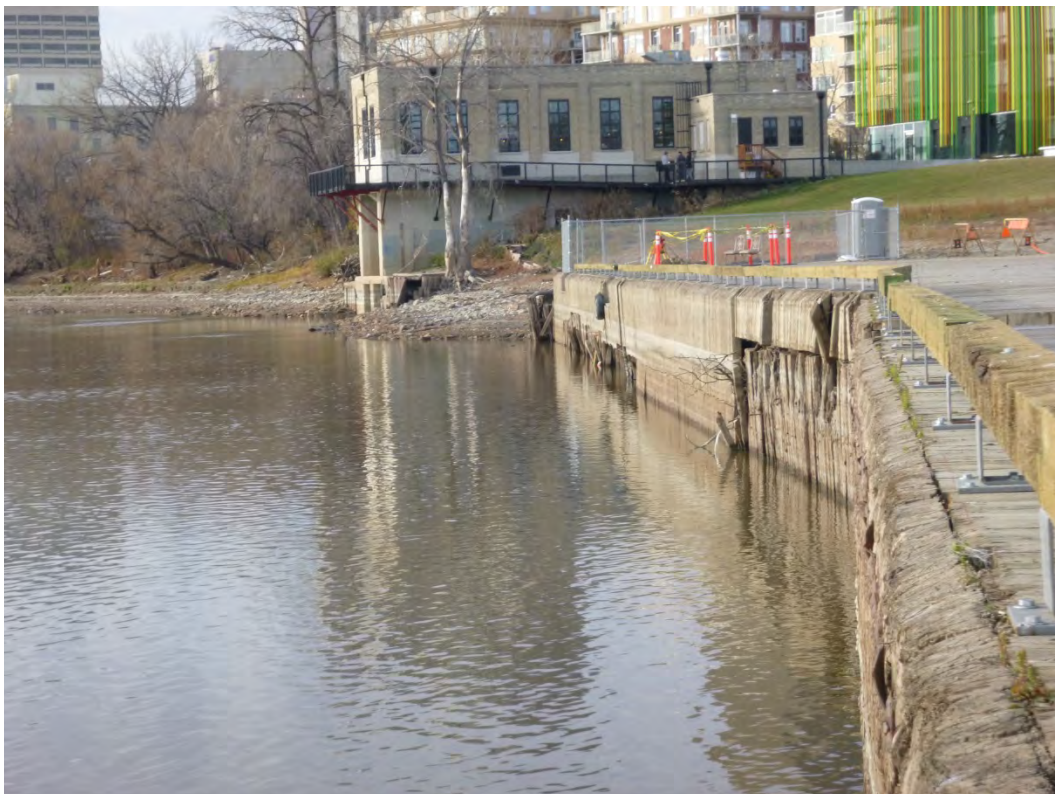
**Photo 4 – View of deteriorated waterside skirting from the North end of Section 2**

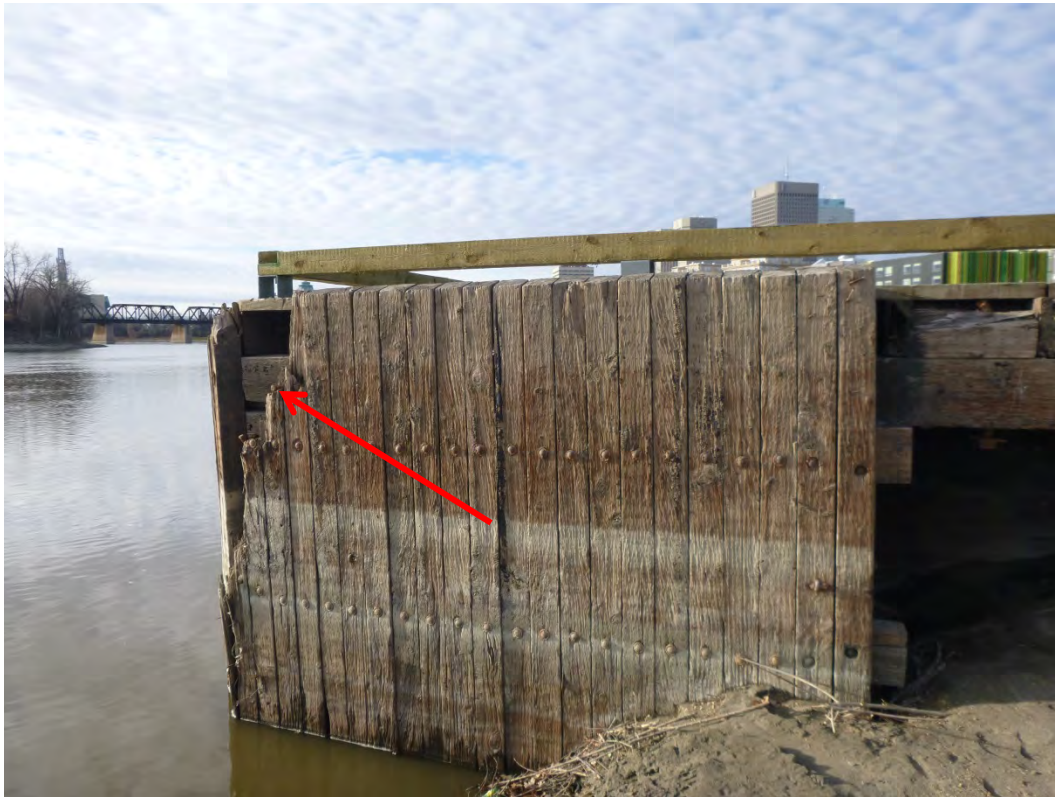
**Photo 5 – North face of Section 2 with damage in upper left corner**

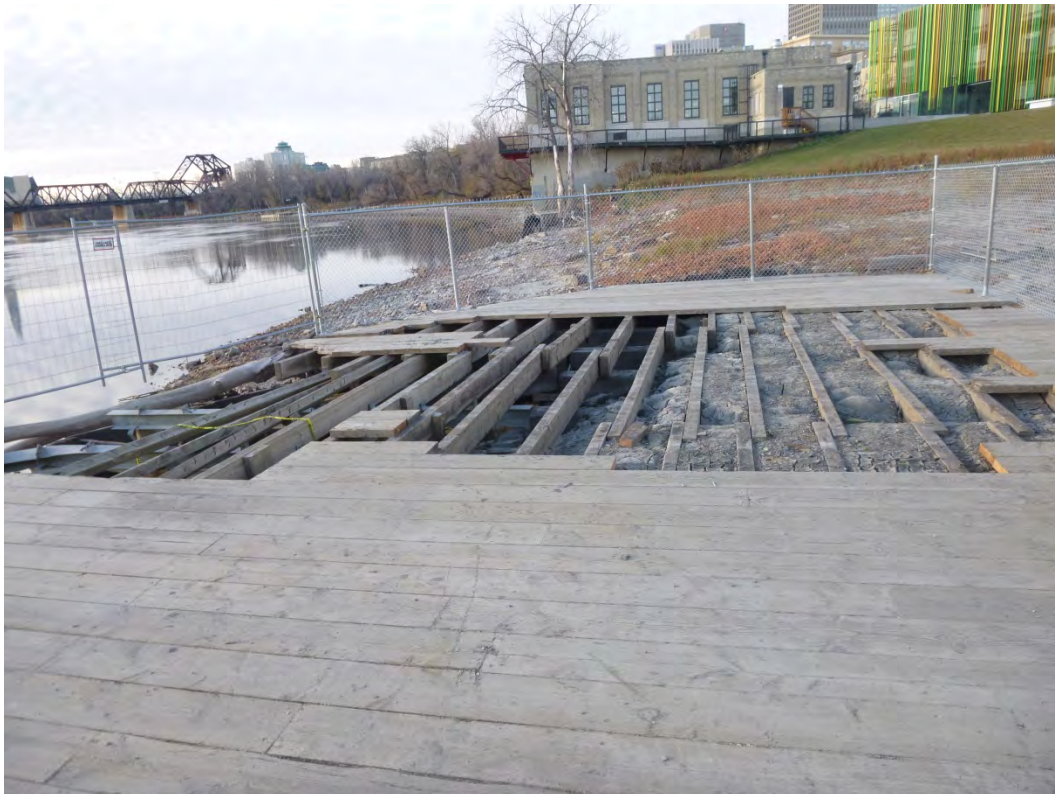
- Photo 6 shows the South end of the deck where several planks have been recently removed for remedial works. The exposed area shows that nearly half of the deck width is resting directly on the embankment material while the other half-width is supported by the deck stringer beams. In the upper riverbank areas it is not possible to determine the condition of beams and piles encased in the riverbank.

**Photo 6 – South end of deck with exposed area for remedial works**

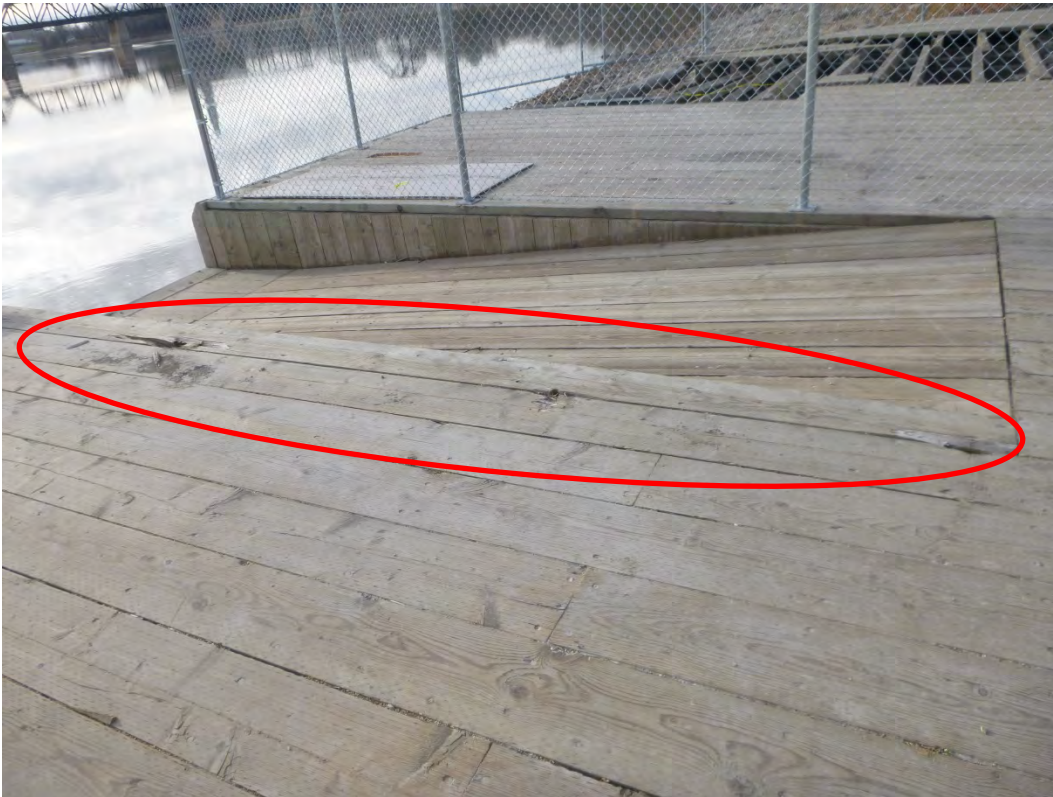
- Photo 7 identifies two planks adjacent to the Southern-most slipway that require replacement. The boards have developed notches that present trip hazards.

**Photo 7 – Two planks adjacent to South slipway that require replacement**

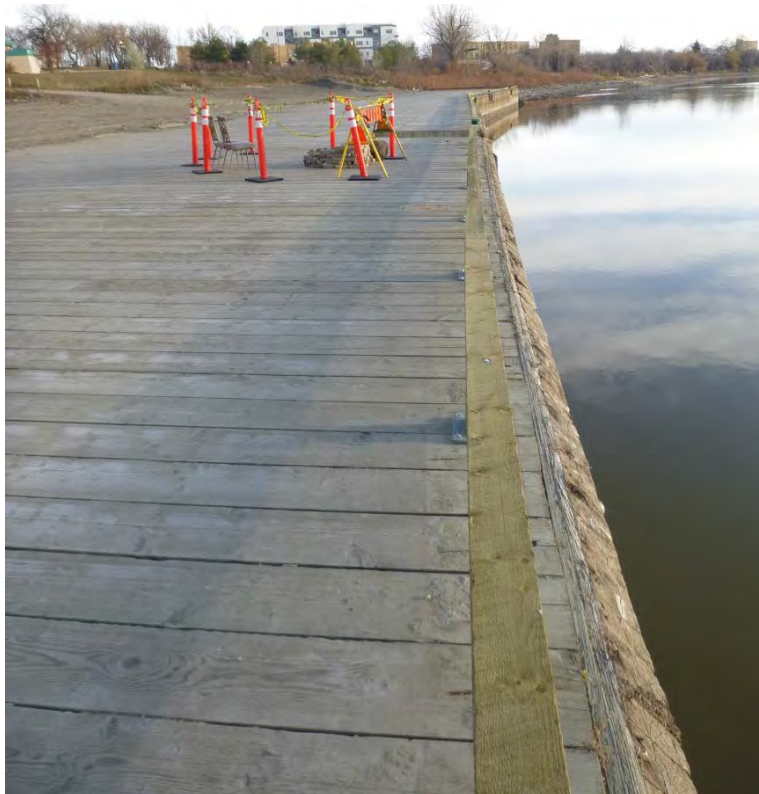
- Photo 8 presents an overall view of the deck just North of the Southern-most slipway. This overall view displays the generally good condition of the deck timbers and the recently replaced perimeter timber curb.

**Photo 8 – Overall view of deck looking north; taken just north of South Slipway**

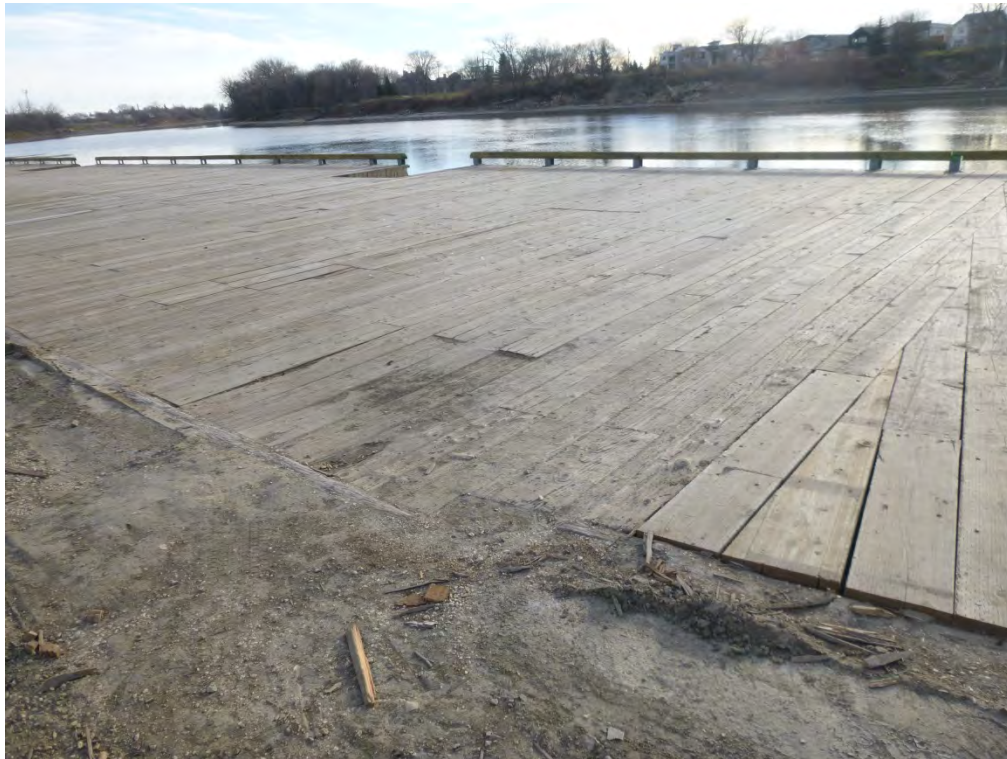
- Photo 9 identifies a depressed area, of approximately 4 m in diameter, where the deck planks, or their supporting structure, have deteriorated (softened) and settled. This deck area is likely no longer supported on structurally sound stringers, beam and/or piles.

**Photo 9 – Area of depressed and deteriorated planks opposite bend marking transition between Section 1 and Section 2, approximately 4.5 m in diameter**

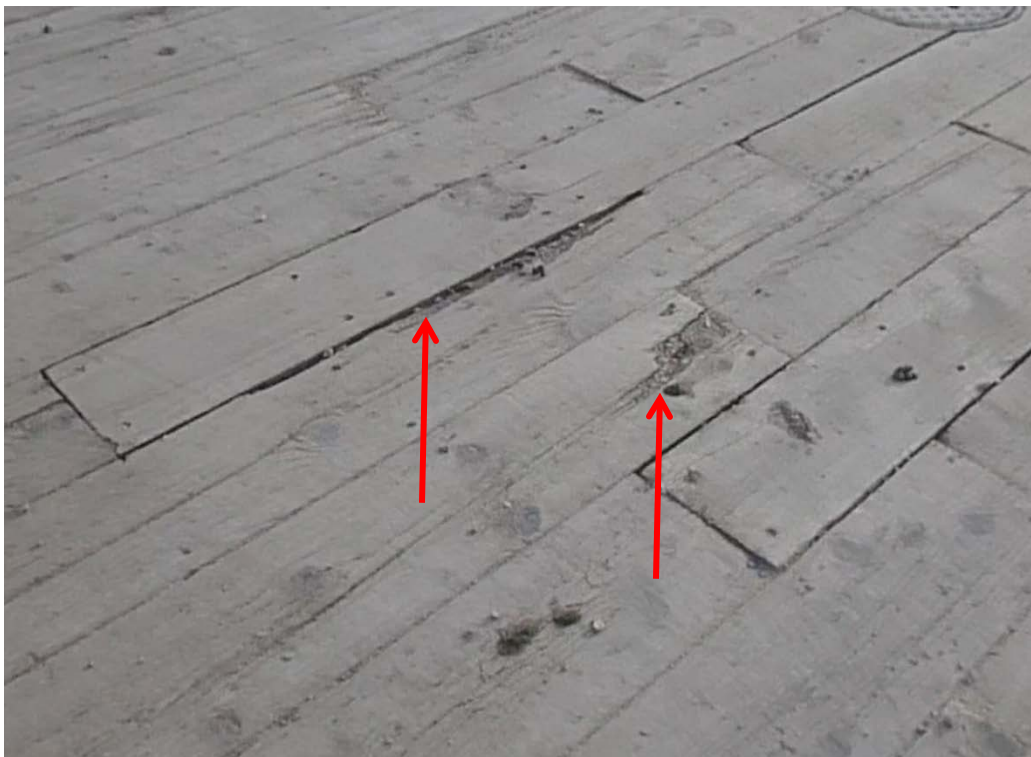
- Photo 10 displays a localized example of planks that have deteriorated and developed notches that present trip hazards. There are approximately a dozen instances of similarly-deteriorated planks throughout the structure.

**Photo 10 – Plank deterioration resulting in a trip hazard near the Section 1 / Section 2 transition**

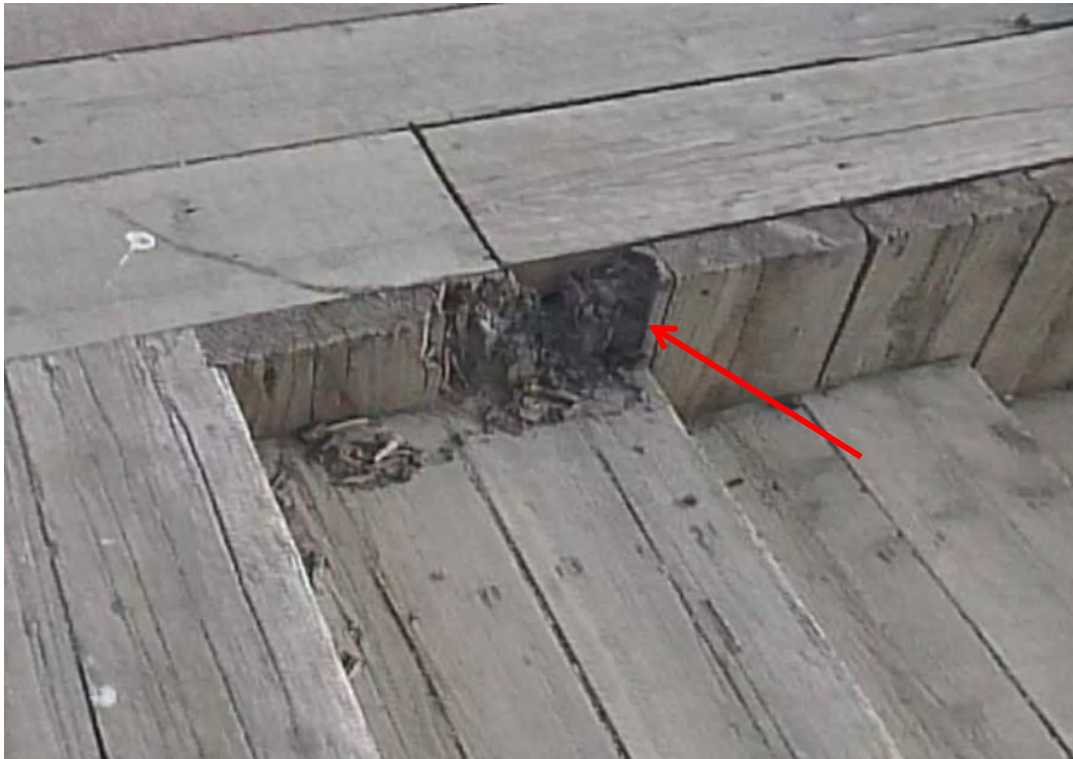
- Photo 11 displays a non-structural side-plank of the Southern Section 2 slipway that may present a trip hazard.

**Photo 11 – Deteriorated plank at southern Section 2 slipway**

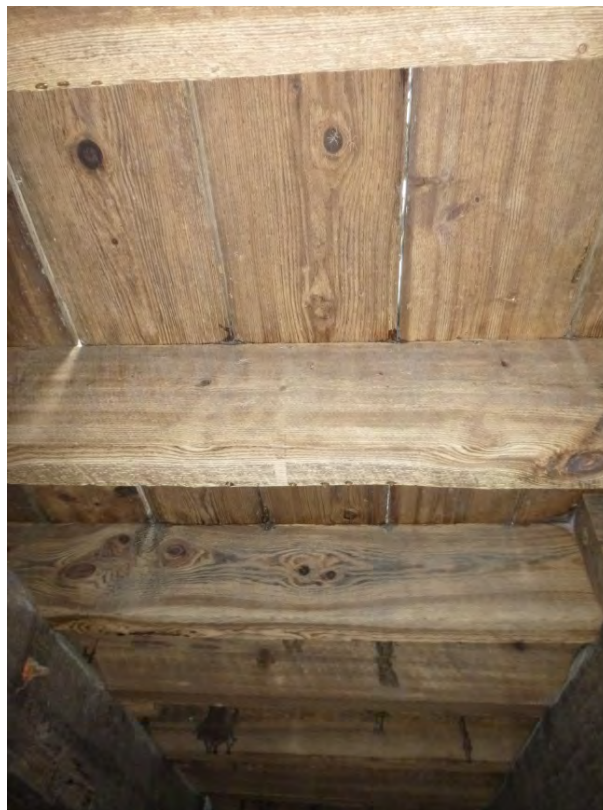
In general, the deck and the stringers (that were visible) were all in fair to good condition. No visible deterioration or warping was noticed. Photo 12 shows a typical view of the underside of the deck with stringers. Nearly half (the West side) of the dock supporting structure including stringers, beams and piles is encased in the riverbank and not visible for inspection.

**Photo 12 – Typical underside view of decking and stringers**

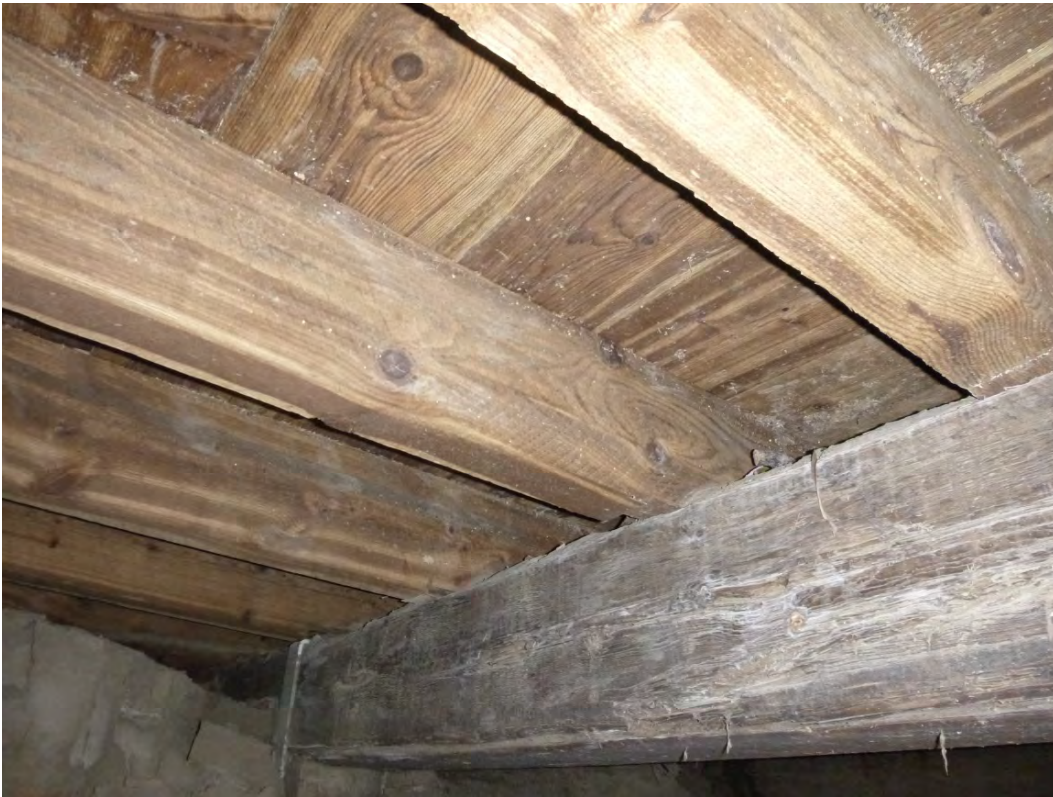
**Photo 13 – Typical condition of timber pile cap beam**

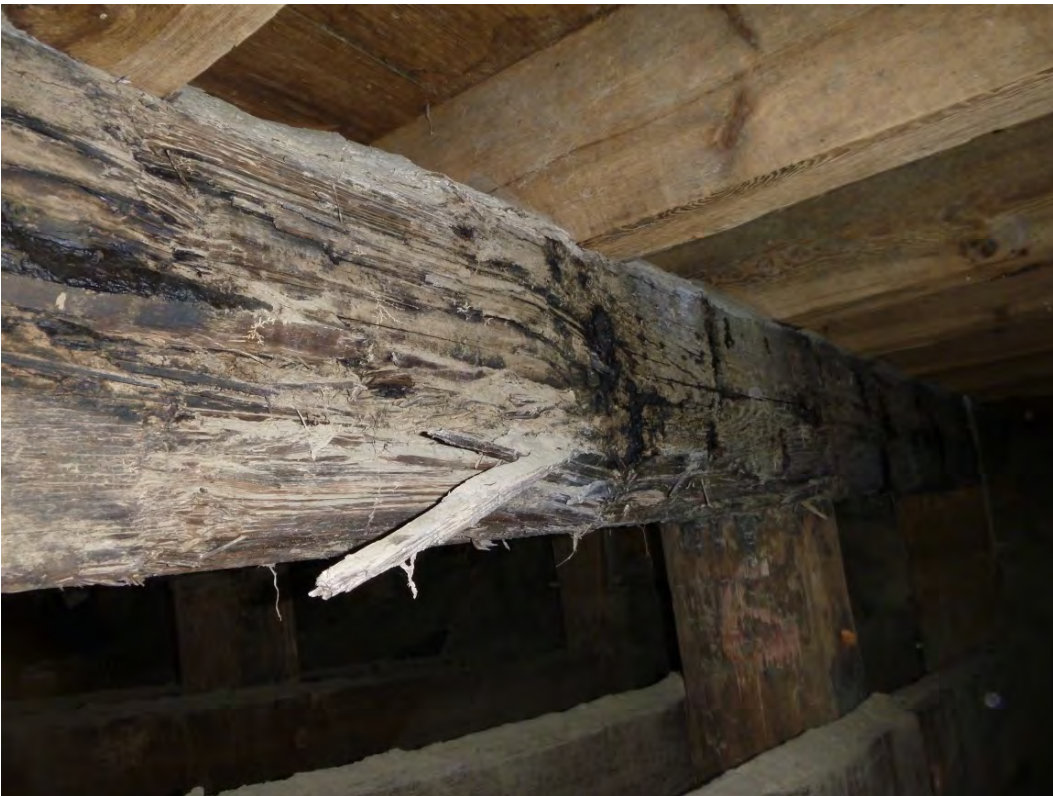
- Photo 13 displays the typical condition of a timber pile cap beam.
- The timber beams along lines 16 and 17 were noted to be in a deteriorated state. Photo 14 shows the beam along line 17.

**Photo 14 – Deteriorated pile cap beam at line 17**

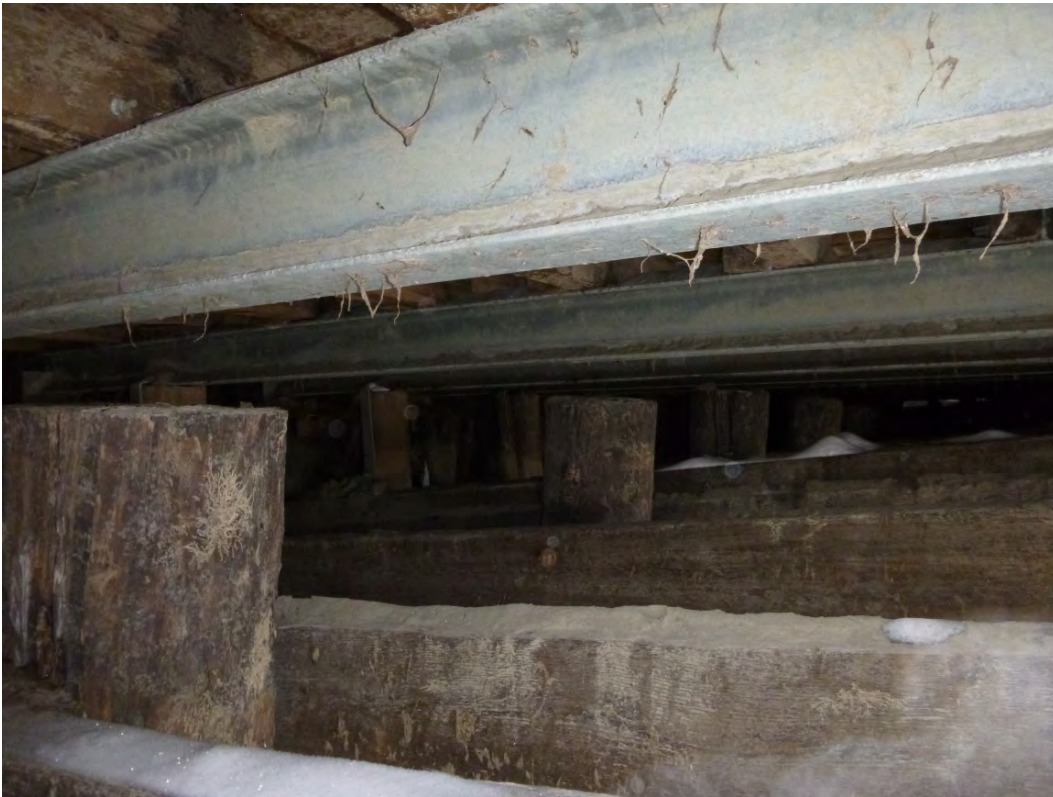
- With the exception of the damaged and deformed steel W200x27 sections on the upstream (South) end of the dock (where the decking is currently removed), the remainder of the W200x27 sections were in good condition, as shown in Photo 15.

**Photo 15 – Typical steel W200x27 girder**

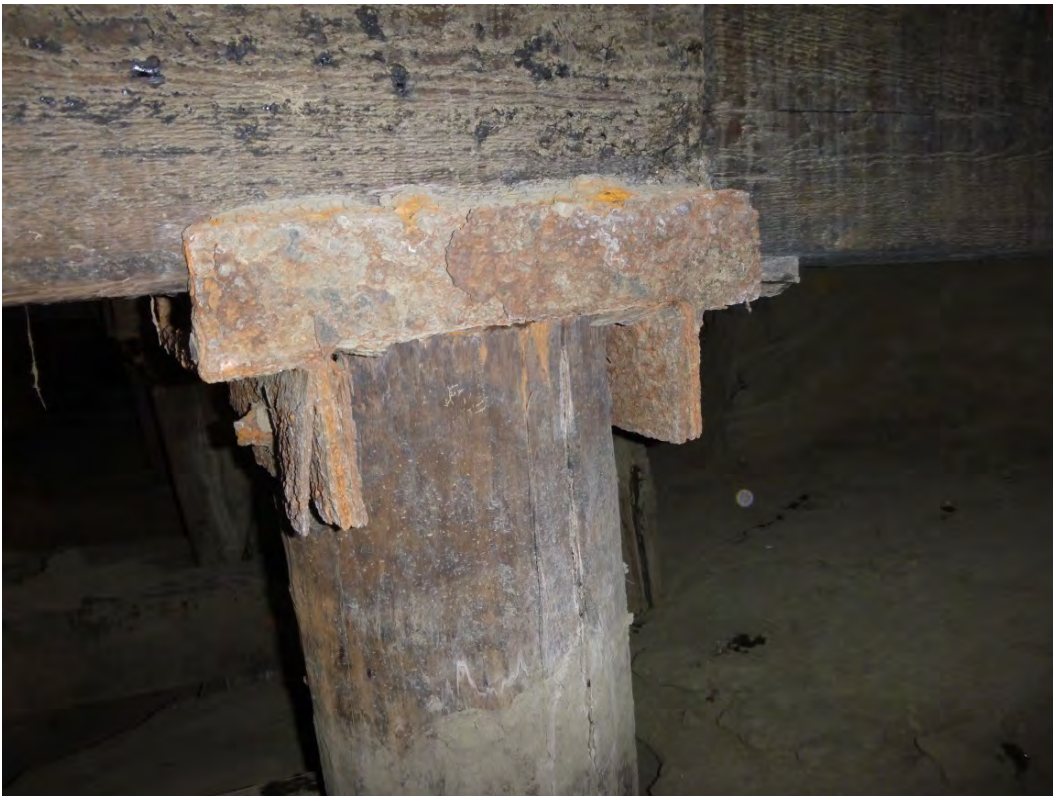
- Many of the steel bearing seats that were installed as part of the original construction phases, prior to the 2001 KGS Group report, were severely deteriorated, as shown in Photo 16. Several of these seats were observed to have deteriorated since the previous assessment.

**Photo 16 – Deteriorated steel pile cap beam support**

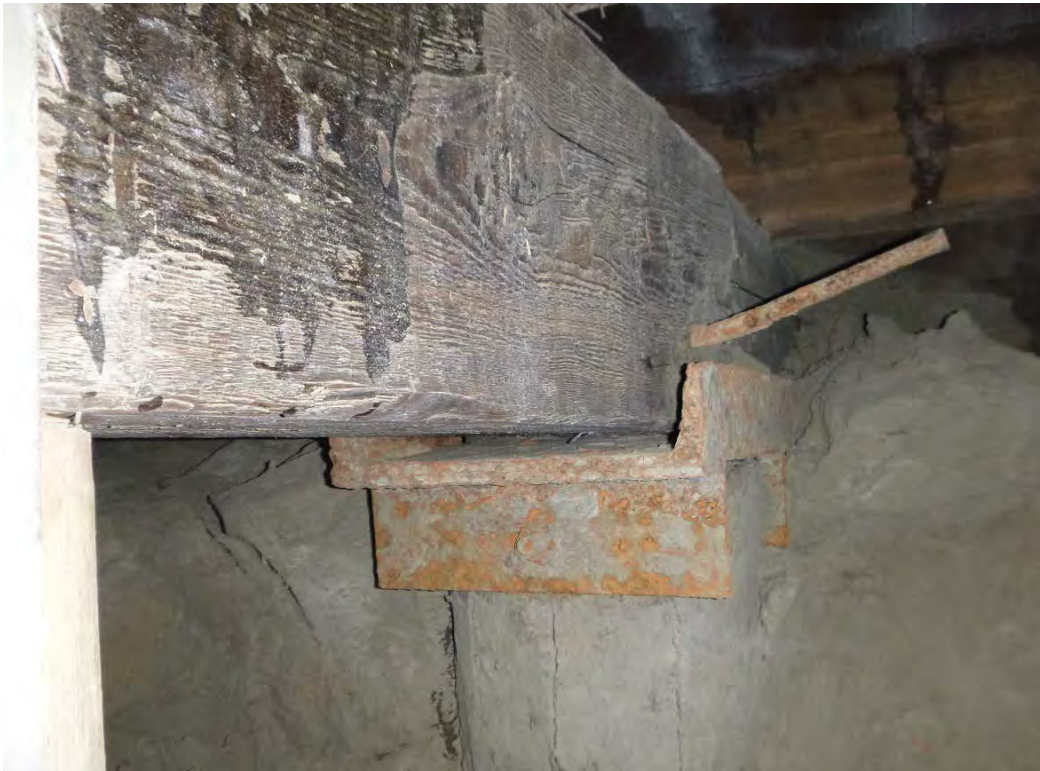
- Several timber pile cap beams spanning between lines C and E were observed to have insufficient bearing support on the pile at line C, where movement prior to the riverbank stabilization or ongoing creep of the inclined pile had caused the steel seat to tilt towards the river (Photo 17).

**Photo 17 – Pile cap beam between E and C; reduced bearing length at steel seat**

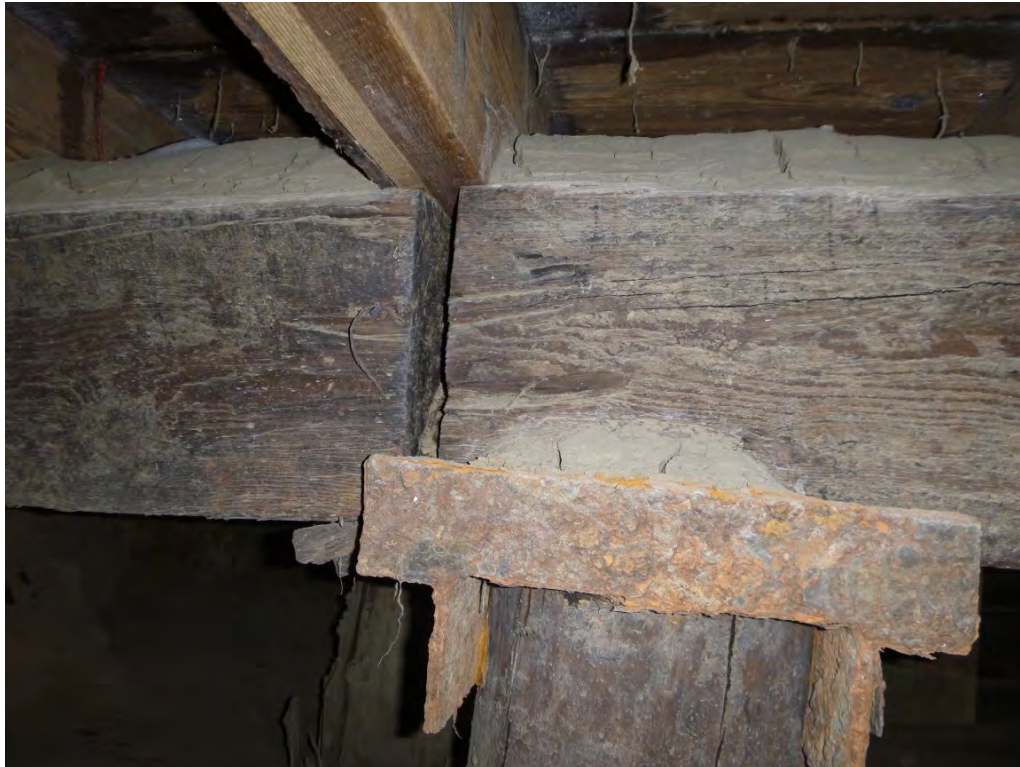
- There were several locations observed where beams embedded in the riverbank had insufficient bearing contact on the steel bearing seats (Photo 18). These beams still had appreciable bearing seat lengths when observed during the 2001 inspection.

**Photo 18 – Insufficient bearing length for beam cantilevering out of riverbank at pile along line C**

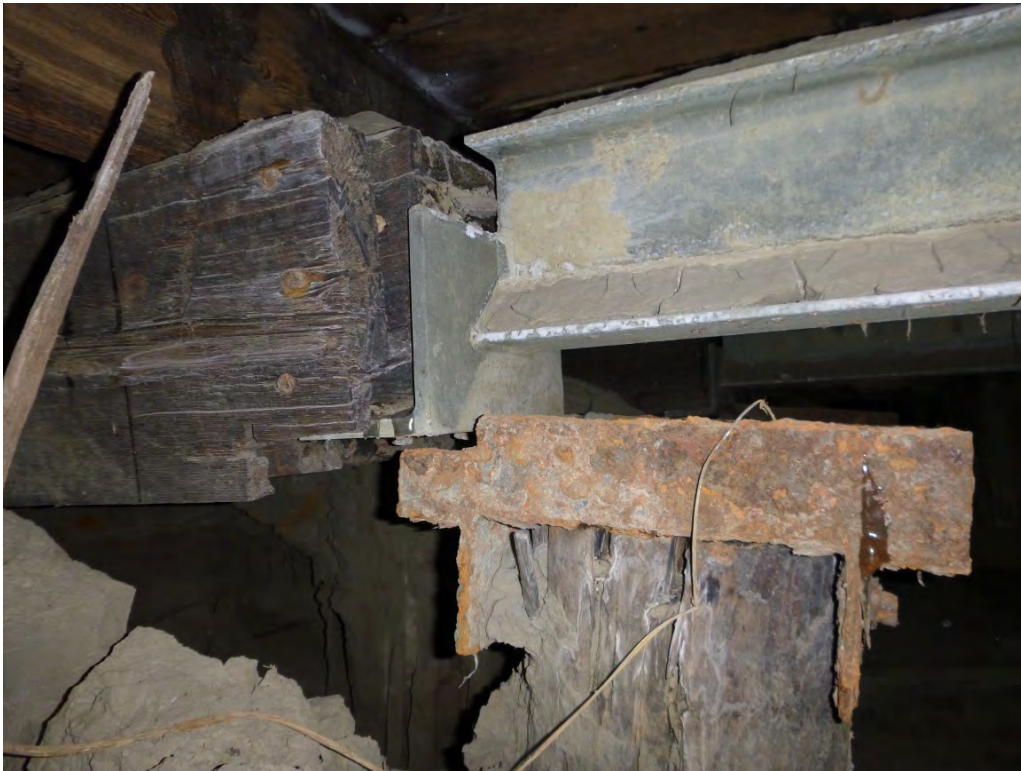
- There were also several locations with beams cantilevering out of the riverbank that had no bearing contact on the steel seats (Photo 19).
- There were several locations where the intermediate support piers of the original timber pile cap beams were tilted or shifted out of place (Photo 20).

**Photo 19 – Beam cantilevering out from riverbank and not bearing on pile, but supported on seat extension of steel beam. Beam has increased deterioration since the 2001 inspection.**

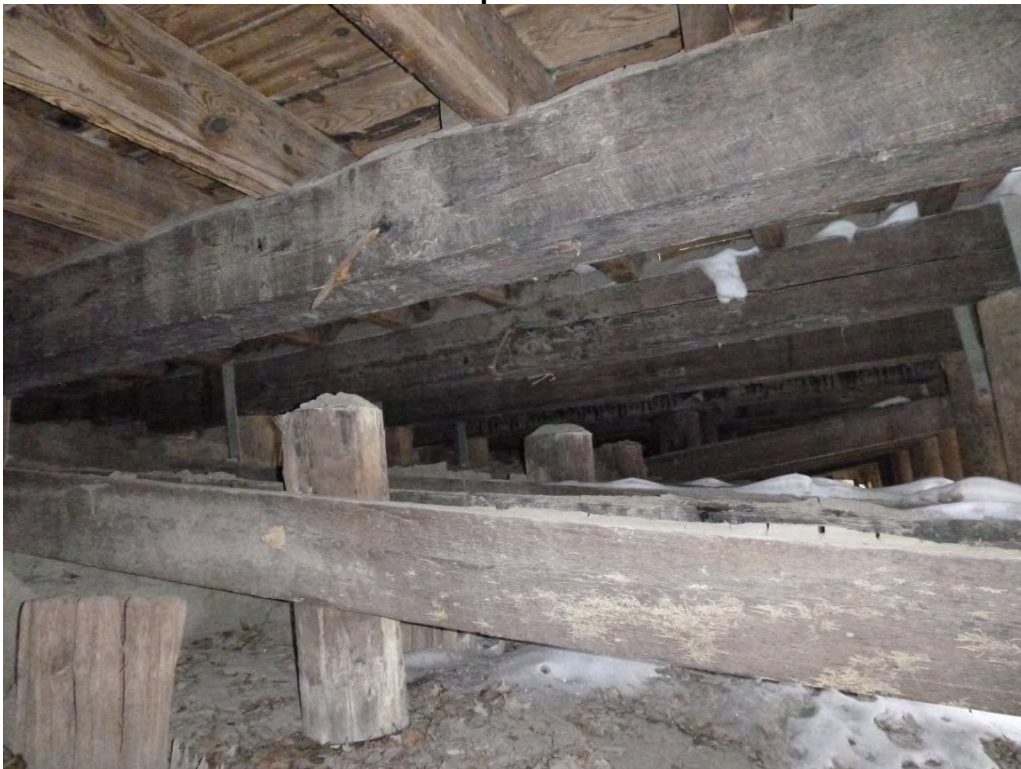
**Photo 20 – Intermediate pier support shifted away from original timber pile cap beam**

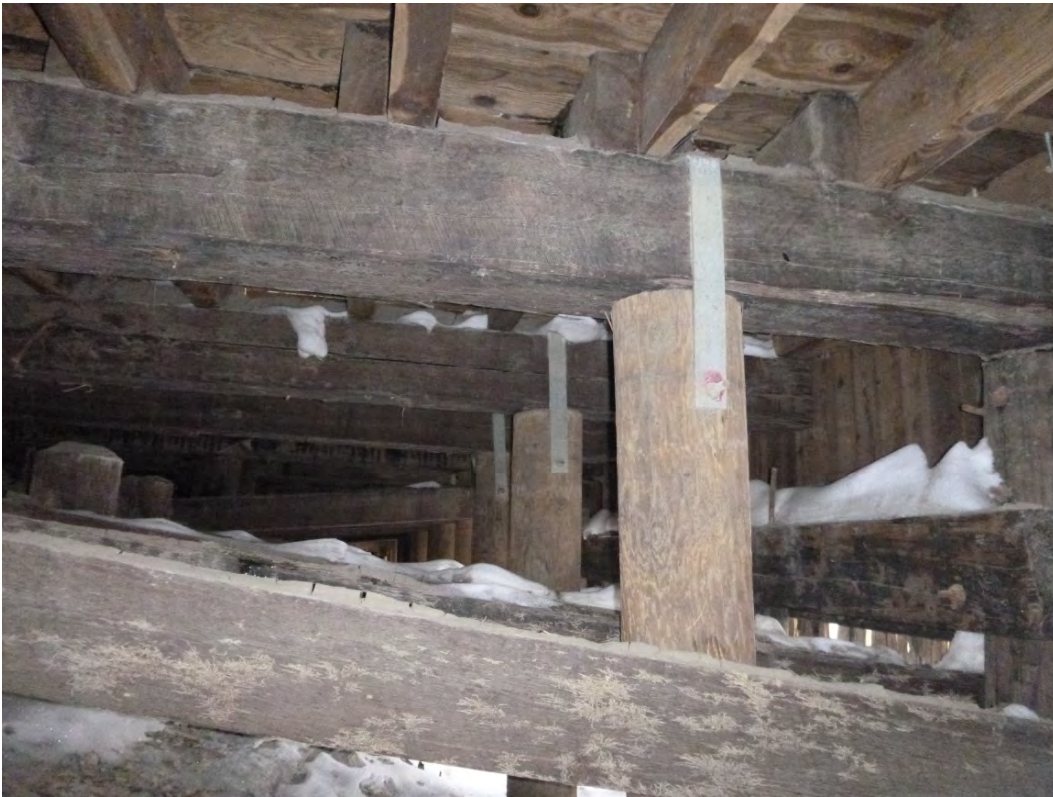
**Photo 21 – Typical condition of remedial piles installed in 2004**

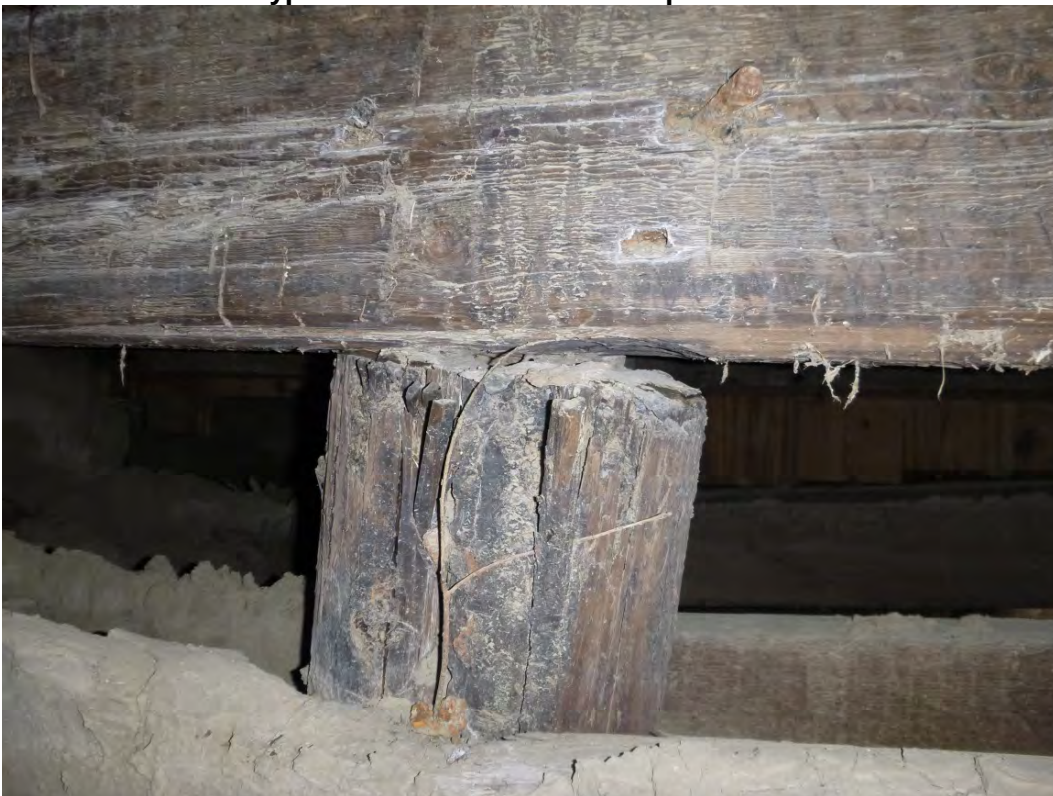
**Photo 22 – Typical tilted pile support**

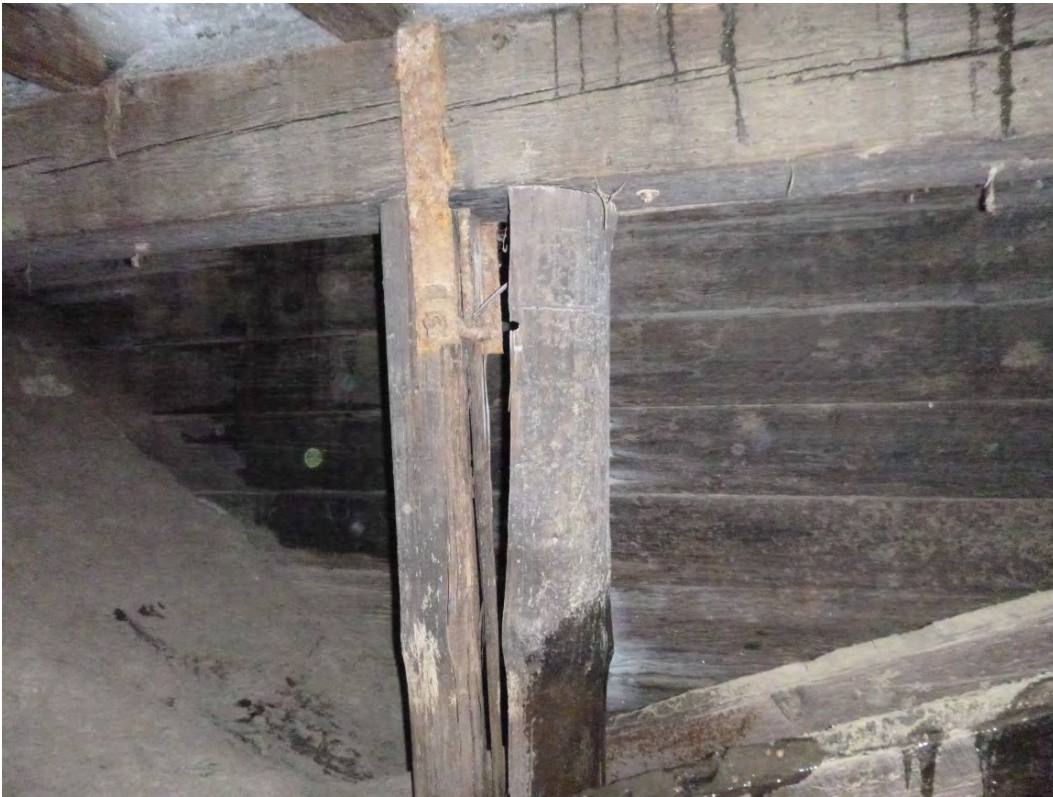
The columns marked with an "S" on Figure 1 were split to varying degrees, with Photo 12 representing an example. The axial compressive capacity of some of the split piles may be only slightly reduced from the design strength of the pile but the current load carrying capacity of these piles is difficult to quantify. While load sharing from the decking/stringer system may spread the load to more capable piles, the load carrying capacity of the split piles should be considered to be reduced, and in some cases negligible.

**Photo 23 – Split pile at line 85**
