May 1, 2015

File No. 14-0107-036

RE: Alexander Dock  
Inspection and Condition Assessment, Final – Rev 0

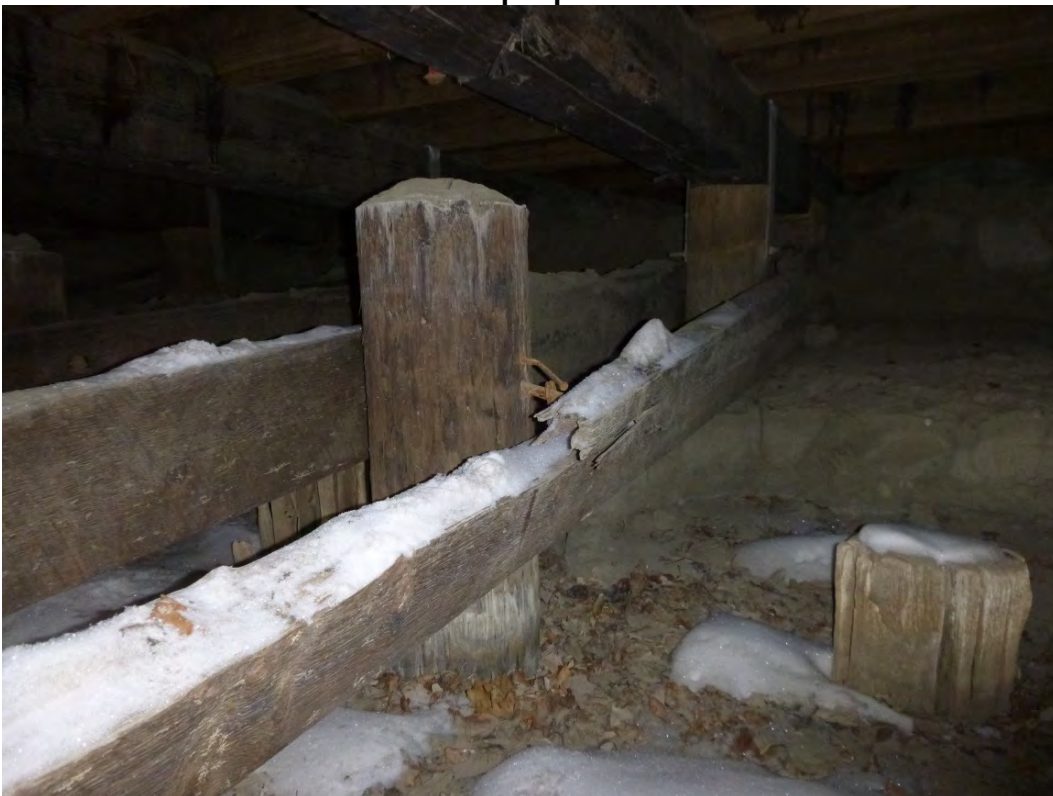
- Several diagonal bracing members were found to be damaged and no longer attached to the timber piles (Photo 24). Of the 82 bracing locations inspected, 15 members (18%) require replacement.

**Photo 24 – Diagonal bracing member no long attached to pile**

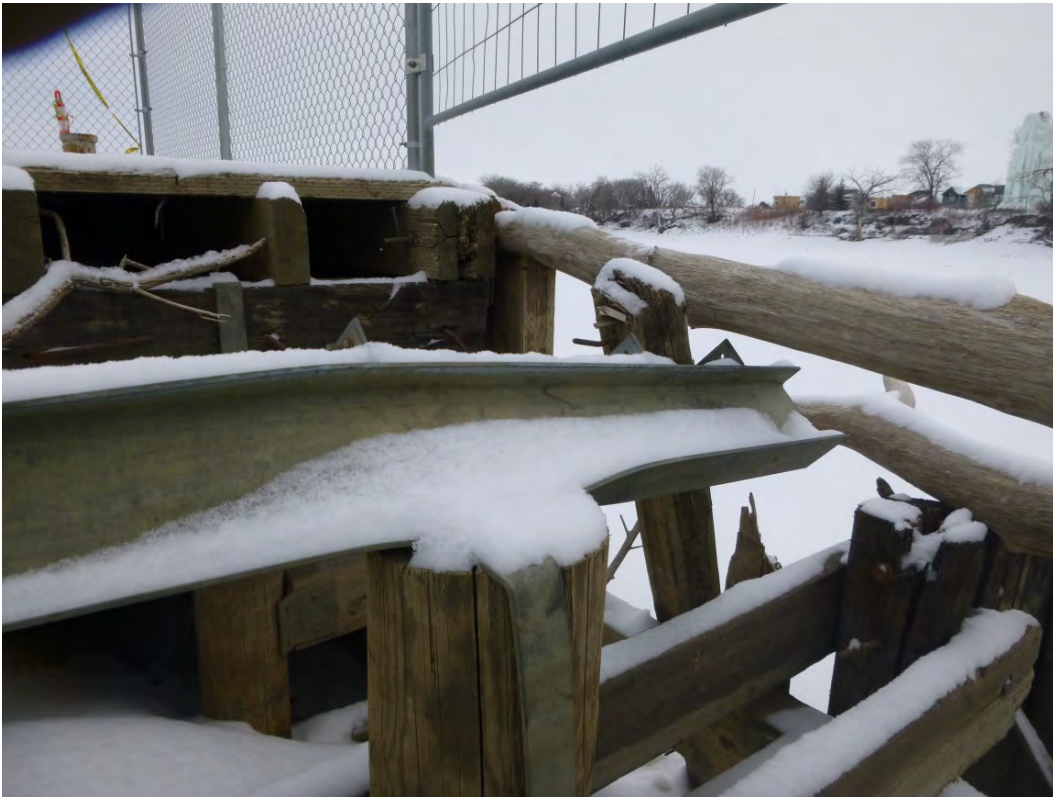
The upstream area of the dock, which has been damaged due to ice impact, appears to be unsalvageable. This area is currently exposed, due to the removal of the decking in this area. The underlying structure is severely damaged and deformed, as shown in Photo 25.

**Photo 25 – Damaged upstream side of Alexander Dock**

- If the City of Winnipeg determines that the entire dock or large sections of the dock are to be used for the long term, a cost analysis of upgrading the upstream damaged area with better ice-resisting capabilities and replacing the deteriorated substructure elements could be conducted. However, given the varying condition and age of much of the substructure, rehabilitation and partial replacement may not be practical or achieve a cost effective long asset. A long term solution would likely warrant demolition of the existing structure and construction of a new dock facility.
