THE CITY OF WINNIPEG

NEWPCC UV TRANSFORMER ENCLOSURE REPAIR

Transformer Inspection Report

Subject: UV Transformer Testing and Inspections

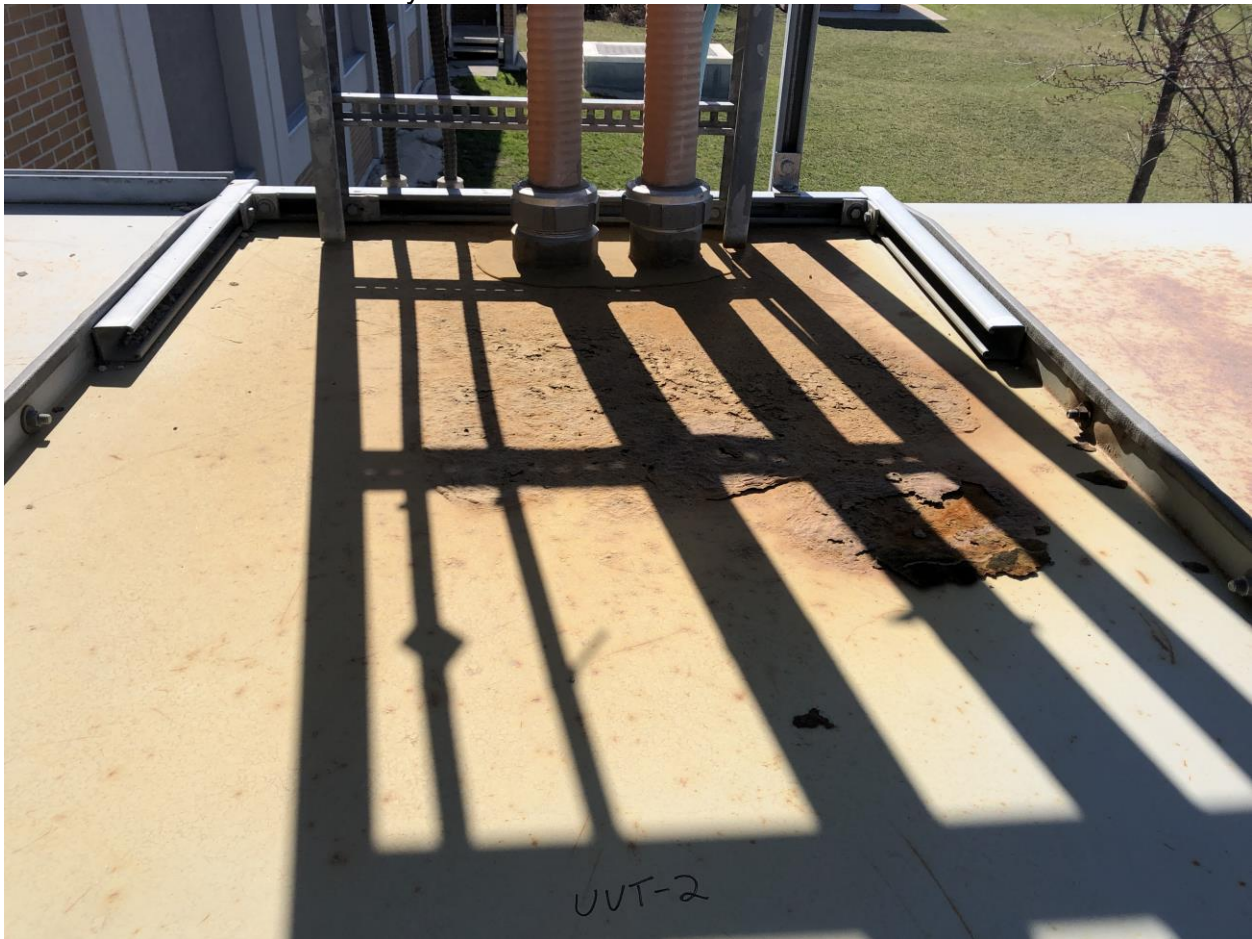
- All 4 outdoor 4160V dry type UV transformers have top entry cable and bus duct. That combined with 3 piece poorly designed enclosure roofs have caused water entry and corrosion of the roof tops. IER recommends continued monitoring of transformers.
- UVT-2 Severely corroded enclosure roof.

Exterior / Interior Condition: top rusting, inside cleaned

Cleaning and inspection only cannot isolate secondary for testing due to ground current of 72A at XO.
 Insulation Resistance High to Low and Ground @ 5KVDC for 1 minute = 43.1G ohms. Test includes primary cables.
 H1 Primary cables heat shrink split exposing tape shield. Shield is broken in 2 places.
 Top of transformer enclosure severely corroded.

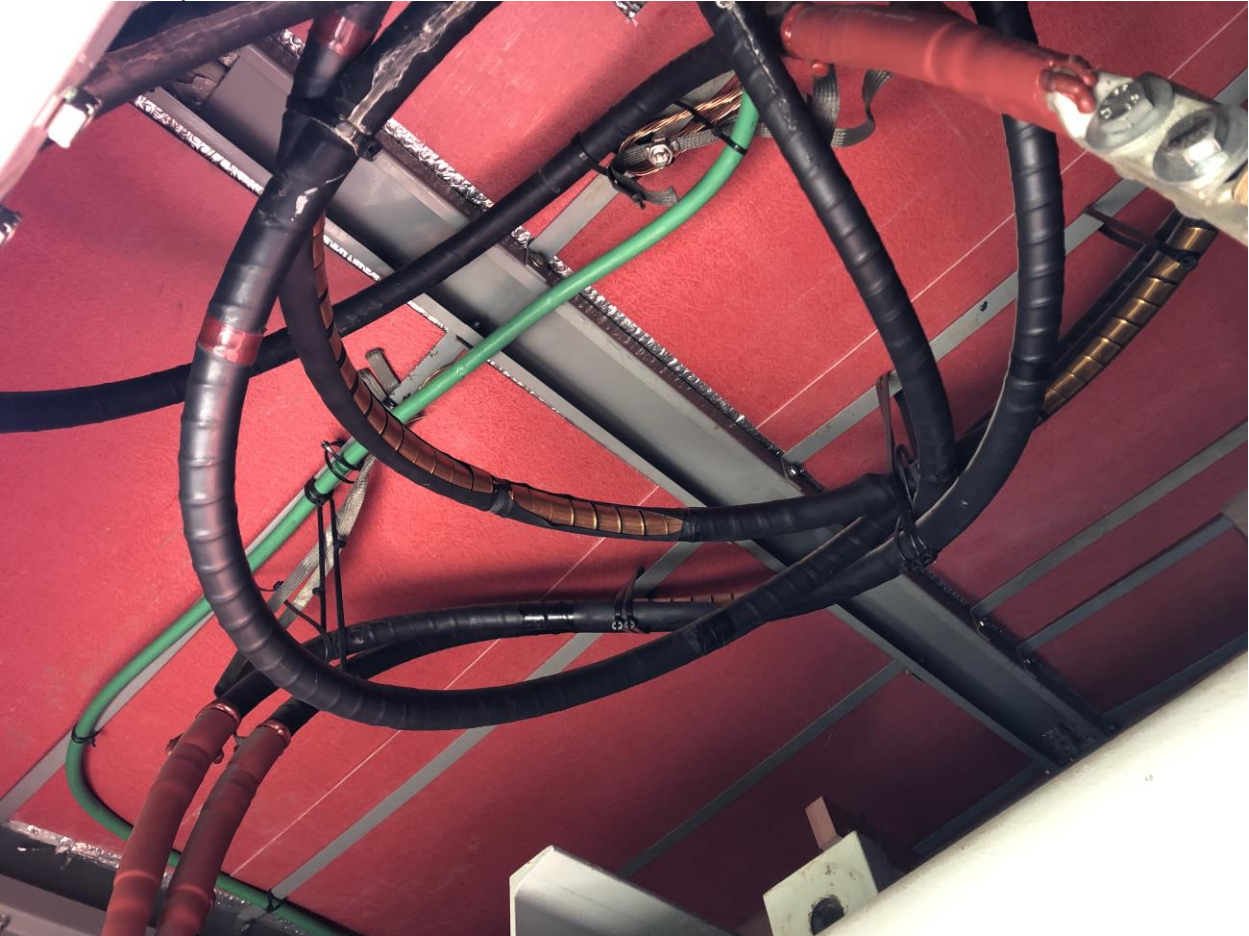
- UVT-2 4160V primary H1 cable heat shrink has split due to transformer heat. This has exposed the tape shield which was found to be broken in 2 places.

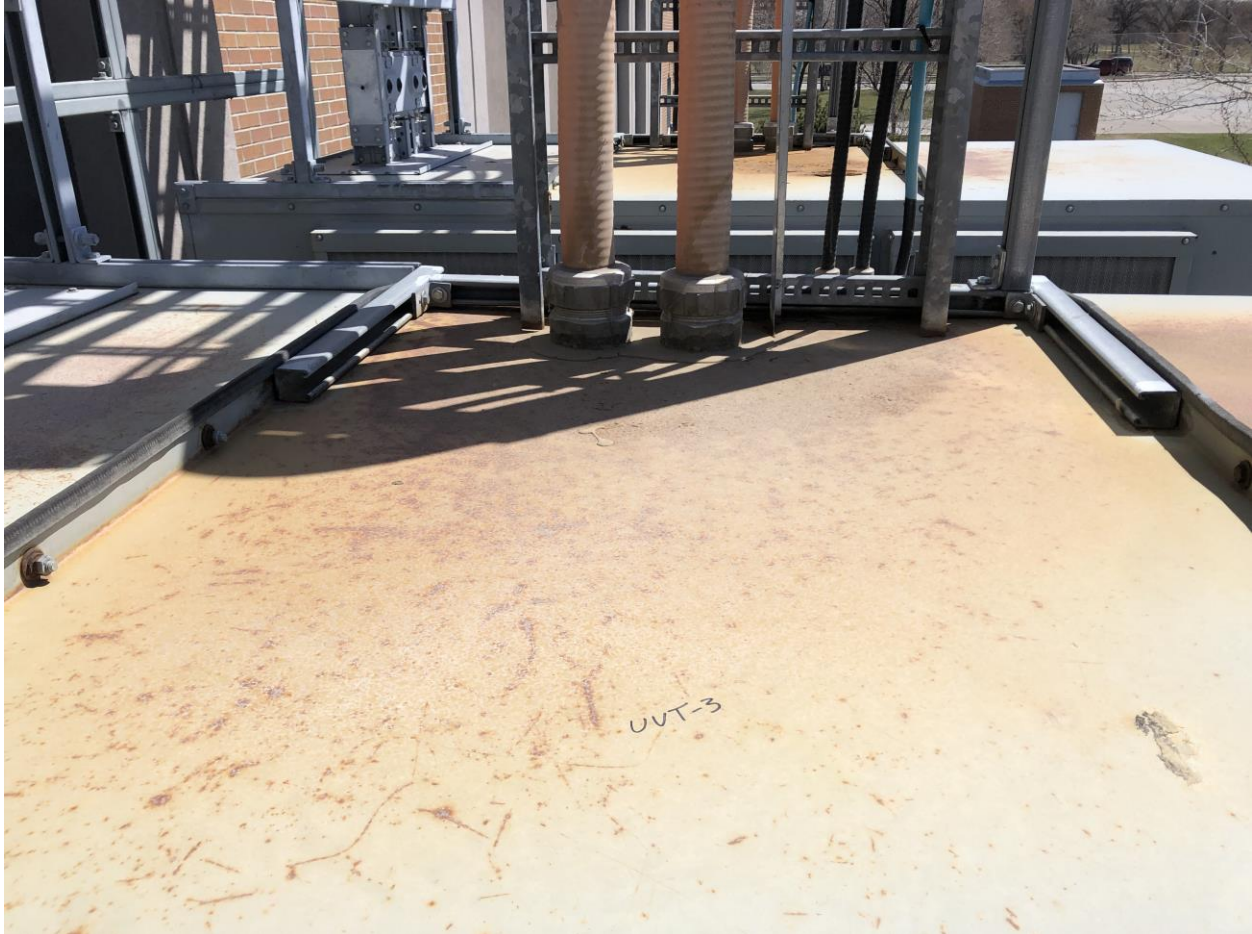
- UVT-3 Corroded Enclosure Roof.

Exterior / Interior Condition: top rusting, inside cleaned.

Cleaning and inspection only cannot isolate secondary for testing due to ground current of 24A at XO.
 Insulation Resistance High to Low and Ground @ 5KVDC for 1 minute = 43.7G ohms. Test includes primary cables.
 Top of transformer enclosure corroded.

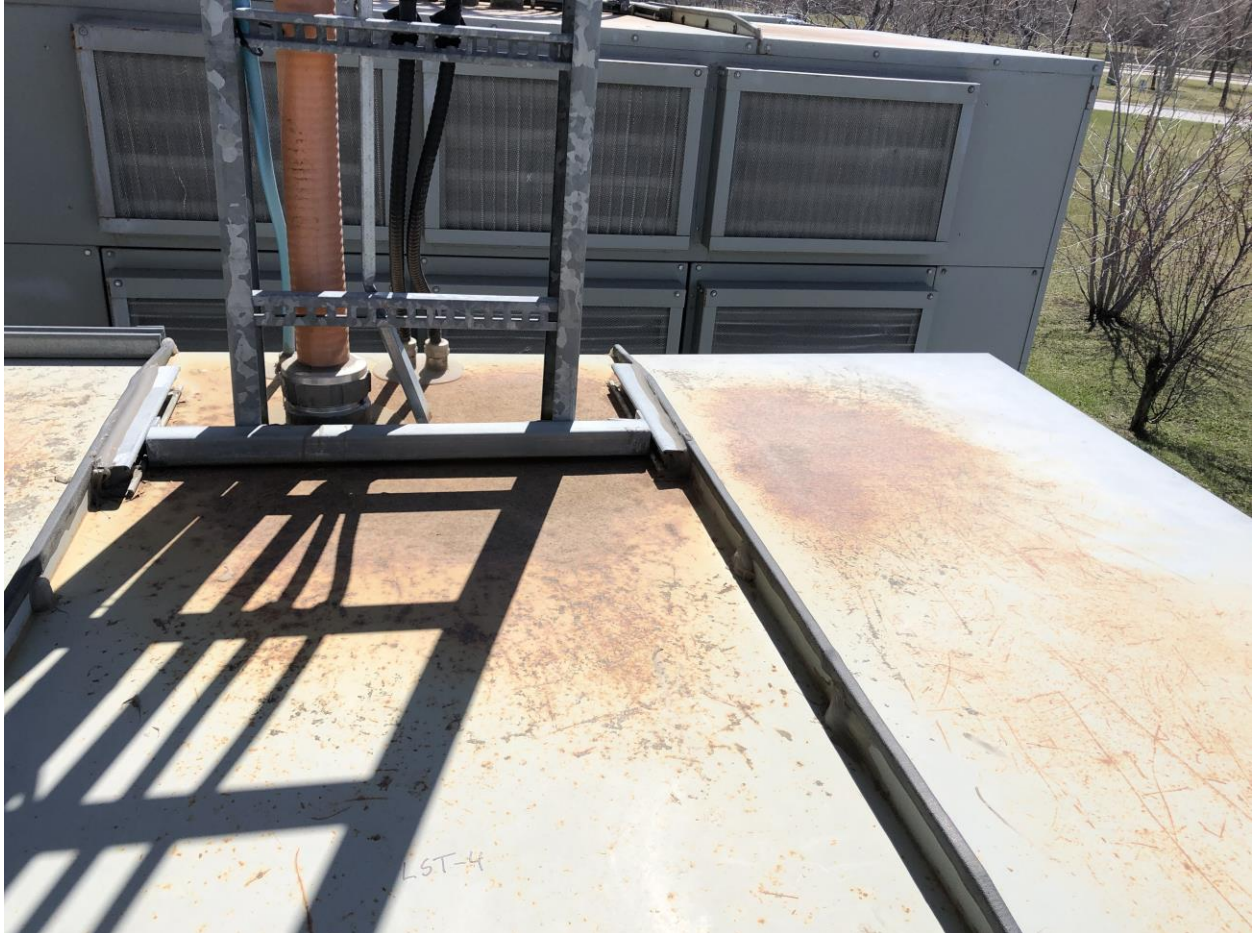
- LST-4 Corroded Roof.

Exterior / Interior Condition: top rusting, inside dirty, cleaned

Secondary disconnected for testing.
 Insulation Resistance High to Low and Ground @ 5KVDC for 1 minute = 40.4G ohms. Test includes primary cables.
 Top of transformer enclosure corroded.

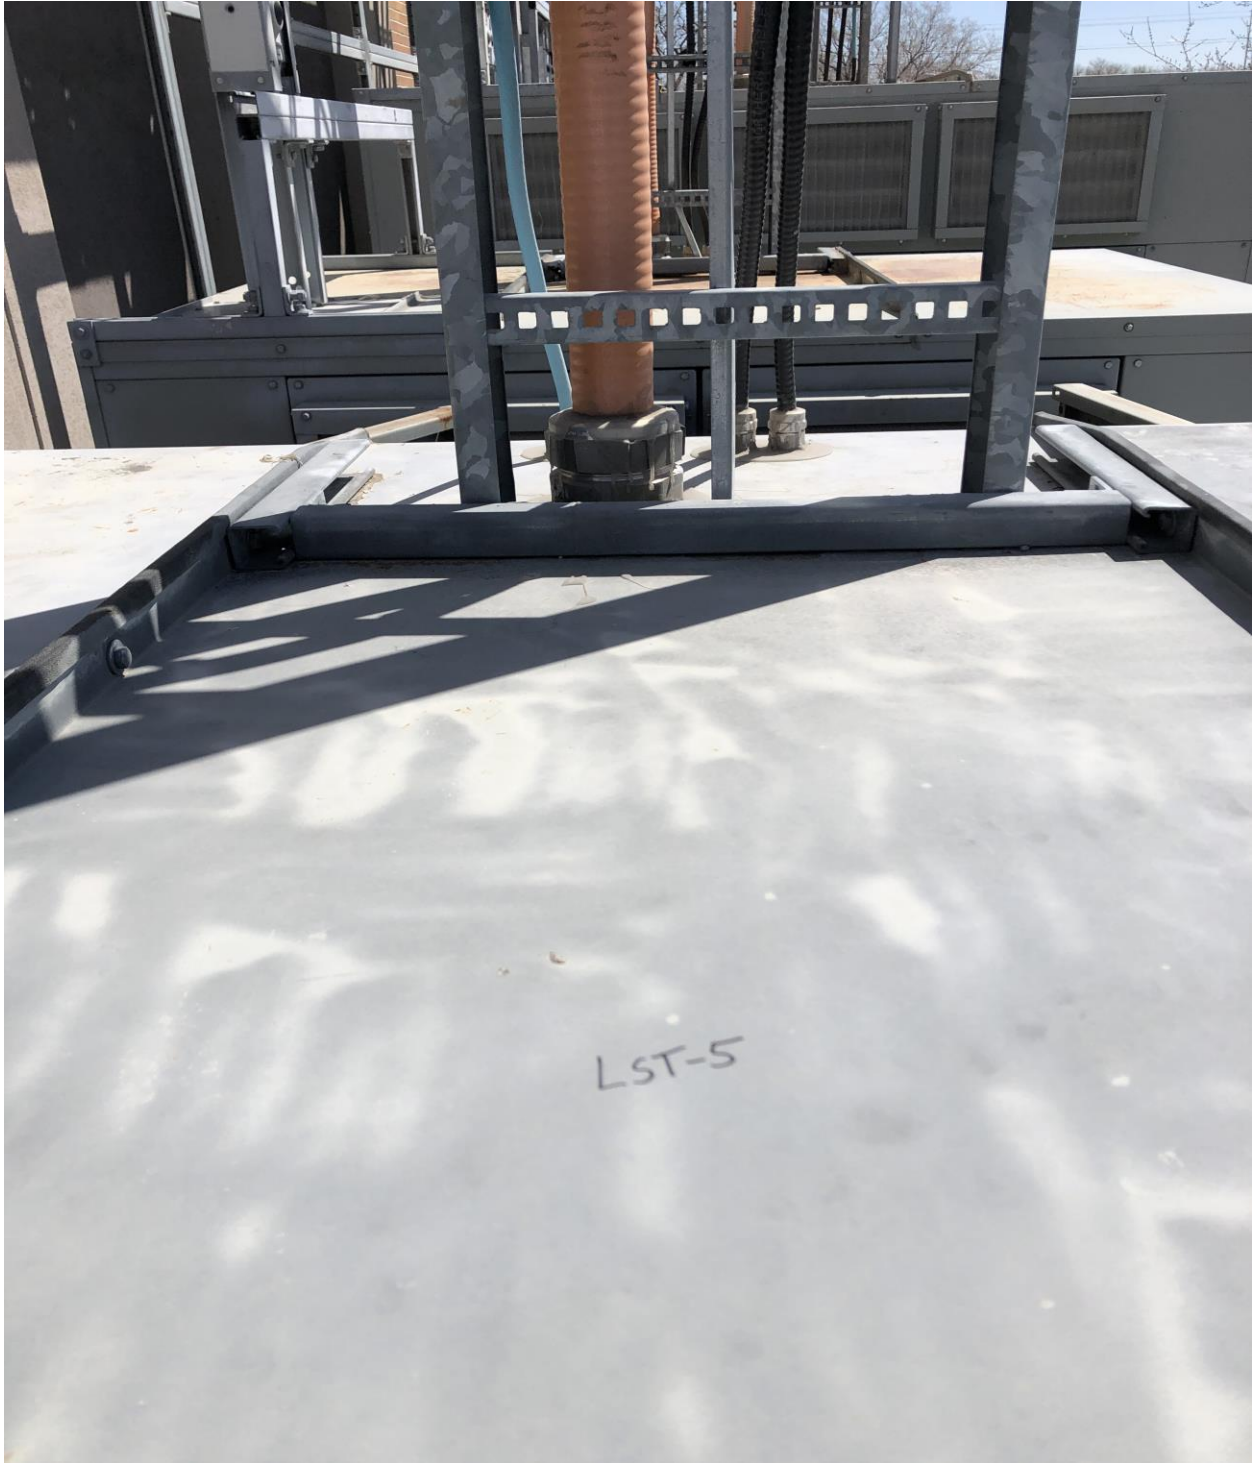
- LST-5 Minor Roof Corrosion.

Secondary disconnected for testing.
 Insulation Resistance High to Low and Ground @ 5KVDC for 1 minute = 47.8G ohms. Test includes primary cables.
 Top of transformer enclosure minor corrosion.
