CCTV SEWER PIPE INSPECTION REPORT

June 2, 2023

734-2300070300-IR-C0001-00

**Subject Logan Avenue Mill and Fill – Keewatin Street to Dee Street
CCTV Sewer Pipe Inspection Report**

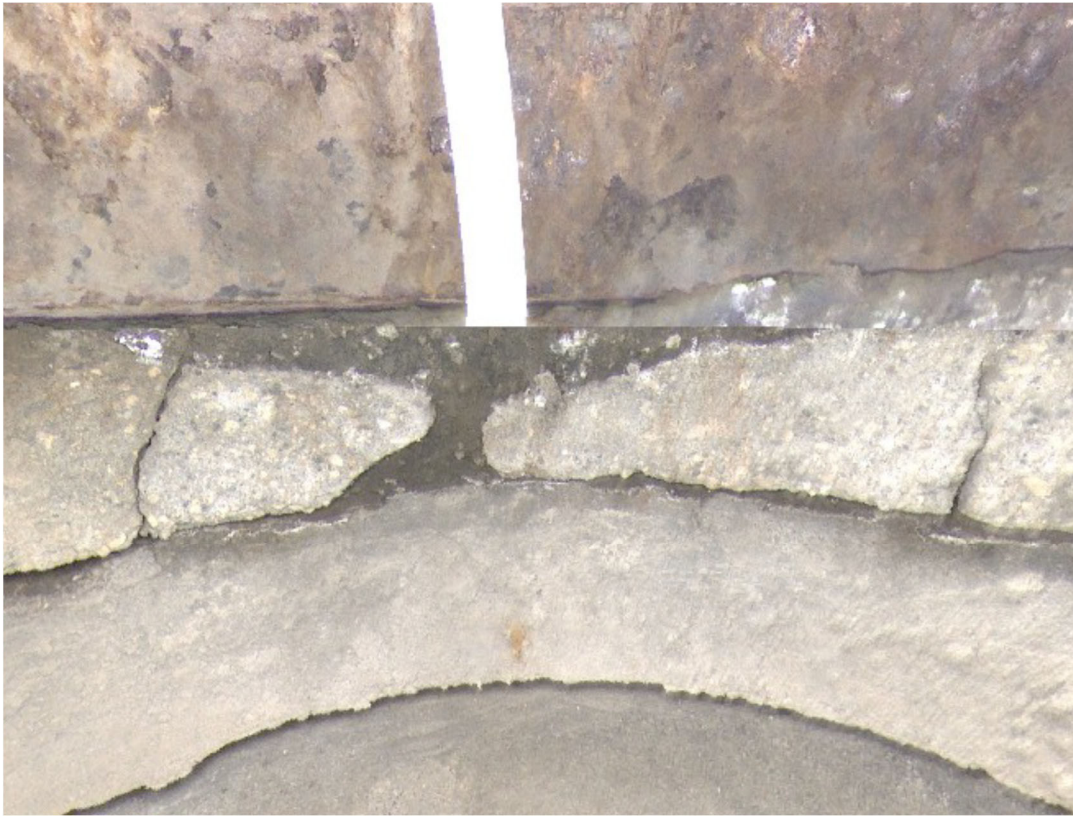
- 750mm adjusting ring (Photo 1) - Broken, soil visible: replacement recommended

Photo #1 – (S-MH20011285) 0.28m deep multiple breaks throughout ring – soil visible

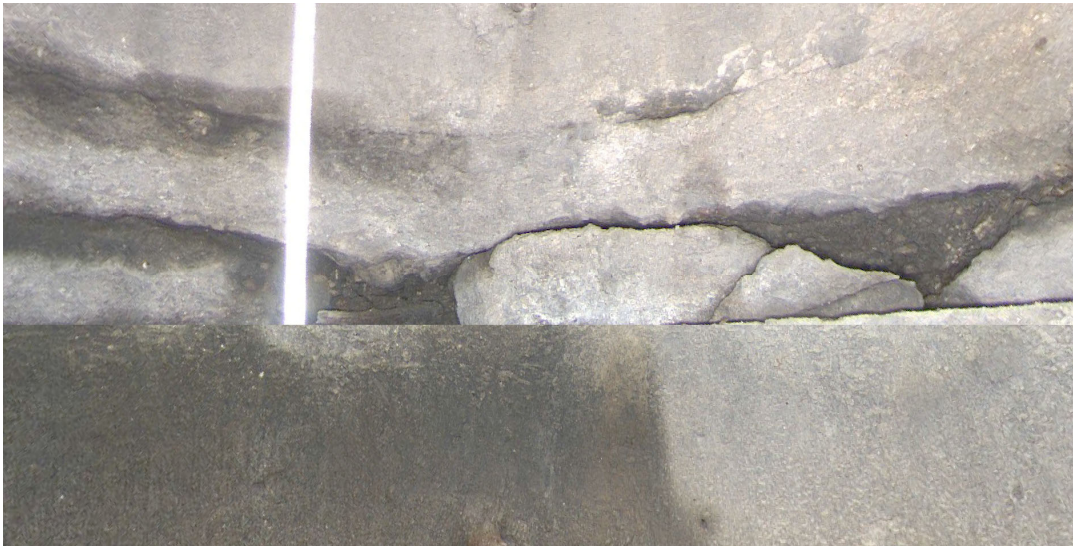
Photo #2 – (S-MH20011280) 0.58m deep multiple breaks throughout ring – soil visible

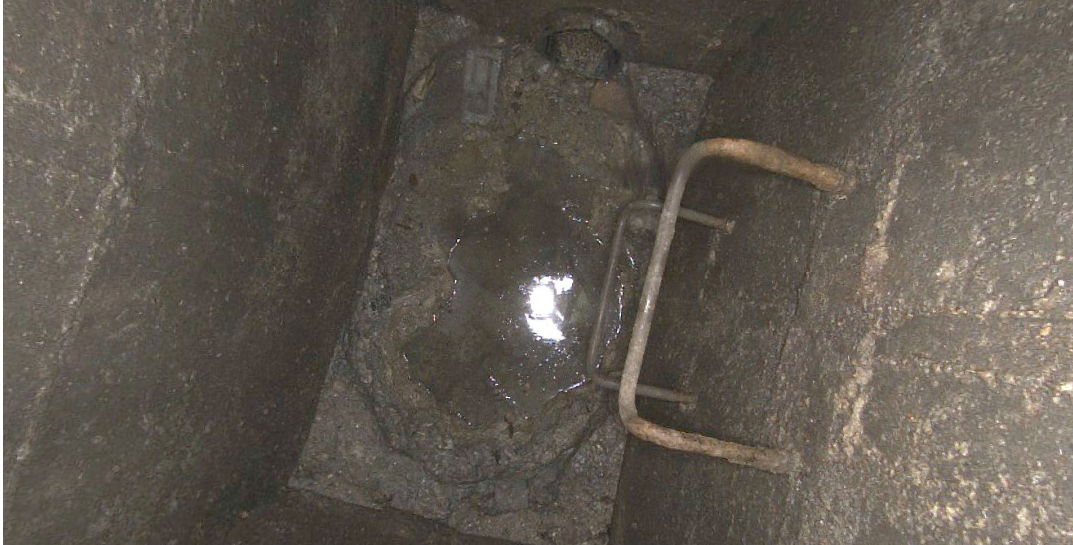
- 750mm adjusting ring (Photo 2) - Broken, soil visible: replacement recommended
- Manhole floor (Photo 3) - Eroded/washed out: re-grouting recommended

Photo #3 – (S-MH20011280) floor washed out

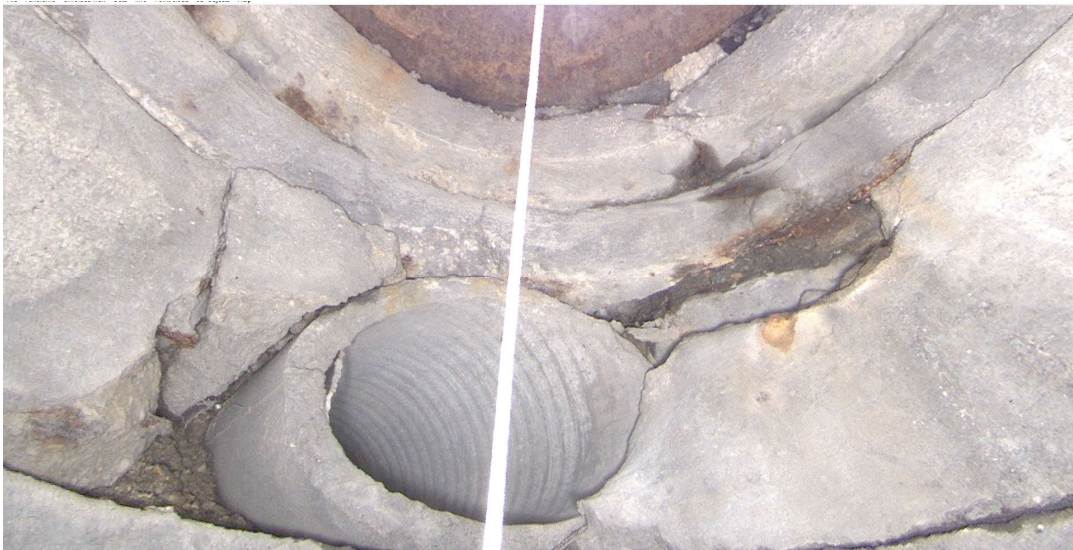
- 750mm adjusting ring (Photo 4) – cracked: replacement recommended
- 750mm – 900 reducer (Photo 4) – cracked: replacement recommended
- 900mm riser (Photo 4) – broken: replacement recommended

Photo #4 – (S-CB20011316) 0.24m-0.66m deep cracked adjuster ring, reducer, and broken riser

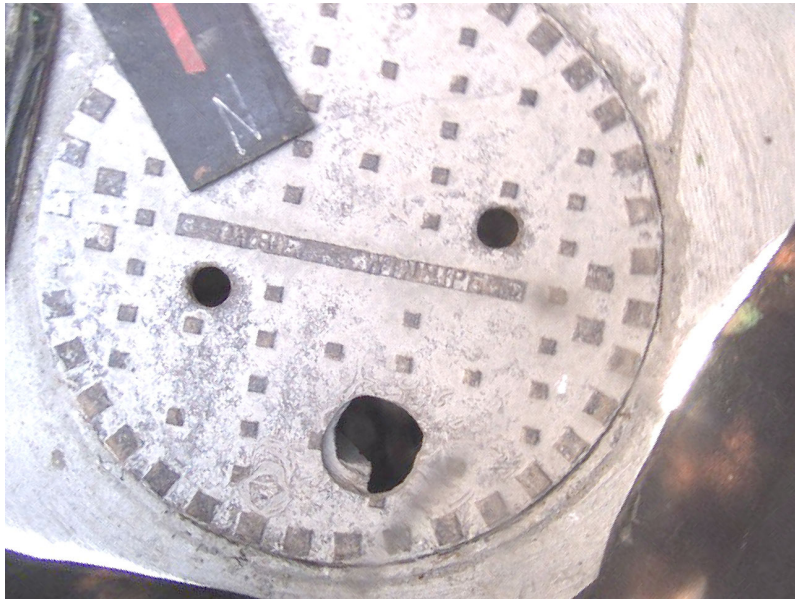
Photo #5 – (S-CB20011317) hole in cover

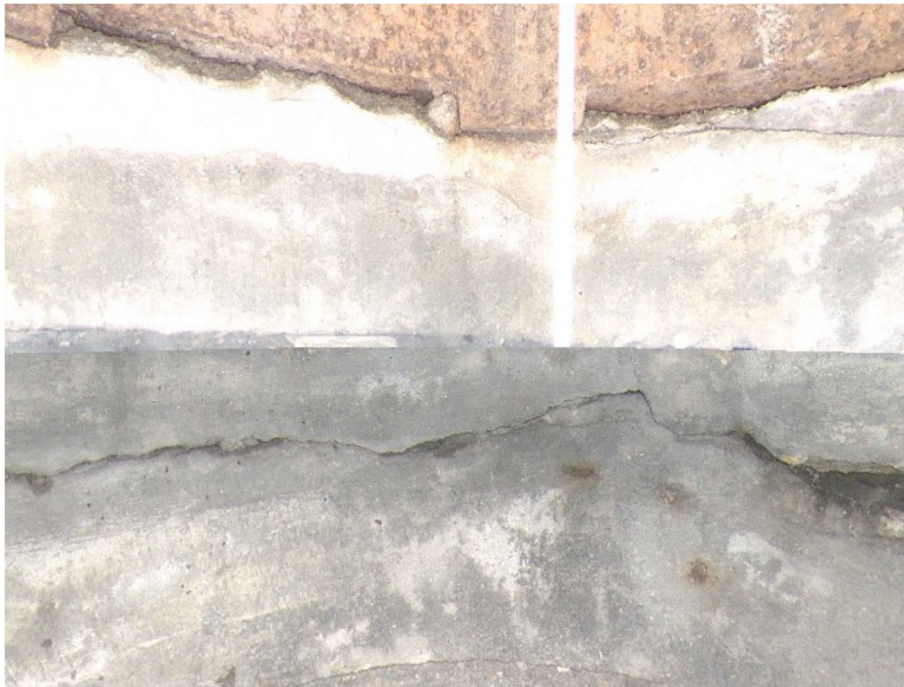
Photo #6 – (S-CB20011317) 0.48m deep - cracks present

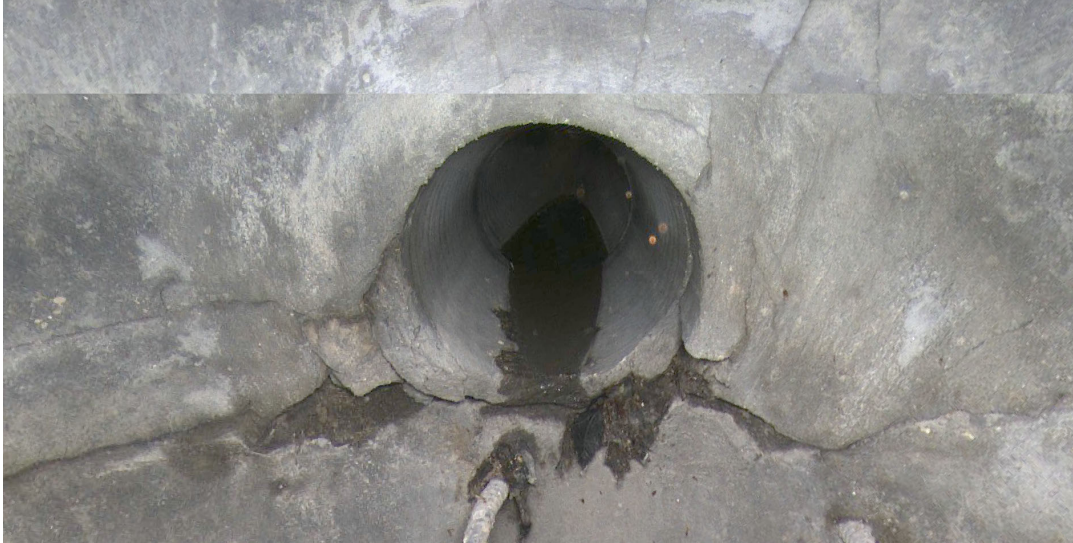
- Hole in cover (Photo 5) – 100mm ± diameter: replacement recommended
- 900mm riser (Photo 6) – cracked: grouting recommended
- 900mm riser (Photo 7) – cracked around lead from catch pit: grouting recommended

Photo #7 – (S-CB20011317) 0.7m deep - cracks present

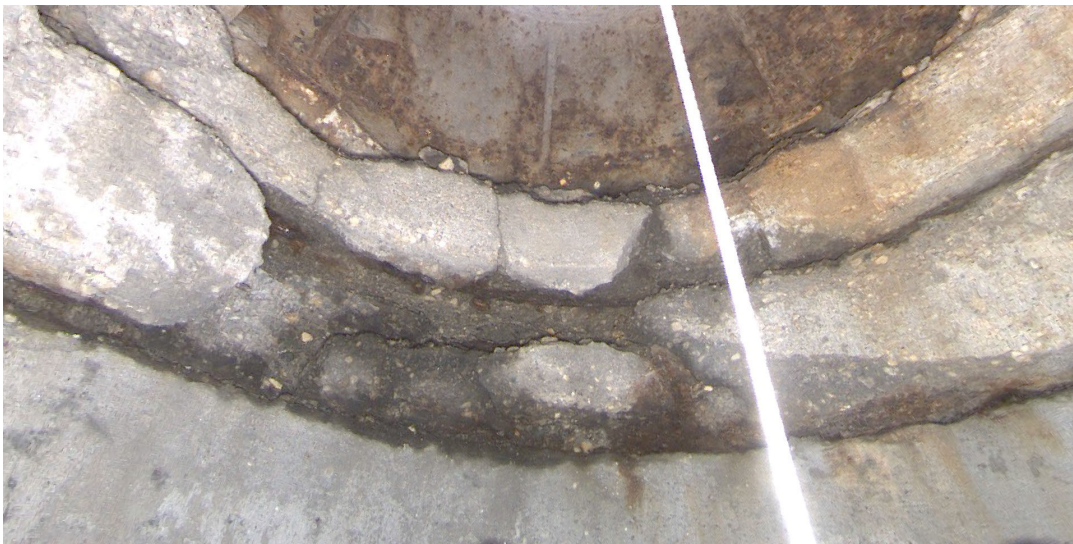
- 750mm adjusting ring and 1200-750 reducer (Photo 8) – cracks: grouting recommended

Photo #8 – (S-MH20011318) 0.48m deep - cracks present

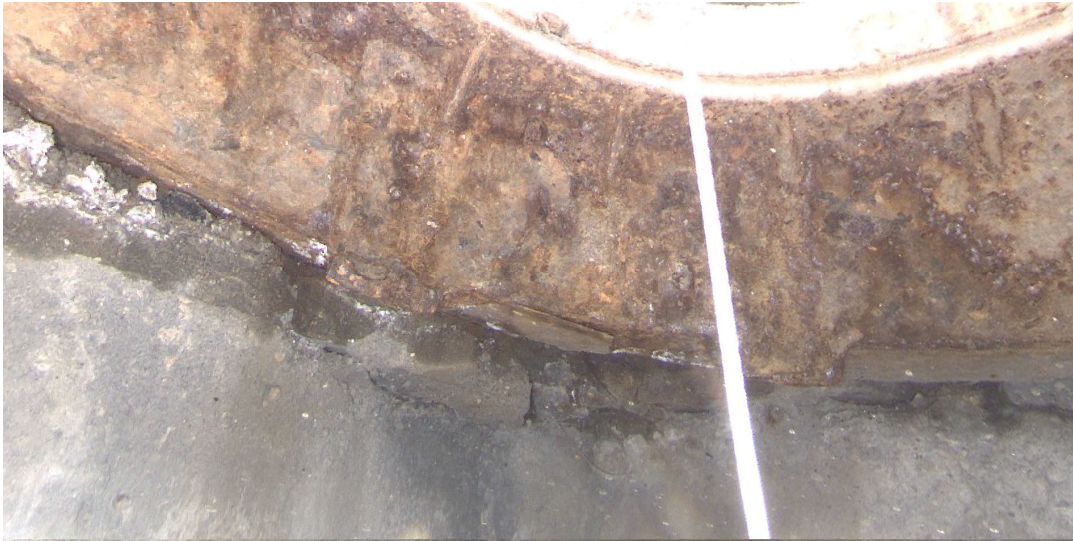
- Concrete spalling/cracking underneath frame (Photo 9) – grouting recommended

Photo #9 – (S-MH20011315) 0.15m deep - cracks/spalling present underneath frame

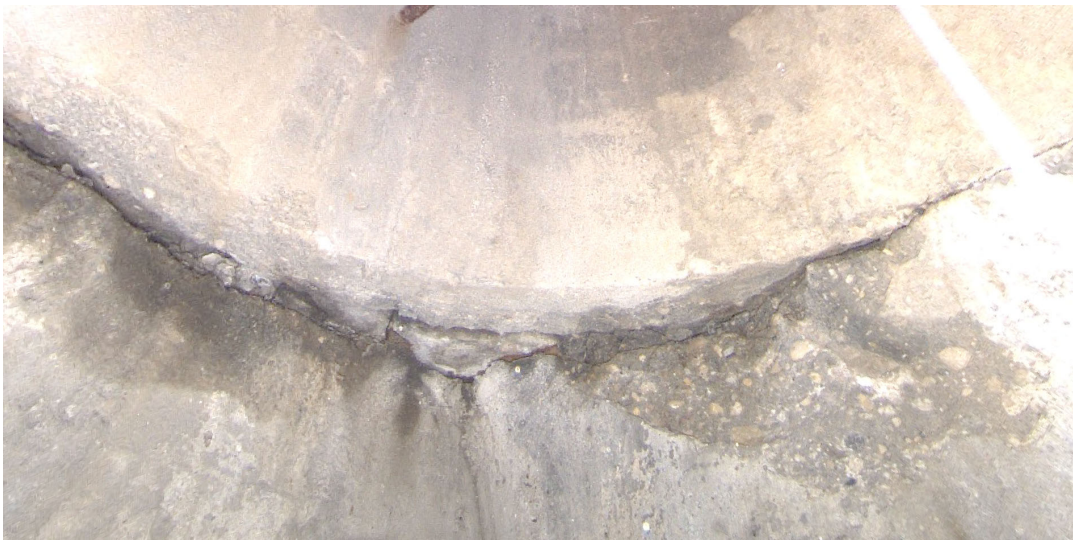
- Concrete spalling/cracking underneath circular riser (Photo 10) – grouting recommended

Photo #10 – (S-MH20011375) 0.81m deep - cracks/spalling underneath circular riser

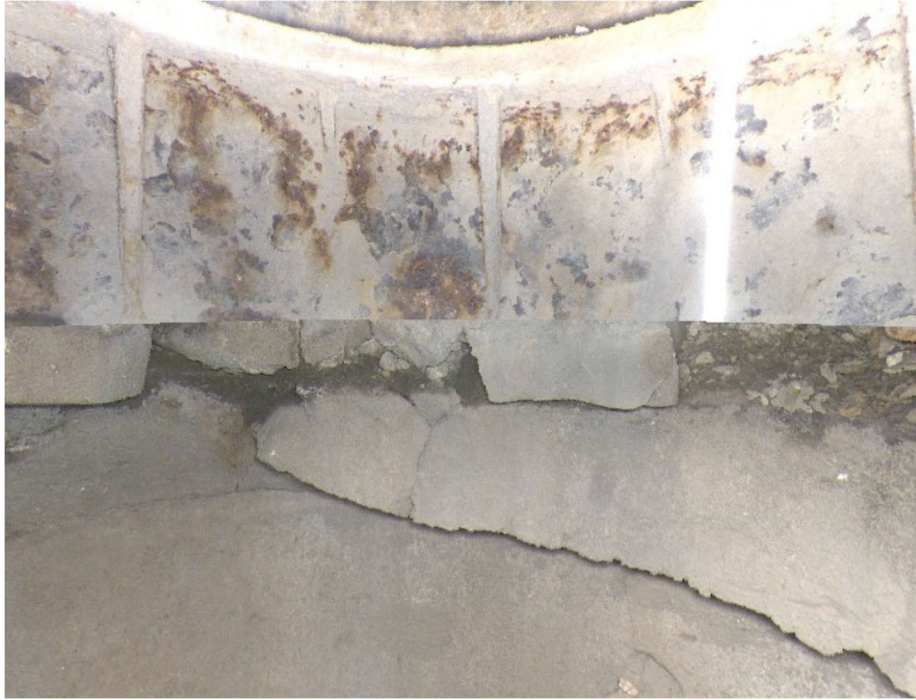
- Concrete spalling/cracking underneath frame as well as in the 900mm-750mm reducer (Photo 11) – grouting recommended

Photo #11 – (S-MH20011365) 0.27m-0.38m deep - cracks/spalling underneath frame and in 900mm-750mm reducer

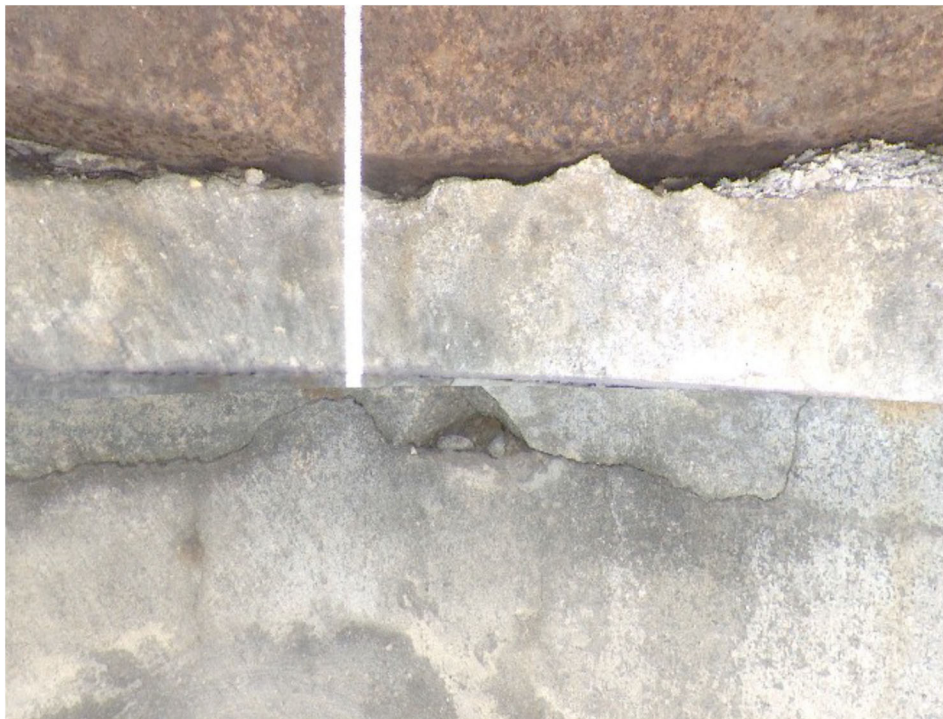
- Concrete spalling/cracking underneath frame as well as in the 900mm-750mm reducer (Photo 12) – grouting recommended

Photo #12 – (S-MH20011363) 0.18m-0.33m deep - cracks/spalling underneath frame and in 900mm-750mm reducer

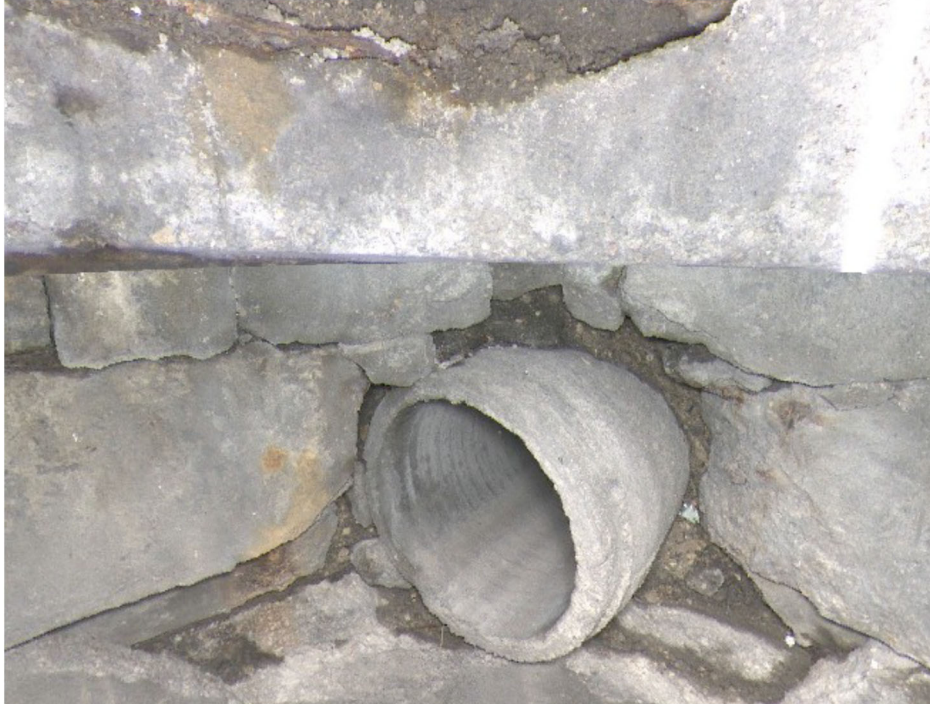
- Multiple fractures in 750mm adjustment ring, 900mm-750mm reducer, 900 riser (soil visible) (Photo 13) – replacement recommended

Photo #13 – (S-MH20011362) 0.25m-1.05m deep - multiple fractures in adjustment ring, reducer and riser – soil visible

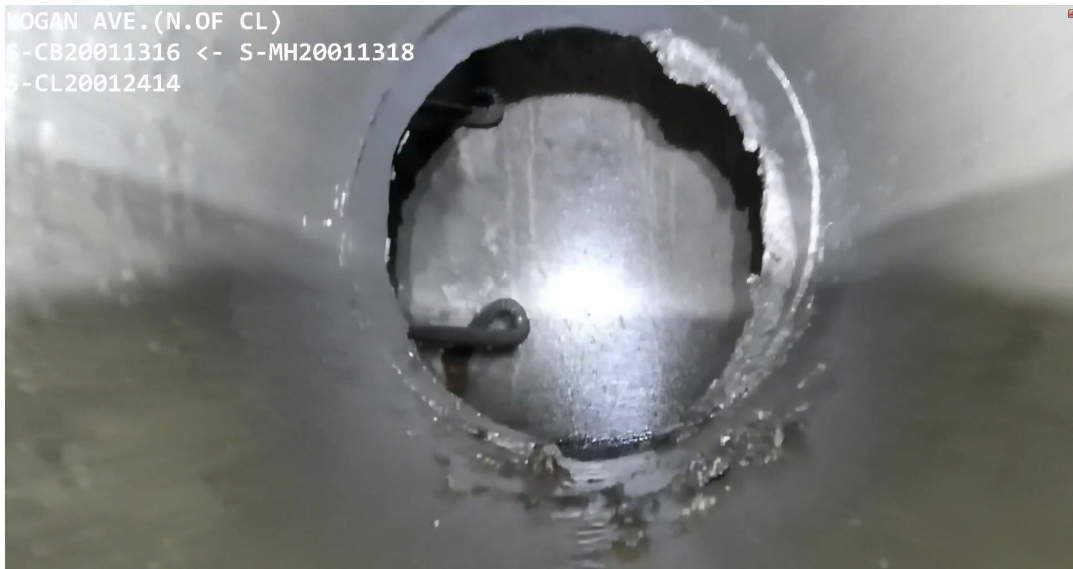
- Pinched gasket protruding 6.3m from MH – no action required
- Circumferential crack 7-5 o'clock (Photo 14) 0.8m from CB – grout from inside of CB recommended

Photo #14 – (S-CL20012414) circumferential fracture from 5 o'clock to 7 o'clock 0.2m from CB

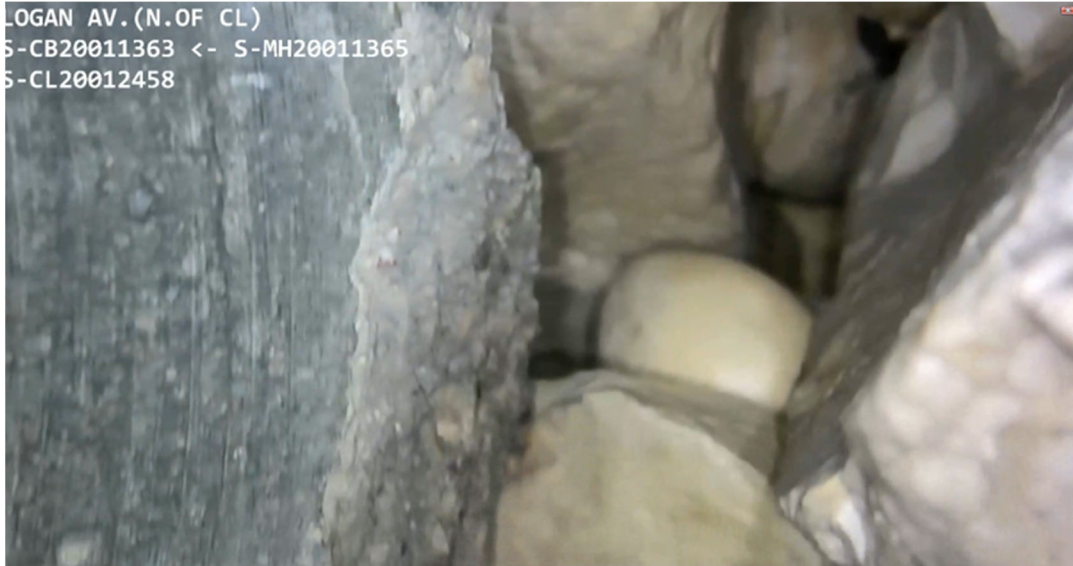
Photo #15 – (S-CL20012458) large void in pipe wall adjacent (within 0.3m) to manhole S-MH20011318

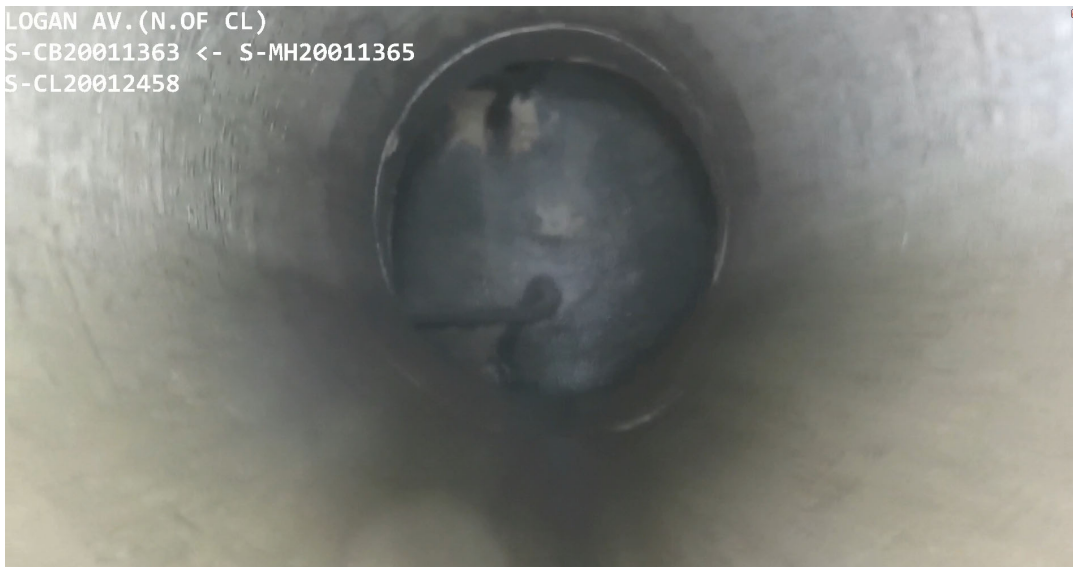
- Large hole/void in pipe from 2 o'clock to 4 o'clock just outside manhole wall – (Photo 15) replacement recommended
- Multiple fractures from 12 o'clock to 12 o'clock (Photo 16) replacement recommended

Photo #16 – (S-CL20012458) multiple circumferential cracks within 1.0m of catch basin

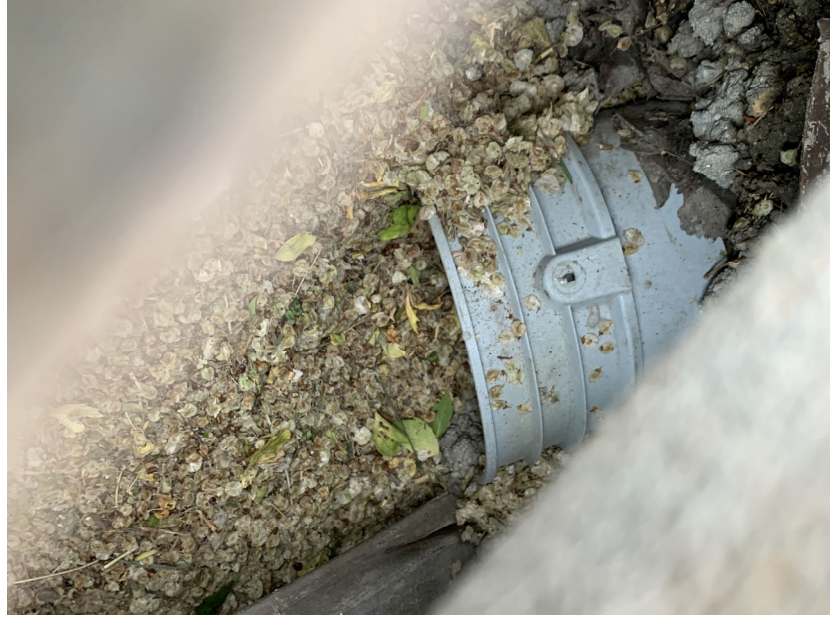
- Wood debris inside – Clean out catch pit recommended
- Plastic pail with bottom removed in place of PVC pipe – (Photo 17) recommend pail be replaced with PVC SDR35 and grout as required

Photo #17 – (no asset number) catch pit connected to S-CB20011362 plastic pail instead of PVC pipe

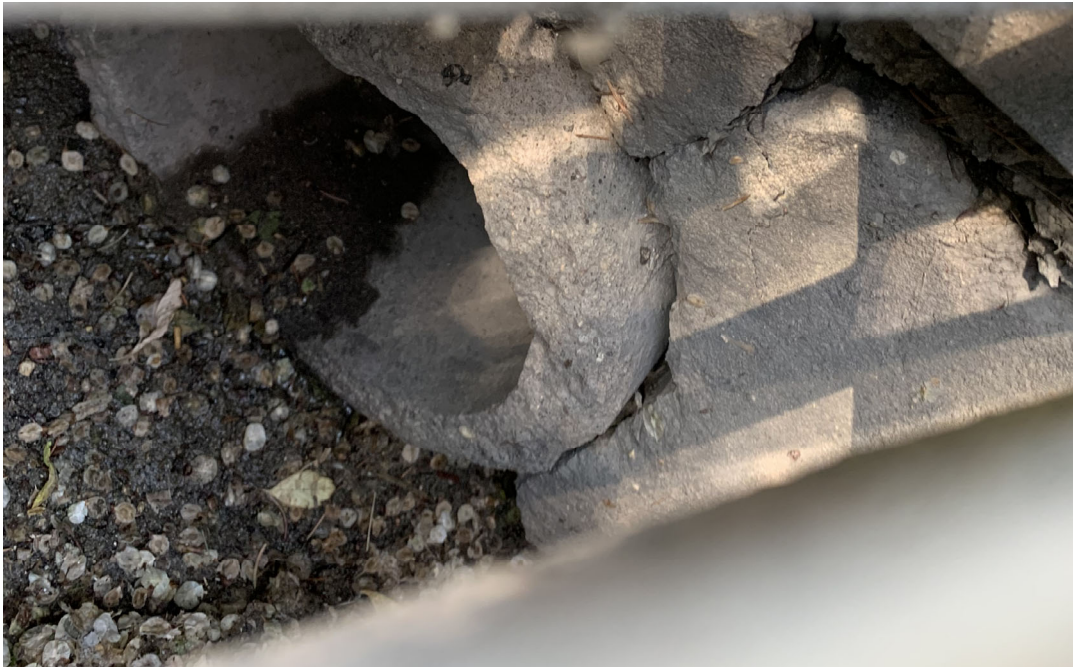
- Cracks around outlet pipe – (Photo 18) Clean out catch pit and grout cracks recommended

Photo #18 – (no asset number) catch pit connected to S-CB20011316 cracks around outlet

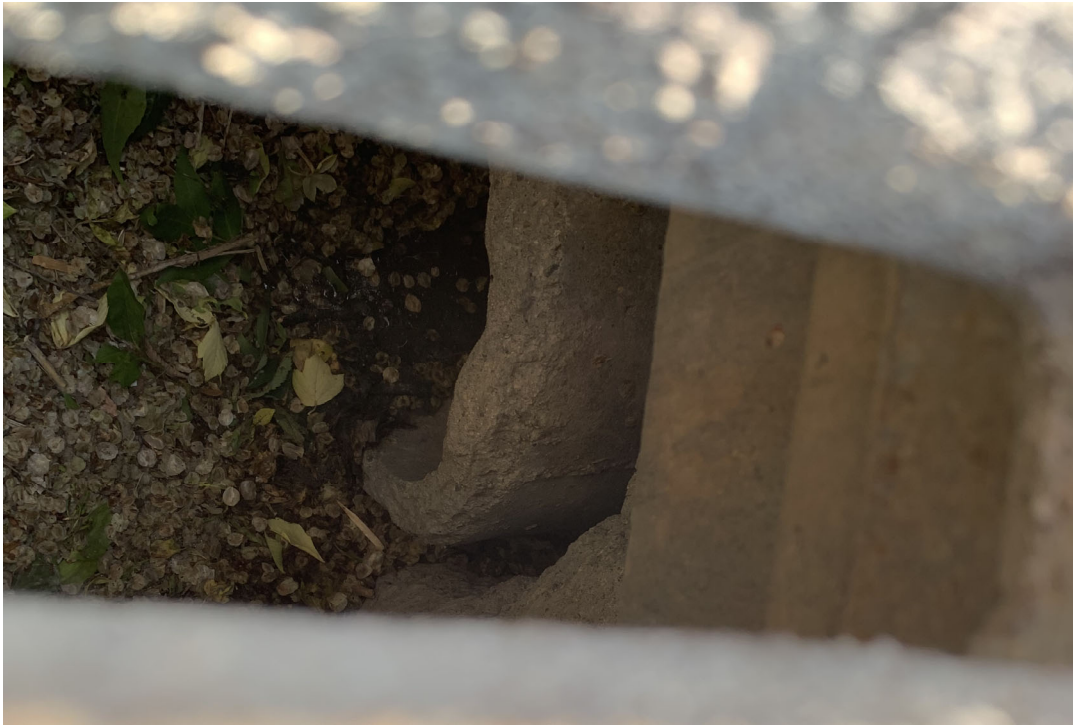
- Void around outlet pipe (Photo 19) – Clean out catch pit and grout voids recommended

Photo #19 – (no asset number) catch pit connected to S-CB20011317 void around outlet pipe
