# **GEOTECHNICAL REPORT**

**Re: 2023 City of Winnipeg Local Street Renewal Program  
Report of Geotechnical Investigation and Test Results**

This letter summarizes KGS Group’s geotechnical results for the 2023 City of Winnipeg (COW) Street Renewal Program in Winnipeg, Manitoba. KGS Group’s scope of services for this project was outlined in our proposal no. 22-000-1495 titled “2023 COW Local Street Renewal Program – Geotechnical Services” dated September 21, 2022.

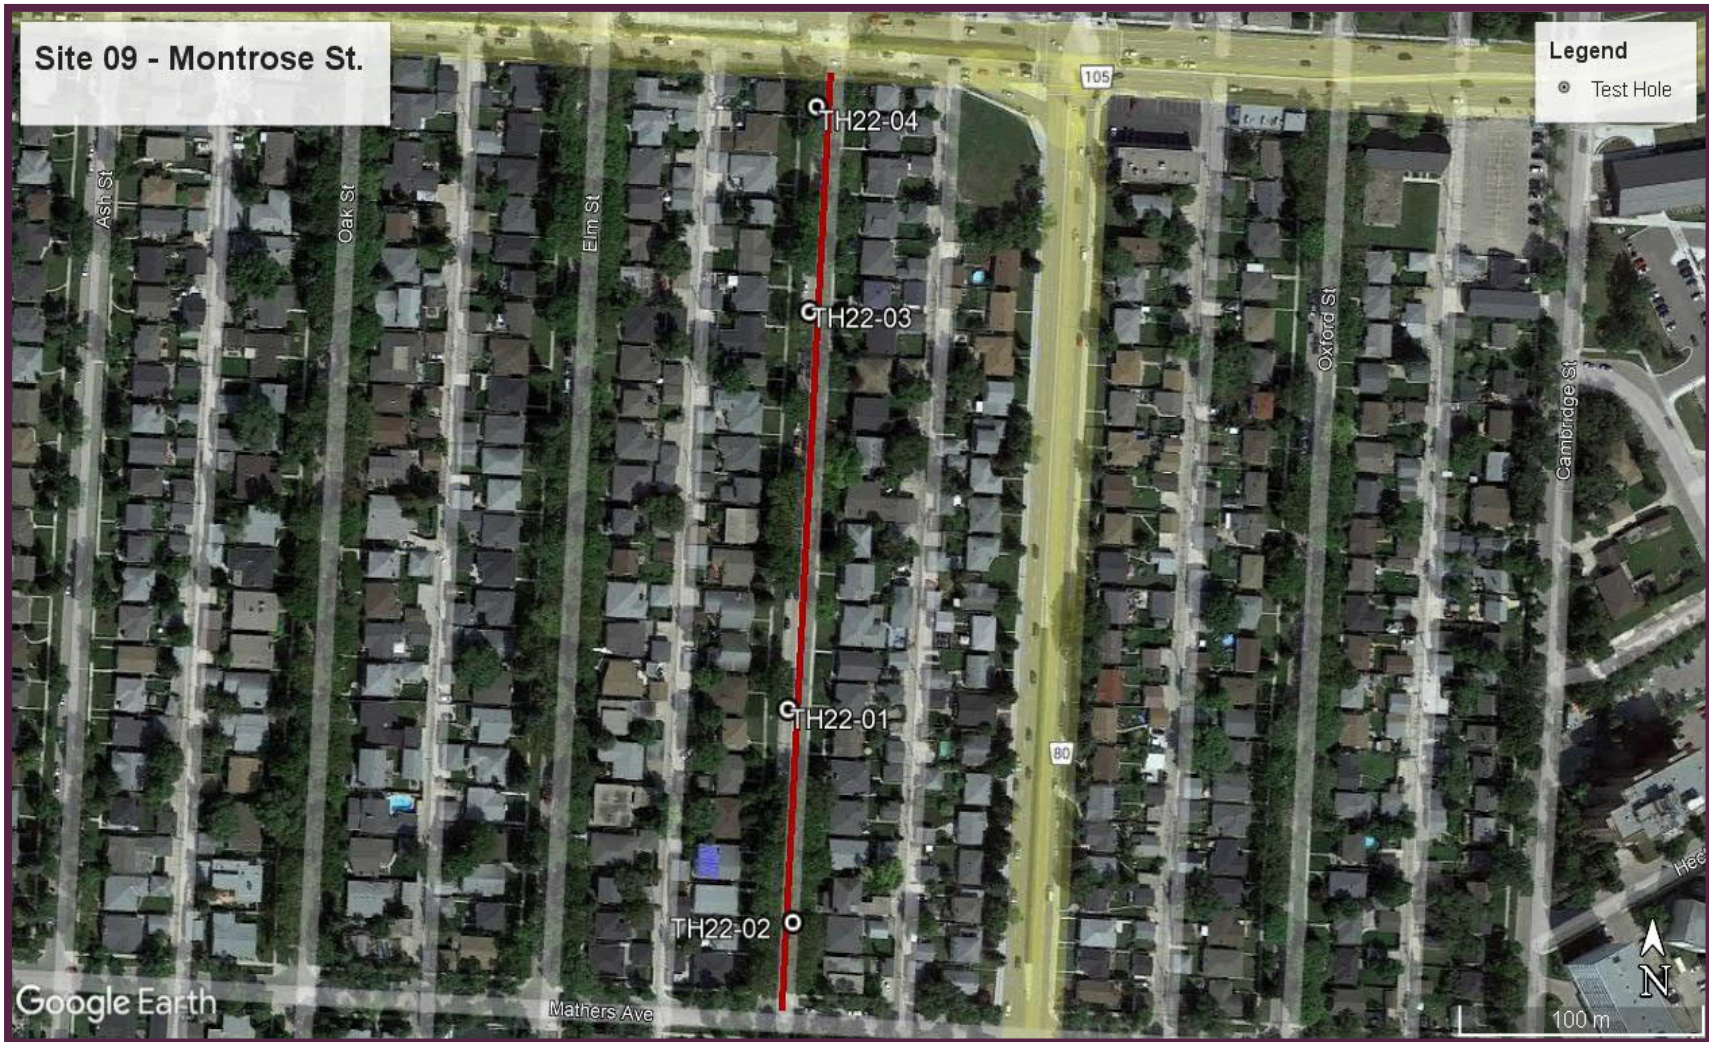
**FIGURE 1: Test Hole Locations for Site 9 - Montrose Street**

Four (4) cores were completed along Montrose Street; two (2) at joint locations (TH22-02 and TH22-04), and two (2) mid-slab (TH22-01 and TH22-03). The pavement surfacing consisted of concrete with a thickness of 159 to 203 mm (6.25 to 8 in.). Base material was only encountered in TH22-02 and consisted of 51 mm (2 in.) thick crushed limestone. Clay subgrade was encountered directly below pavement in the remaining test holes. Core hole locations are shown in Figure 1 attached.

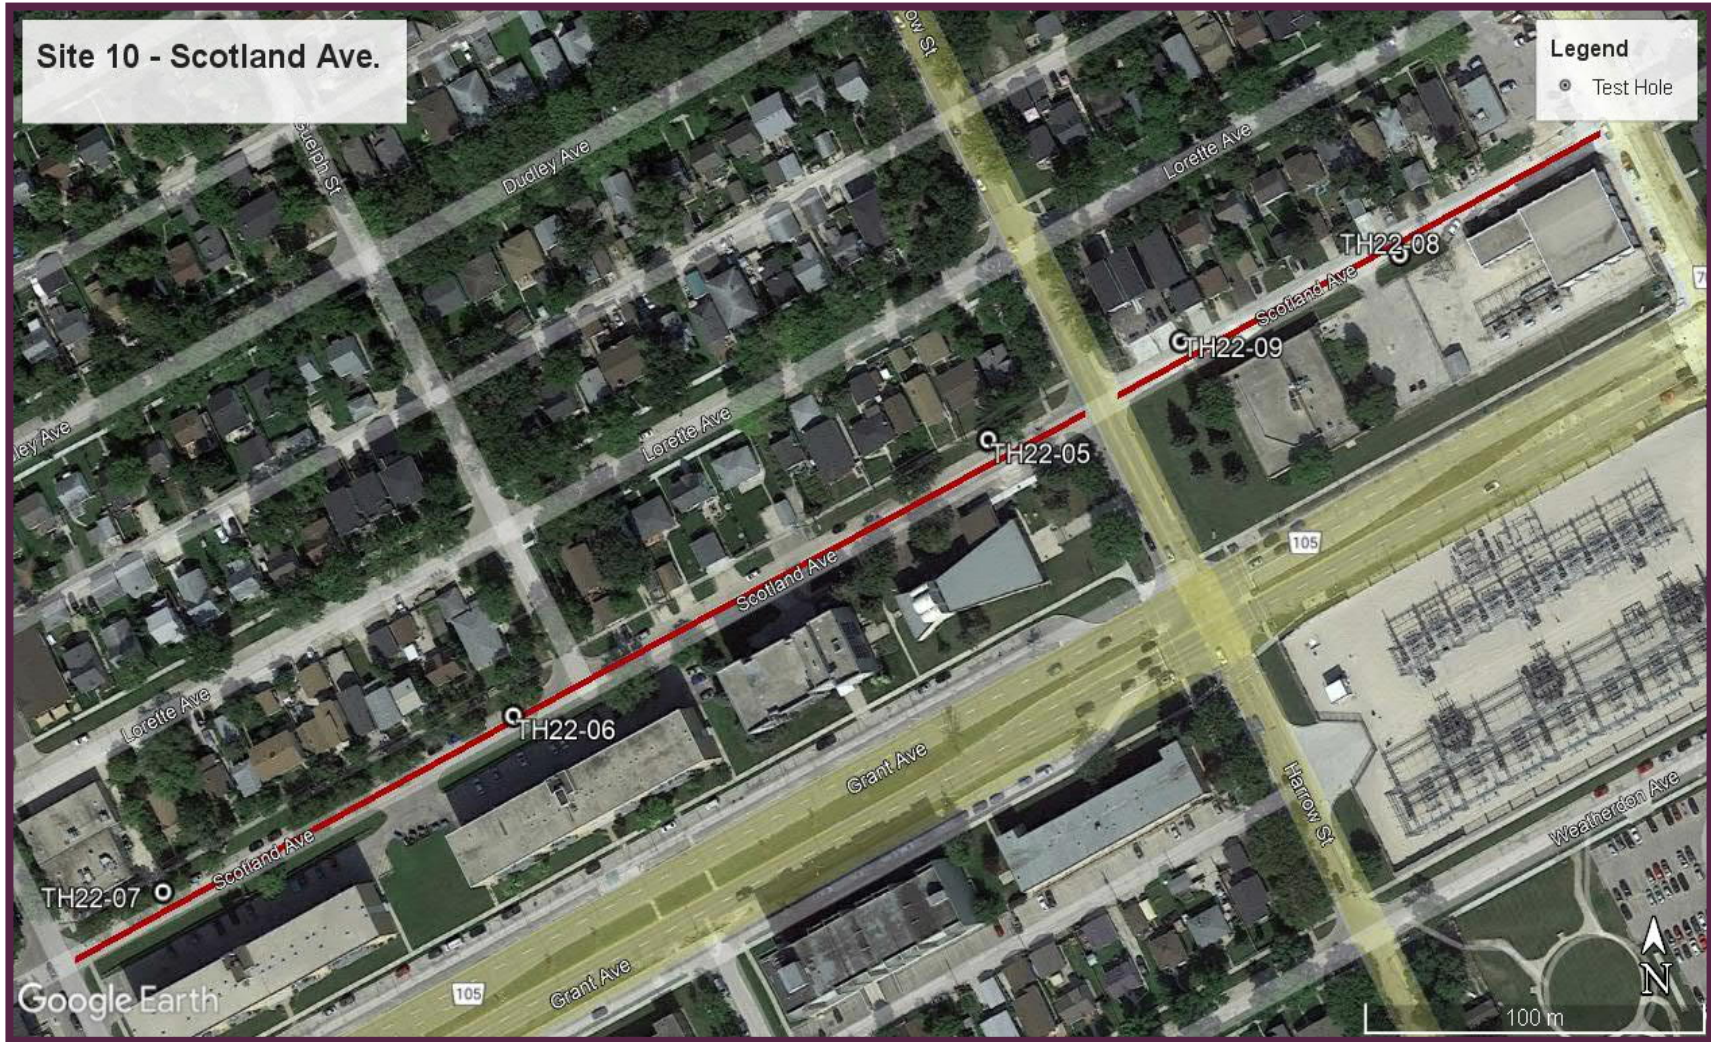
FIGURE 2: Test Hole Locations for Site 10 - Scotland Avenue

Five (5) cores were completed along Scotland Avenue; three (3) at joint locations (TH22-06, TH22-07 and TH22-09), and two (2) mid-slab (TH22-05 and TH22-08). Pavement surfacing consisted of concrete with a thickness of 171 to 222 mm (6.75 to 8.75 in.). Base material consisted of crushed limestone 25 mm (1 in.) thick in TH22-09, and granular 38 to 51 mm (1.5 to 2 in.) thick in TH22-07 and TH22-05. Clay subgrade was encountered directly below pavement in TH22-06 and TH22-08. Core hole locations are shown in Figure 2 attached.

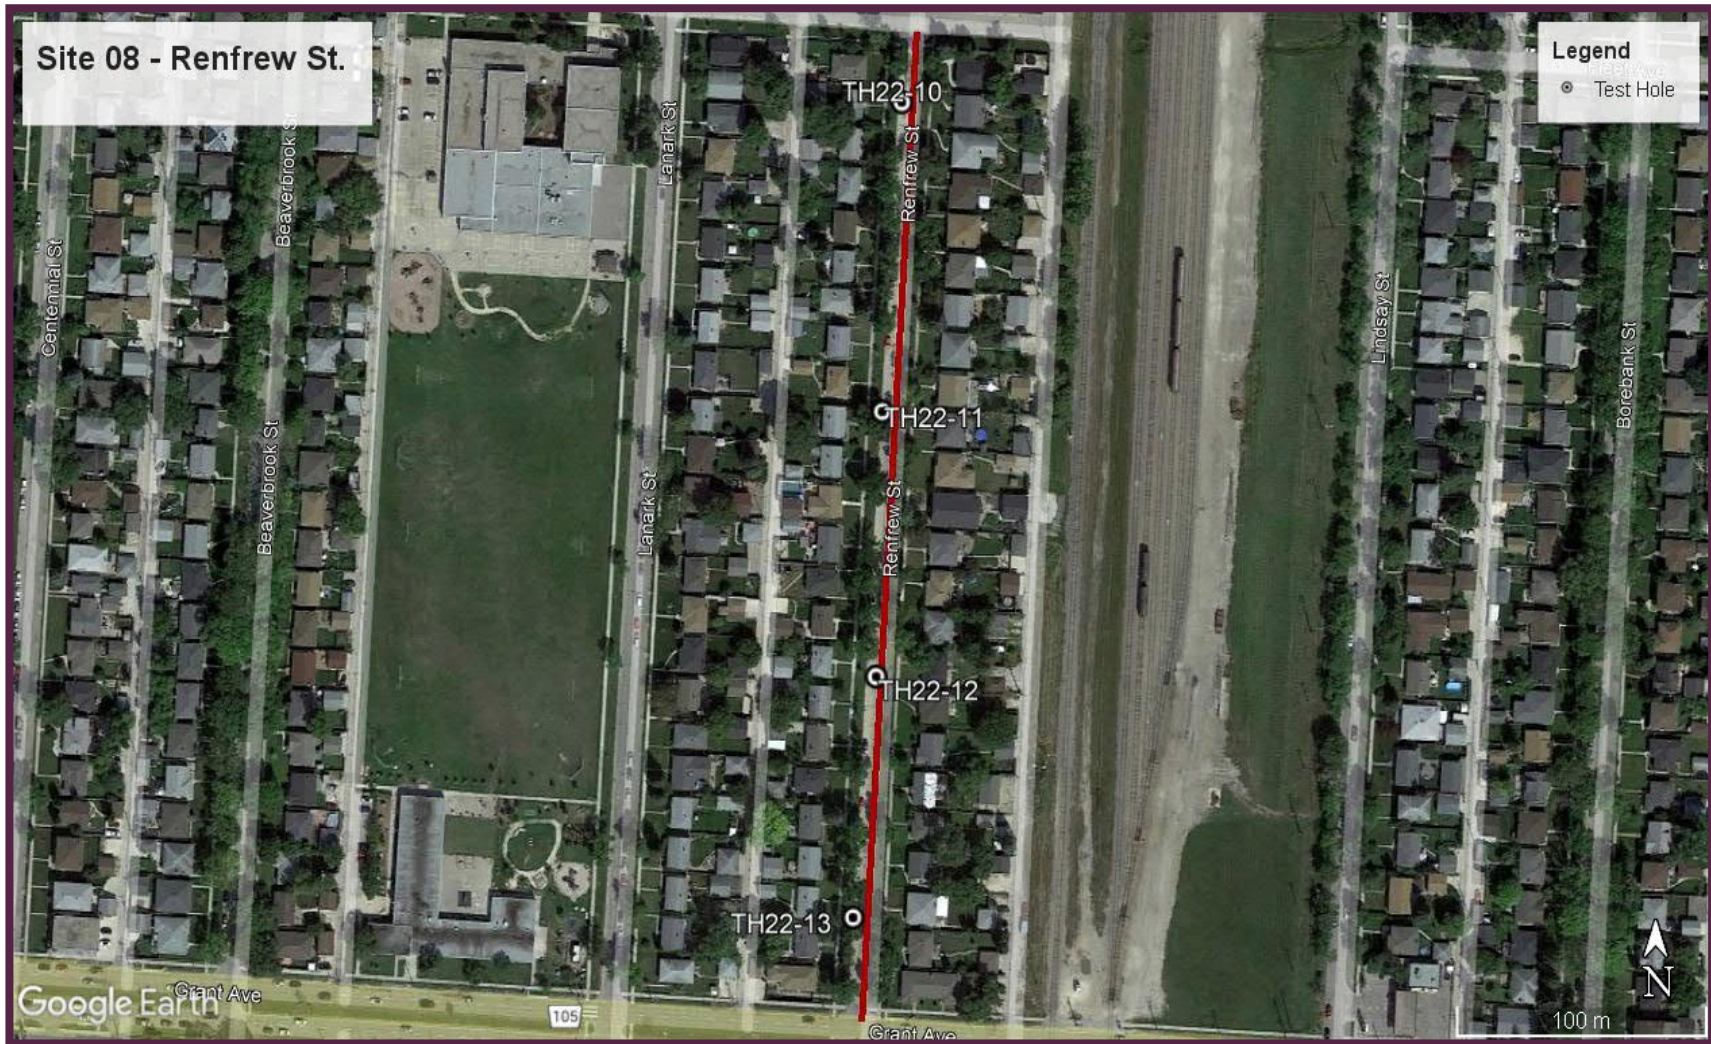
FIGURE 3: Test Hole Locations for Site 8 - Renfrew Street

Four (4) cores were completed along Renfrew Street; two (2) at joint locations (TH22-11 and TH22-13), and two (2) mid-slab (TH22-10 and TH22-12). The pavement surfacing consisted of concrete ranging in thickness from 152 to 178 mm (6 to 7 in.). Base material consisted of crushed limestone 51 to 76 mm (2 to 3 in.) thick in TH22-10 and TH22-11, and granular 38 mm (1.5 in.) thick in TH22-13. Clay subgrade was encountered directly below pavement in TH22-12. Core hole locations are shown in Figure 3 attached.

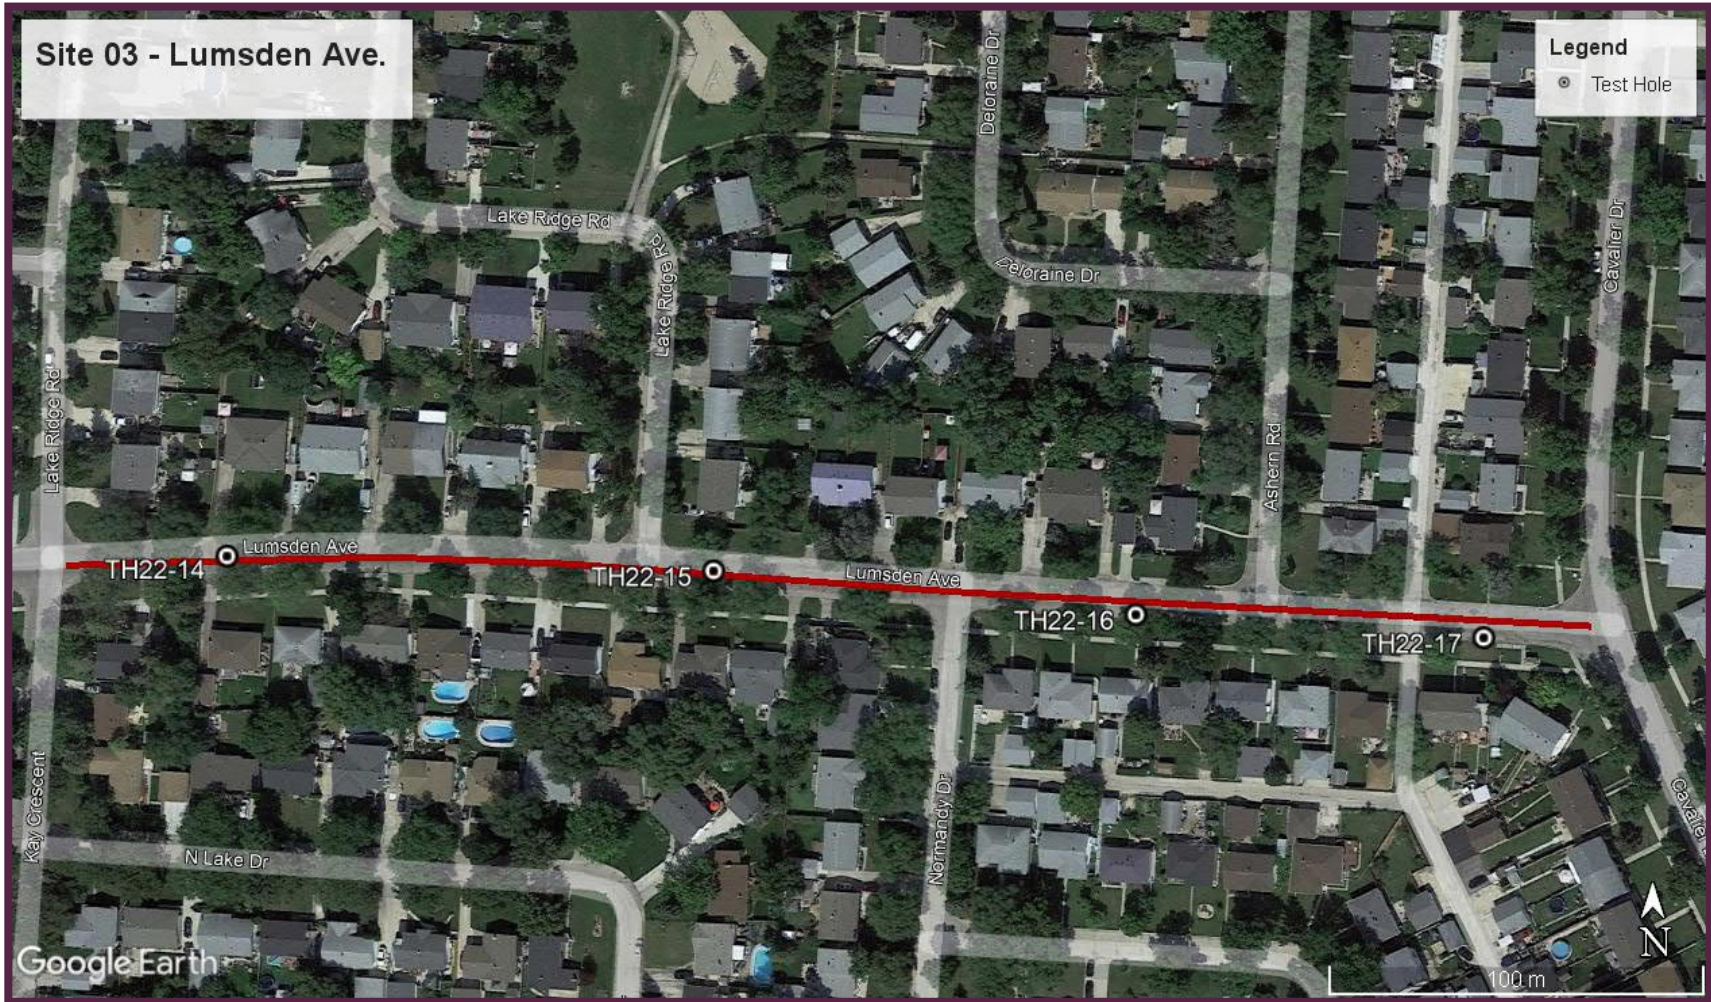
FIGURE 4: Test Hole Locations for Site 3 - Lumsden Avenue

Four (4) cores were completed along Lumsden Avenue; two (2) at joint locations (TH22-15 and TH22-17), and two (2) mid-slab (TH22-14 and TH22-16). The pavement surfacing consisted of asphalt over concrete material. The asphalt and concrete were 38 to 48 mm (1.5 to 1.9 in.) and 184 to 222 mm (7.25 to 8.75 in.) in thickness respectively. Granular base material ranged in thickness from 38 to 137 mm (1.5 to 5.4 in.). Core locations are shown on Figure 4 attached.

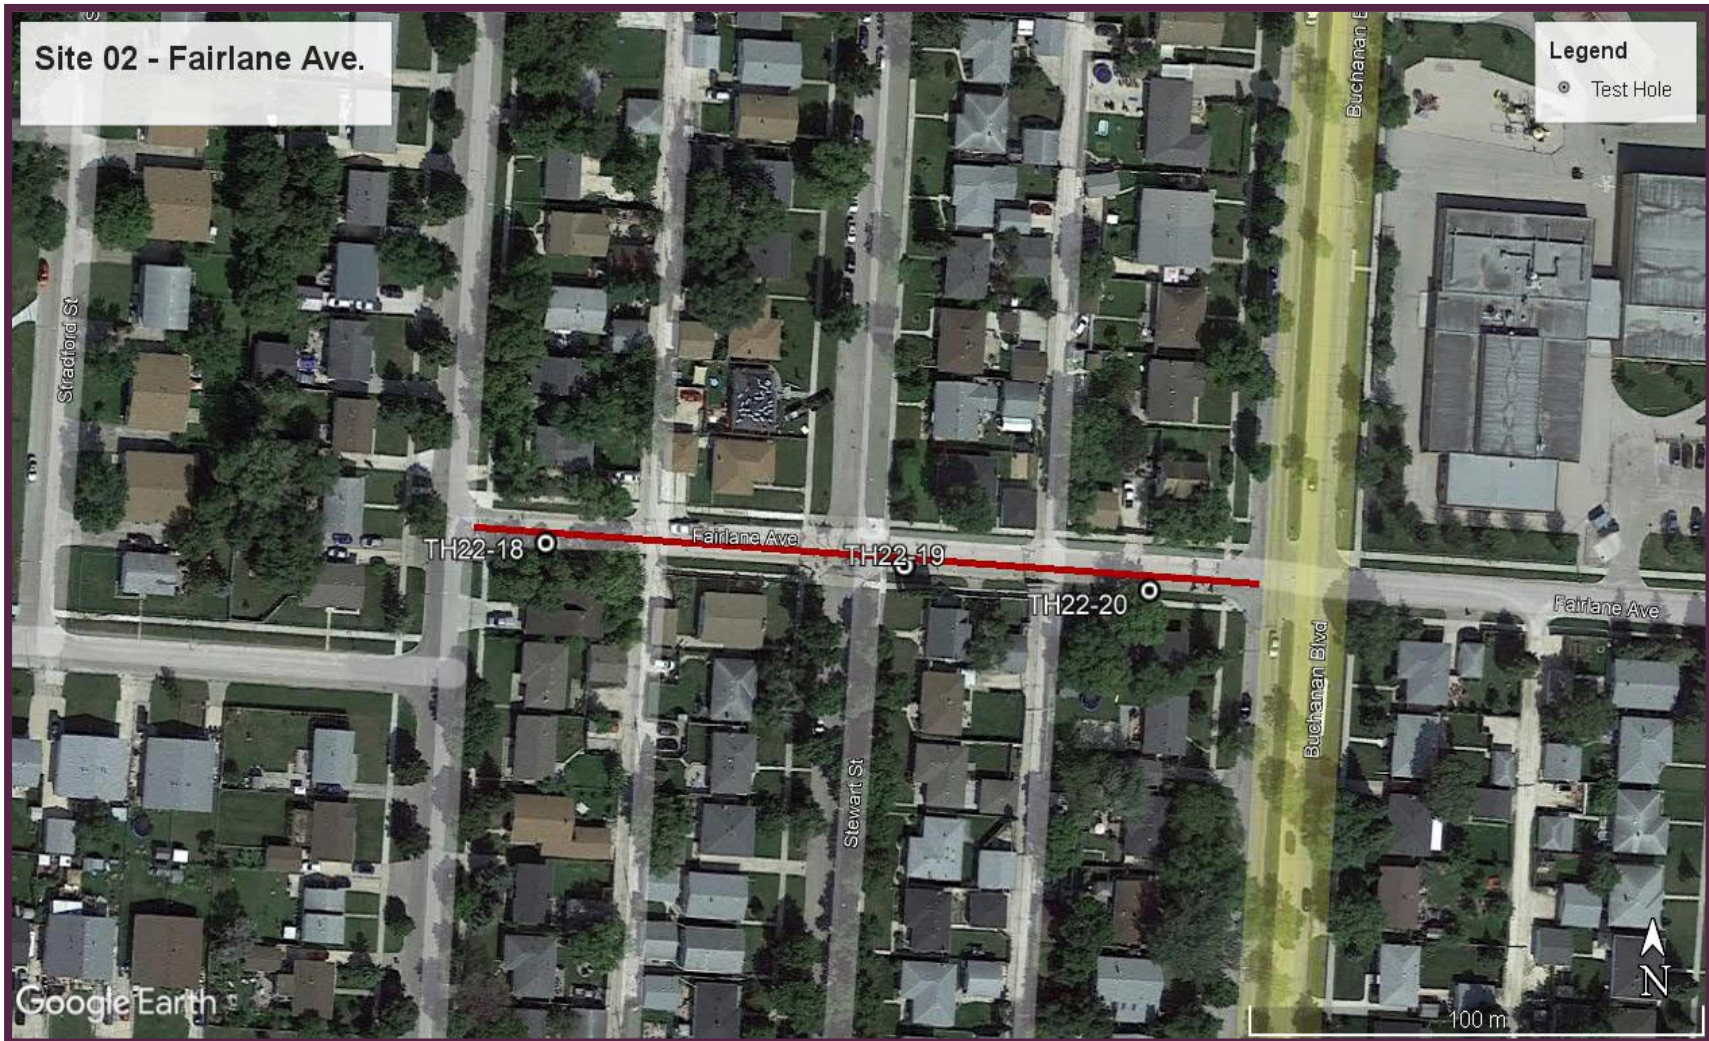
FIGURE 5: Test Hole Locations for Site 2 - Fairlane Avenue

Three (3) cores were completed along Fairlane Avenue; two (2) at joint locations (TH22-18 and TH22-20), and one (1) mid-slab (TH22-19). The pavement surfacing consisted of concrete material ranging in thickness from 152 to 159 mm (6 to 6.75 in). Base material consisted of limestone crush over granular and varied in thickness from 159 to 216 mm (6.25 to 8.5 in). Core locations are shown on Figure 5 attached.

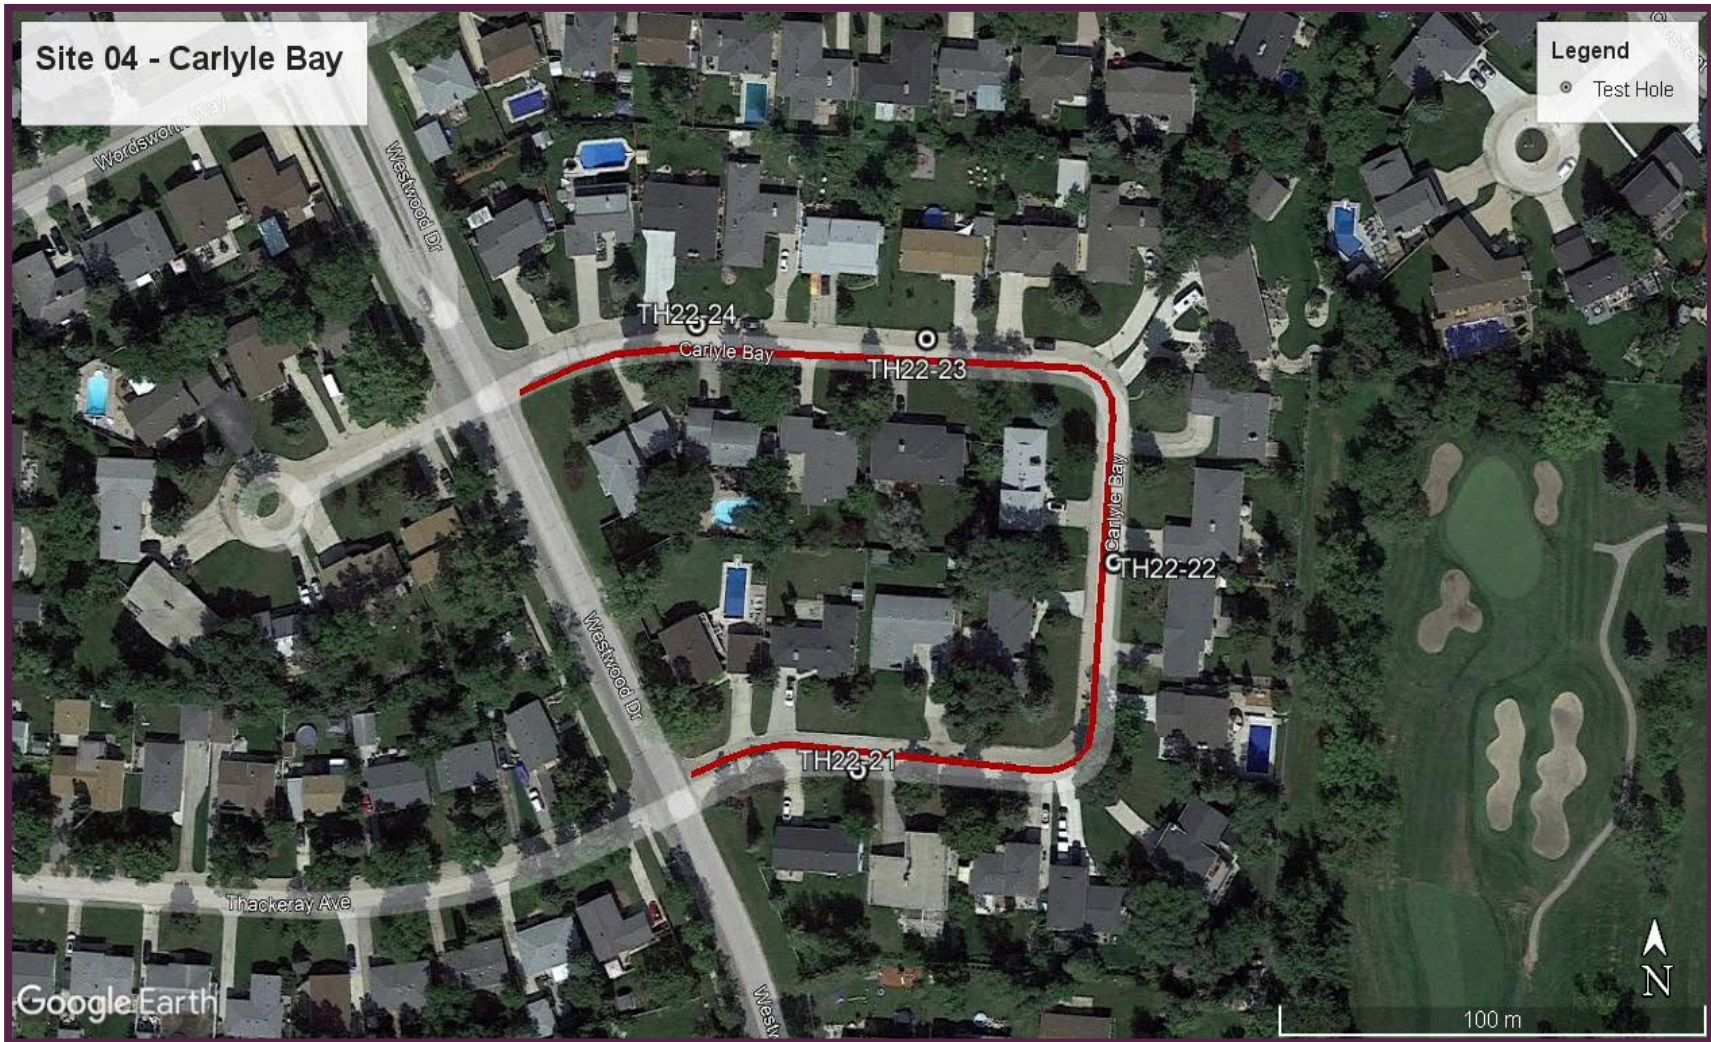
FIGURE 6: Test Hole Locations for Site 4 - Carlyle Bay

Four (4) cores were completed along Carlyle Bay; two (2) at joint locations (TH22-21 and TH22-23), and two (2) mid-slab (TH22-22 and TH22-24). The pavement surfacing consisted of concrete material with a thickness between 156 to 203 mm (6.13 to 8 in). Base material consisted of crushed limestone and ranged in thickness from 73 to 197 mm (2.9 to 7.75 in). Core locations are shown in Figure 6 attached.

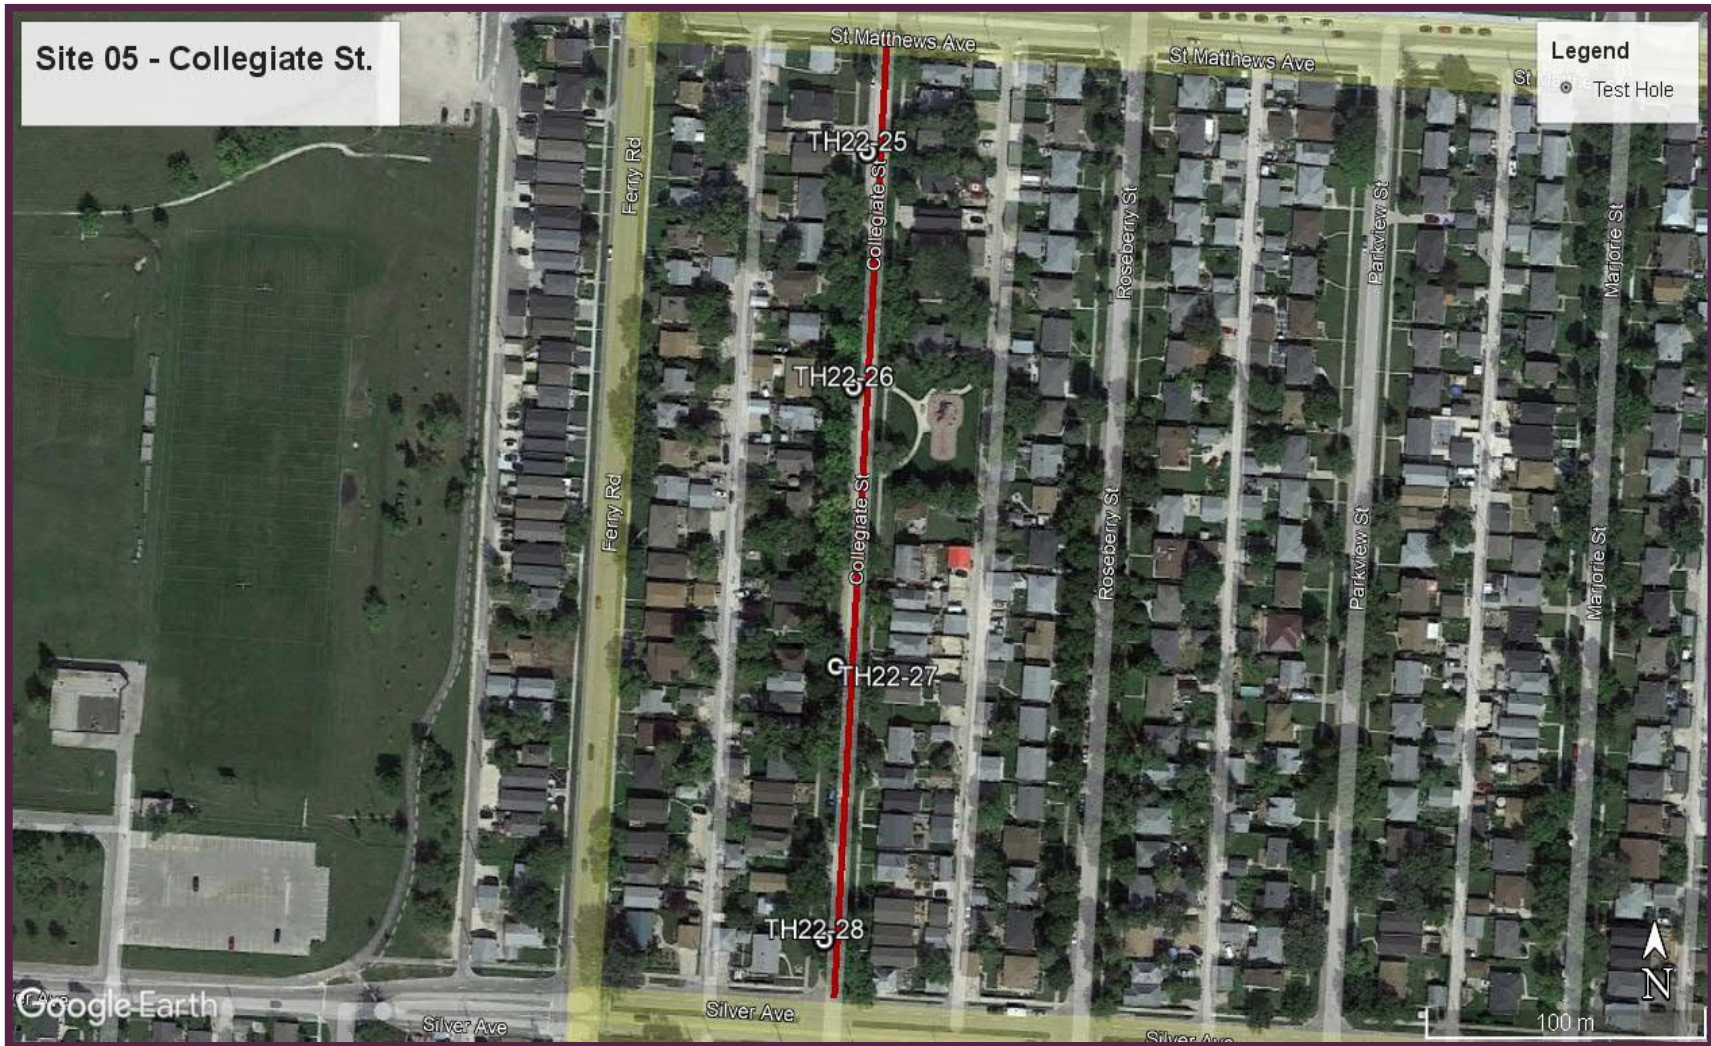
FIGURE 7: Test Hole Locations for Site 5 - Collegiate Street

Four (4) cores were completed along Collegiate Street; two (2) at joint locations (TH22-26 and TH22-28), and two (2) mid-slab (TH22-25 and TH22-27). The pavement surfacing consisted of concrete 143 to 159 mm (5.6 to 6.25 in) in thickness. Granular base material was encountered below pavement in TH22-25 and was 25 mm (1 in) thick. Clay subgrade was observed directly under pavement in TH22-26, TH22-27, and TH22-28. Core locations are shown in Figure 7 attached.

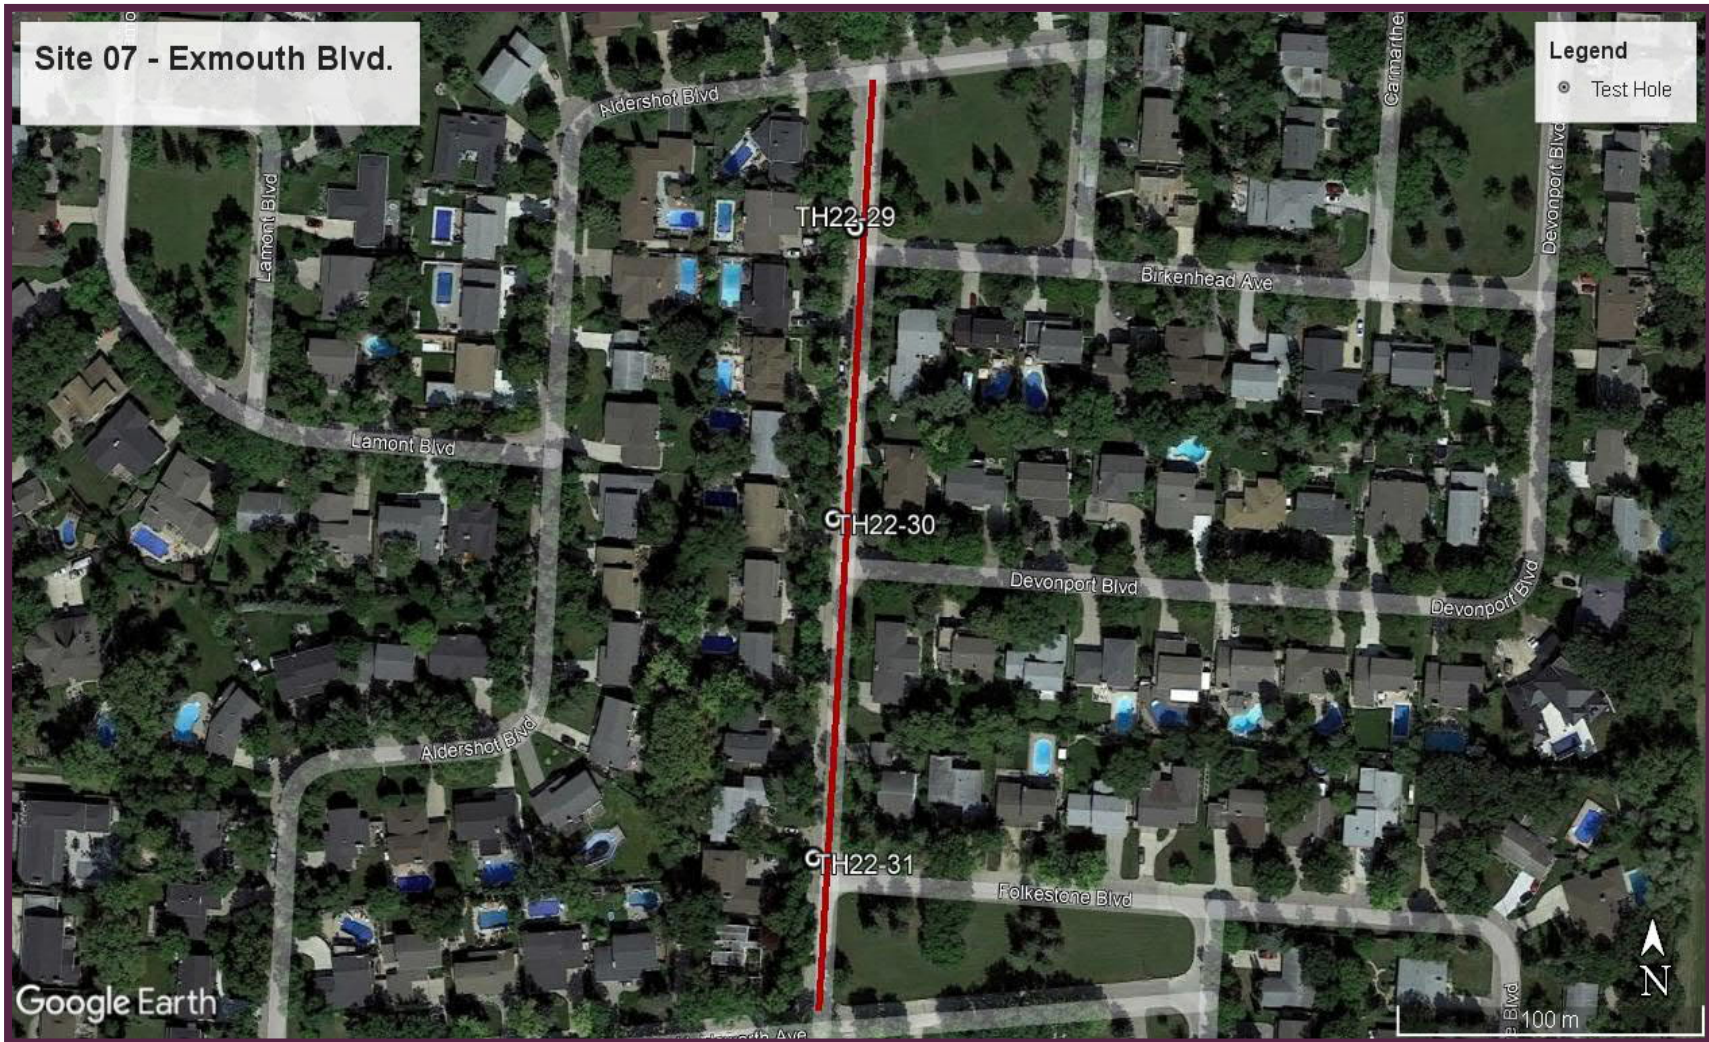
FIGURE 8: Test Hole Locations for Site 7 - Exmouth Boulevard

Three (3) cores were completed along Exmouth Boulevard; two (2) at mid-slab locations (TH22-29 and TH22-31), and one (1) on-joint (TH22-30). The pavement surfacing consisted of 152 to 159 mm (6 to 6.25 in) of concrete underlain by 29 to 324 mm (1.13 to 12.75 in.) of granular base. Coring hole locations are shown in Figure 8 attached.

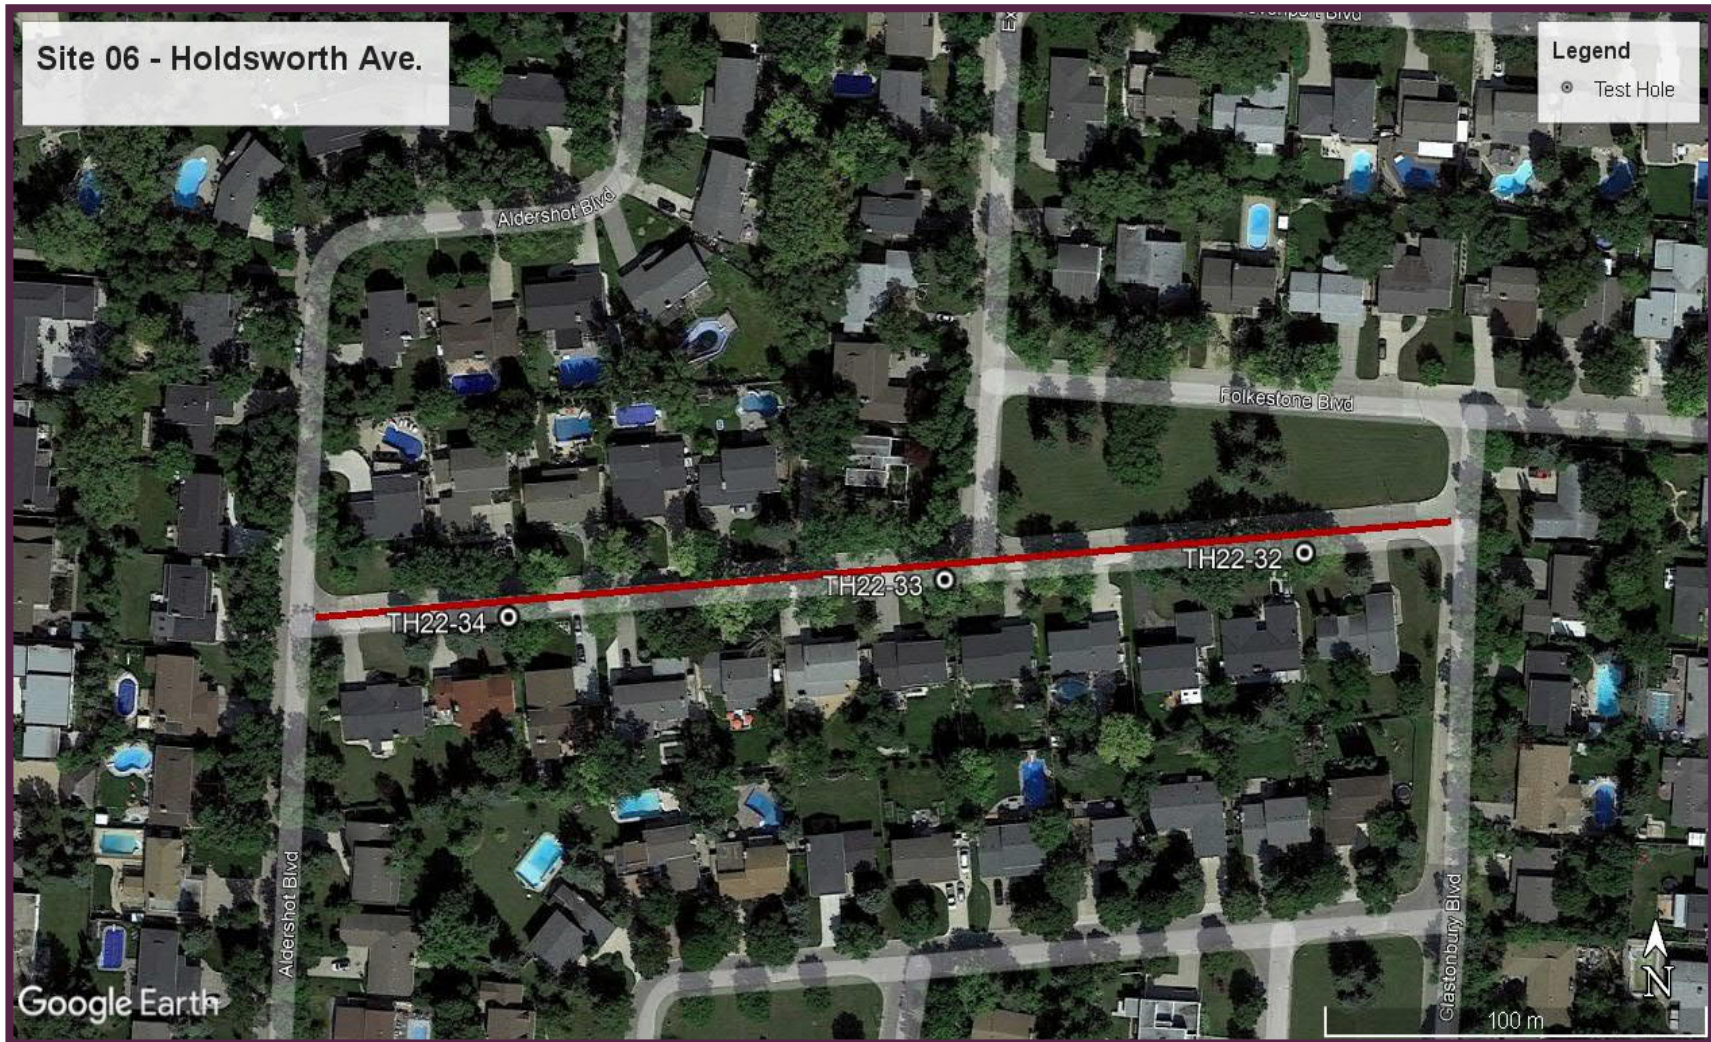
FIGURE 9: Test Hole Locations for Site 6 - Holdsworth Avenue

Three (3) cores were completed along Holdsworth Avenue; two (2) at mid-slab locations (TH22-32 and TH22-34), and one (1) on-joint (TH22-33). Pavement surfacing consisted of 127 to 140 mm (5 to 5.5 in) thick concrete at TH22-33 and TH22-34, and asphalt 44 mm (1.75 in.) thick over 146 mm (5.75 in.) of concrete at TH22-32. Underlying base material consisted of crushed limestone with sand which ranged in thickness from 76 to 127 mm (3 to 5 in) in TH22-32 and TH22-34. Thickness of base material in TH22-33 could not be determined due to hand excavation refusal at 495 mm (19.5 in) on a suspected cobble. Core locations are shown in Figure 9 attached.

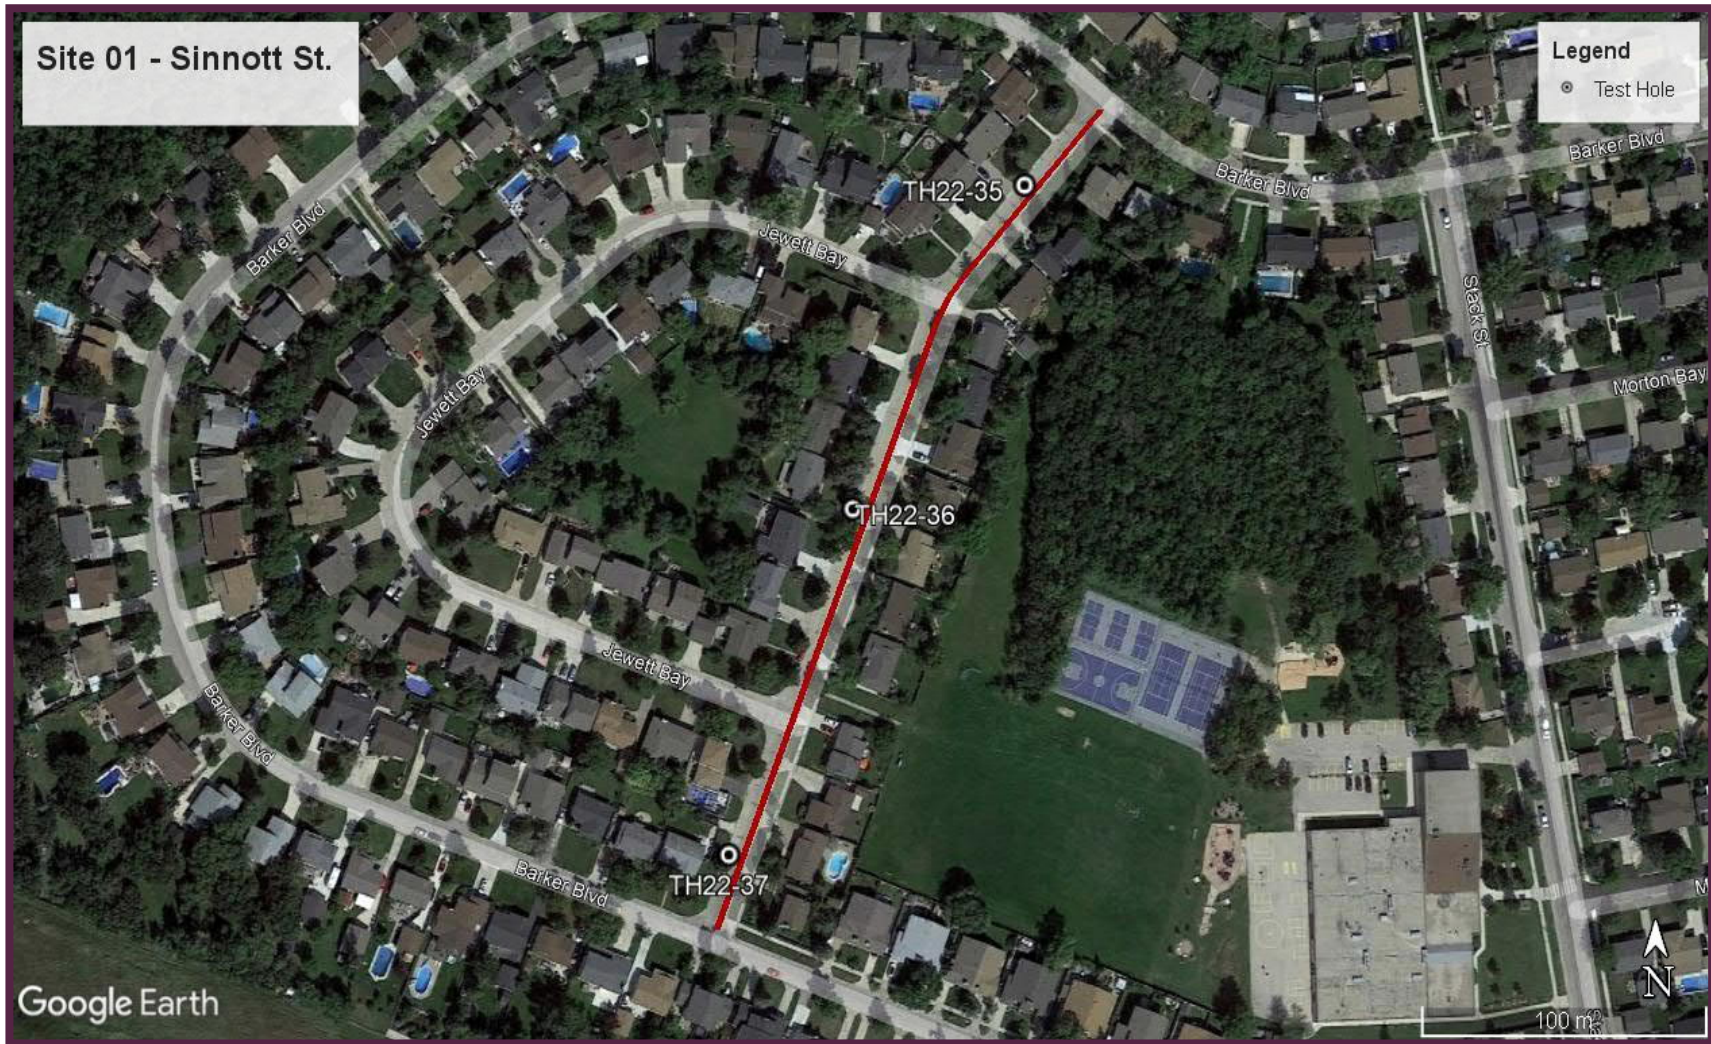
FIGURE 10: Test Hole Locations for Site 1 - Sinnott Street

Three (3) cores were completed along Sinnott Street; two (2) at joint locations (TH22-35 and TH22-37), and one (1) mid-slab (TH22-36). The pavement surfacing consisted concrete with a thickness from 178 to 191 mm (7 to 7.5 in). Granular base material 76 mm (3 in) in thickness was encountered directly below pavement in TH22-35 and TH22-36. Clay subgrade was encountered immediately below pavement in TH22-37. Core locations are shown on the attached Figure 10.

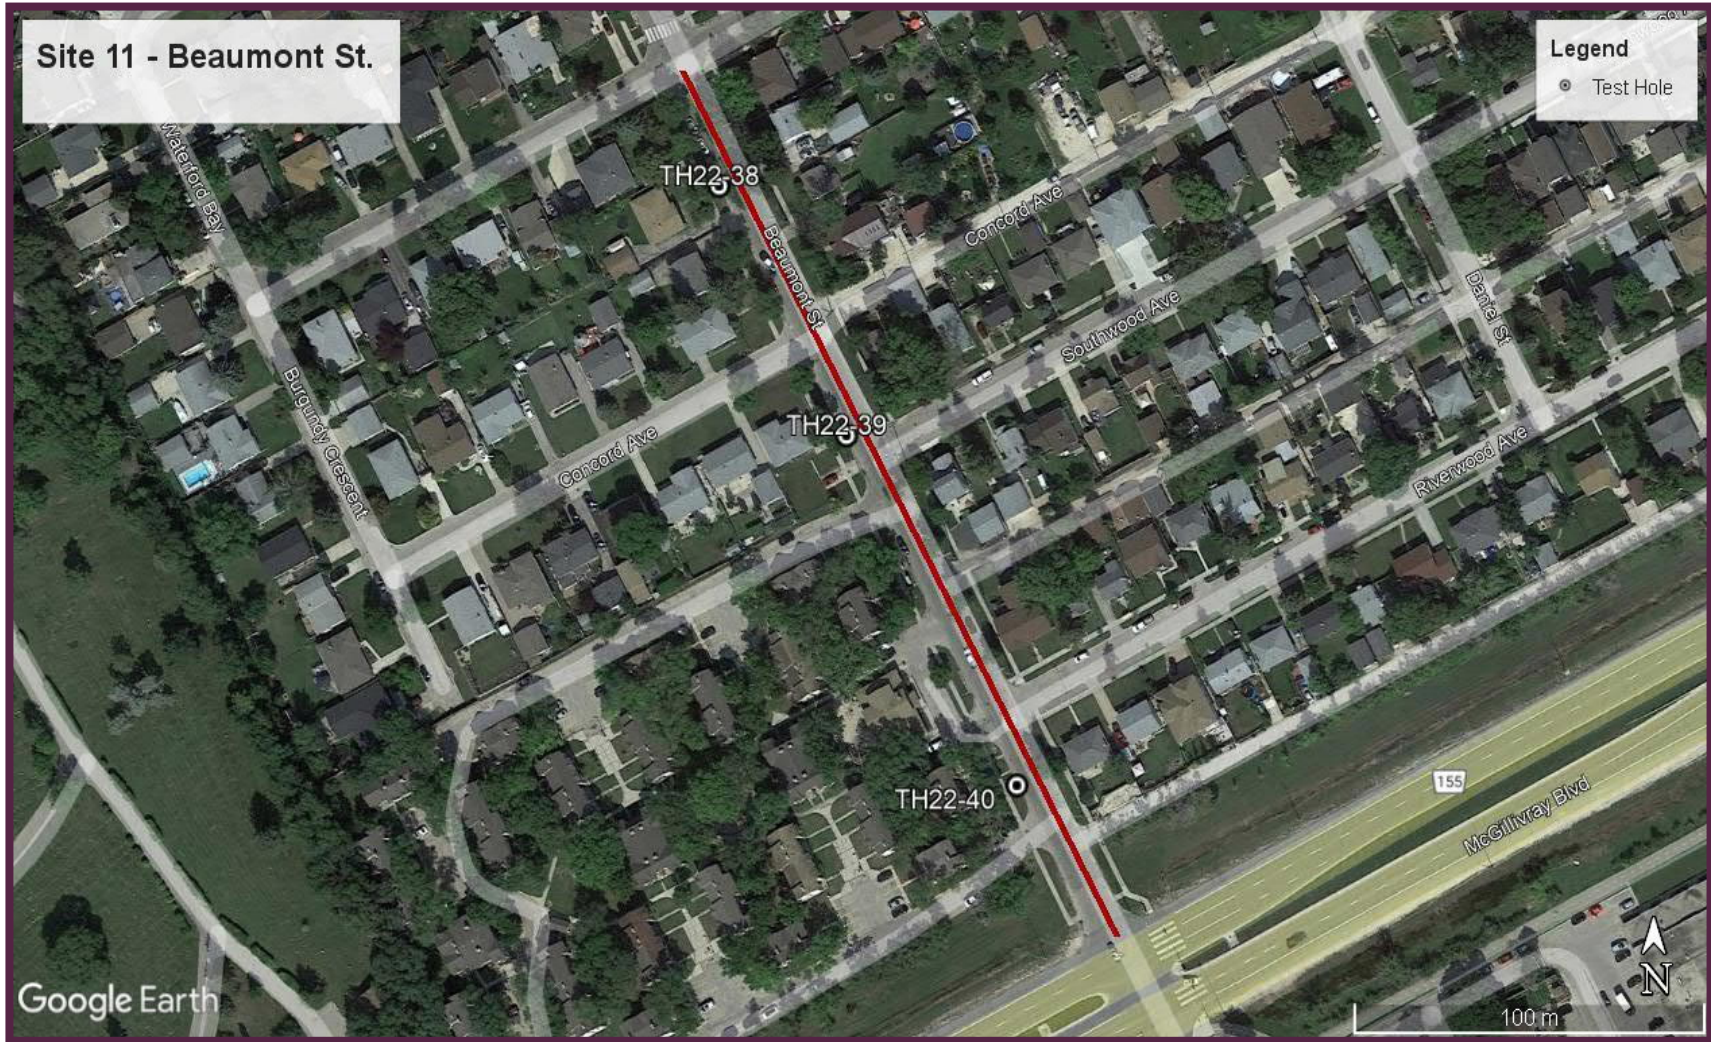
FIGURE 11: Test Hole Locations for Site 11 - Beaumont Street

Three (3) cores were completed along Beaumont Street at mid-slab locations (TH22-38 to TH22-40). The pavement surfacing consisted of asphalt material 114 to 241 mm (4.5 to 9.5 in) thick, with two (2) distinct pavement layers encountered at TH22-38. Base material ranged in thickness from 254 to 343 mm (10 to 13.5 in.) and consisted of granular over sand in TH22-38 and TH22-39, and granular in TH22-40. Core locations are shown in Figure 11 attached.

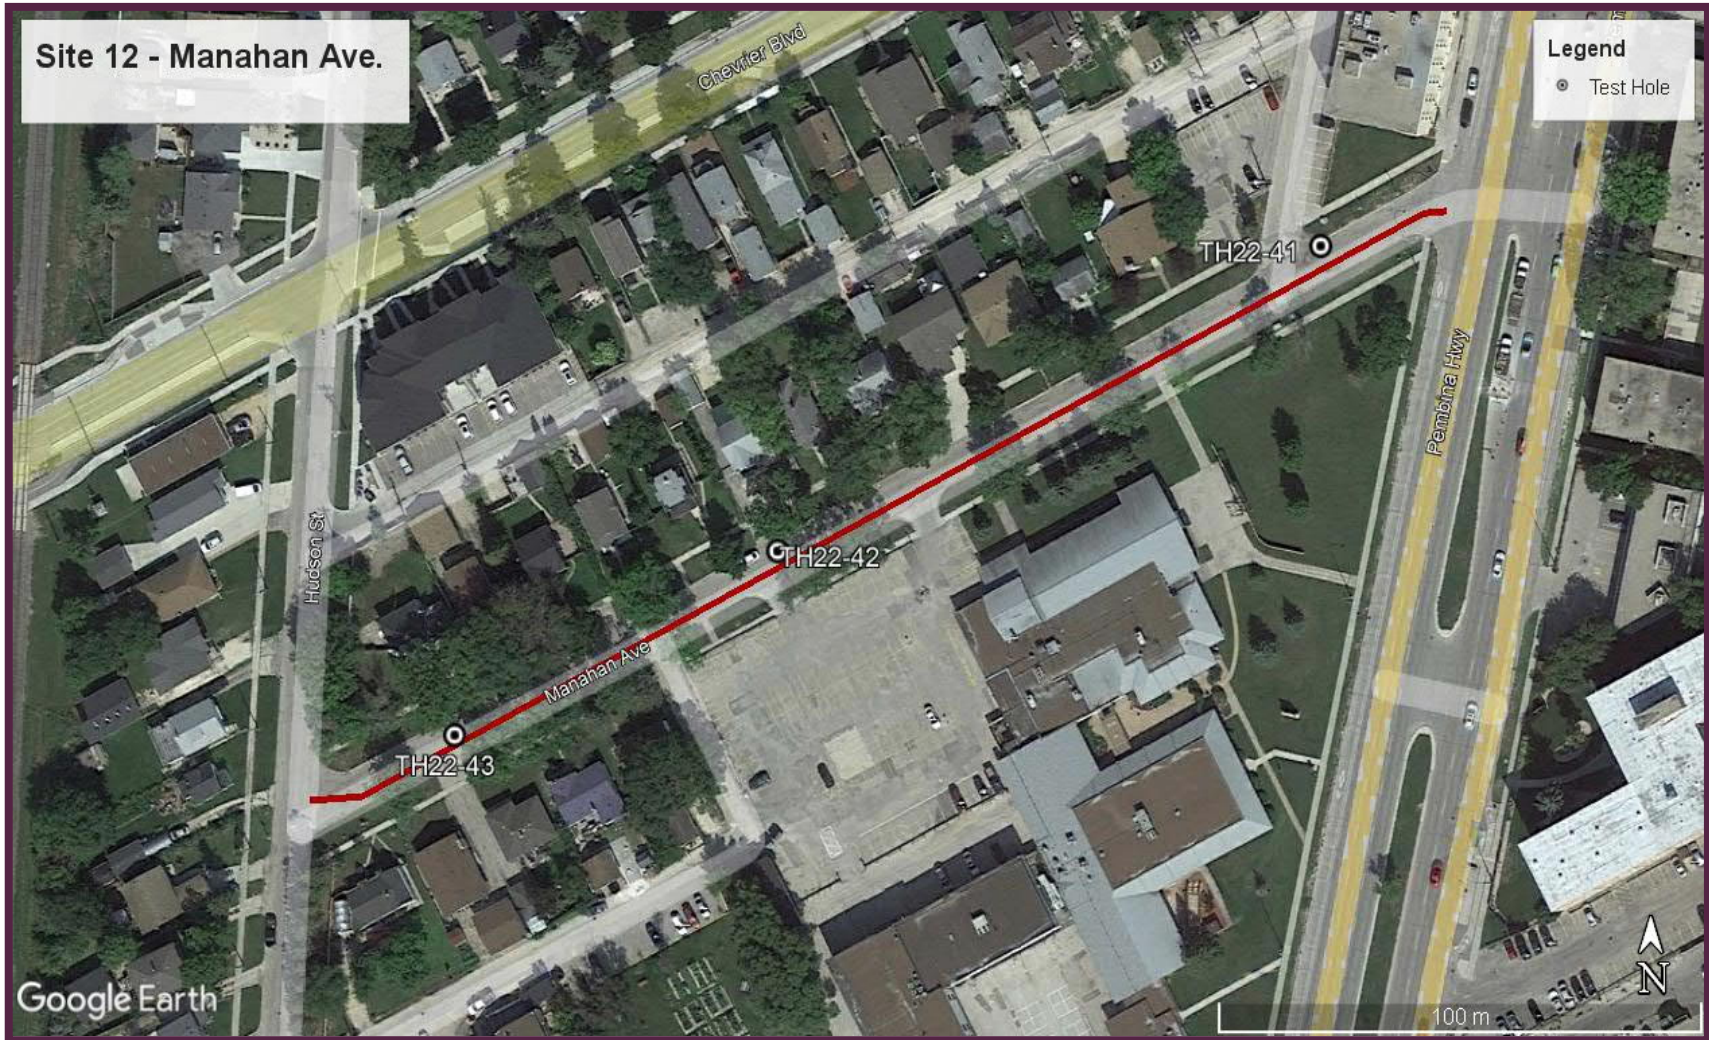
FIGURE 12: Test Hole Locations for Site 12 - Manahan Avenue

Three (3) test holes were advance along Manahan Avenue to a depth of 2.3 m (7.5 ft) below pavement surface using a 50 mm hand auger. Two (2) test holes were completed at joint locations (TH22-41 and TH22-42), and one

(1) was completed mid-slab (TH22-43). The general stratigraphy encountered in the test holes was interpreted by KGS Group to consist of asphalt over granular base material, a sandy clay layer, and an underlying high plasticity clay containing an embedded silt layer. Further description of each layer is provided below and the test hole logs are provided in Appendix B. Test hole locations are shown in attached Figure 12.
