GEOTECHNICAL REPORT

September 30, 2022

File No.: 22-035-02

RE: City of Winnipeg RFP No. 796-2022, River Avenue, Stradbrook Avenue and Wellington Crescent Rehabilitation

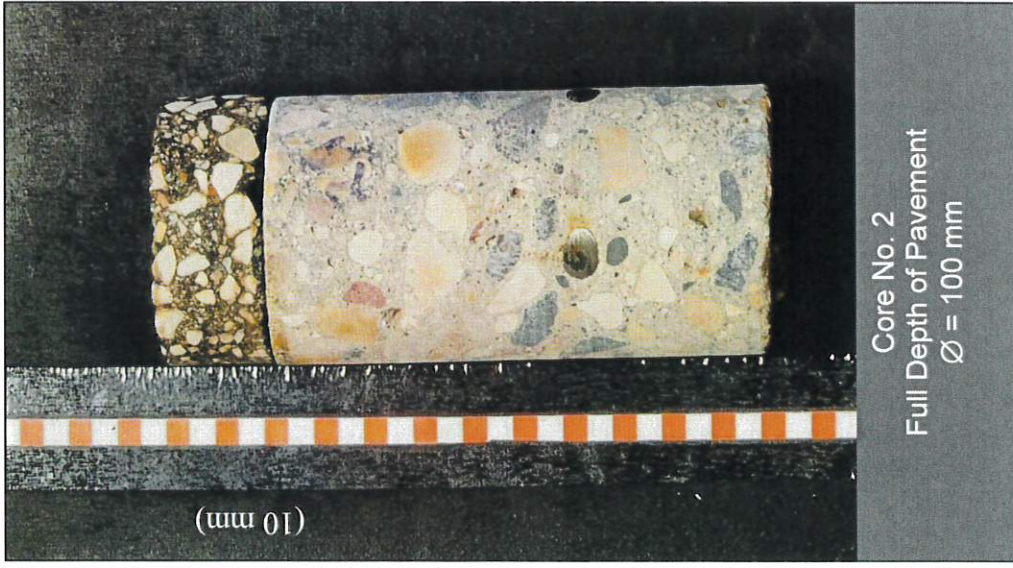
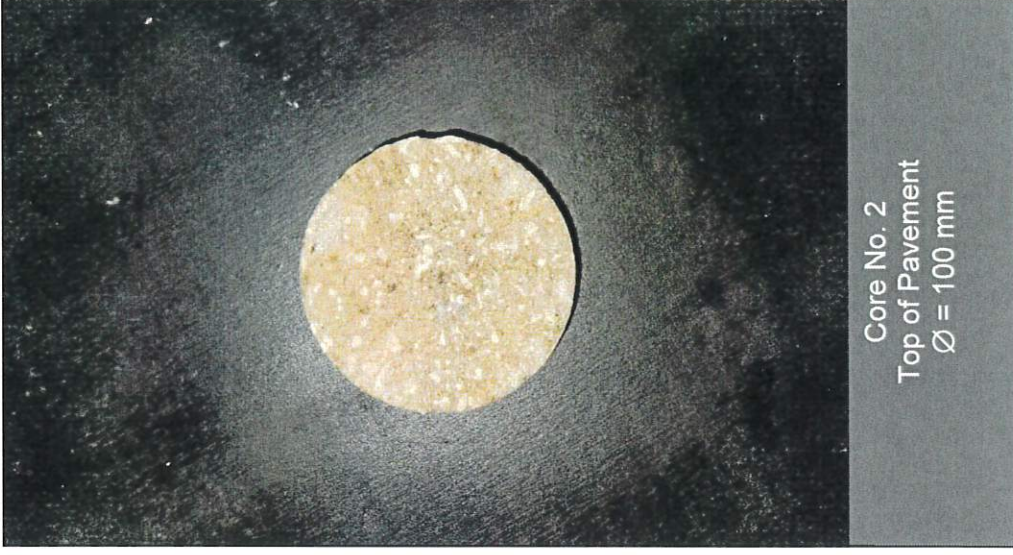
Photograph 2: Specimen from River Avenue, North Curb Lane

Comments: Core No.'s 6 to 12 were recovered on September 21, 2022, Core No.'s 1 to 5 were recovered on September 22, 2022. Core No. 2 contained a 10M reinforcing steel bar, encountered 112.0 meters below surface of pavement. The steel was removed prior to testing.

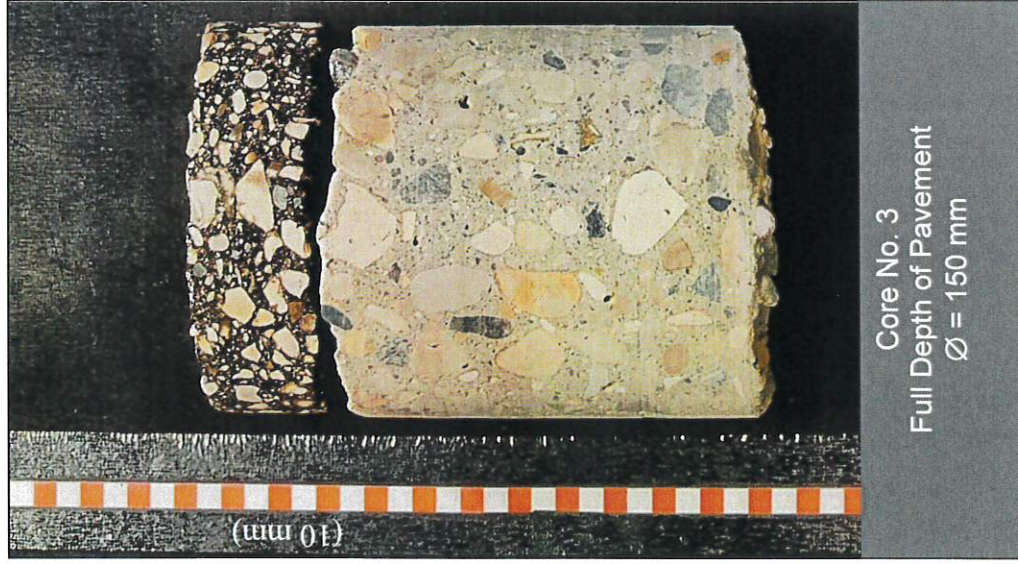
Core No. 3
Full Depth of Pavement
Ø = 150 mm

Photograph 3: Specimen from River Avenue, South Curb Lane
