Water and Waste Department • Service des eaux et des déchets

September 7, 2005

Inspection: Avenue Lemay Land Drainage Sewer, Rue Landry to the Red River

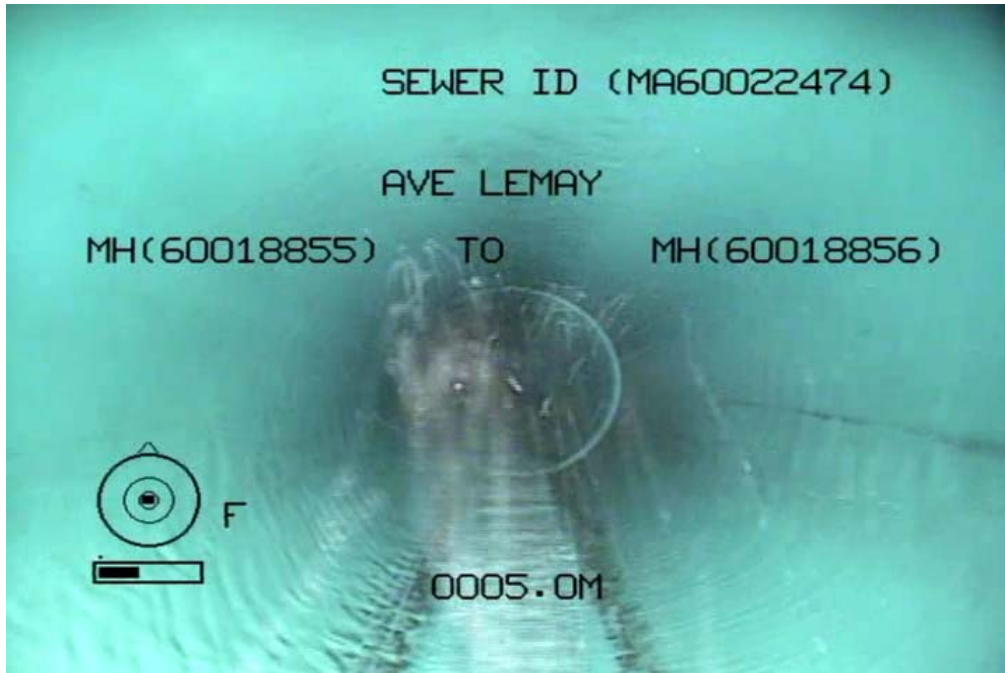
The assessment shows that, overall, all sections of the sewer system are in good working condition (see Figures 1 – 4).

Figure 1 – 300 mm PVC land drainage sewer pipe in good condition.

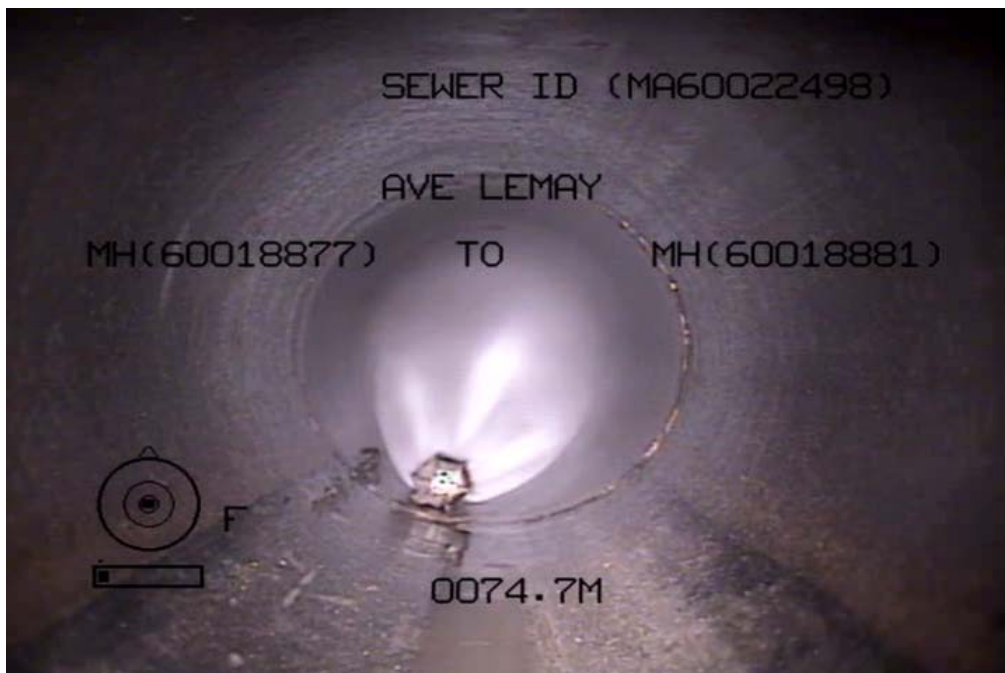
Figure 2 – 750 mm concrete land drainage sewer pipe in good condition.

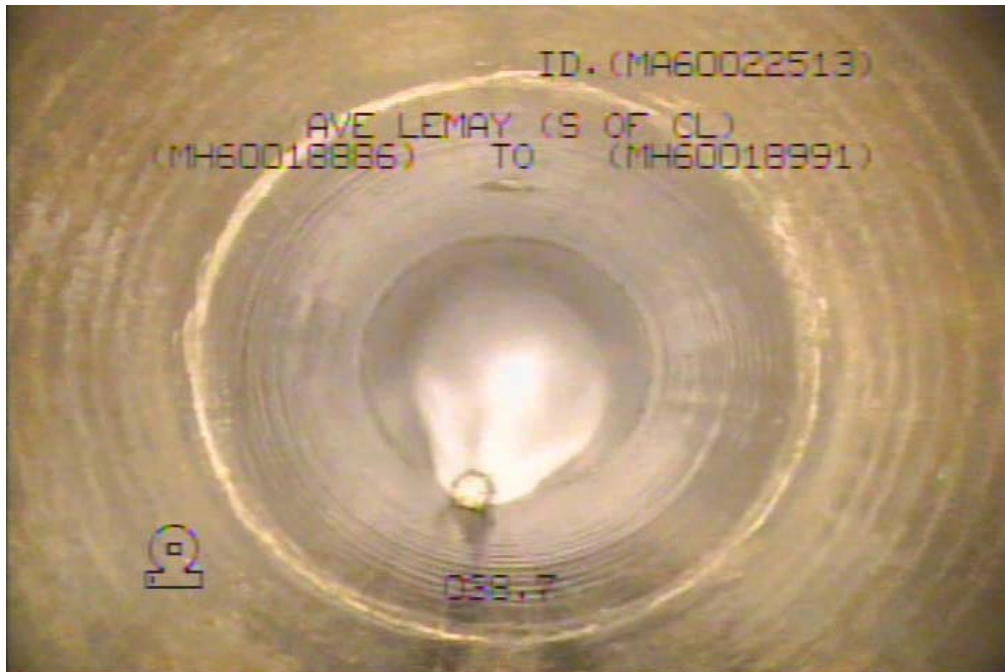
Figure 3 – 900 mm concrete land drainage sewer pipe in good condition.

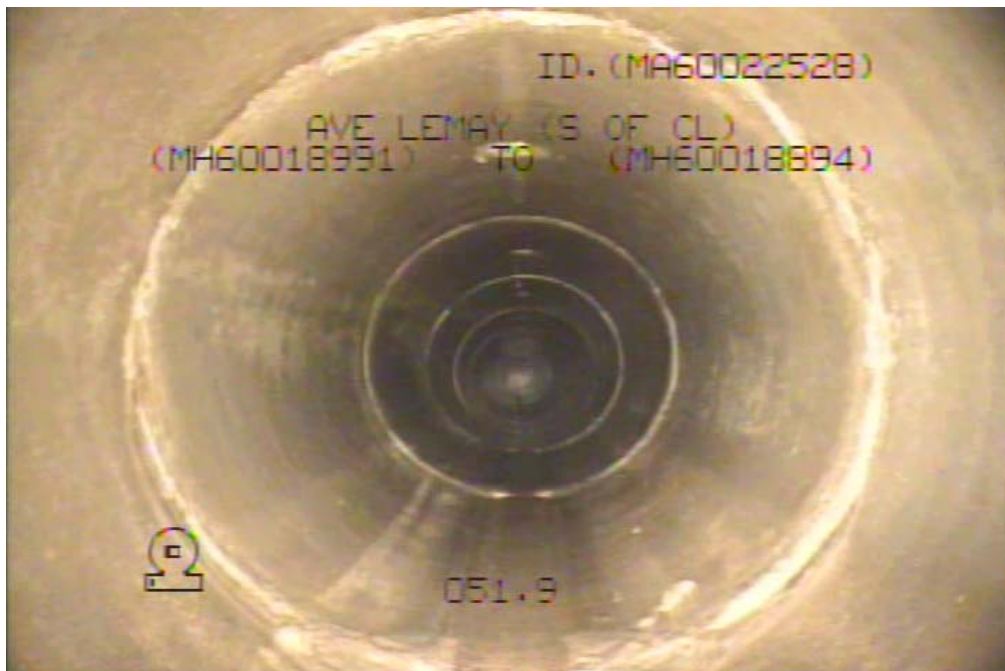
Figure 4 – 900 mm concrete land drainage sewer pipe in good condition.

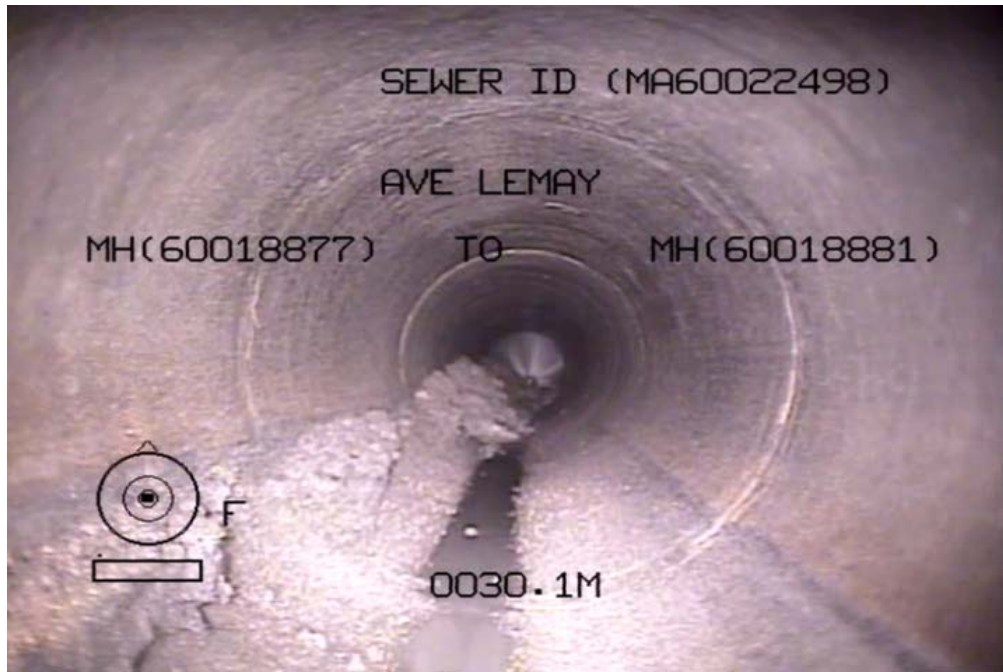
2. Debris had built up in a 30-metre stretch about the midpoint of the 107 metre section between the second manhole east of Rue La Barriere and the manhole at Rue St. Pierre. The debris had filled 20 to 25% of this section of the sewer (see Figure 5).

Figure 5 – Silt debris in 750 mm diameter land drainage sewer on Avenue Lemay. Before cleaning, there was an estimated 20 to 25% build-up of debris in the pipe.

It is not unusual to get some debris accumulation in sewers. All the debris has been removed.

These unique conditions do not place the sewer system in any immediate danger. The sewer continues to perform. Until we can make the repairs, we will monitor and clean the section of sewer that is accumulating debris. We will do this annually.

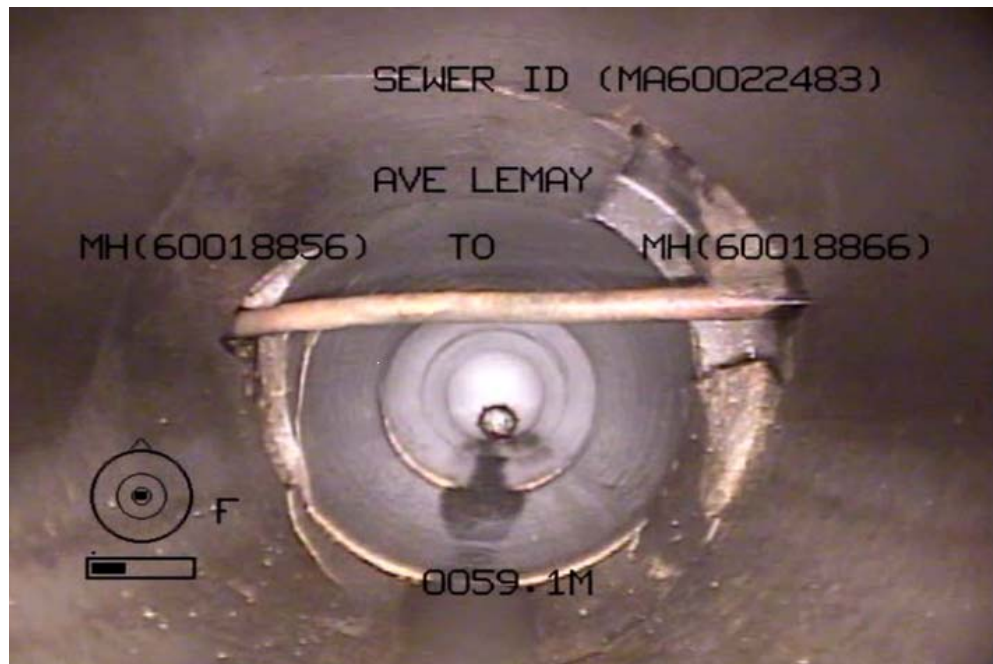
- A 19 mm diameter copper water service was installed through a section of 300 mm diameter sewer between the manhole at Rue Landry and the first manhole east of Rue Landry (see Figure 6). Missing pipe segment and holes can be seen. The holes indicate the service was unintentionally installed through the land drainage sewer. The water pipe would have been installed using trenchless technology, which allows the pipe to be installed with minimal disruption to the ground. The workers have a general idea of where the pipe is travelling, but aren't able to track the exact path of the pipe. This likely occurred during a 1995 water main renewal project.

The sewer still works properly, but there is a structural weakness at this point in the sewer pipe. It is also a point of entry for debris.

Figure 6 – 19 mm water service through 300 mm diameter land drainage pipe on Avenue Lemay.

3. Other pipes pass through the sewer system in several places. This is unusual but does not affect the operation of the sewer system. However, these are areas of structural weakness of the pipe, and we plan to repair these parts of the sewer to prevent a structural failure in the future.

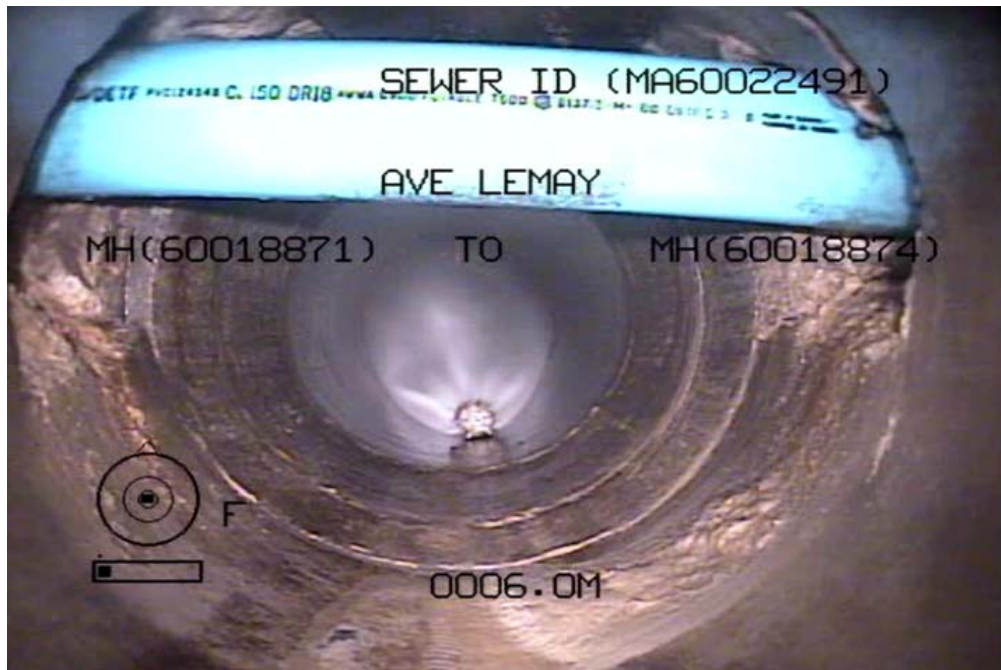
- A 150 mm diameter PVC water main was installed through a section of 750 mm diameter sewer between the manhole at Rue La Barriere and the first manhole east of Rue La Barriere (see Figure 7). Missing pipe segments and holes in the land drainage pipe are visible. The construction indicates that the water main was unintentionally installed through the land drainage sewer. This was likely done as part of a 1986 water main renewal project.

The sewer still works properly, but there is a structural weakness at this point in the sewer pipe. It is also a point of entry for debris.

Figure 7 – 150 mm diameter PVC water main through 750mm diameter land drainage sewer on Avenue Lemay.

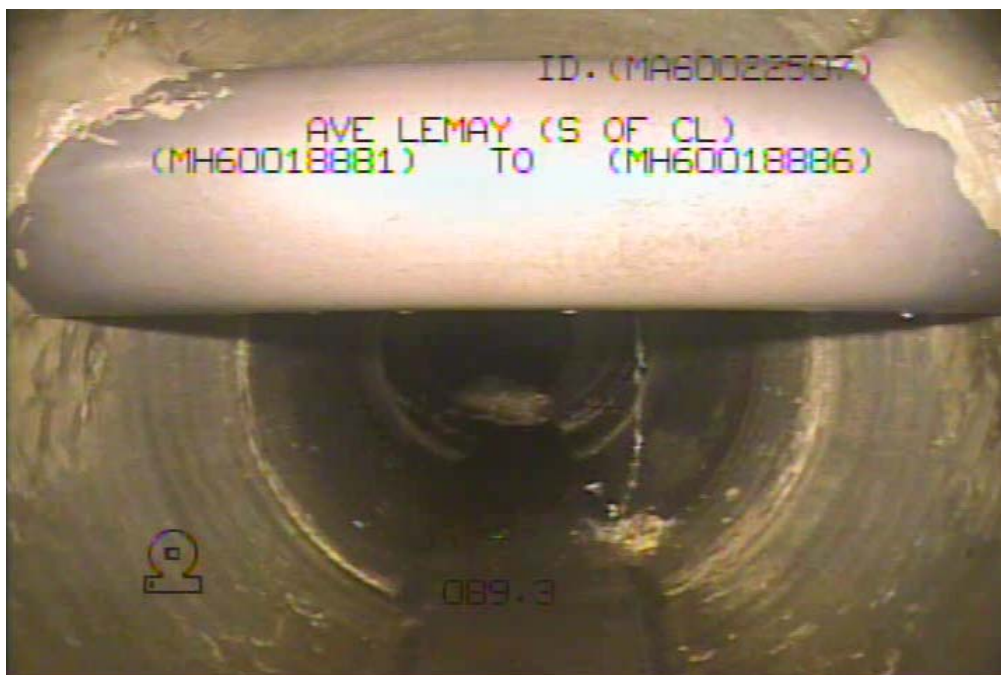
- A 200 mm diameter wastewater sewer was installed through the 900 mm land drainage sewer on Avenue Lemay at Rue La Grave (see Figure 8). The wastewater sewer was installed through the land drainage sewer. The holes are grouted and sealed, indicating this was done intentionally. It was installed as part of work done on the land drainage sewer for the Rural Municipality of Fort Garry in 1961.

This installation was acceptable in unique situations back in the 1960s, but it would likely not occur in present day designs.

Figure 8 – 200 mm diameter wastewater sewer through 900 mm diameter land drainage pipe on Avenue Lemay.
