City of Winnipeg

Discoloured Water Investigation Report of Findings

AECOM

April, 2011

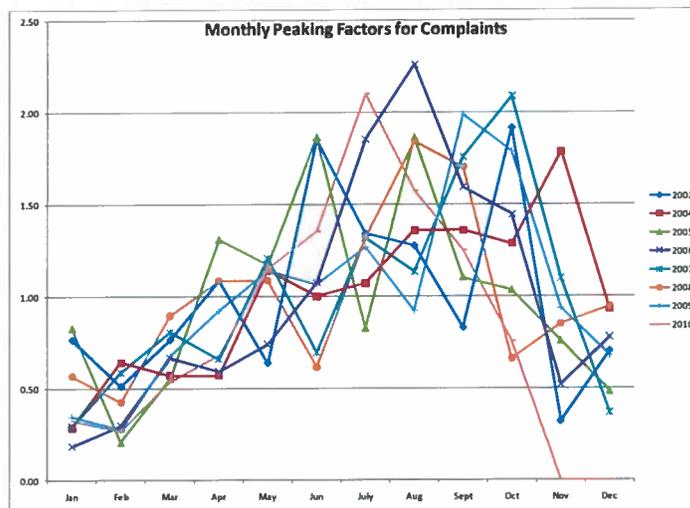
Figure 3: Monthly Peaking Factors for Complaints 2003-2010

4. Although the magnitude of complaints has increased markedly, the monthly variation pattern is reasonably consistent with past variations that have been observed seasonally. To examine and illustrate this, monthly peaking factors were generated to examine seasonal trends. The peaking factors compared each monthly total to the average monthly total for each individual year. The results are depicted in **Figure 3**. While the magnitude of complaints has increased markedly, the seasonal variation pattern for 2010 observed in **Figure 3** appears very similar to typical annual seasonal variations prior to the commissioning of the WTP.

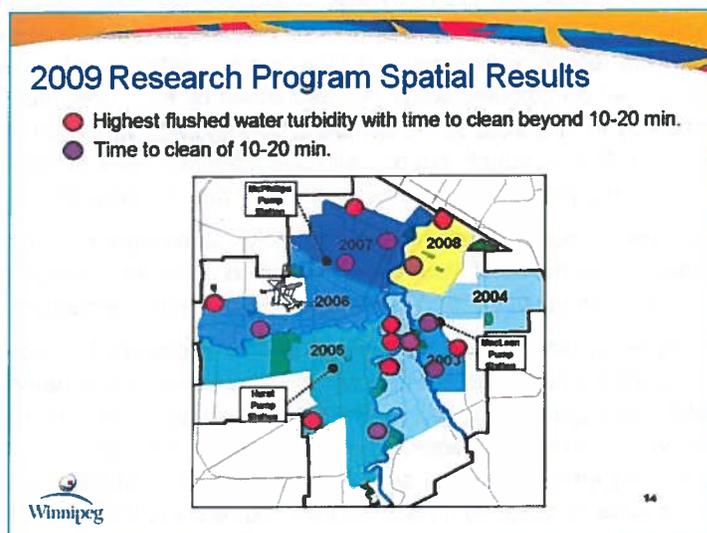
Figure 4: Results of 2009 Flushing Research Project

8. The observations that the materials are old and were present pre-WTP are consistent with observations from the City's 2009 Watermain Flushing Research Project which indicated significant presence of high turbidity water at numerous locations in the system after six years of uni-directional flushing (see **Figure 4**). While the uni-directional flushing program was very successful in improving overall aesthetic water quality in the distribution system, the 2009 research did indicate that significant materials were present in the water distribution system, especially in areas of the system where normal operation produces low average flow velocities.

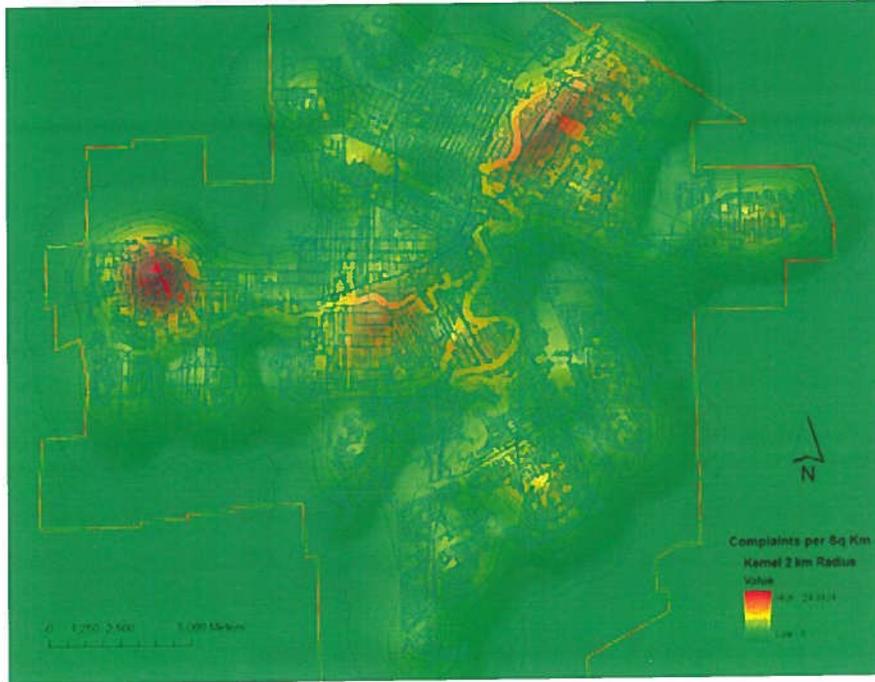
Figure 5: Spatial Variation of Complaints: Jan-Oct 2010

9. The spatial groupings of complaints reported in 2010 display a distinct clustering effect with increased densities of complaints being reported in a number of distinct areas of the system (see **Figure 5**). While not confirmed by detailed hydraulic modelling, there is a distinct increase in frequency of complaints in areas of the system that would be considered "null" points between the distribution pumping stations or system extremities that would be anticipated to have lower velocity profiles on a regular basis. This suggests that some areas of the system may be more prone to suffering event related complaints due to their unique boundary conditions or flow characteristics under normal operation.

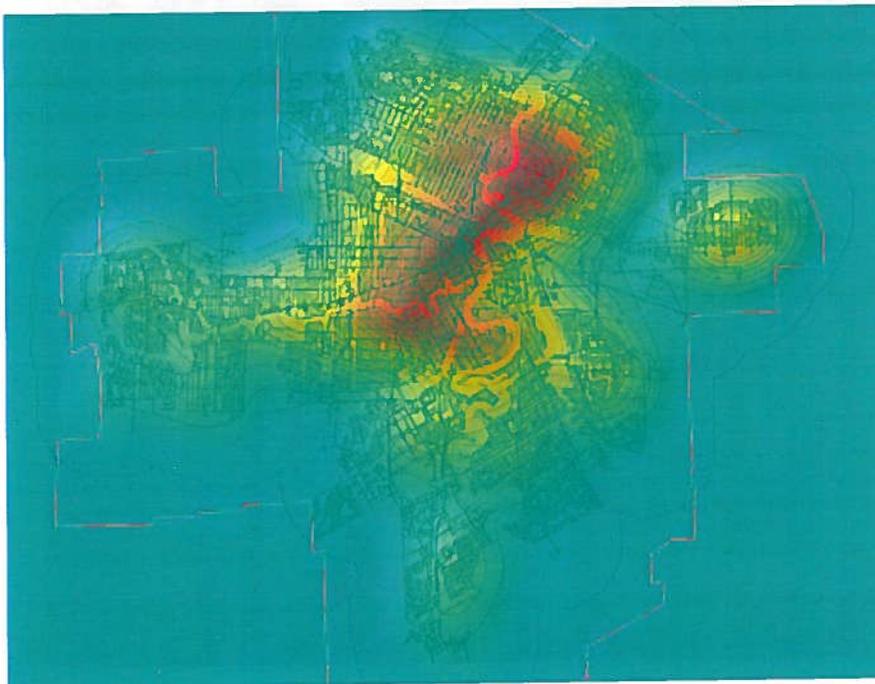
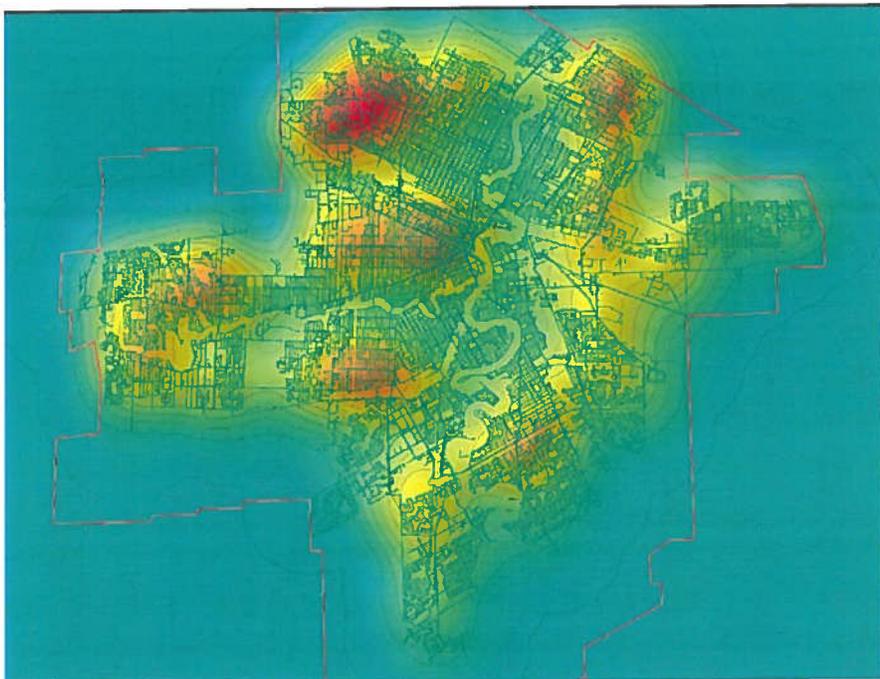
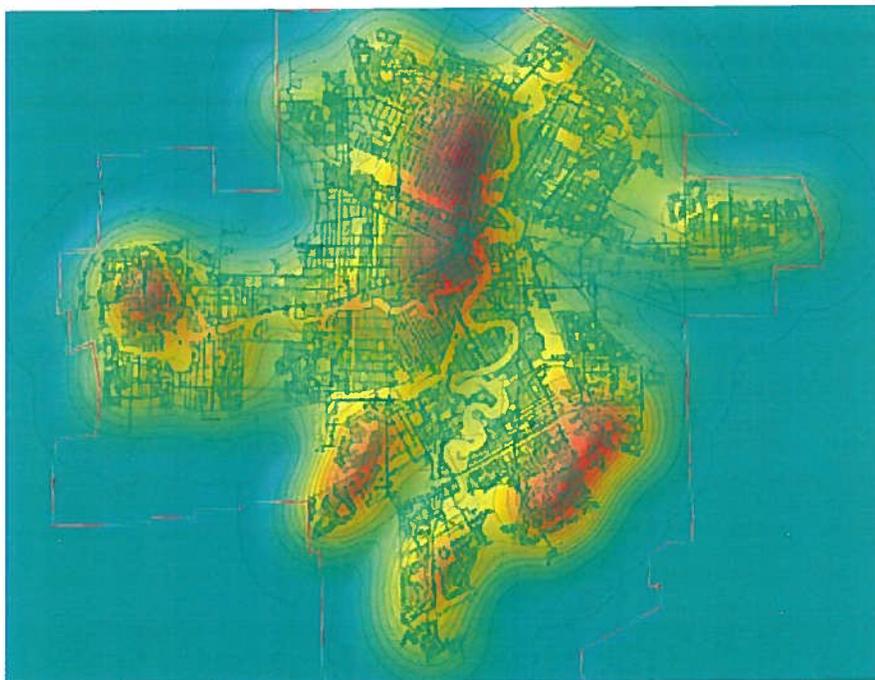
11. There does not appear to be any strong correlation between complaints and pipe material or pipe age. **Figure 6**, **Figure 7**, and **Figure 8** depict the spatial density of ferrous metal, cementitious, and thermoplastic lined pipes. A robust statistical assessment (see **Appendix A**) does not show any correlation of any distinct material type that independently accounts for the majority of the complaints.
