APPENDIX A
HAZARDOUS BUILDING MATERIALS ASSESSMENT

Hazardous Building Materials Assessment

St. James Civic Centre
2055 Ness Avenue
Winnipeg, Manitoba

October 4, 2018

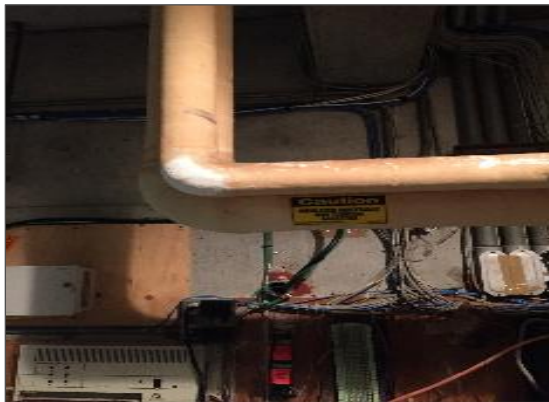
Parging cement, containing chrysotile asbestos, is present on pipe fittings (elbows, valves, tees, hangers etc.) on the domestic (DW), hot water heating (HWH), steam, and rain water leader systems (Samples 0001A-C, 0002A-C, 0006A-C, 0017A-C, 0021A-C, and 0035A-C). Parging cement is a friable insulation, was jacketed with canvas and observed in good condition.

Photograph No. 1: Asbestos-containing parging cement present on fittings, elbows, valves and tee's of the Domestic, hot water, steam system.

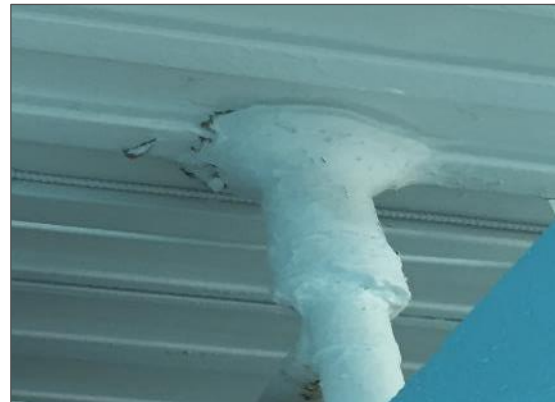
Photograph No. 2: Asbestos-containing parging cement on rain water leader fittings.

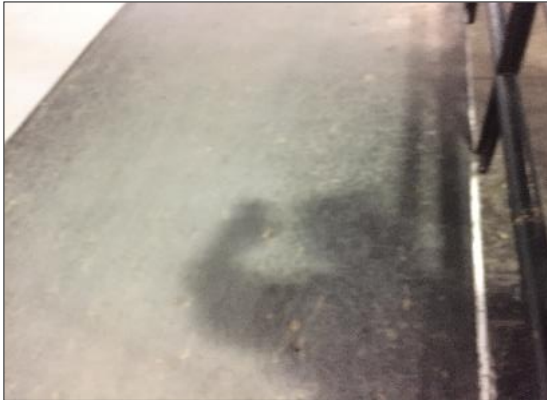
Photograph No. 4: Non-asbestos skate matting within the rink Loc.15 (Samples 0018A-C).

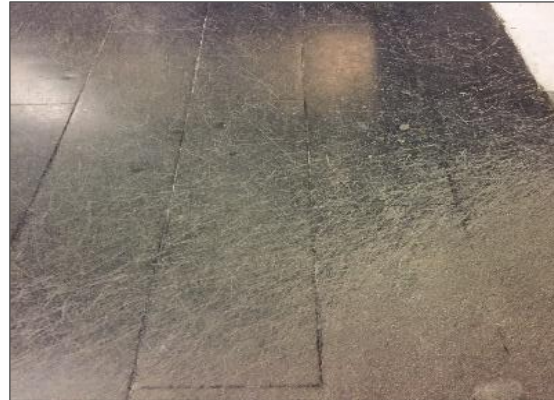
Photograph No. 5: Non-asbestos skate matting within the rink Loc.15 (Samples 0019A-C).

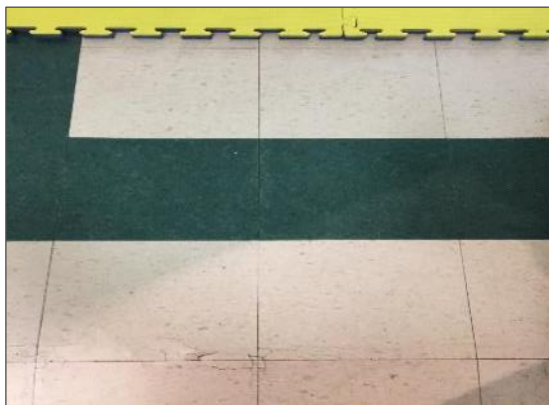
Photograph No.10: Non-asbestos vinyl floor tiles in the basement yoga room Loc. 9 (Samples 0012A-C).

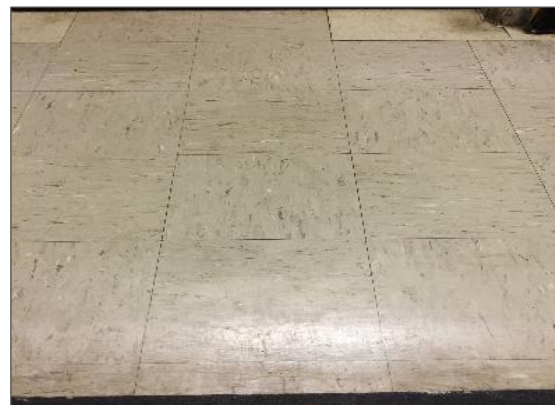
The vinyl floor tiles and mastic are non-friable and are in good condition.

Photograph No.11: Asbestos-containing vinyl floor tiles Various Locations (Samples 0015A-C).

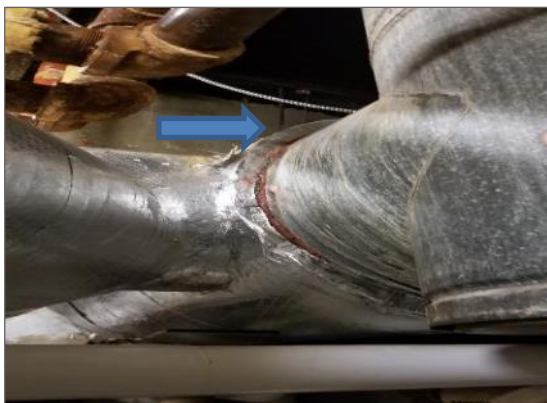
Photograph No. 21: Non-asbestos red/brown mastic on uninsulated ducting within the basement (Samples 0003A-C).

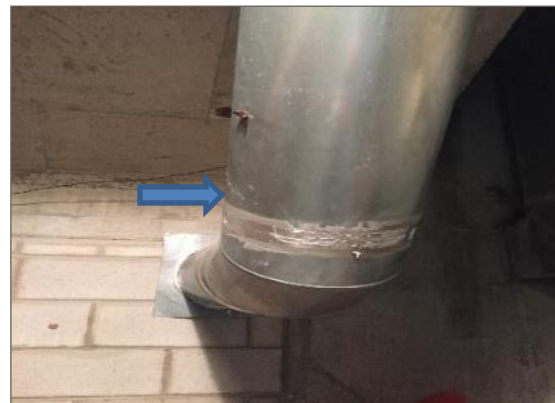
Photograph No. 22: Non-asbestos grey mastic on uninsulated ducting throughout the building.

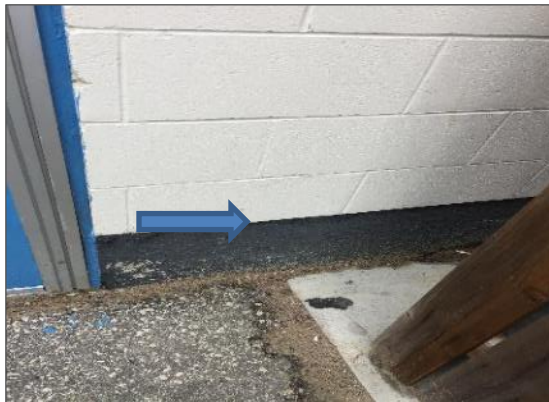
Stucco containing chrysotile asbestos is present as exterior finish on the lower 1' – 4' of the building (Samples 0055A-C).

Photograph No. 27: Asbestos-containing stucco on lower exterior walls (Samples 0055A-C).

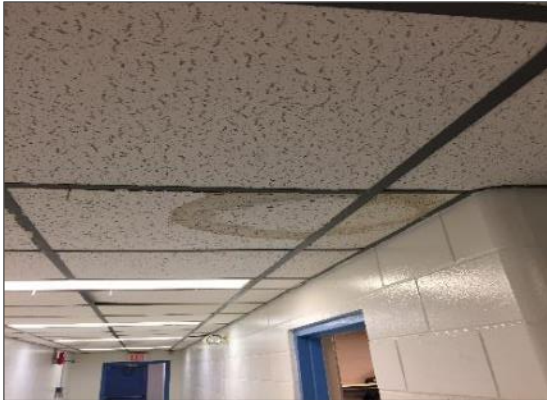
- 3 tiles within the basement board room Loc. 9;
- 15 tiles within the main floor corridor Loc. 28;
- 6 tiles within the pool corridor Loc. 38;
- 3 tiles within the main floor corridor Loc. 57;
- 4 tiles within the mezzanine washroom Loc. 62; and
- 4 tiles within the mezzanine washroom Loc. 64.

Photograph No. 28: Mouldy/water stained ceiling tiles in various locations.

Material, Quantity and Condition	Location	Recommended Procedure
Mould-impacted Ceiling tiles, 5 square feet	Location Nos 28, 38, 57, 62, and 64. Photograph No. 28	Remove in accordance with CCA Level 1 mould abatement procedures

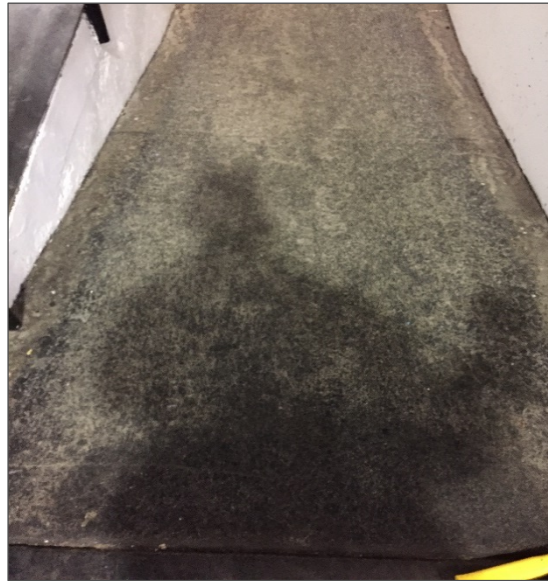
Photograph No. 6: Non-asbestos skate matting within the rink Loc.15 (Samples 0020A-C).

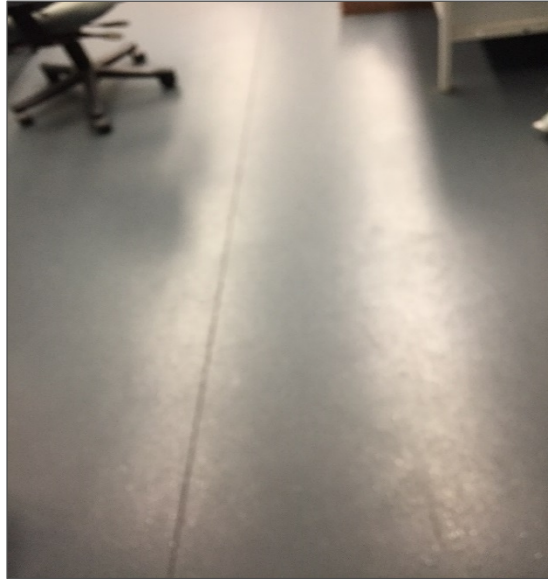
Photograph No. 8: Non-asbestos vinyl sheet flooring within the pool entrance Loc.39 (Rubber).

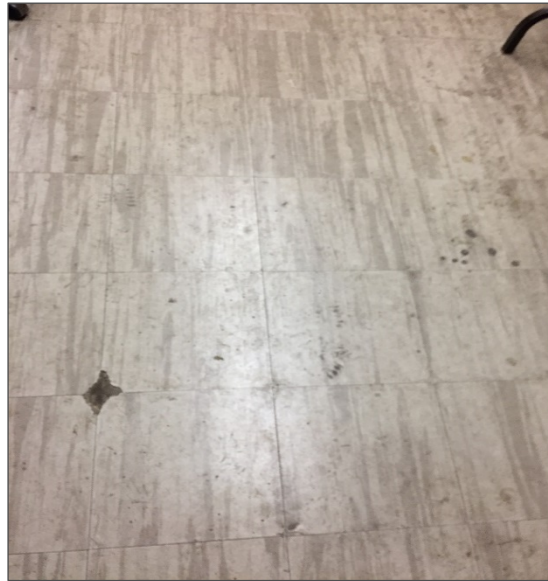
Photograph No. 12: Asbestos-containing vinyl floor tiles within the rink sound room Loc.15 (Samples 0023A-C).

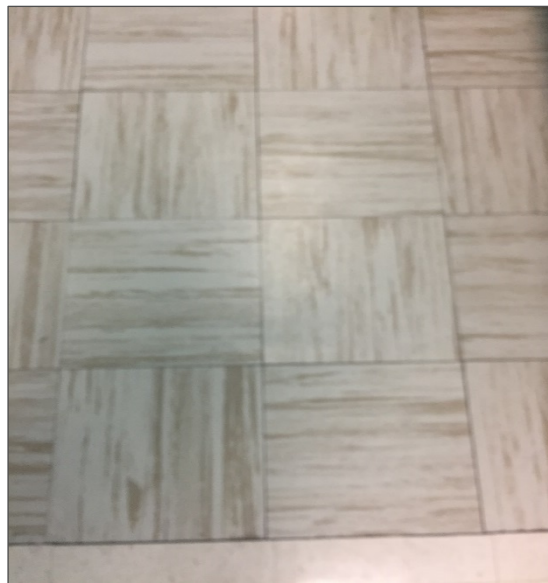
Photograph No. 13: Asbestos-containing vinyl floor tiles within pool corridor and office Loc.'s 38 and 43 (Samples 0033A-C).

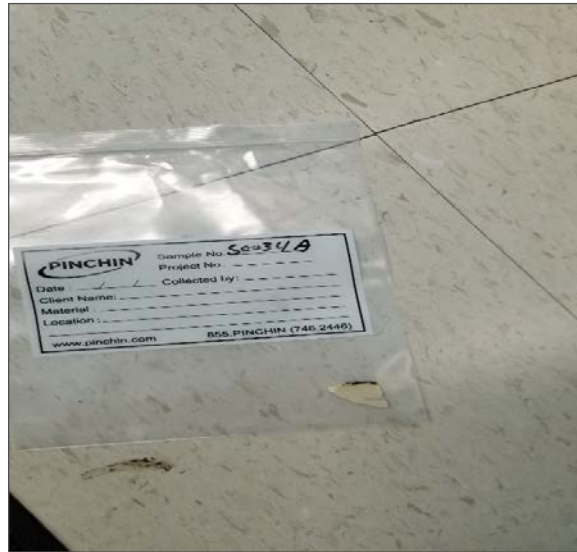
Photograph No. 14: Non-asbestos vinyl floor tiles within the pool corridor Loc.38 (Samples 0034A-C).

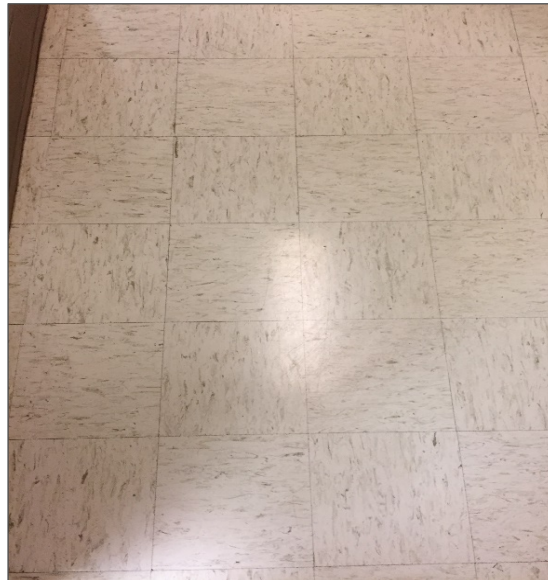
Photograph No. 16: Asbestos-containing vinyl floor tiles within the auditorium and adjacent rooms Loc.48 (Samples 0039A-C).

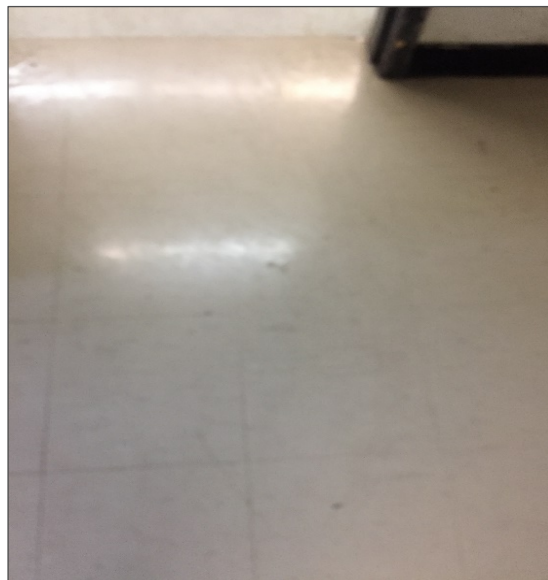
Photograph No. 17: Non-asbestos vinyl floor tiles within the corridors Loc.'s 52 and 58 (Samples 0038A-C).

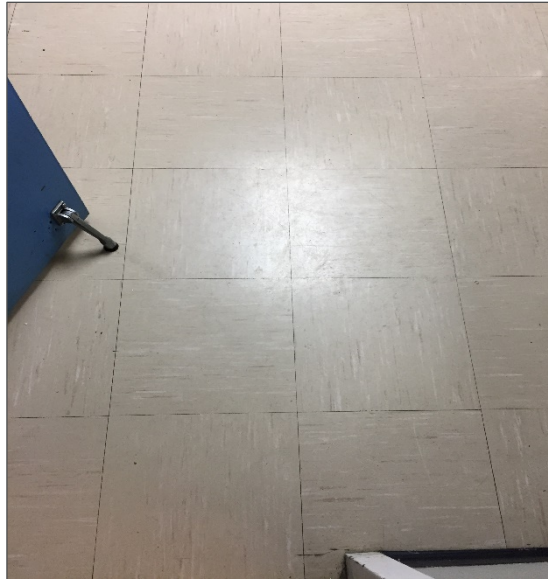
Photograph No. 18: Asbestos-containing vinyl floor tiles within the staff room Loc.59 (Samples 0046A-C).

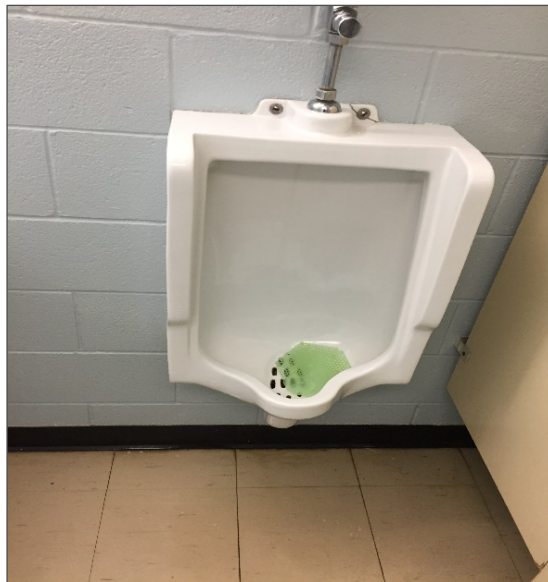
Photograph No. 19: Non-asbestos vinyl floor tiles within the mezzanine washrooms and offices (Samples 0050A-CA-C).

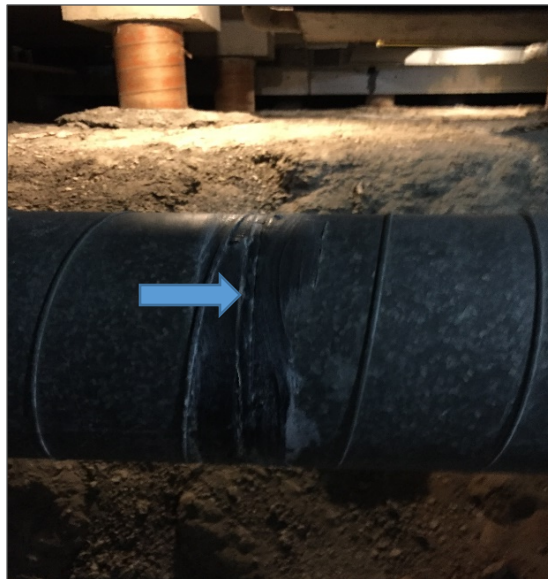
Photograph No. 23: Non-asbestos black/grey mastic present on uninsulated ducting within the south crawlspace and basement (Samples 0005A-C).

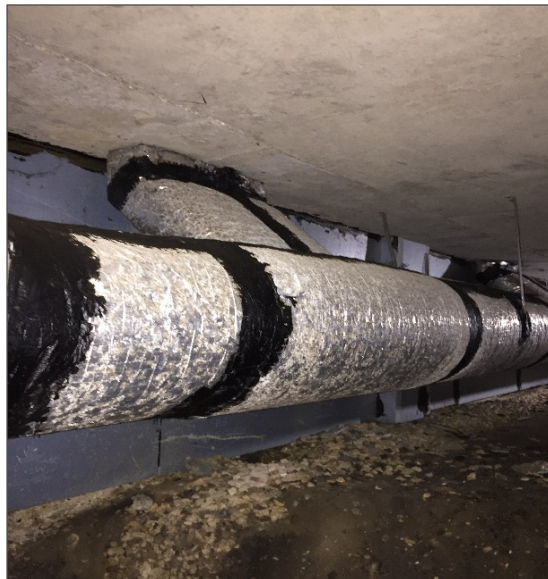
Black tar mastic present on jacketing of duct insulation within South crawl space contains chrysotile asbestos (Samples 0007A-C and 0009A-C).

Photograph No. 25: Asbestos-containing black tar mastic on ducting within the south crawlspace (Samples 0009A-C).

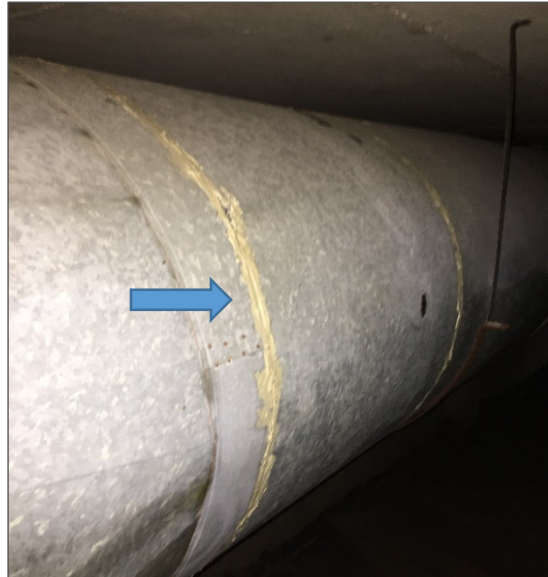
Beige mastic present on uninsulated ducting within the South crawlspace, basement board room Loc.9 contains chrysotile asbestos (Samples 0008A-C).

Photograph No. 26: Asbestos-containing beige mastic present on uninsulated ducting within the south crawlspace and basement board room (Samples 0008A-C).
