APPENDIX B
BUILDING CONDITION ASSESSMENT REPORT

prepared by Crosier Kilgour & Partners Ltd.

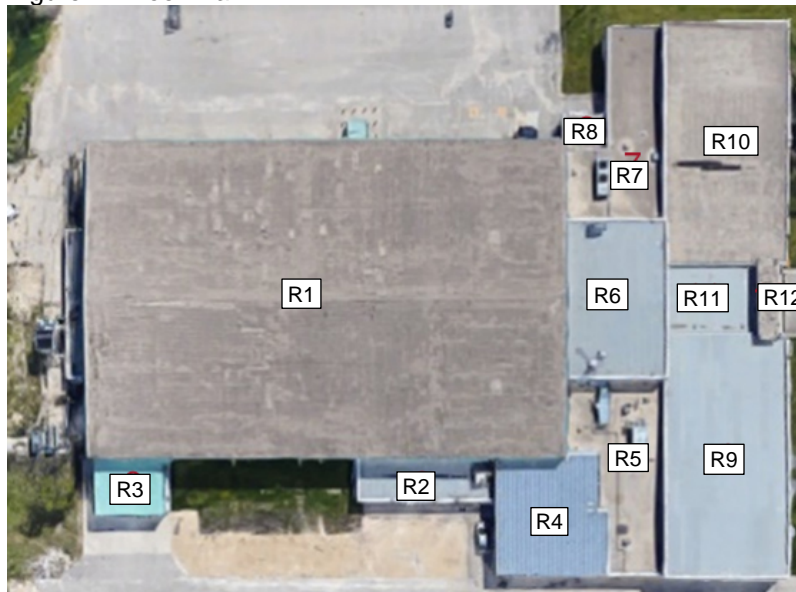
Roof Facet, R1, R5, R7, R8, R10, and R12 the existing is a 4-ply asphaltic roof system. The assembly consists of a gravel coat, asphaltic 4 ply felt paper, fiberboard, and 2-ply organic felt vapor barrier. On R1, R5, R7, R8, and R12 the slope on all roofs are under 0.1% approximately .2/12. R10 roof, the existing slope is approximately 3/12.

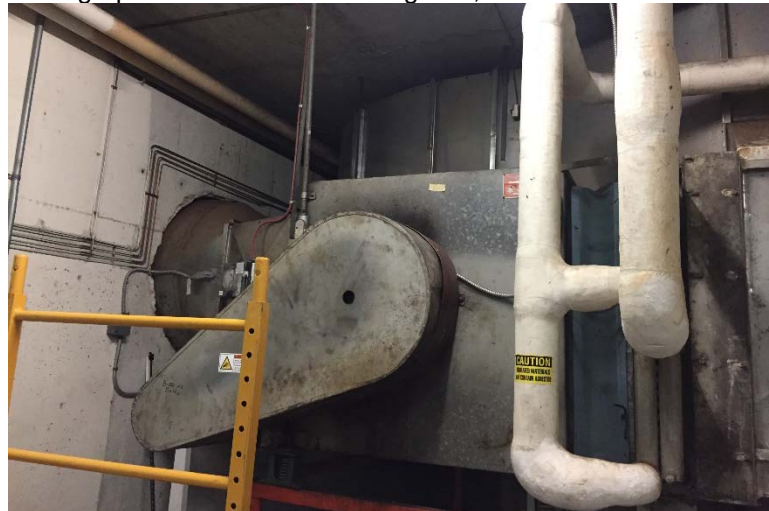
.2 Fresh Air Unit (AHU-2)

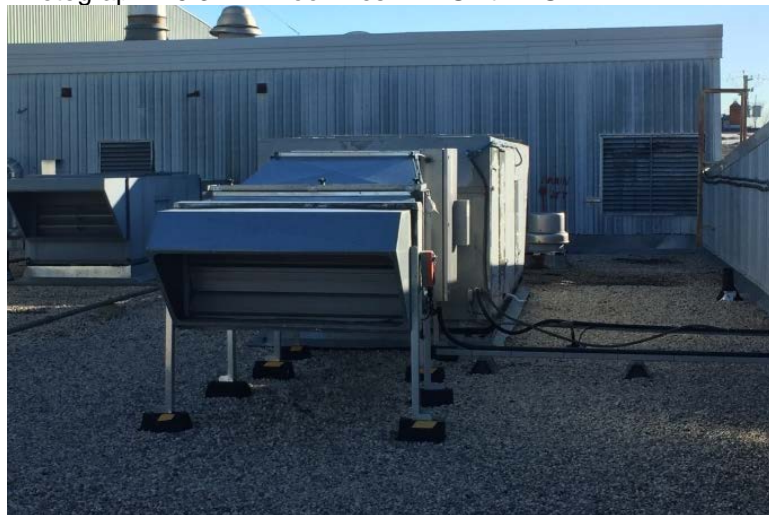
Photograph 2.5.3.2-1: Pool Fresh Air Unit AHU-2

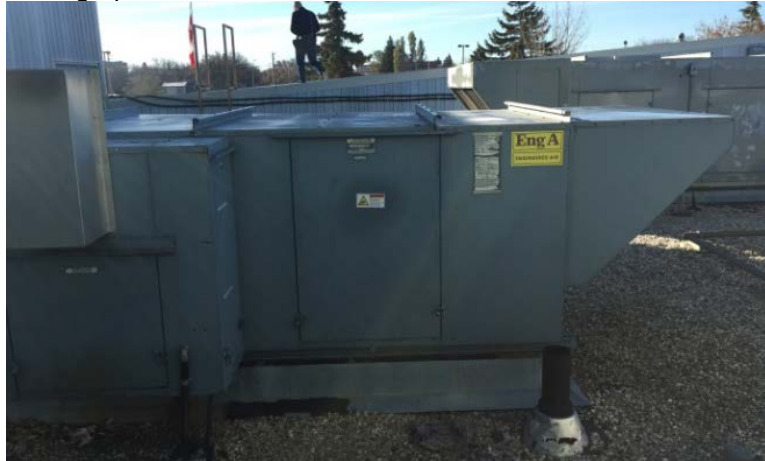
.4 Change Room Exhaust

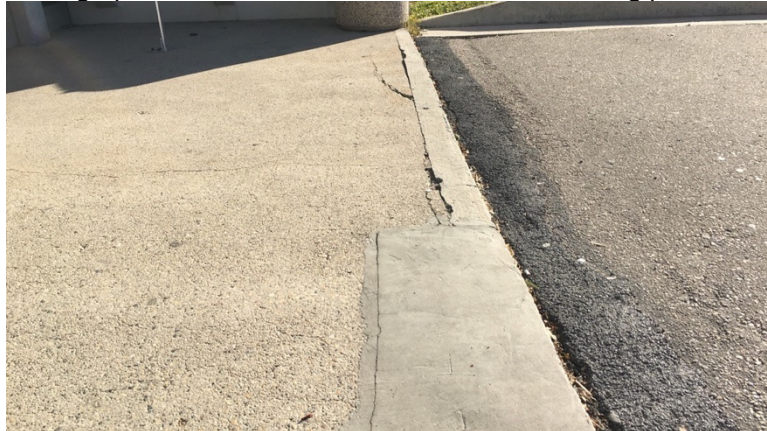
Recommendation 3.1.1.2-1: Complete localized repairs to address concrete deterioration and tripping hazard at transition.

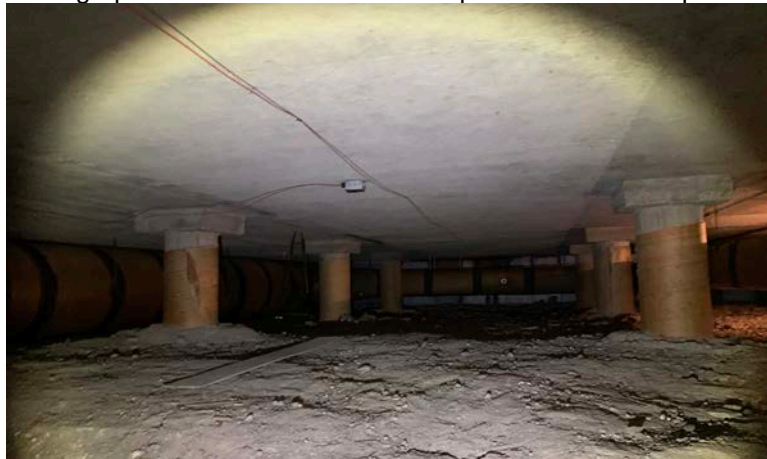
Photograph 3.2.1.1-1: Unfinished crawlspace floor show exposed soil.

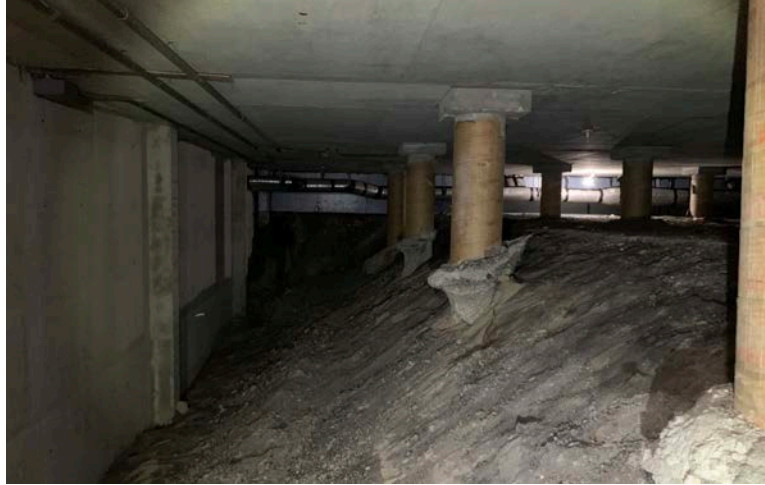
Recommendation 3.2.1.1-1: The crawlspace does not have a functioning vapour barrier. Remediation of the crawlspace is recommended including grading of the existing soil to direct water away from structural members, installation of a new drainage system and sump pits (if required, see mechanical), and installation of a vapour retarder and sand cover. Installation of new sub-surface drainage, vapour barrier, and sand cover is recommended within 5 years.

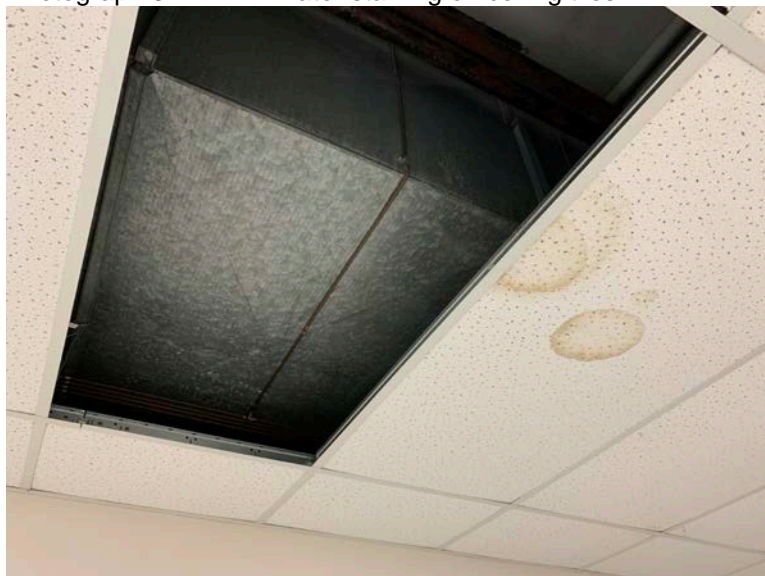
Photograph 3.2.1.2-1: Water staining on ceiling tiles.

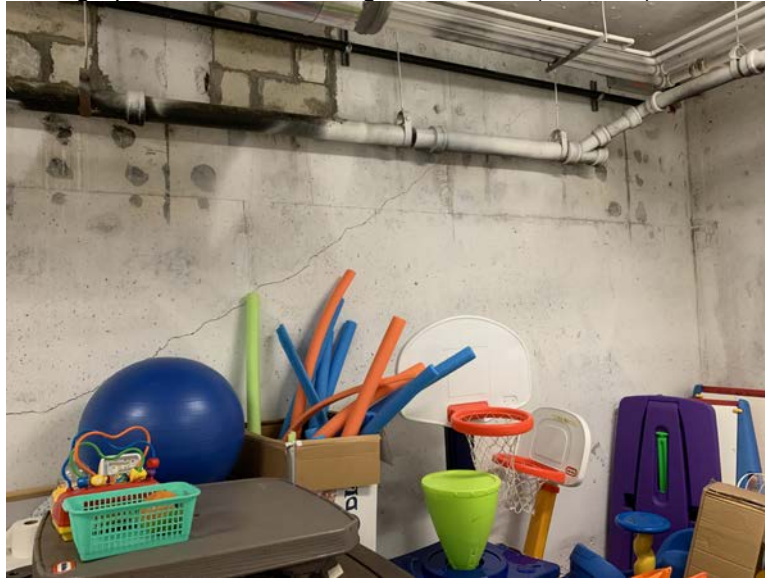
Photograph 3.2.1.3-2: Cracking in north wall (centre).

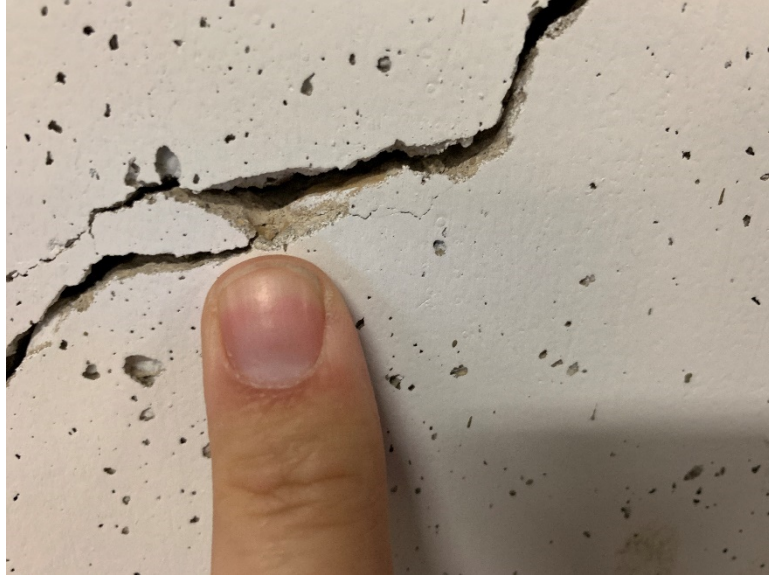
Photograph 3.2.1.3-4: Evidence of displacement in wall.

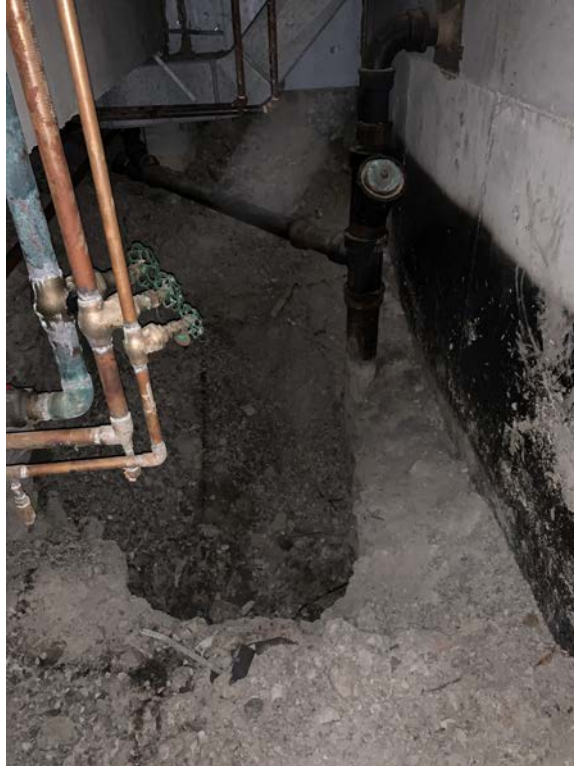
The cause(s) of the cracking could not be determined but is consistent with overloading in flexure, possibly due to soil pressure. A review of the original drawings indicates that the wall construction consists of a 10" concrete wall reinforced with 2 - #8 horizontal bars top and bottom; #4 bars at 24" on-centre vertical inside face; and #3 bars at 18" on-centre horizontal inside face.

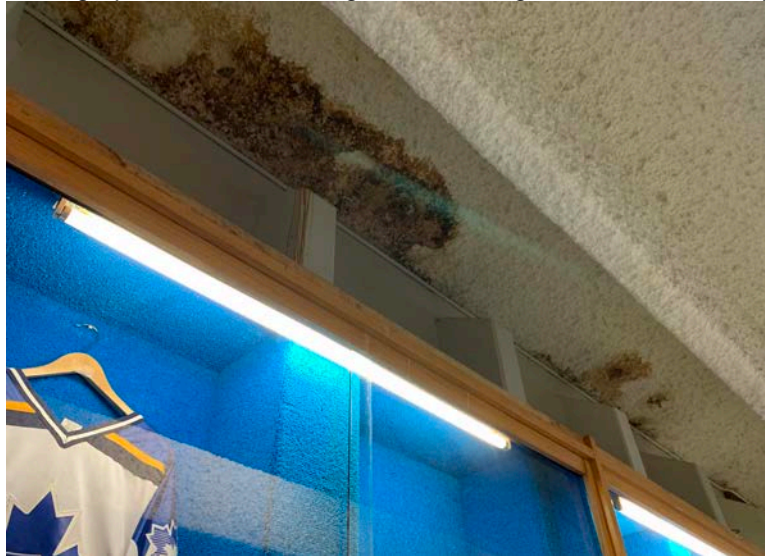
- .2 The precast roof tees are covered with a textured finish which is preventing visual inspection of the tee connections. No obvious evidence of structural distress of the tees was observed.

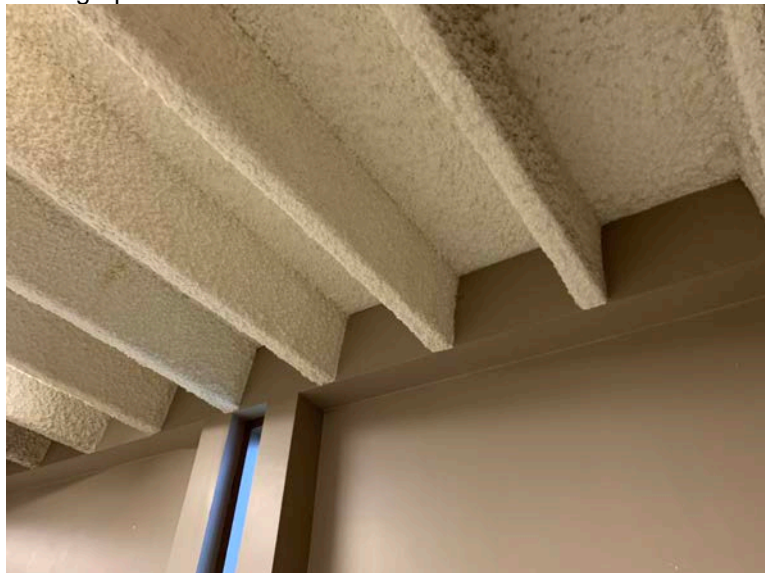
Photograph 3.2.2.3-1: Precast concrete roof tees.

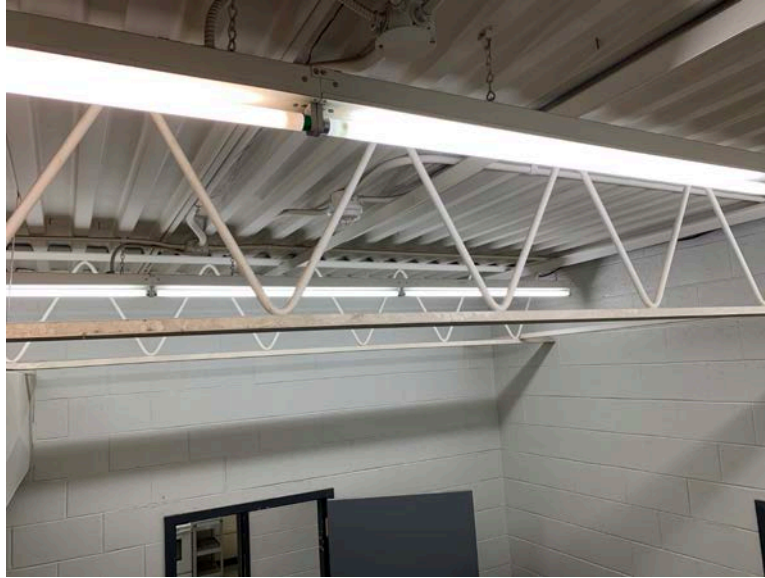
Photograph 3.2.2.4-1: Steel joists at low roof.

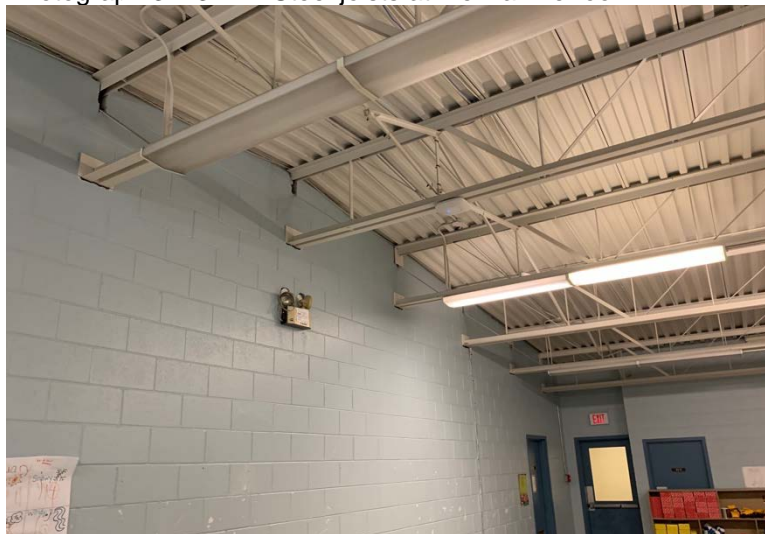
- .2 Horizontal cracking was observed in the south concrete block bearing wall. The cause of the cracking could not be determined. Repointing of the crack is recommended.

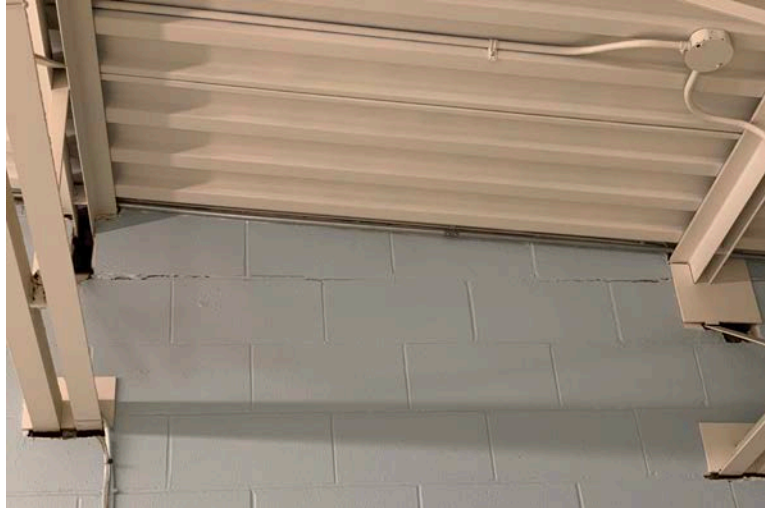
Recommendation 3.2.2.2-1: Repoint horizontal crack in concrete block wall.

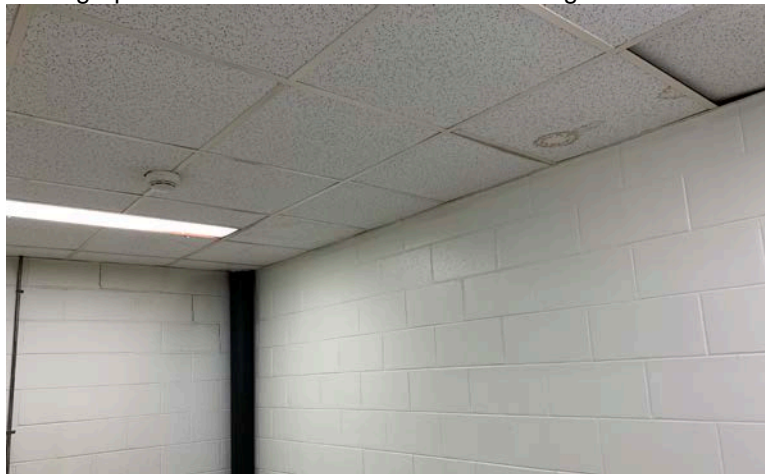
Recommendation 3.2.2.3-1: Repoint step cracking in concrete block wall.

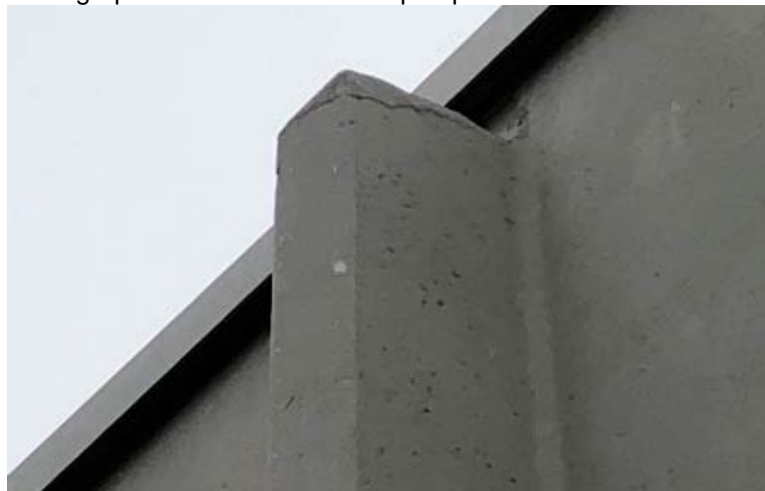
Photograph 3.3.1.1-1: Crack at top of precast concrete column.

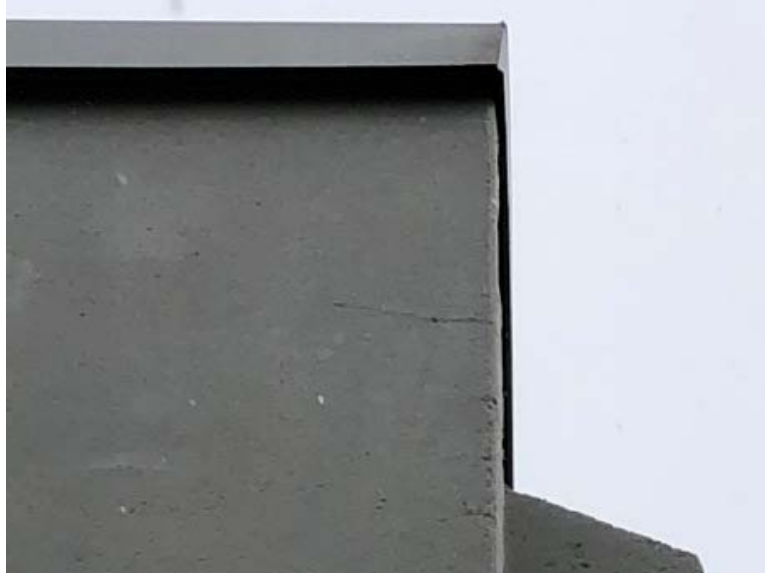
Photograph 3.3.1.1-3: Spalled corner of pre-cast concrete column.

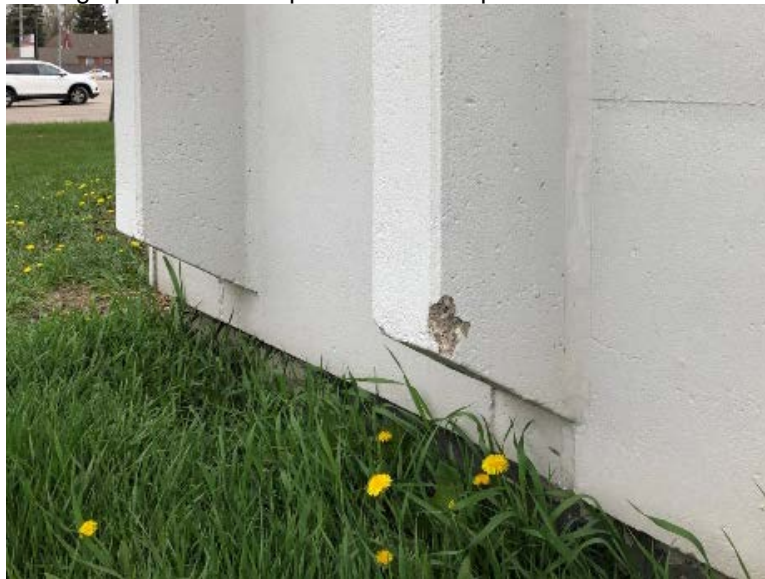
Recommendation 3.3.1.1-1: Localized concrete repairs are recommended to address localized areas of concrete damage. Repairs will vary depending on location but could include localized patching of delaminated or spalled concrete; epoxy injection of cracks; and/or sealing of cracks with an elastomeric sealant. Repairs should include replacement of the elastomeric wall coating.

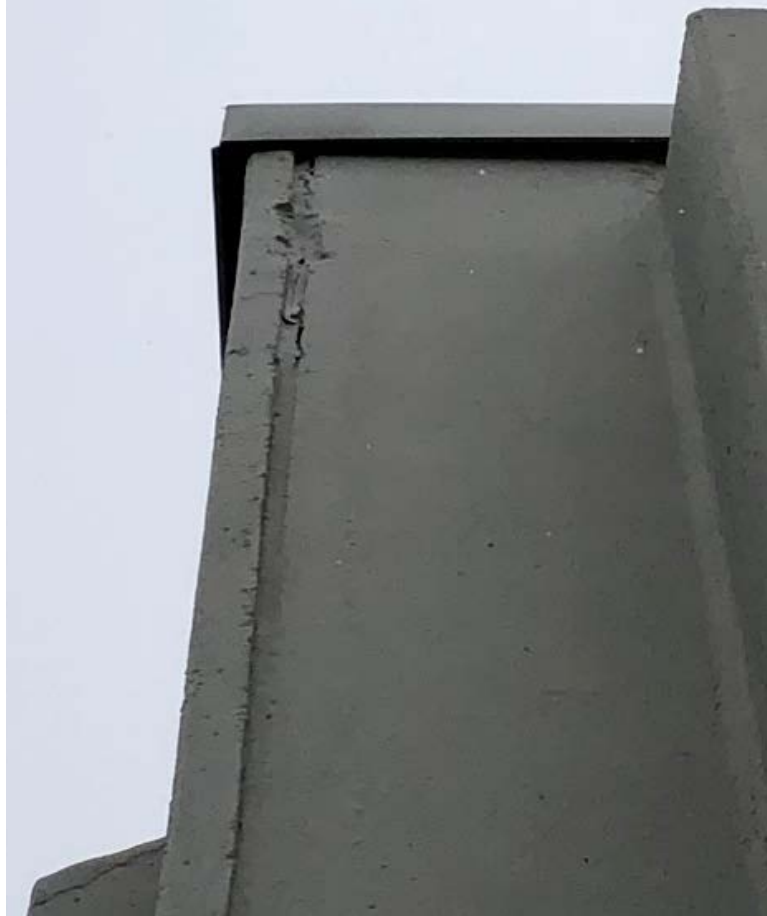
- .3 Evidence of thermal bridging and air leakage at the parapet level of the precast concrete panels was observed during the thermographic scan in Appendix A (Photographs 3.3.1.3-1 and 3.3.1.3-2) indicating discontinuities at the roof wall interface. A review of the original building drawings suggests that a path for air leakage likely exists between the precast wall and roof panels. Random thermal anomalies like those shown in Photograph 3.3.1.3-1 and 3.3.1.3-2 indicate that air leakage is occurring. Mechanical pressurization and stack effect will act to force the interior air up through the wall and roof assemblies. The lack of

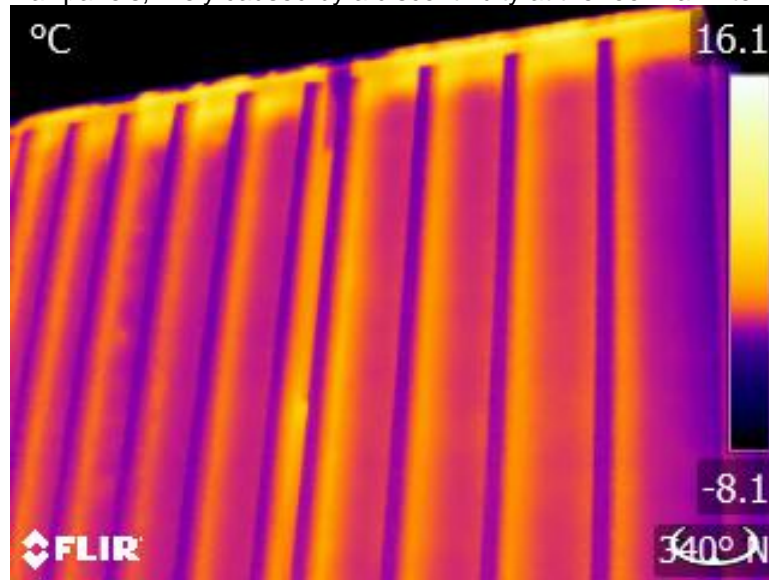
Photograph 3.3.1.3-2: View of elevation showing the typical thermal bridging pattern. Additionally, air leakage is visible at the top of the panels likely from the roof wall interface.

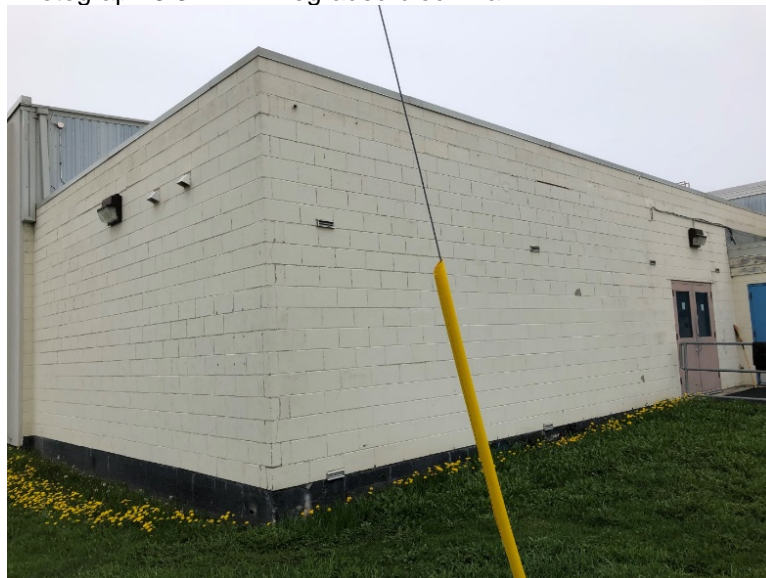
Photograph 3.3.1.4-1: Degraded block wall.

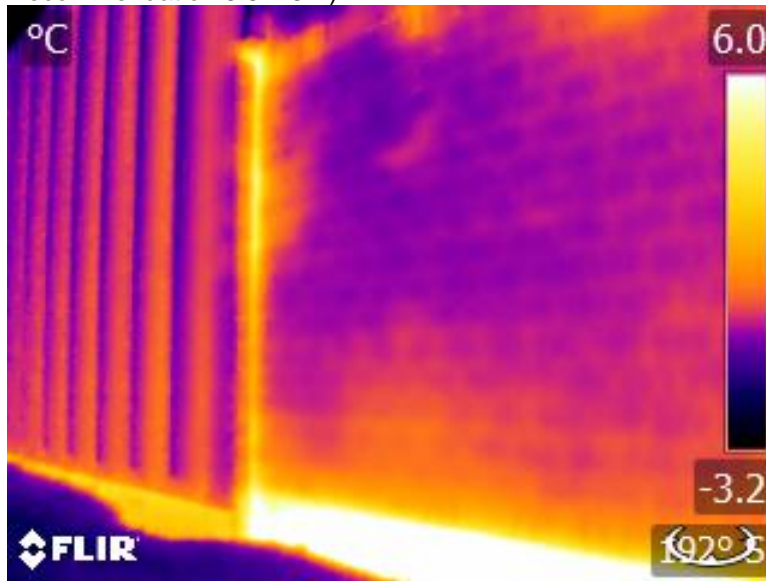
Photograph 3.3.1.4-3: View of the concrete block wall at the North East corner. Note the brighter spots are mechanical system vents evenly spaced below the parapet level. A thermal anomaly is present along the assumed roof line.

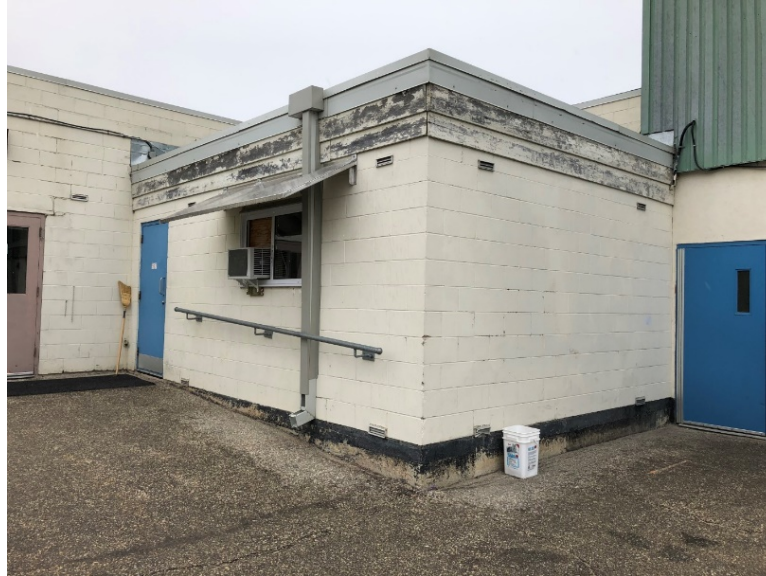
Water damaged gypsum wall board was observed in the north corridor on the north wall perpendicular to the east exterior block wall (Photograph 3.3.1.4-5). Paint was peeling from the interior surface of the east exterior block wall, adjacent the exit door (Photograph 3.3.1.4-6) was also visible. The conditions are indicative of moisture infiltration or condensation on this surface.

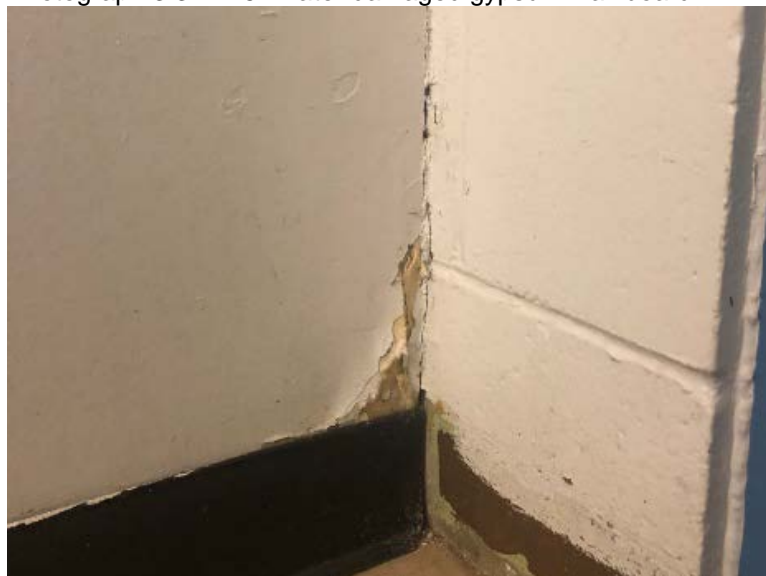
Photograph 3.3.1.4-5: Water damaged gypsum wall board.

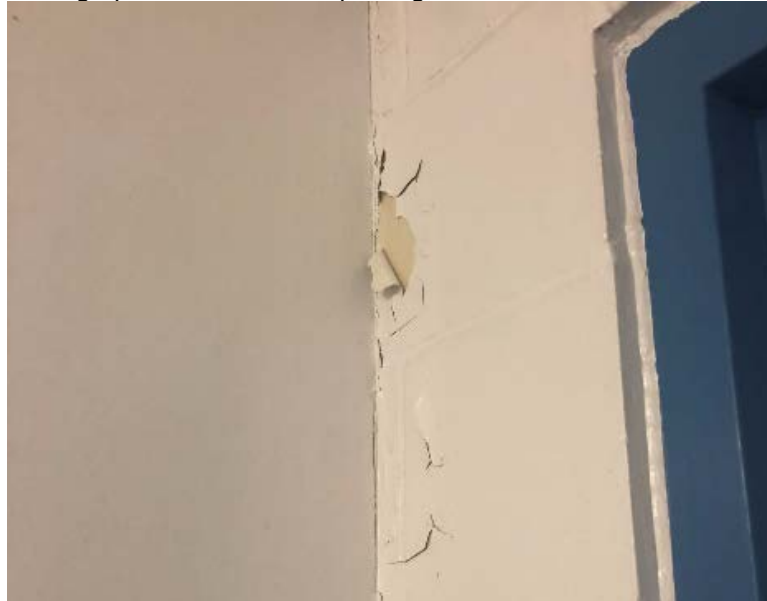
Recommendation 3.3.1.4-1: Remove and wood trim on exterior face of the women's change room, below the cap flashing.

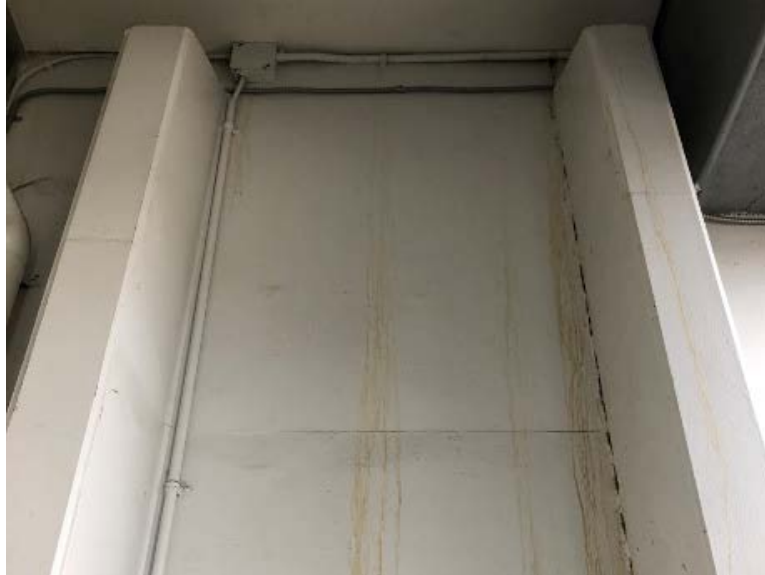
- .6 Water staining was observed on the ceiling in the main entrance foyer, specifically at light fixture locations, and along the east wall between the foyer and the auditorium, indicating potential roof leakage. Refer to Section 3.3.3 for roofing recommendations.

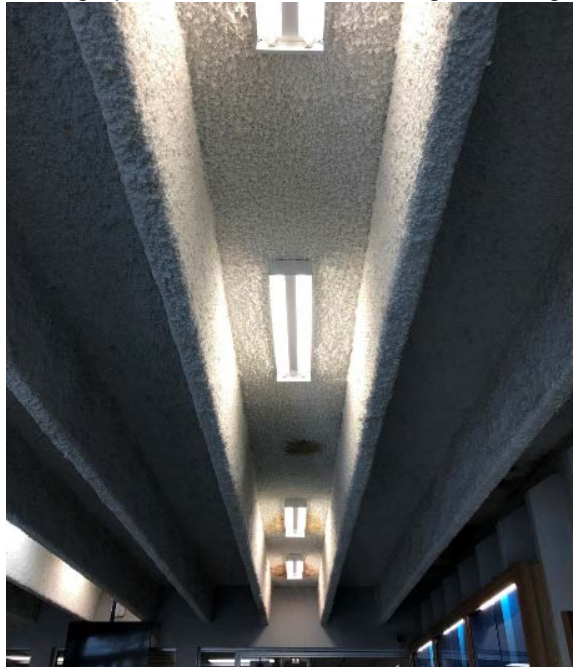
Photograph 3.3.1.6-1: Water staining on ceiling at light fixture locations.

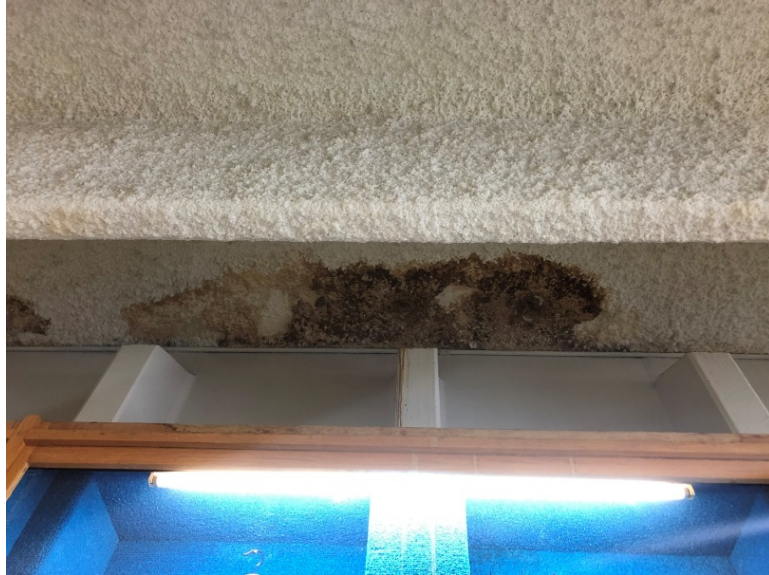
- .7 Moisture staining and evidence of leakage was observed within the corridor adjacent to the east exit door (Photograph 3.2.2.1-1) and below the transition from the low roof over main hall to the stairwell (Photograph 3.2.2.1-2). Refer also to Section 3.3.3 for recommendations.

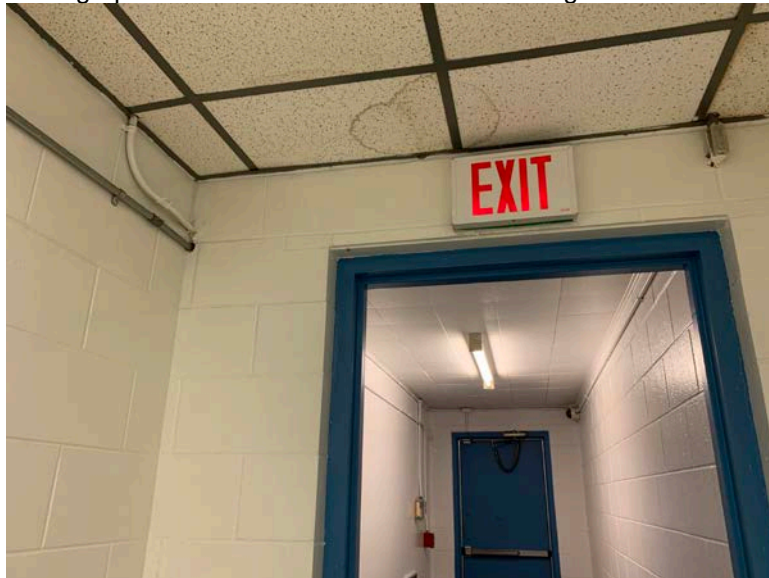
Photograph 3.2.2.1-1: Evidence of leak in ceiling tile at east exit door.

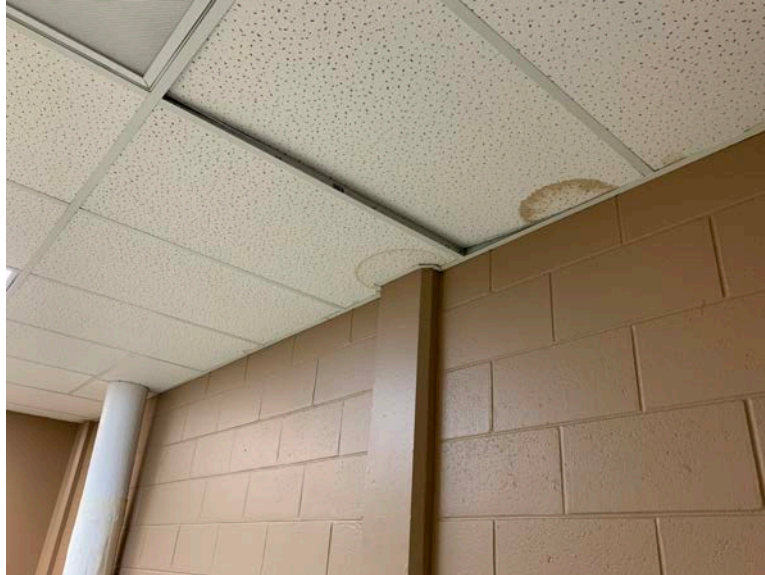
- .8 Water staining was observed on the ceiling tiles in the corridor leading to the coat room at the stairwell corner, as well as within the coat room along the west wall, indicating potential roof leakage at this interface. Refer also to Section 3.3.3 for recommendations.

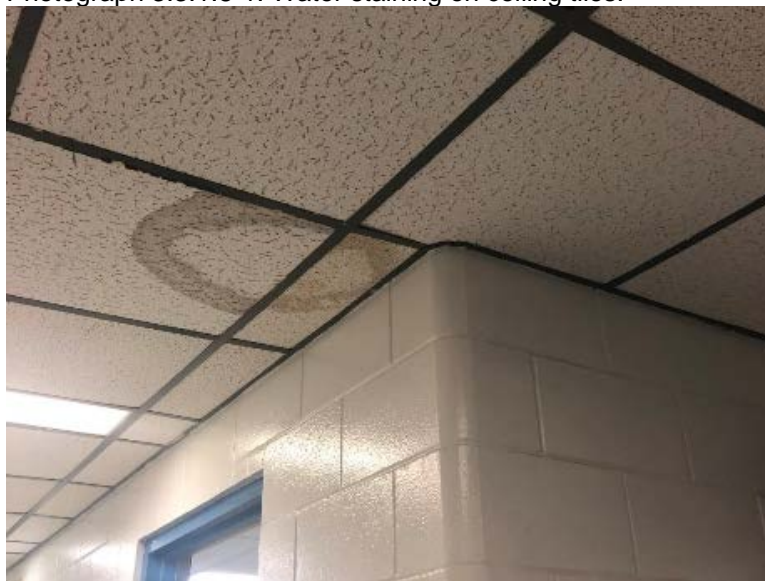
Photograph 3.3.1.8-1: Water staining on ceiling tiles.

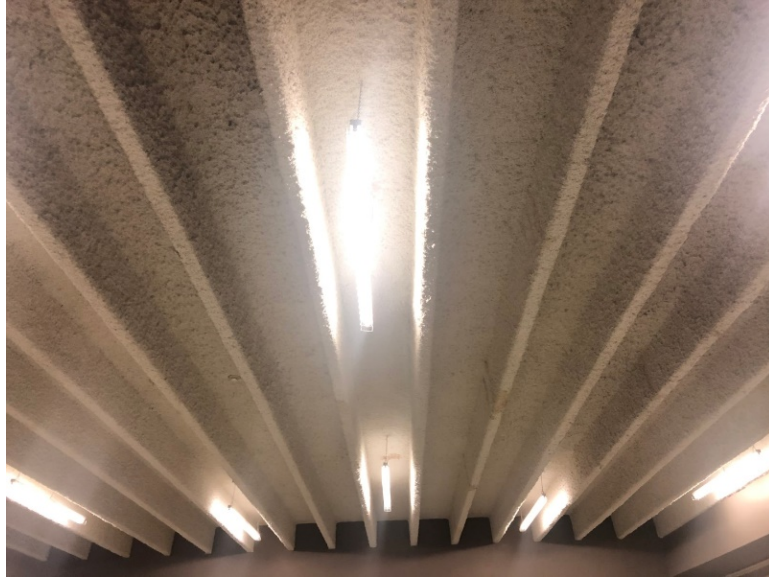
- .10 Paint was peeling from the underside of the roof deck in the daycare, specifically along the south wall, indicating potential moisture issues along this interface.

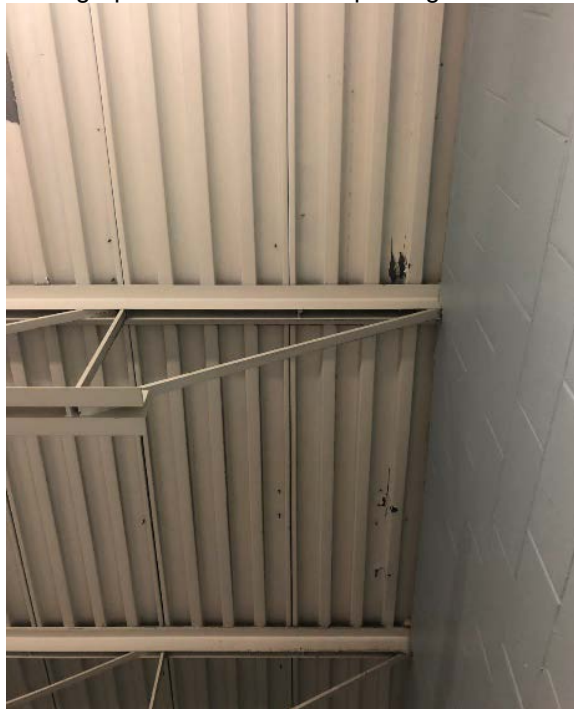
Photograph 3.3.1.12-1: Paint peeling from steel deck.

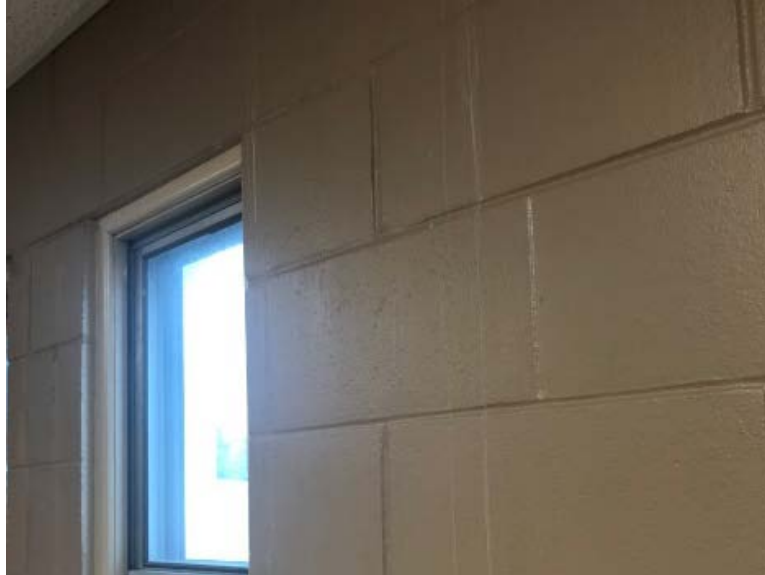
Photograph 3.3.1.13-1: Water staining on concrete block.

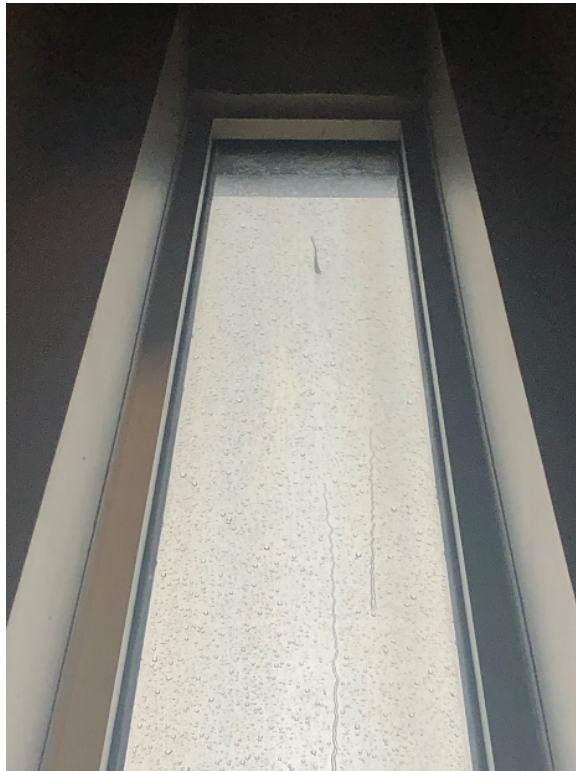
Recommendation 3.3.2.1-1: Existing aluminum ribbon windows along the south elevation are exhibiting sealed unit failure. Short term replacement is recommended to increase thermal performance, visibility, and occupant comfort. It is recommended that associated flashing and sealant replacement and repairs be conducted simultaneously to increase the performance and durability of the window tie into the overall envelope system.

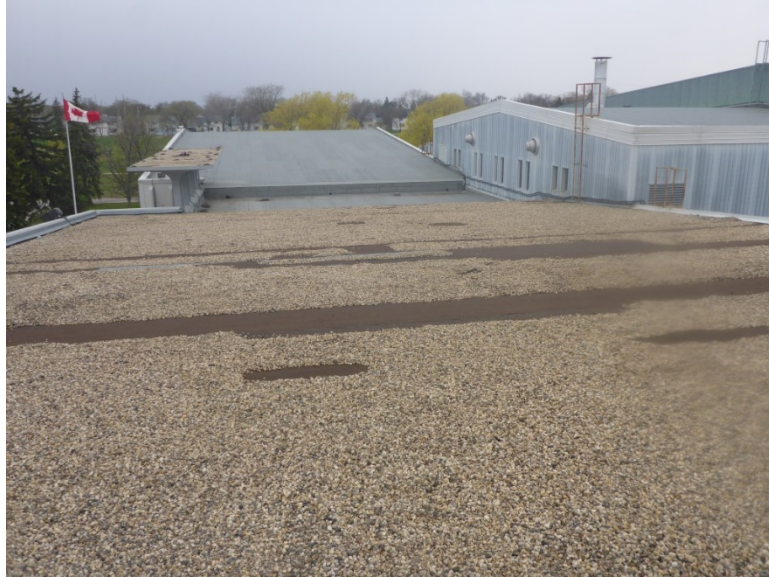
Photograph 3.3.3.1-2: View blister and membrane splits on Roof R8.

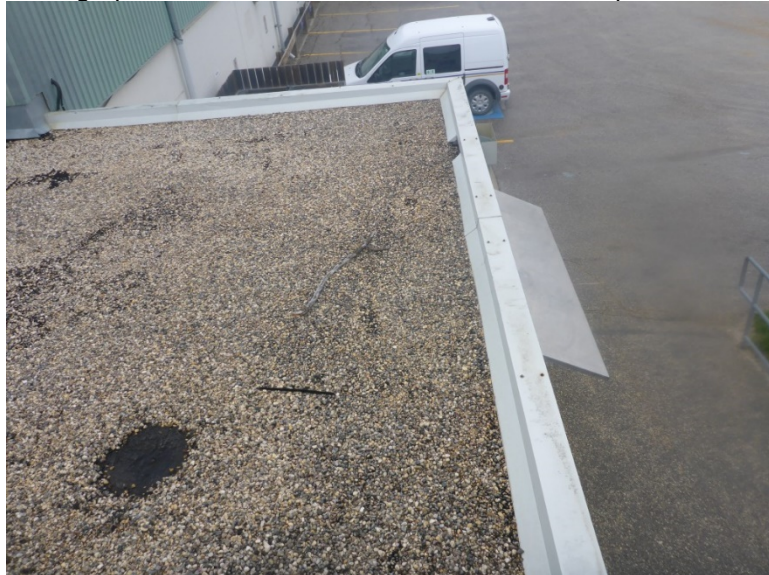
Recommendation 3.3.3.1-1: Replace existing roofs R7, R8, and R10.

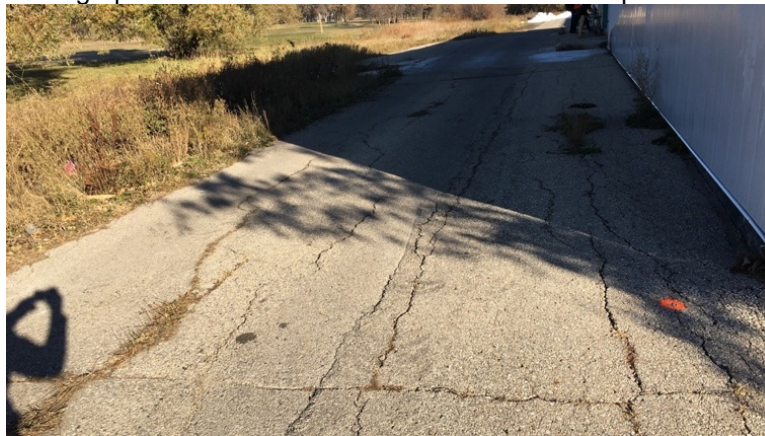
Recommendation 4.1.1.1-1: Complete localized repairs to existing sidewalks and curbs to address potential tripping hazards and deterioration. Repairs will range from localized patches to full depth replacement.

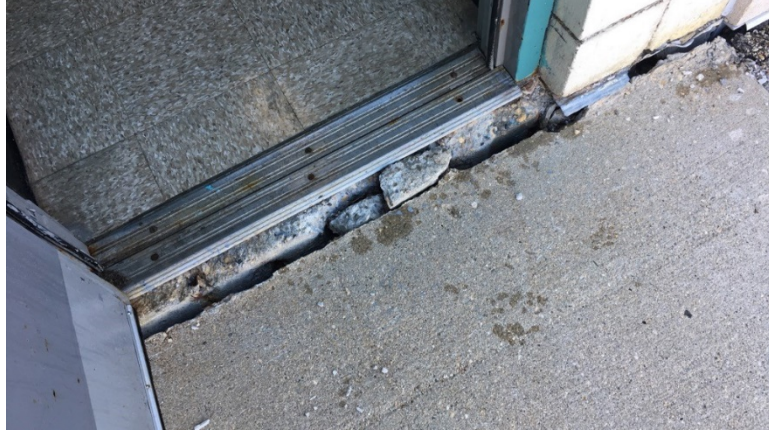
Recommendation 4.1.1.2-1: Complete localized repairs to address concrete deterioration and tripping hazard at transition.

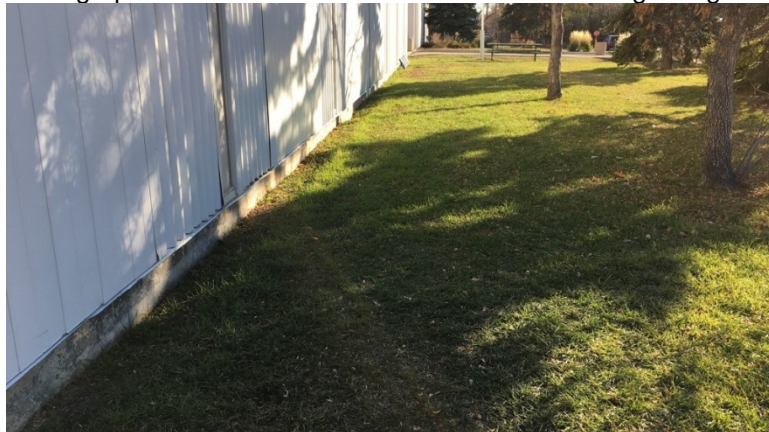
Photograph 4.1.2.2-1: Partial view of south elevation grading.

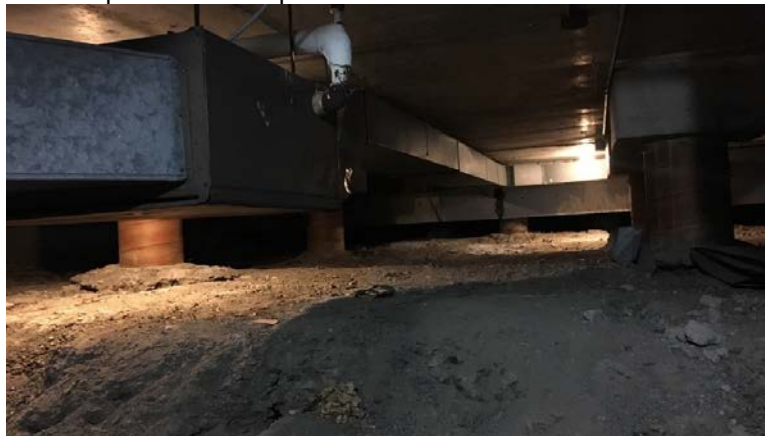
Photograph 4.2.1.1-2: Unfinished crawlspace floor show exposed soil.

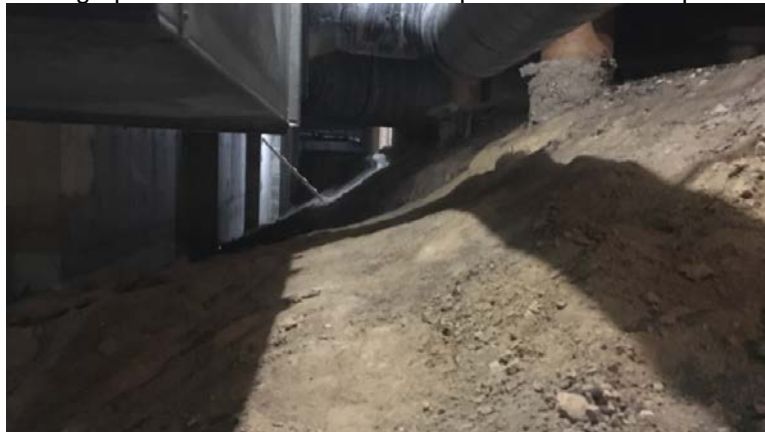
Recommendation 4.2.1.1-1: The crawlspace does not have a functioning vapour barrier. Remediation of the crawlspace is recommended including grading of the existing soil to direct water away from structural members, installation of a new drainage system and

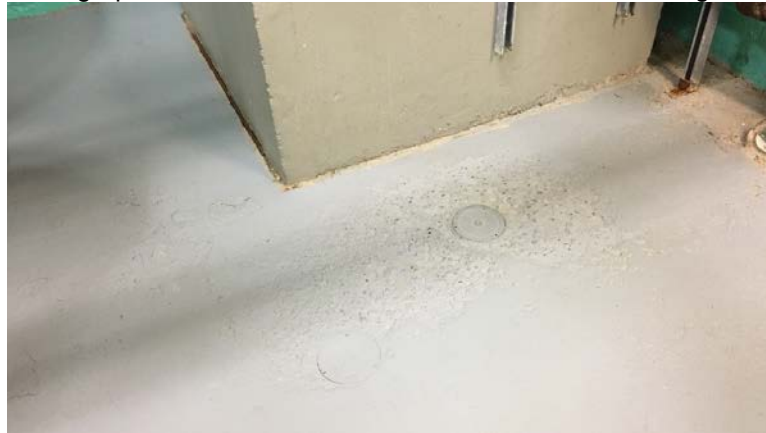
Recommendation 4.2.1.2-1: Complete localized repairs to slab to address miscellaneous surface defects.

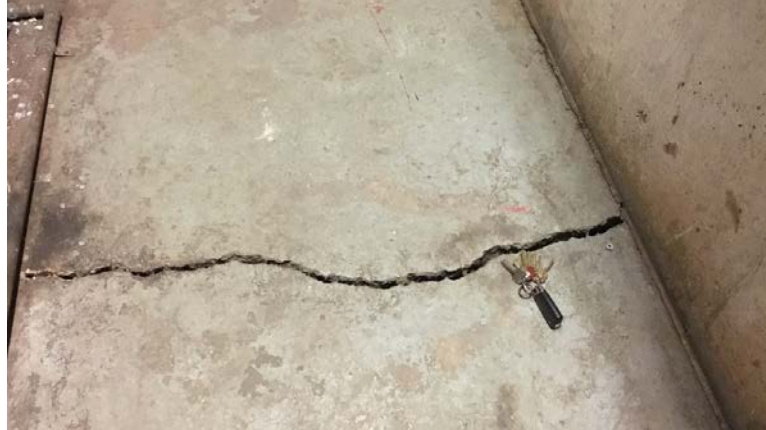
Recommendation 4.2.1.3-1: Complete localized repairs to slab to address miscellaneous surface defects.

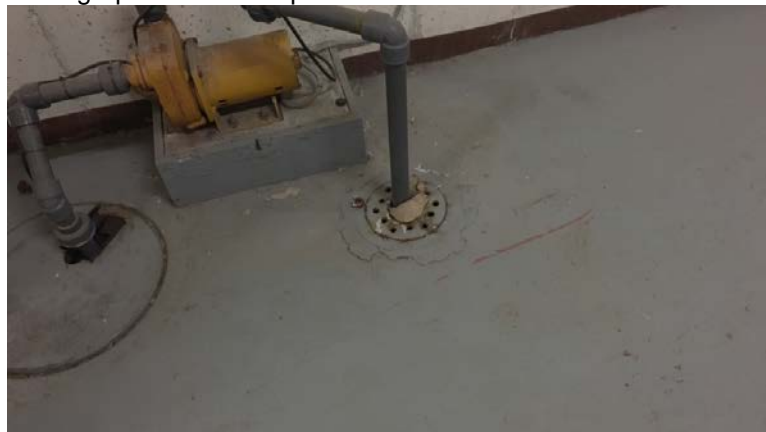
Recommendation 4.2.1.4-1: Complete localized repairs to slab to address miscellaneous surface defects.

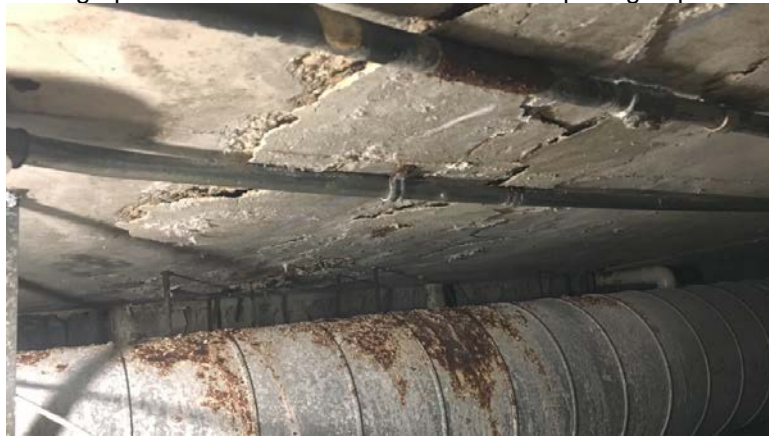
Efflorescence and corrosion staining were observed along the existing construction joints in the pool walls and soffit (Photograph to 4.2.2.1-2). The conditions are caused by water seepage through the joint.

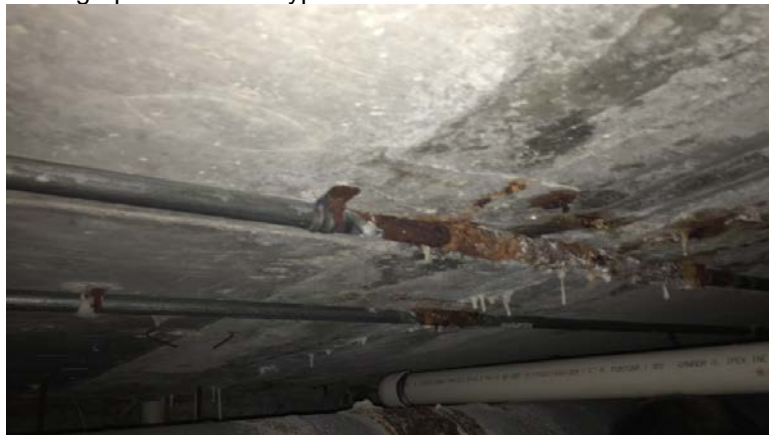
It was reported by on-site personnel that concrete repairs have been completed by City personnel to address deterioration of the pool deck slab (Photograph 4.2.2.1-3). Repairs consisted of chipping out loose concrete patching with a concrete repair material. Further repairs are required around opening in the main floor slab.

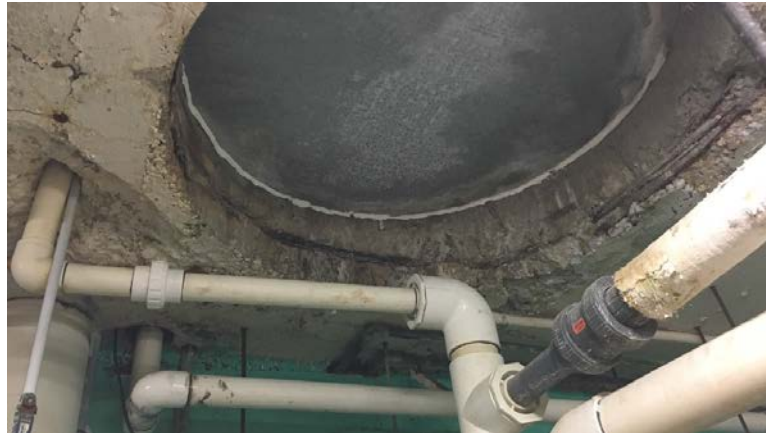
Overall, the deterioration of the concrete is directly related to water seepage through the concrete pool walls. It also indicates that the existing tile is not providing an effective waterproof barrier.

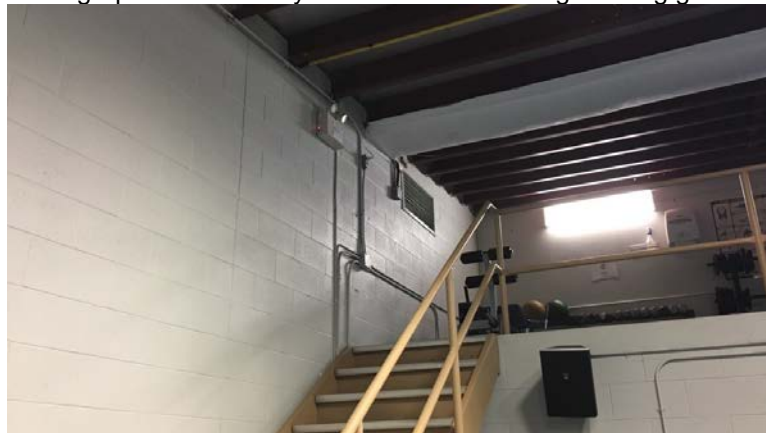
Photograph 4.2.3.1-1: Gym mezzanine showing existing guardrail.
