APPENDIX B
BUILDING CONDITION ASSESSMENT REPORT

prepared by Crosier Kilgour & Partners Ltd.

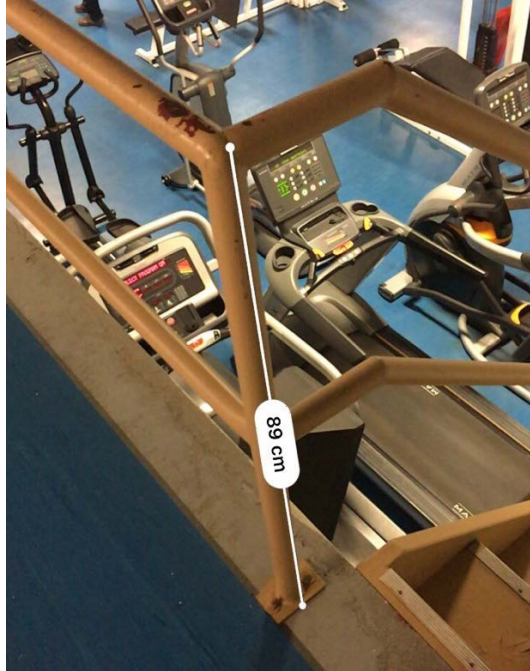
Recommendation 4.2.3.1-1: Upgrade existing guardrail to meet current code requirements.

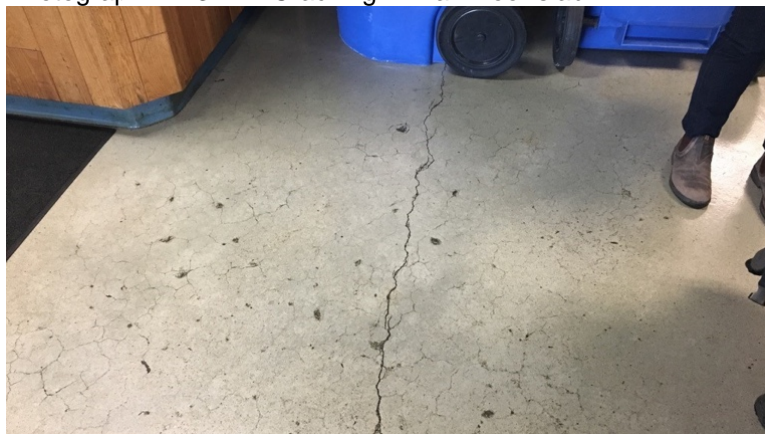
Photograph 4.2.3.2-1: Cracking in main floor slab.

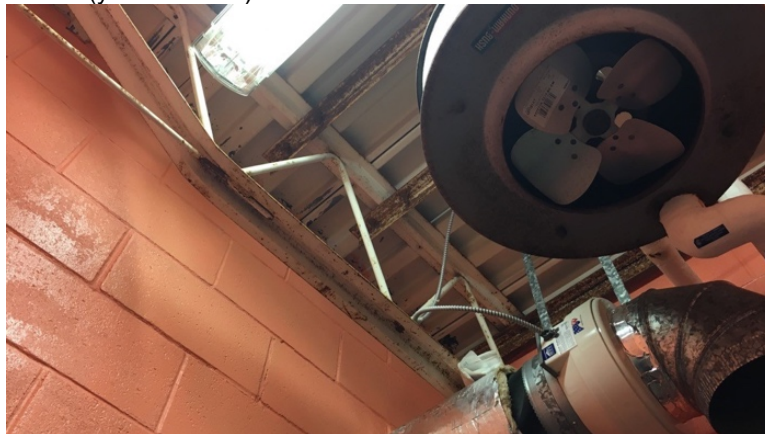
The roof joists are exposed and visible within the change rooms. On-site personnel indicated that the joists and deck were painted approximately 3 years ago with an epoxy-based paint. The joists are generally in good condition however some rust staining showing through.

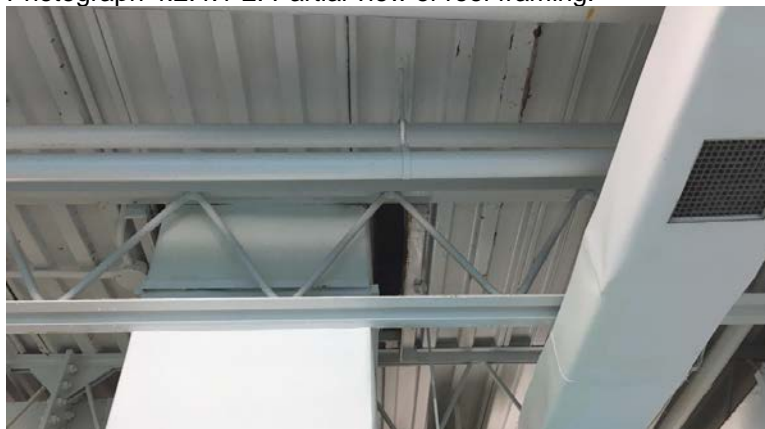
Photograph 4.2.4.1-2: Partial view of roof framing.

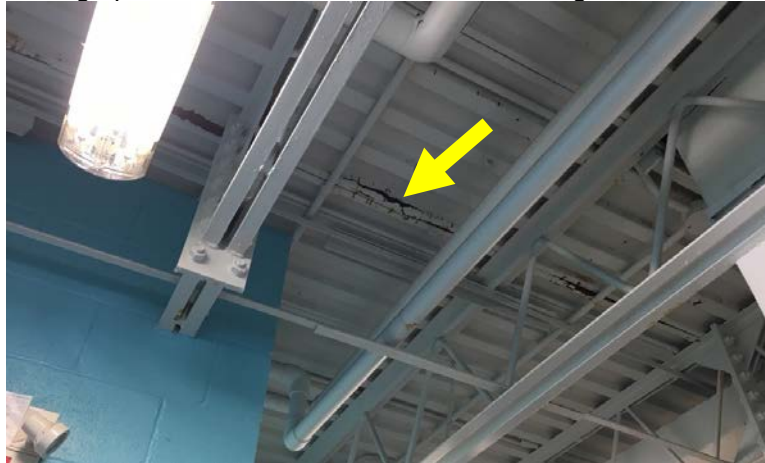
Recommendation 4.2.4.1-1: Minor surface corrosion was visible on structural framing. Removal or corrosion and repainting will be required periodically throughout the life of the structure. Consideration should be given to the environmental conditions which selecting materials. Painting is considered normal maintenance.

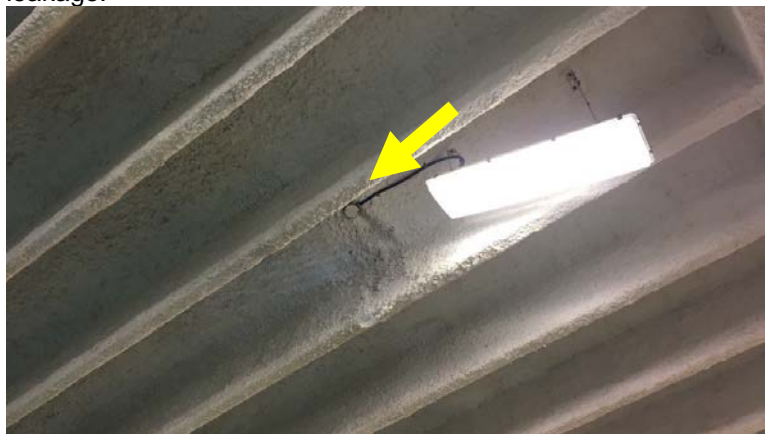
- .3 The gym at the northwest corner is constructed of a pre-engineered steel frame building. The structural framing is in good condition. An active roof leak above gym was observed during the site visit. Refer to Section 3.3.4 for roofing recommendations.

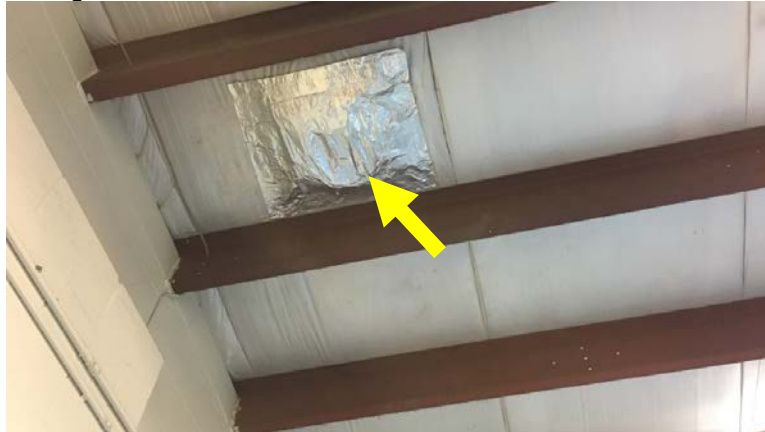
- .4 Leakage reported above corridor. Leakage is reported in the spring. Leakage during summer months was not reported.

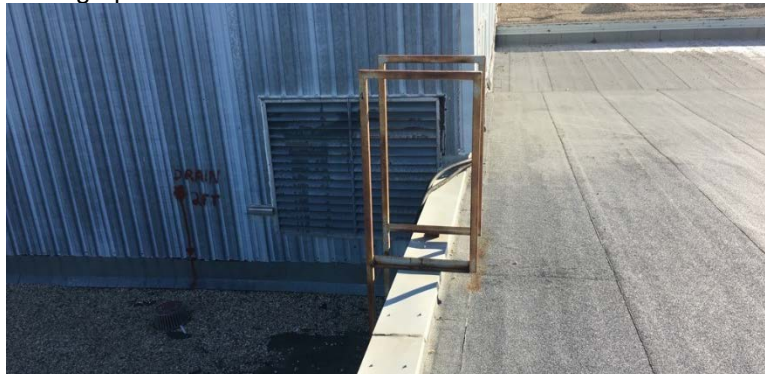
Photograph 4.2.5.2-1: Access ladder from the west roof to south roof.

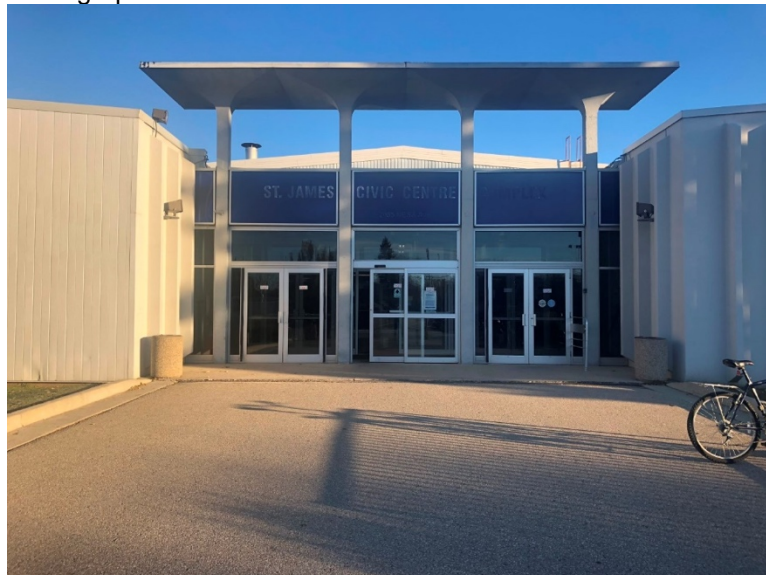
Photograph 4.3.1.3-1: Over-all view of the main entrance at the St. James Civic Centre.

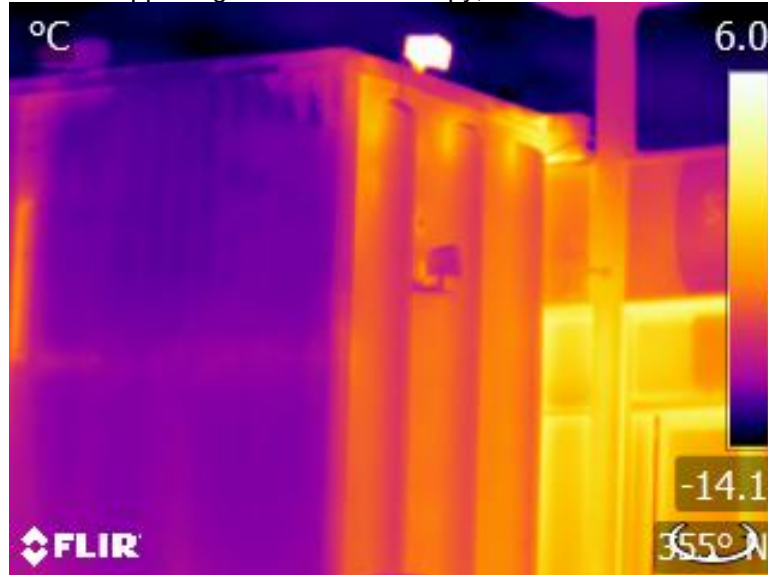
Photograph 4.3.1.3-3: Condensation observed at the existing metal cladding along the West elevation.

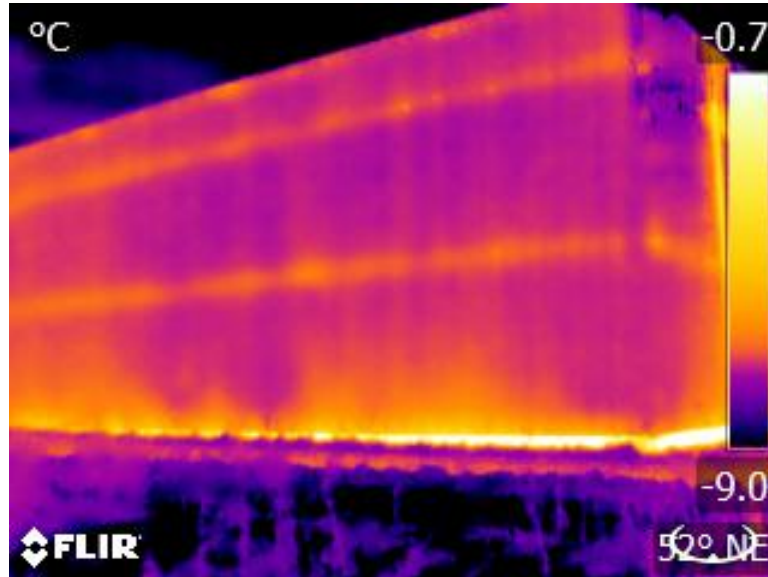
Photograph 4.3.1.3-5: Moisture stains at the existing masonry face block with localized block unit and mortar joint deterioration outside the women's locker/washroom.

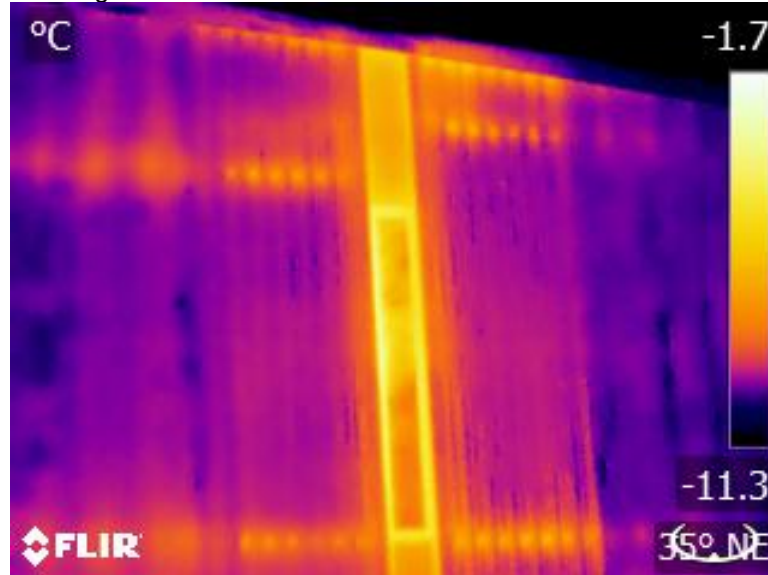
Recommendation 4.3.1.3-1: Remove and replace masonry face block including insulation and vapour permeable air barrier membrane at the exterior of the women's locker/washroom area. Localized repairs of masonry back-up and joint repointing.

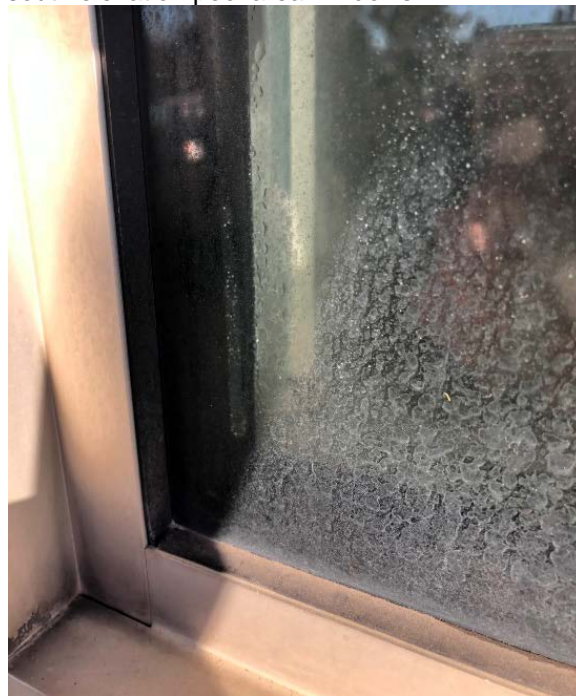
Photograph 4.3.2.1-2: Condensation on the metal panels above the south elevation pool windows.

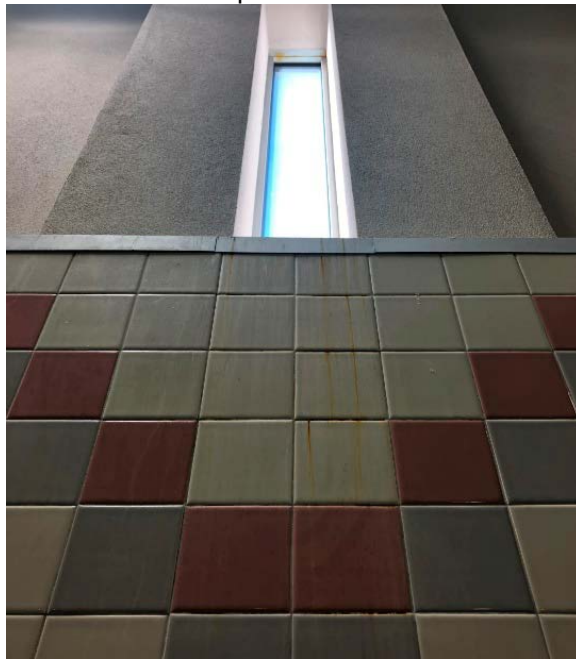
Recommendation 4.3.2.1-1: Existing aluminum ribbon windows along the west end of the south elevation are exhibiting sealed unit failure. Short term replacement is recommended to increase thermal performance, visibility, and occupant comfort. It is recommended that associated flashing and sealant replacement and repairs be conducted simultaneously to increase the performance and durability of the window tie in to the overall envelope system.

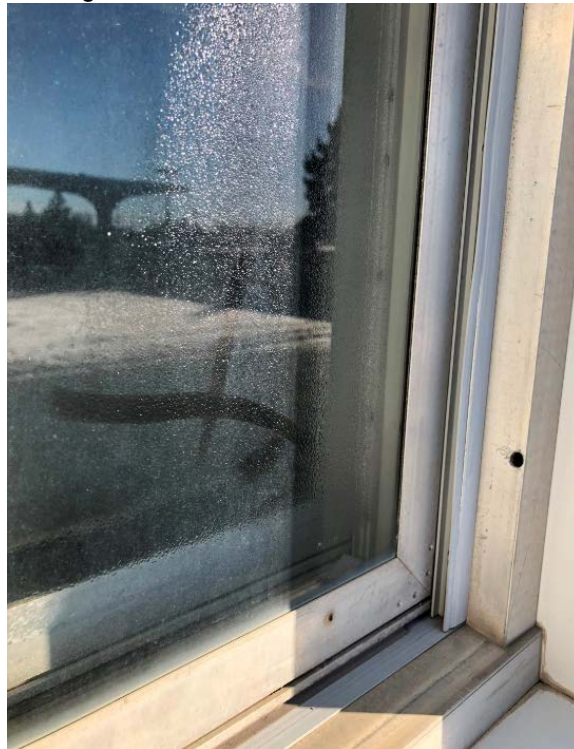
No visible cracks were observed in any of the vertical slider units. There was no sealant installed at aluminum head, sill, and jamb flashing, or around window frame perimeter to flashing interfaces, creating opportunity for bulk water infiltration.

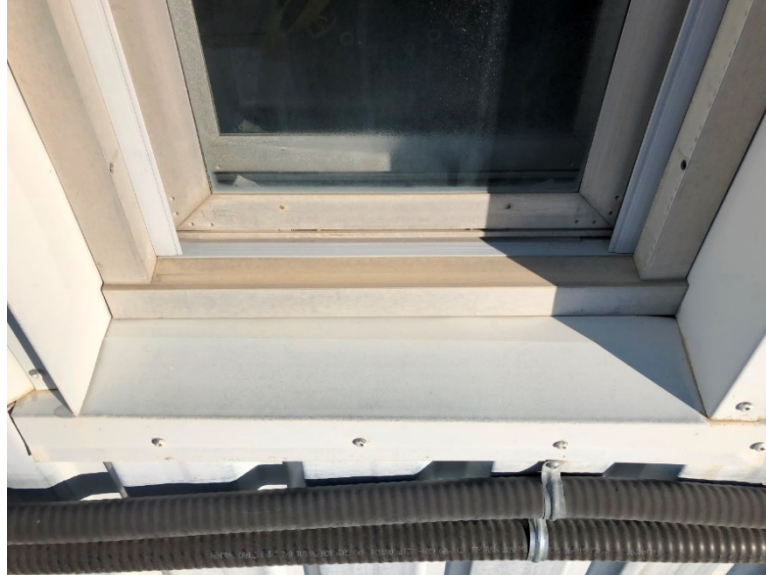
Recommendation 4.3.2.2-1: Existing operable aluminum vertical hung slider windows along the upper storey of the south elevation are not energy efficient or high-performance units. Short term replacement is recommended to increase thermal performance, visibility, and occupant comfort. It is recommended that associated flashing and sealant replacement and repairs be conducted simultaneously to increase the performance and durability of the window tie into the overall envelope system.

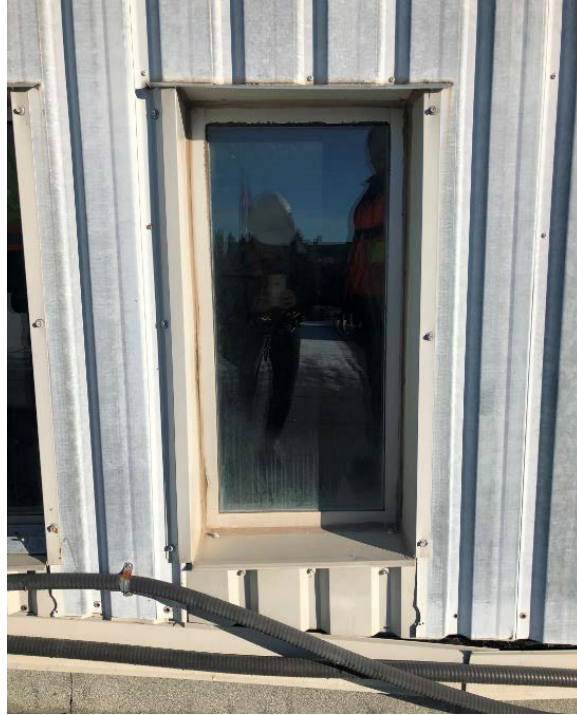
Sealant at flashing interfaces is degraded due to environmental exposure, including cracking and stiffening of the sealant, creating opportunity for bulk water infiltration.

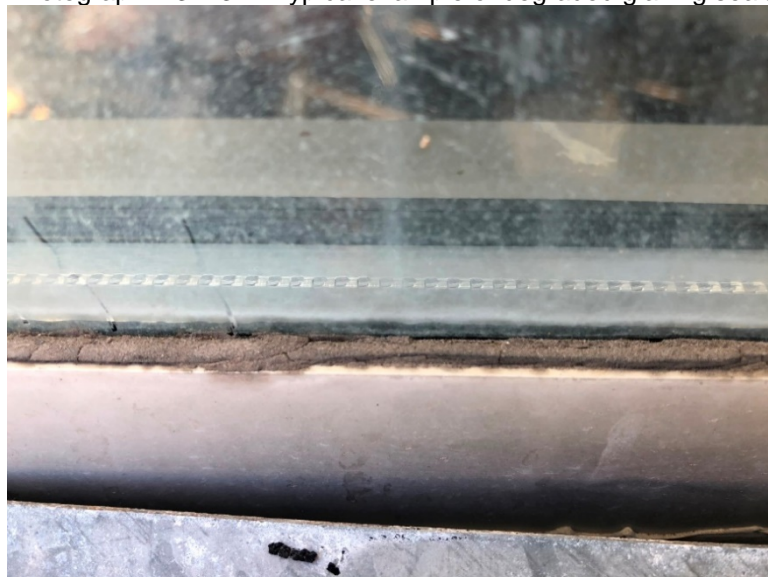
Photograph 4.3.2.3-3: Typical example of degraded glazing sealant and mildew growth at head and upper portion of the jambs.

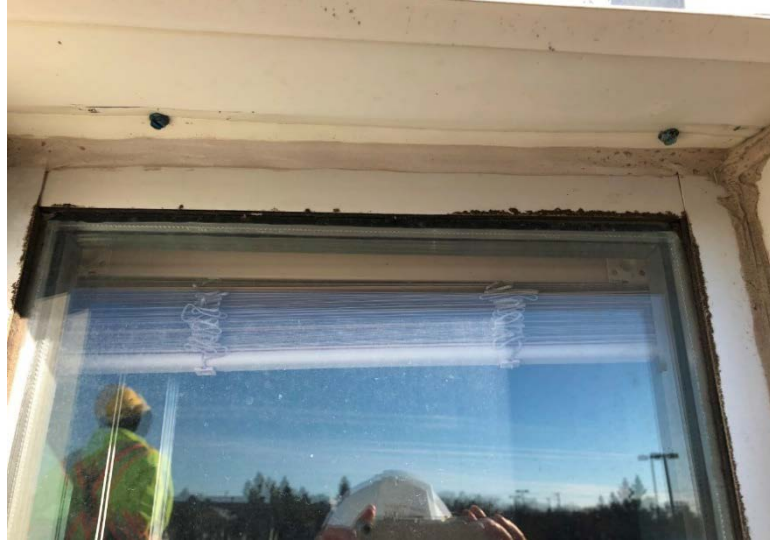
Photograph 4.3.2.3-4: Typical example of degraded sealant at flashing interfaces.

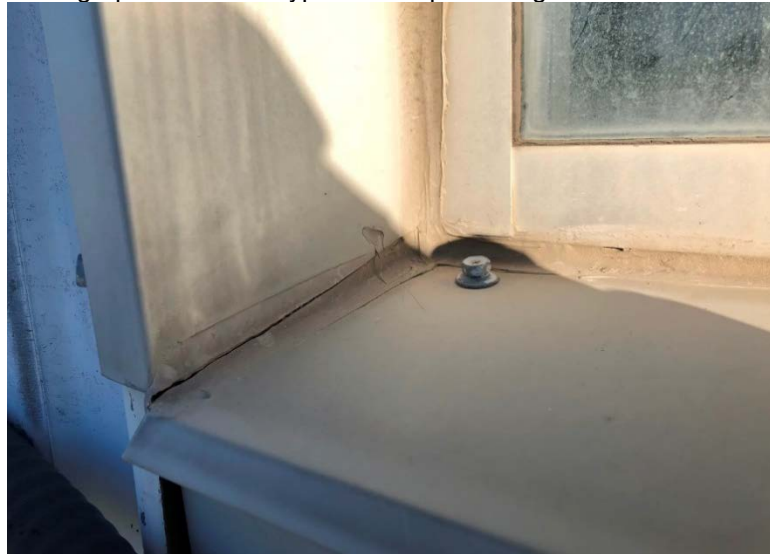
Recommendation 4.3.2.3-1: Existing aluminum framed interior glazed ribbon windows along the upper storey of the south elevation are nearing their expected service life of 25 years. Short term replacement is recommended to increase thermal performance, visibility, and occupant comfort. It is recommended that associated flashing and sealant replacement and repairs be conducted simultaneously to increase the performance and durability of the window tie in to the overall envelope system.

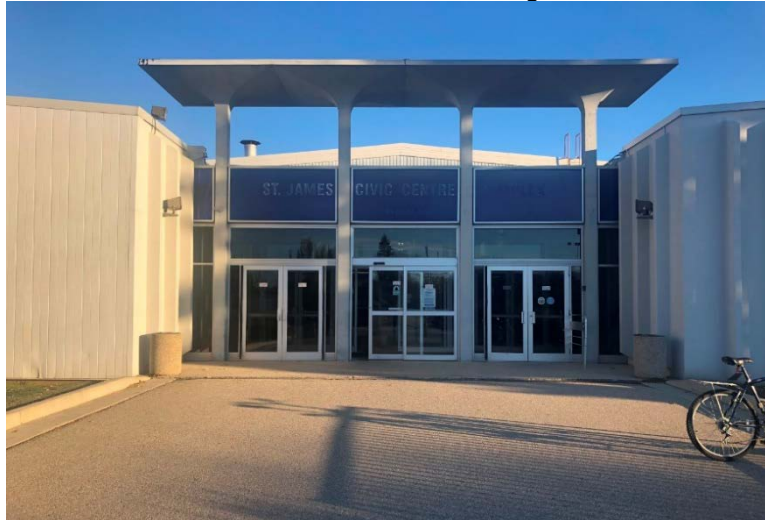
Though the sealed units did not exhibit visible evidence of seal failure, though frost point testing of three of the 11 window units revealed seal failure in each instance. Significant water staining was observed on the interior aluminum frames and adjacent surfaces, indicating areas potentially prone to condensation.

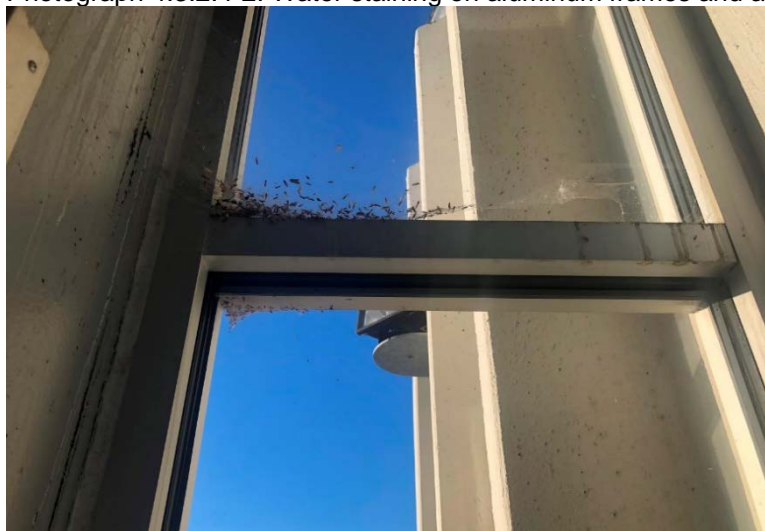
Photograph 4.3.2.4-2: Water staining on aluminum frames and adjacent surfaces.

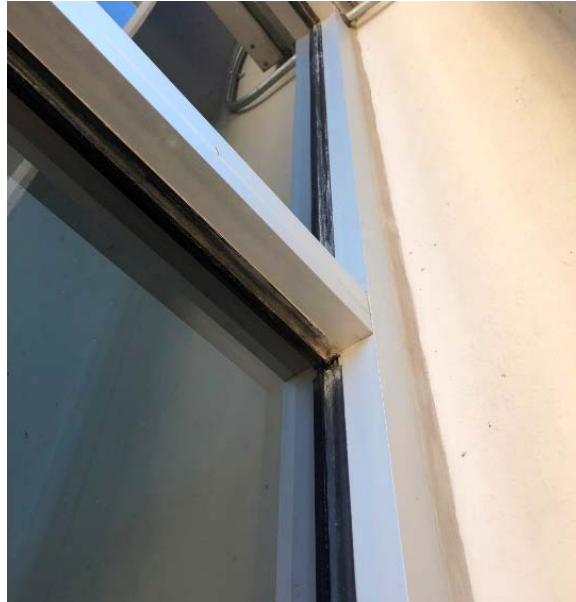
Sealant applied to the exterior frame to wall interfaces was deteriorated and separating from the wall surface, creating opportunity for bulk water infiltration. Similar conditions were observed on the interior surfaces.

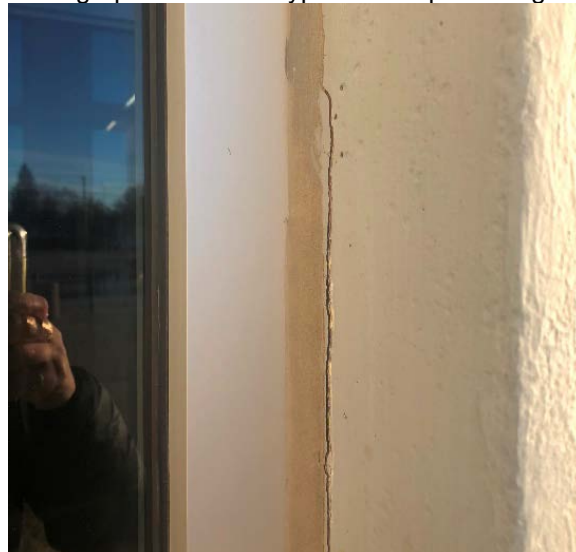
Photograph 4.3.2.4-4: Typical example of degraded sealant at frame to wall interface.

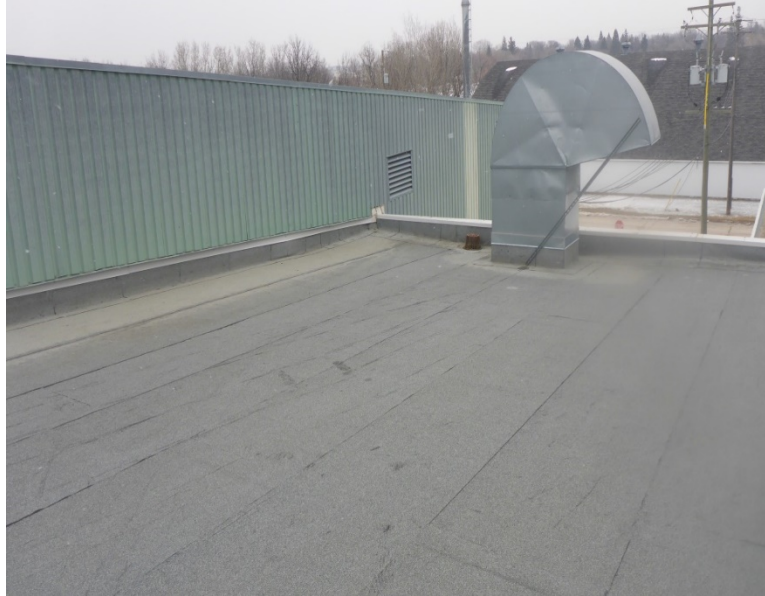
- .2 The low roof R5 (Photograph 4.3.3.2-1) and canopy roof R12 (Photograph 4.3.3.2-2) are in poor condition. Drainage on the pool roof R9 is satisfactory to the interior drains. Currently the roof shows exposed membrane throughout and areas of ponding water. We observed multiple repairs on the existing curbs and roof penetrations (Photograph 4.3.3.2-3). The existing roof system is a typical 4-ply asphaltic membrane, fiber support panel, expanded polystyrene insulation, organic felt vapor barrier on a gypsum support panel.

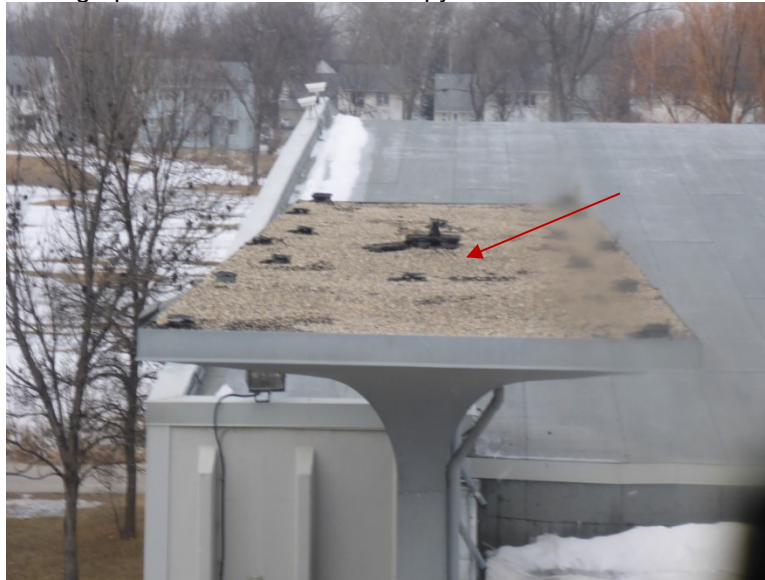
Photograph 4.3.3.2-2: View of canopy roof R12.

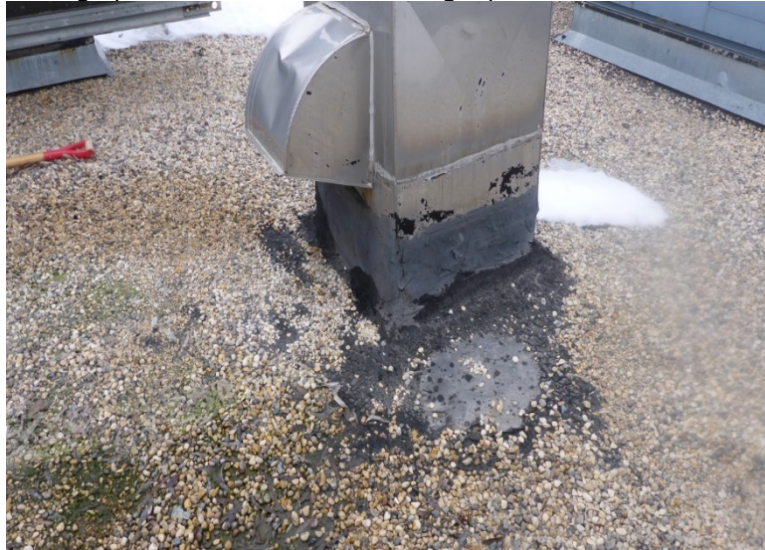
- .3 The metal roof systems R3 and R4 (Photograph 4.3.3.3-1) are in poor condition. The existing roof system is a typical metal standing seam roof panel, with underlying blanket insulation. The existing assembly is original to this roof facet and is near the end of its service life. We observed several repairs, randomly throughout the metal panels. Due to the age of the galvanized panels and minor defects, further repair will be necessary to extend the roof system life cycle. We observed openings at the roof penetrations and roof wall interface that has allowed water to infiltrate into the building.

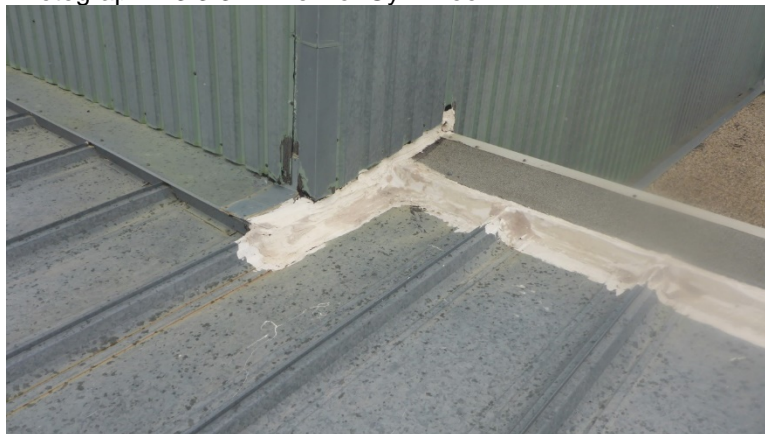
Photograph 4.3.3.3-1: View of Gym Roof R4.

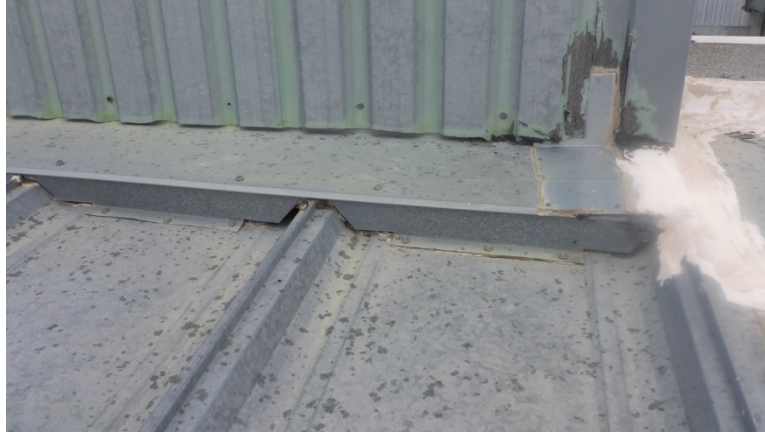
Photograph 4.3.3.3-2: Showing repair at roof wall interface.

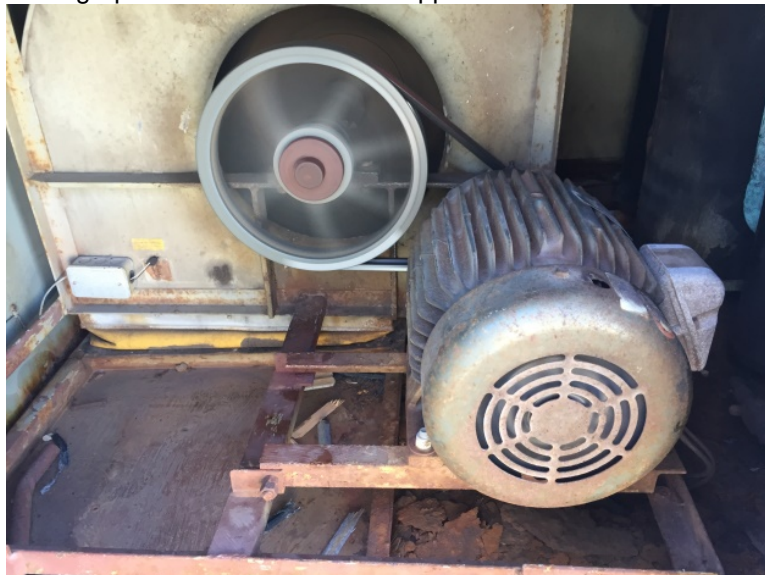
Photograph 4.4.1.1-1: Corroded supports for fan motor

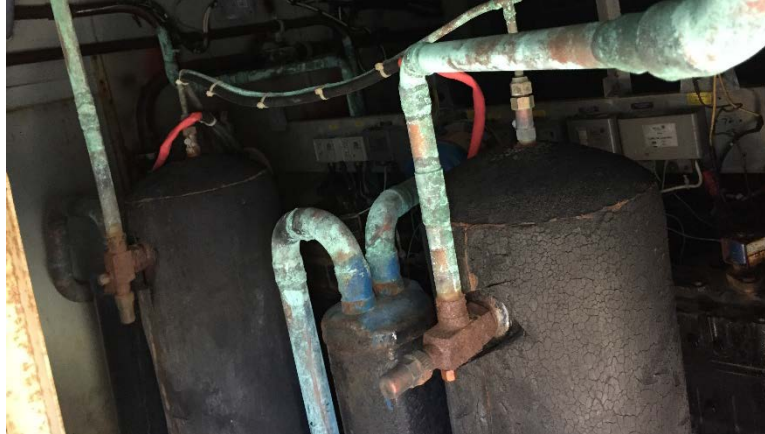
Currently warm humid pool air is returned to AHU-2, located on the roof, where it is mixed with preheated fresh air before being reintroduced back to AHU-1 located in the basement. With the failure of the mechanical cooling, there is no longer any provision for mechanical cooling. Conditioning relies on exhaust from the change rooms and introduction of equivalent fresh air to control humidity levels. No dedicated exhaust or relief for pool deck area and no controlled system is in place to reduce or relieve humidity from pool deck leads to:

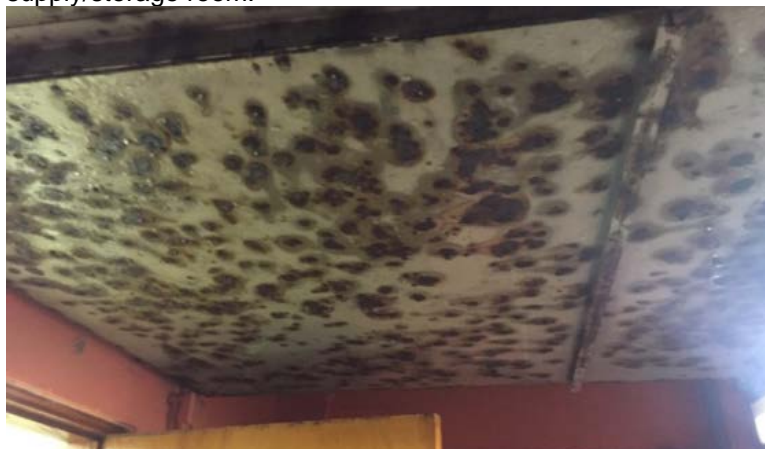
Photograph 4.4.1.1-3: Discoloured, corroded and pitted ductwork exposed in pool supply/storage room.

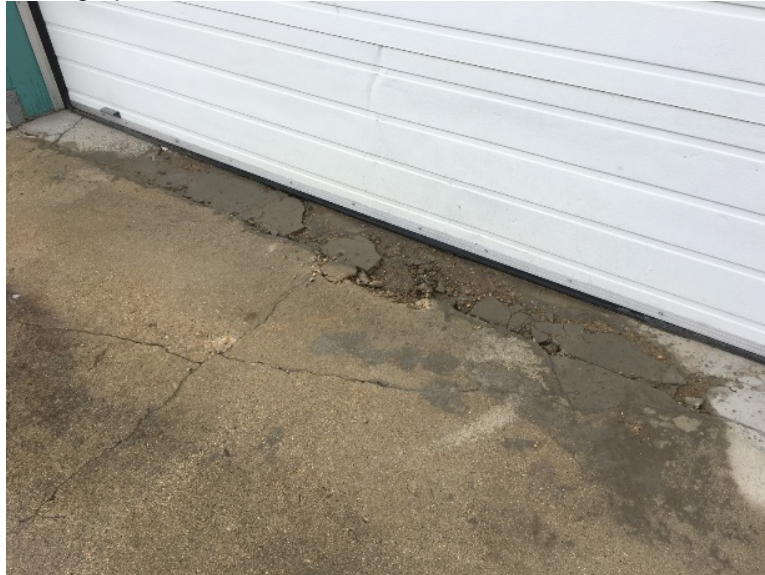
Recommendation 5.1.1.1-1: Complete localized concrete repairs.

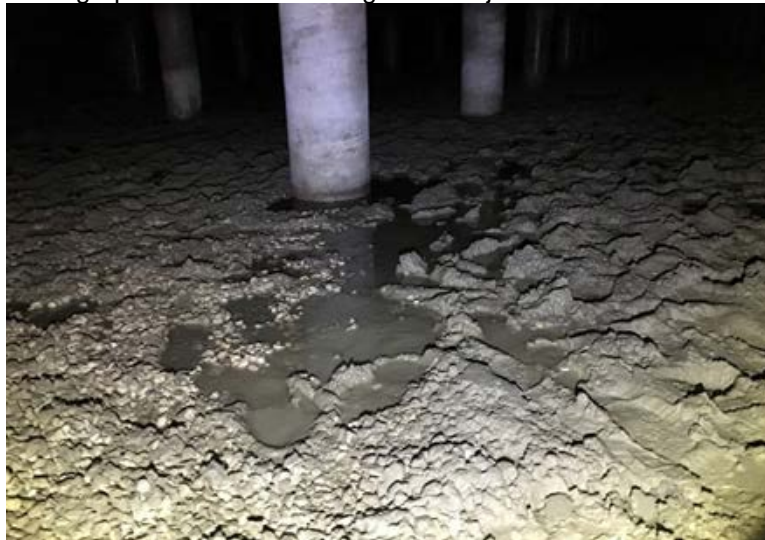
Photograph 5.2.1.1-2: Standing water adjacent to column.

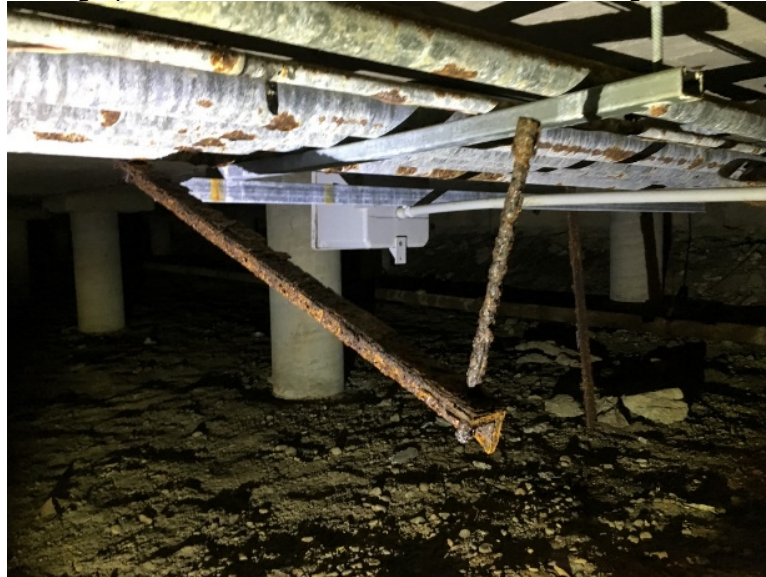
Photograph 5.2.1.1-3: Corrosion of conduits and hangers.

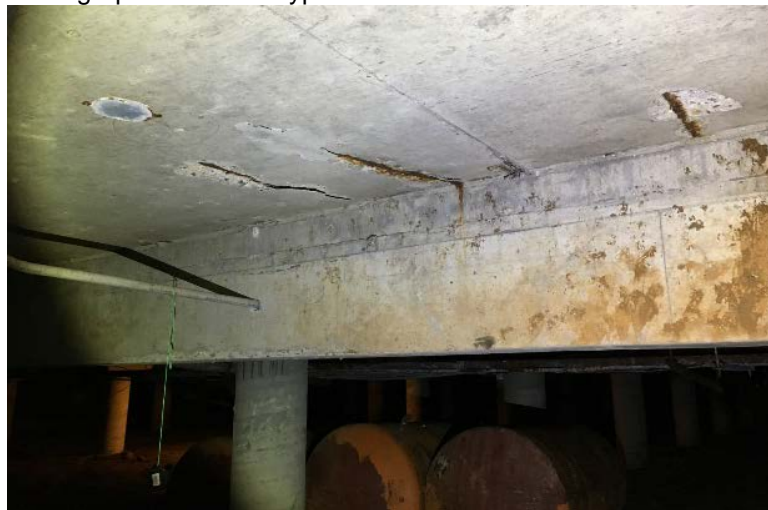
Recommendation 5.2.1.2-1: Complete structural concrete repairs. Structural concrete repairs are required to address existing deterioration. Repairs are required in the short term to address existing deterioration. Repairs will include removal of all loose concrete down to a sound substrate, exposing all corroding reinforcing steel, sandblasting existing concrete and reinforcing steel, and infilling with a proprietary concrete repair material.

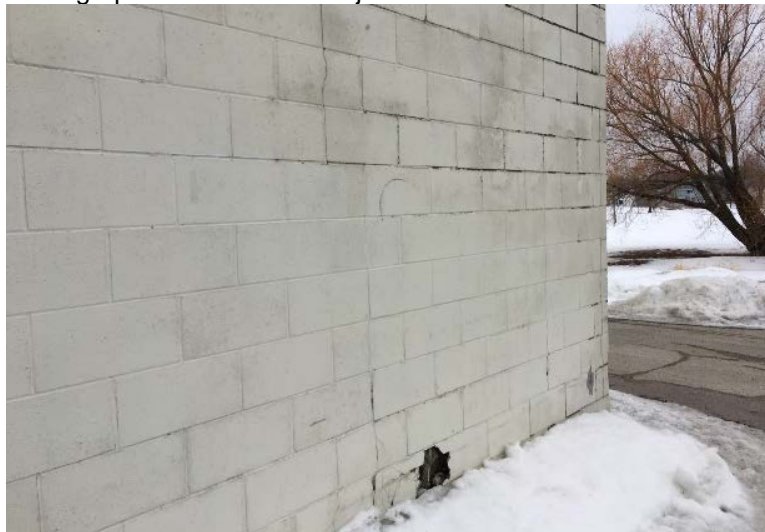
Photograph 5.2.1.3-2: Mortar joint deterioration of exterior concrete block walls.

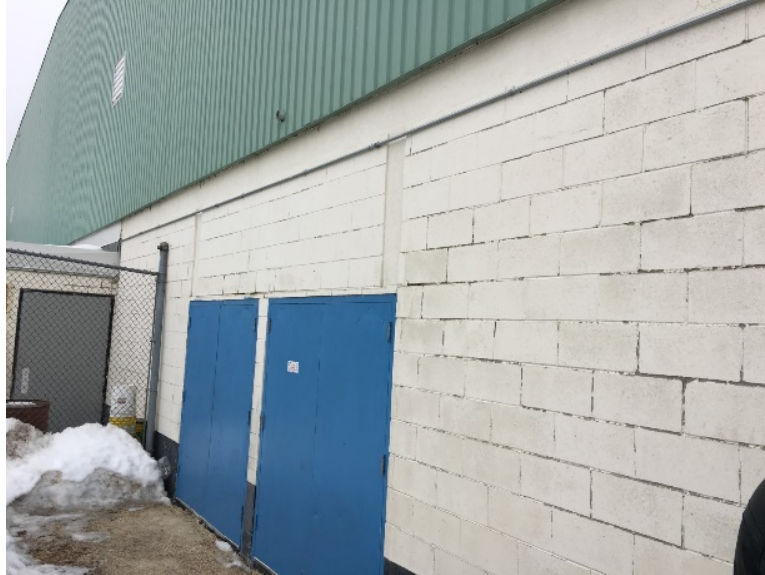
Recommendation 5.2.1.3-1: The exterior concrete block walls are in fair to poor condition. Repairs are required in the short term to address deterioration of the mortar joints and masonry control joints.

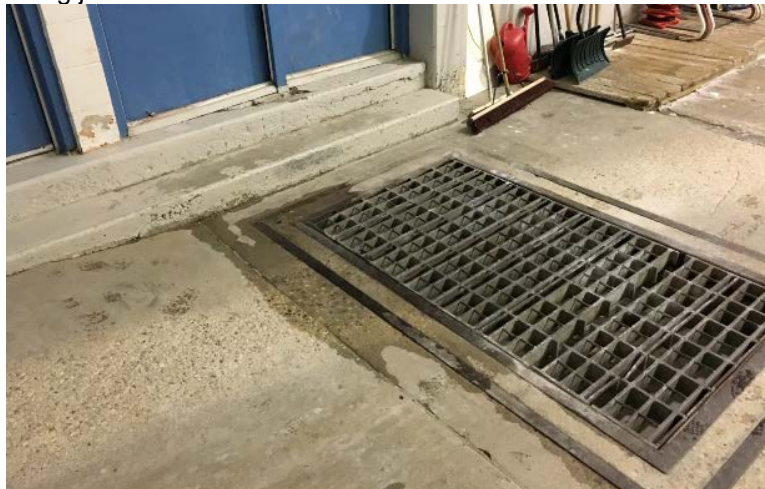
Photograph 5.2.1.4-1: Surface deterioration around snow melt pit. Concrete deterioration along joint and door sill.

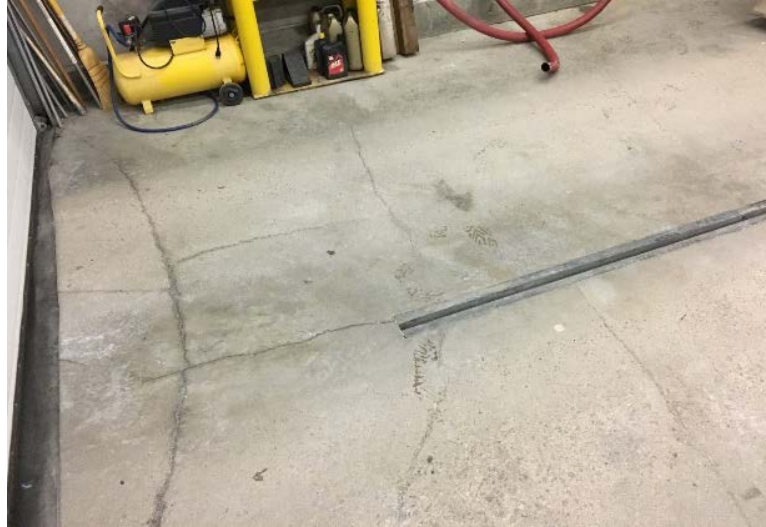
Recommendation 5.2.1.4-1: Installation of protective measures such as a penetrating silane sealer or waterproofing membrane should be considered in the long term.

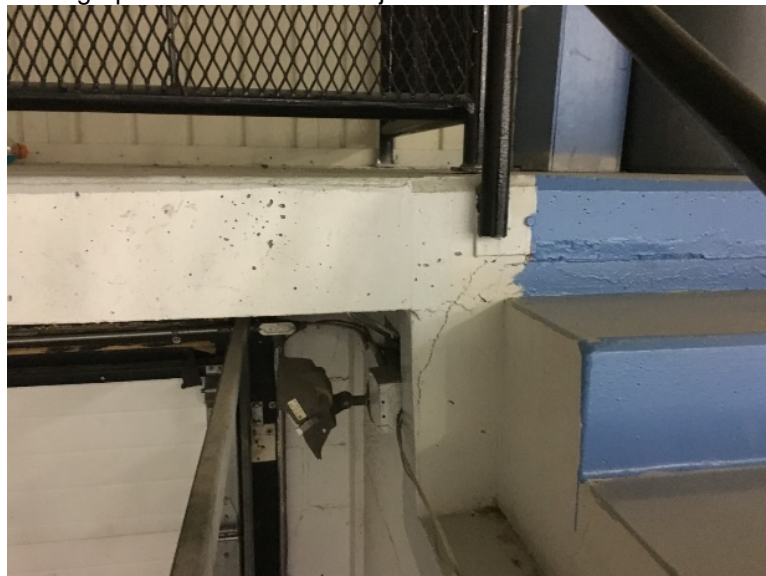
Photograph 5.2.1.5-1: Crack at joint between concrete bleachers and landing.

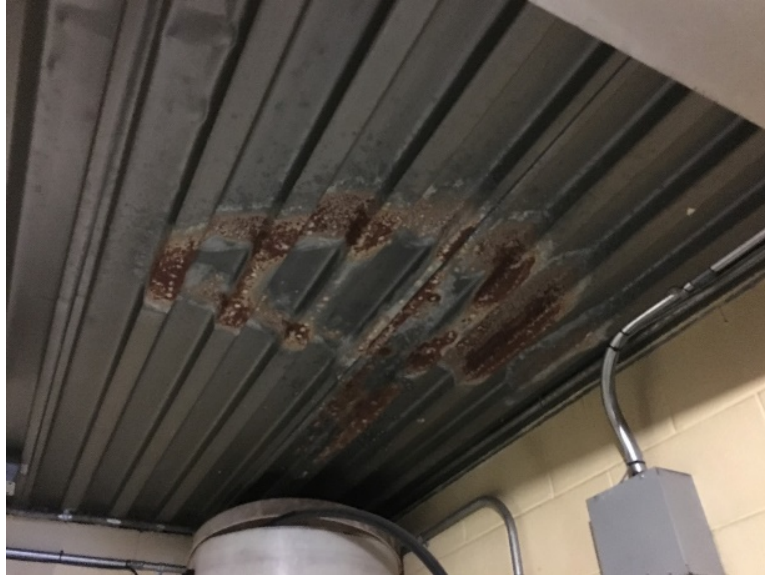
Recommendation 5.2.1.6-1: Removal of the corrosion and painting of the deck is recommended to address existing corrosion.

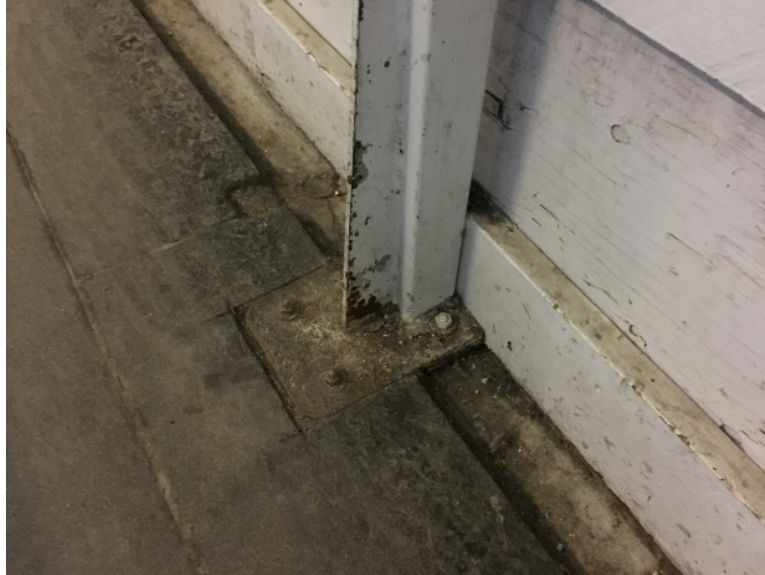
Recommendation 5.2.1.7-1: Periodic repairs and painting will be required.

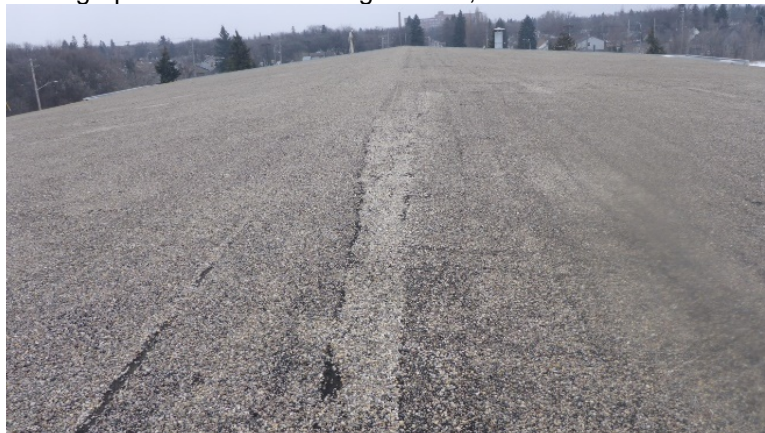
Photograph 5.3.2.1-1: Showing R1 roof, view of arena.

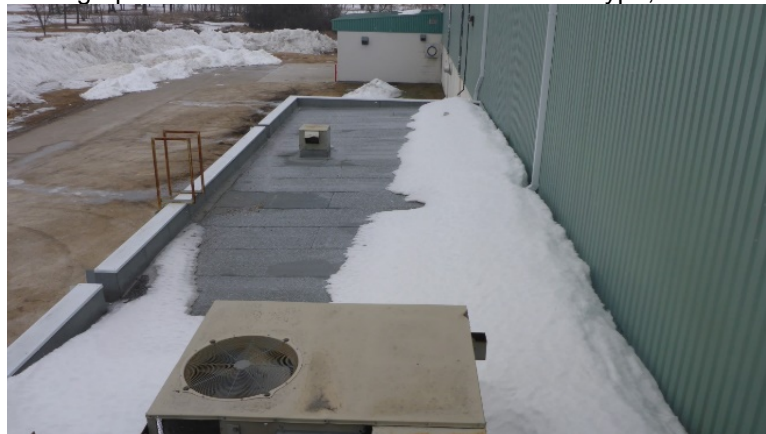
Recommendation 5.3.2.2-1: Annual maintenance required.

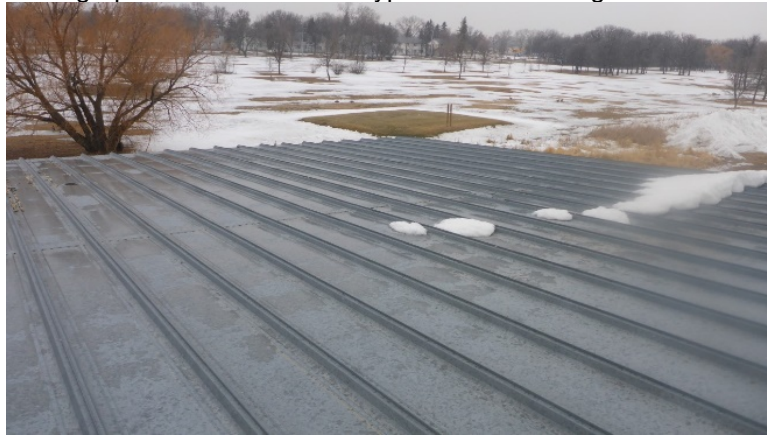
Photograph 5.3.2.3-2: Typical repair on a metal panel.

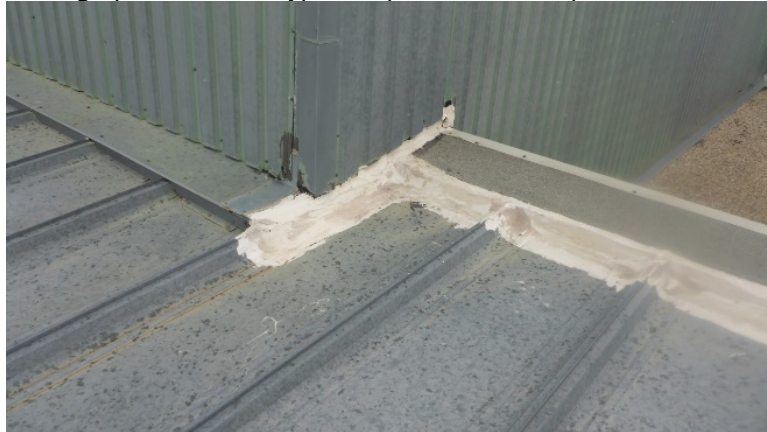
Recommendation 5.3.2.3-1: Annual maintenance required.
