<p>METRIC <small>WHOLE NUMBERS INDICATE MILLIMETRES DECIMALIZED NUMBERS INDICATE METRES</small></p>	B.M. ELEV.	DESIGNED BY: M.M.		<p>CITY OF WINNIPEG PUBLIC WORKS DEPARTMENT ENGINEERING DIVISION</p>
		DRAWN BY: J.G.W.		
		CHECKED BY: D.N.B.		
		APPROVED BY: D.N.B.		
		AUTHORIZED BY:		
	1 ISSUED FOR ADDENDUM 2 15/05/20 J.W.	ORIGINAL SIGNED BY M. MADY	BID OPPORTUNITY NO.: 163-2020	ARLINGTON OVERPASS (CPR YARDS) 2020 STRUCTURAL STEEL REPAIRS
	0 ISSUED FOR TENDER 27/04/20 J.W.	M. MADY BRIDGE MAINTENANCE ENGINEER		STRUCTURAL STEEL AND MISCELLANEOUS DETAILS (1 OF 6)
	REVISION DATE BY

SHEET 7 OF 12
 HORIZONTAL: N.T.S.
 VERTICAL: N.T.S.
 CITY DRAWING NUMBER: B106-20-07

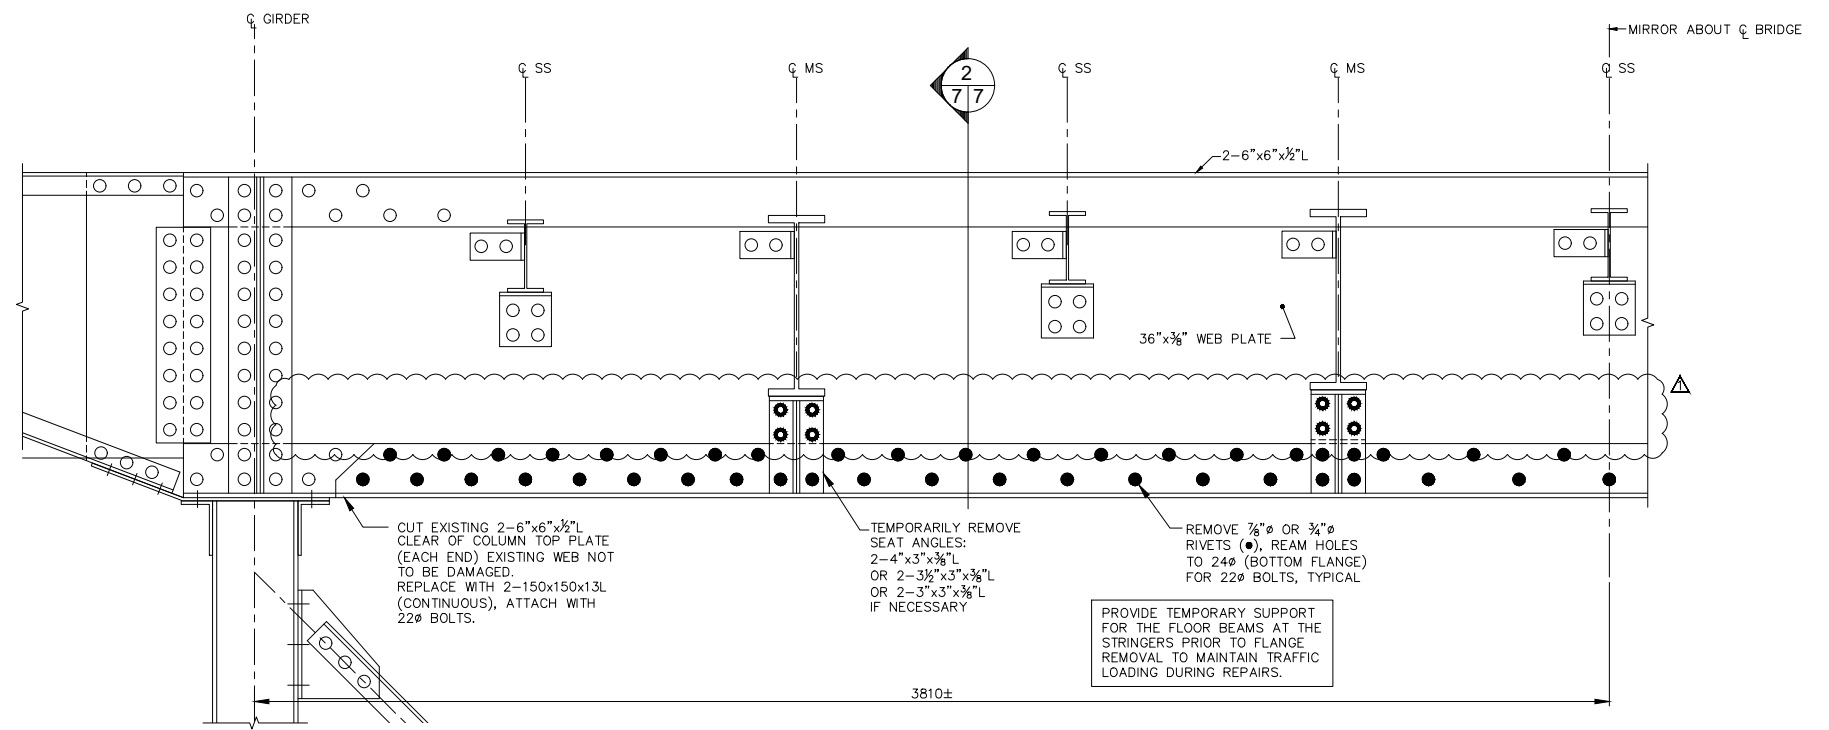
SECTION @ APPROACH SPAN - SHOWING FLOOR BEAM - TYPE 1 REPAIR
 SCALE N.T.S. *REPAIR AT SUBSTRUCTURE UNIT IS SHOWN. REPAIR AT INTERMEDIATE FLOOR BEAM IS SIMILAR

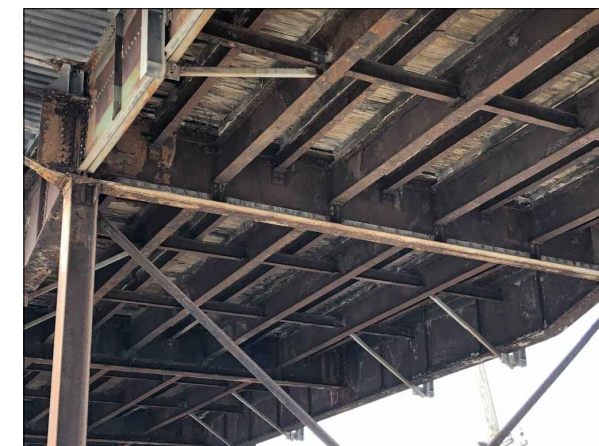
EXISTING CONDITION OF DIAPHRAGM BEAM ABOVE JARVIS AVENUE
