INSPECTION REPORT

PROJECT Shoal Lake Aqueduct
Program 2.7 Aqueduct Overflow Inspections
Mile 83 Overflow Structure

DATE October 15, 2000

OWNER The City of Winnipeg,
Water and Waste Department

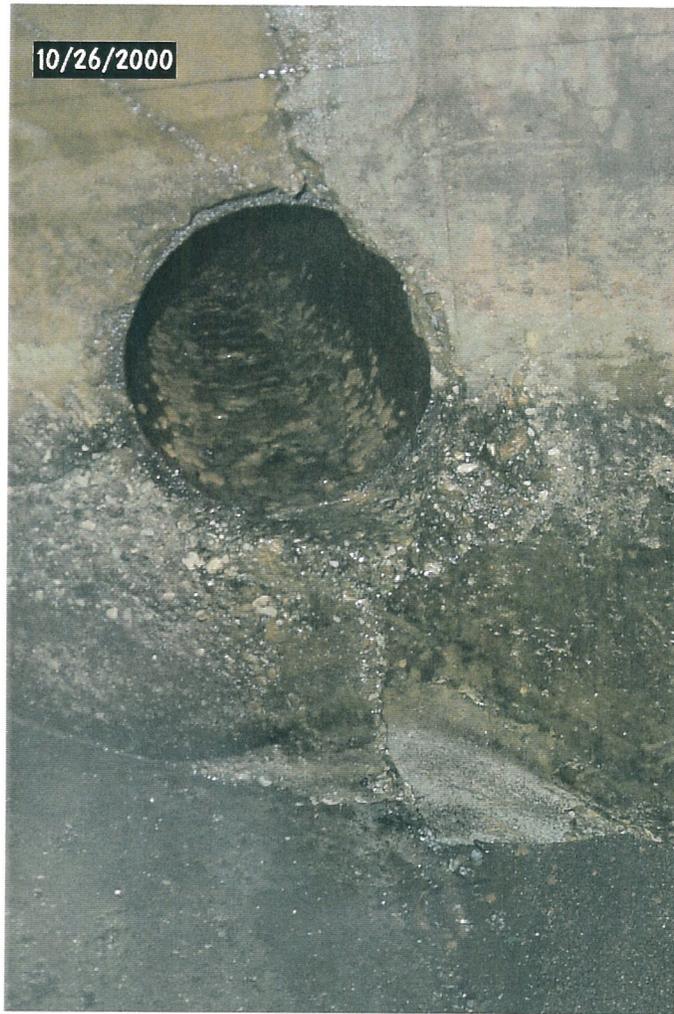
Mile 74 Aqueduct Drain

- Excellent condition. No visible cracks or honeycomb. Concrete appears to be sound.
- Flap gate on Aqueduct drain has surface corrosion, but operates freely and appears to seat well.

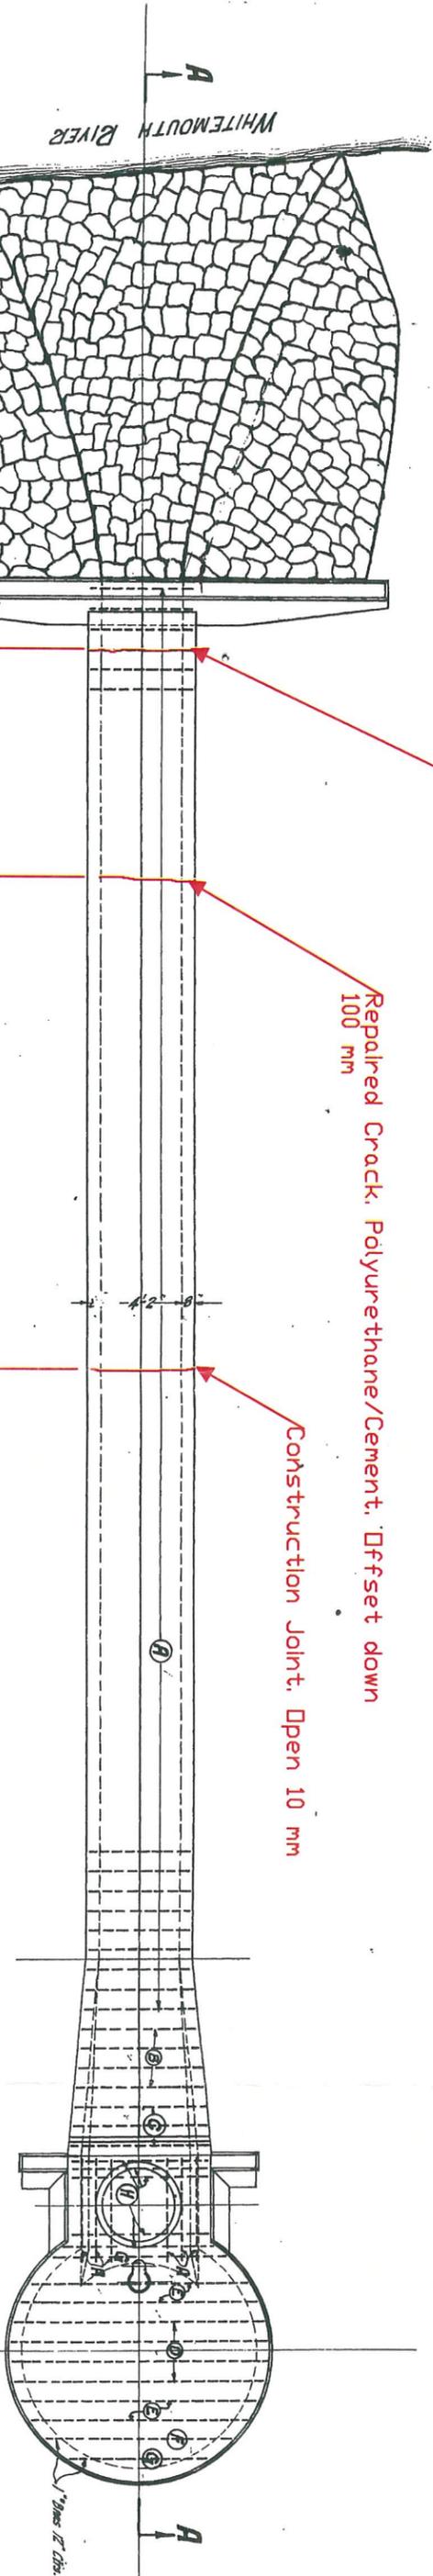
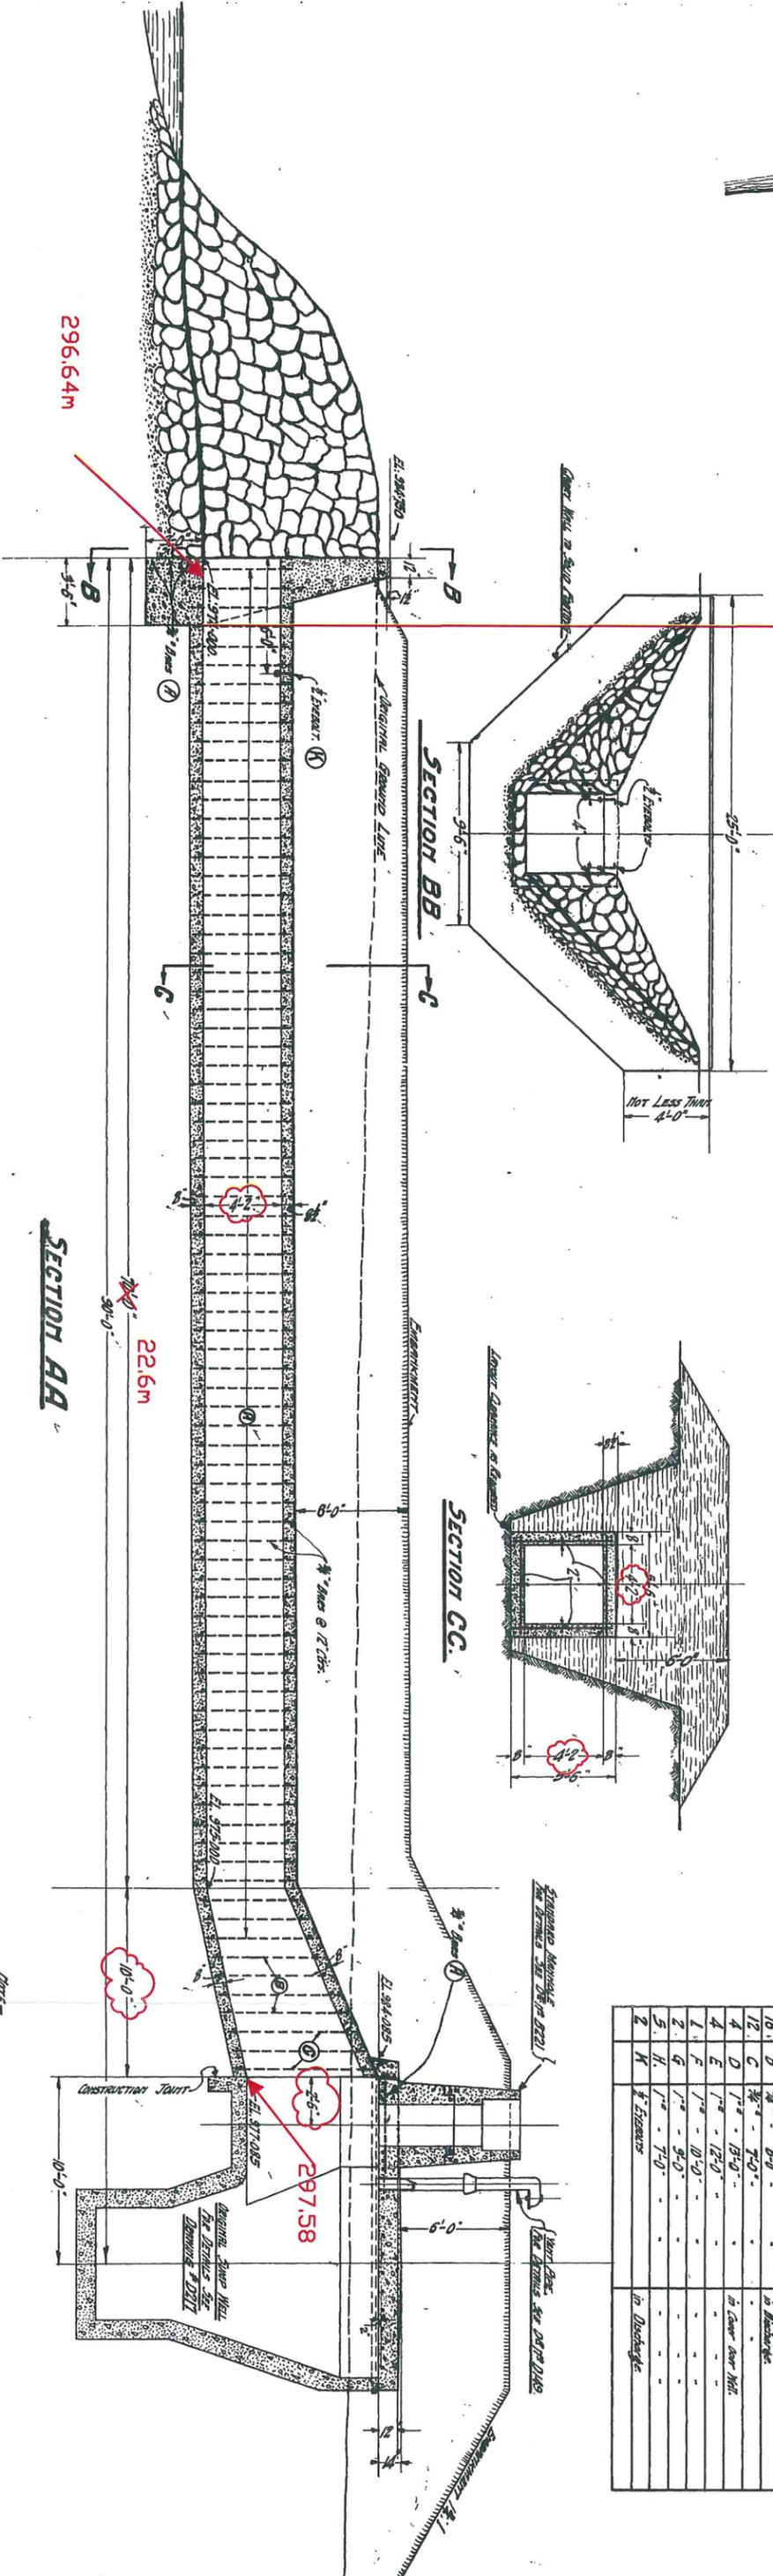
GREATER WINNIPEG WATER DISTRICT
 COVERED DISCHARGE FOR WHITEMOUTH RIVER
 OVERFLOW STRUCTURE

Repaired crack, Polyurethane/cement. 2- 'U' channels bolted on ceiling

Repaired Crack, Polyurethane/Cement. Offset down 100 mm

Construction Joint. Open 10 mm
