# **GEOTECHNICAL REPORT**

### Geotechnical Report for Ness Avenue

<p><b>THE NATIONAL TESTING LABORATORIES LIMITED</b>  <small>Established in 1959</small></p>	<p>Project No.: STA-604          Date: March 30, 2006</p>	<p>Provided by: Starline Consulting Ltd.          Scale: NTS</p>	<p>2006 City of Winnipeg Regional and Local Streets Program          Ness Avenue Westbound          Ferry Road to Belvidere Street          Winnipeg, Manitoba</p>
---	---	--	--

City of Winnipeg  
 2006 City of Winnipeg Regional and Local Streets Program  
 Geotechnical Investigation  
 Ness Avenue Westbound  
 Ferry Road to Balviders Street

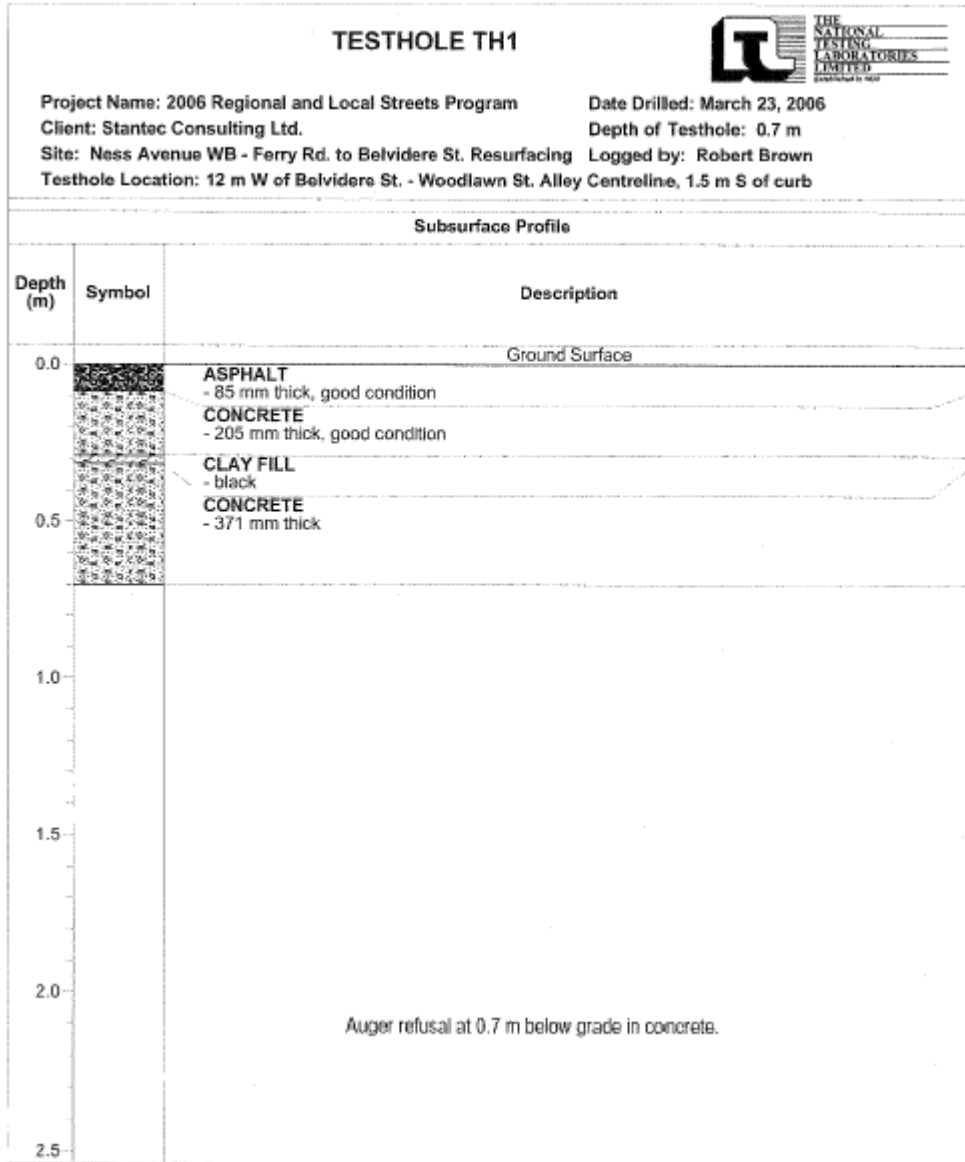
**Test Hole Log for TH1**

1. A thin layer of clay fill was encountered underlying the concrete in TH1. Underlying the clay fill was a second layer of concrete. Auger refusal was encountered in TH1 within the second concrete layer at a depth of 675 mm below the top of the pavement.
2. Detailed testhole locations are provided in the attached testhole logs.
3. Granular fill was only encountered underlying the concrete in TH6. No granular fill was encountered in the remaining testholes.
