**POST-TENSIONING REPAIR**

B.M. ELEV.	DESIGNED BY: R.A.W.		ENGINEER'S SEAL	ENGINEER'S SEAL		MARYLAND TWIN BRIDGES REHABILITATION PROJECT EAST BRIDGE REHABILITATION	CITY DRAWING NUMBER: B108-06-15
	DRAWN BY: N.B.G.						SHEET 15 OF 38
	CHECKED BY: R.A.W.		CONSULTANT PROJECT NO. 05-5069-1000				
	REVIEWED BY: S.S.R.		EXISTING POST-TENSIONING TENDONS INSPECTION AND REMEDIAL REPAIRS				
2 ISSUED FOR TENDER 02/07/06 N.B.G.	HOR. SCALE: AS NOTED	RELEASED FOR CONSTRUCTION: [Signature]					
1 ISSUED FOR CITY REVIEW 12/14/05 N.B.G.	DATE: DEC. 2005	DATE: DEC. 2005

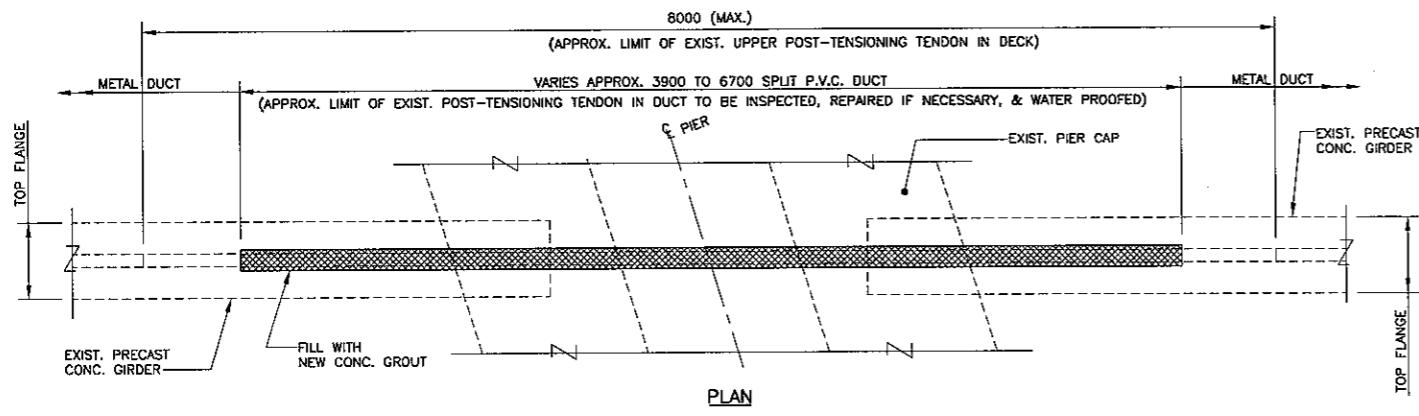
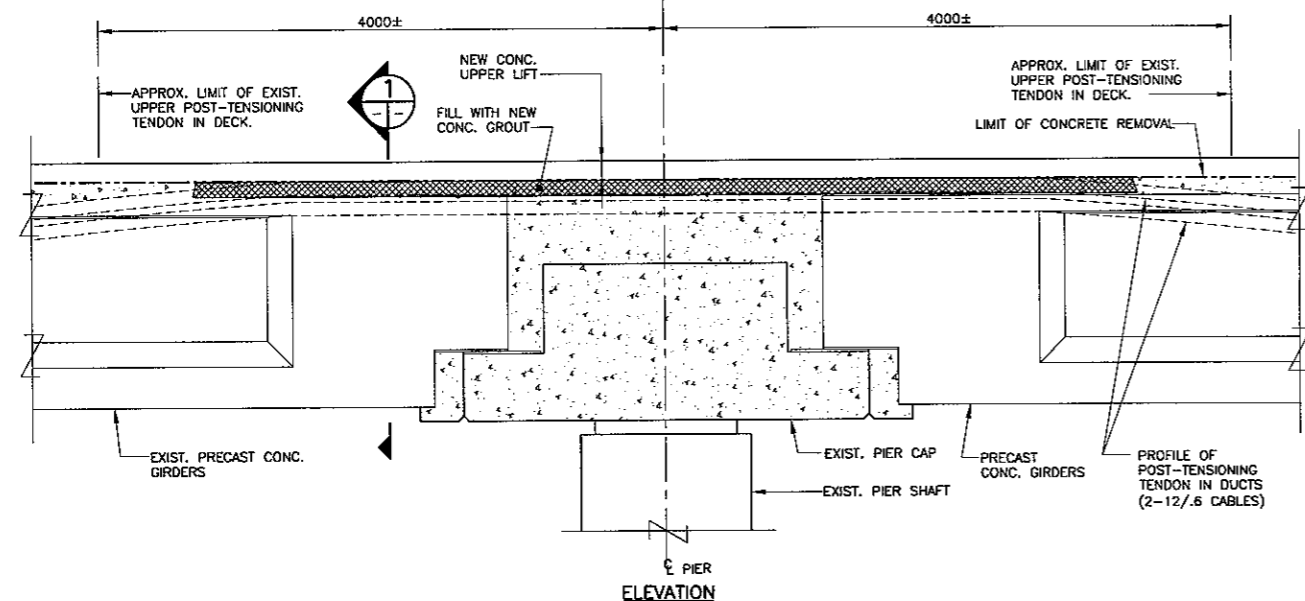
**EXISTING POST-TENSIONING TENDON IN DECK AT PIER LOCATIONS**

1: 25 **NOTE:**  
7 EXISTING POST-TENSIONING TENDONS IN THE DECK ARE TO BE INSPECTED AT EACH PIER LOCATION. SEE EXISTING BRIDGE DECK DRAWING (ON SHEET NO. 10) FOR LOCATIONS OF POST-TENSIONING TENDONS IN PLAN.

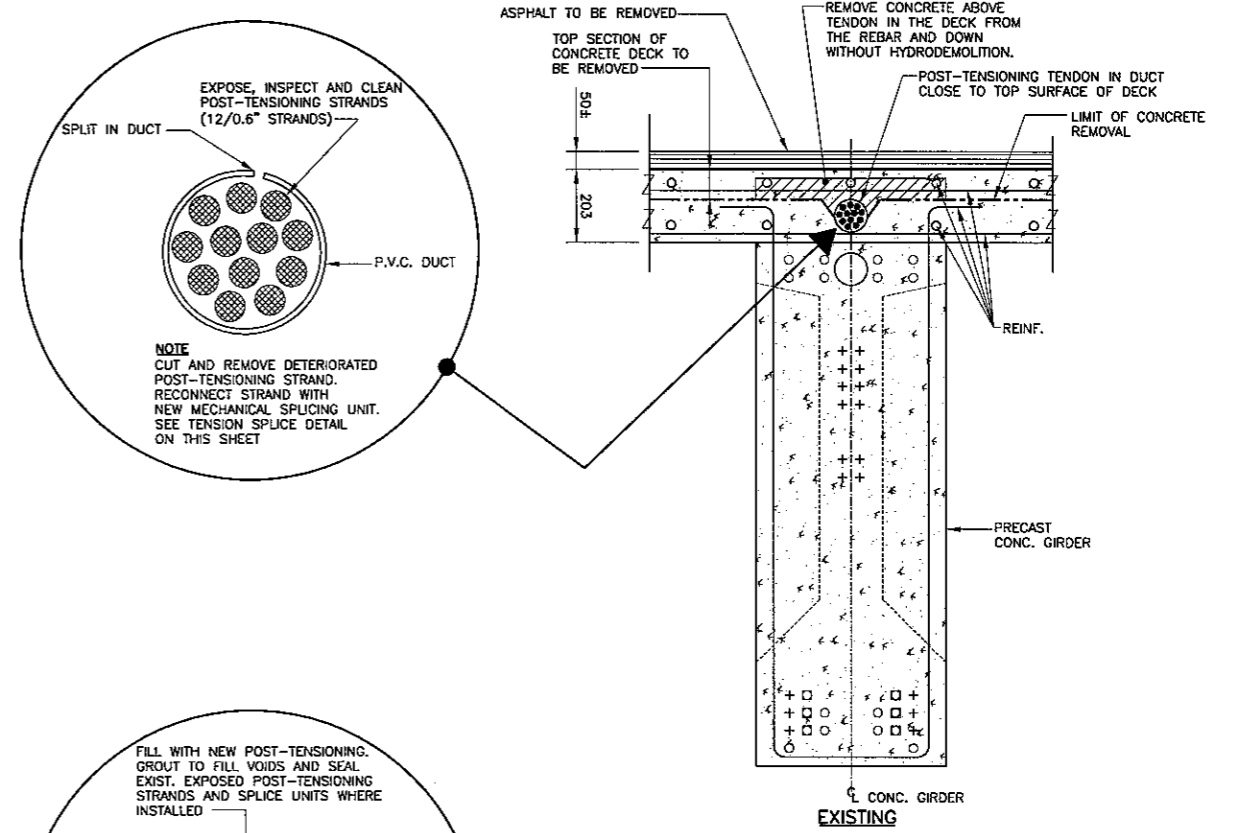
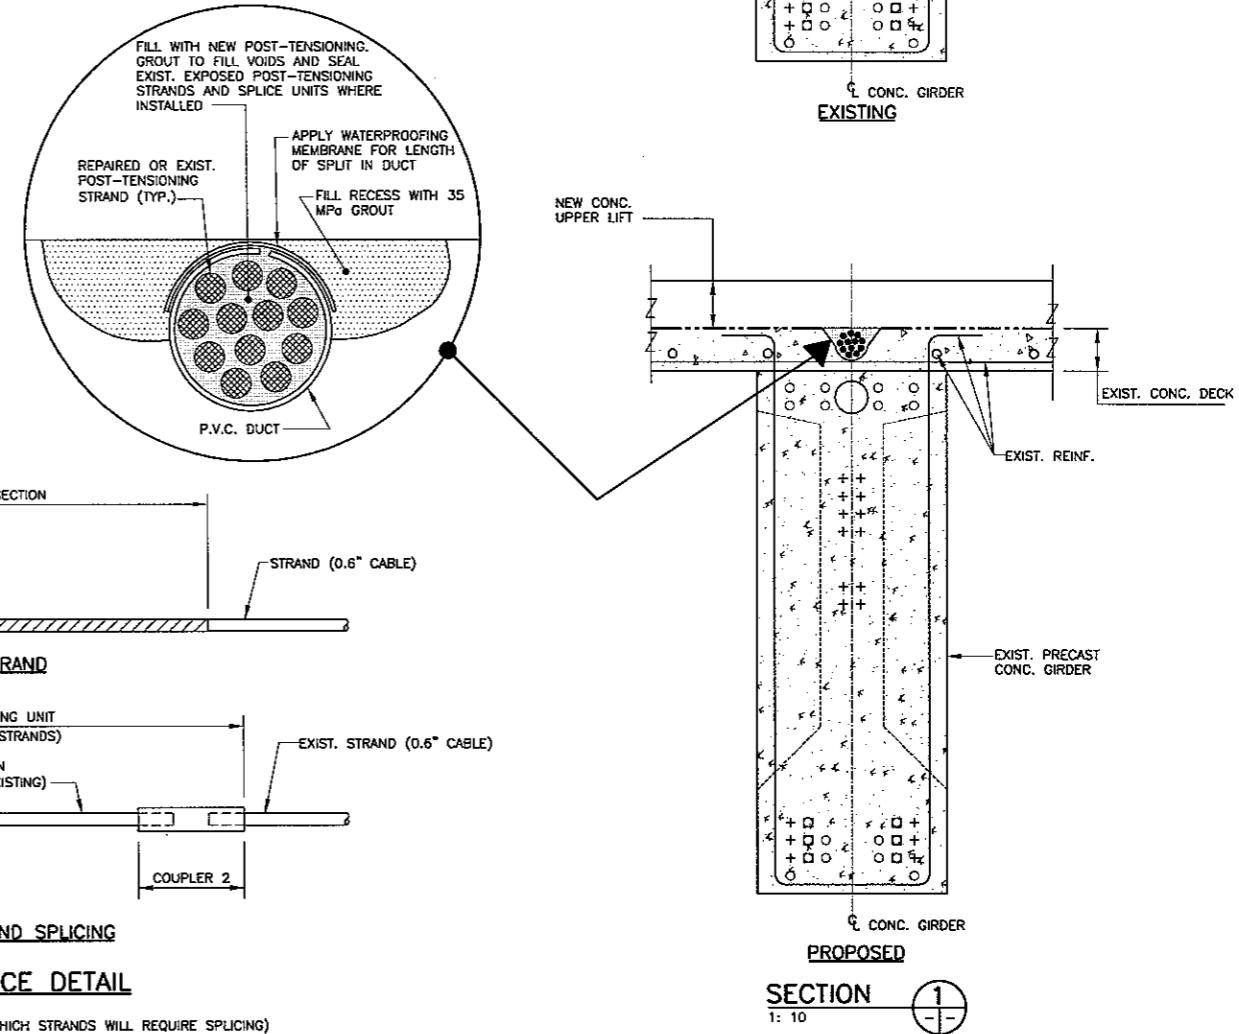
1. THE INTENT OF THIS WORK IS TO INSPECT THE P/T DUCTS LOCATED IN THE DECK ABOVE THE PIERS FOR COMPLETENESS OF GROUT FILL. IF NOT COMPLETELY FILLED, THE UNFILLED LENGTH OF DUCT IN THE DECK IS TO BE OPENED, THE STRANDS INSPECTED AND REPAIRED AS REQUIRED, AND THE VOIDS GROUTED. FINALLY THE SPLIT LENGTH OF THE P.V.C. DUCT IS TO BE WATERPROOFED.
2. THERE ARE 28 SUCH LOCATIONS. (7 OVER EACH PIER)
3. IT IS IMPORTANT THAT FOR THE ENTIRE TIME THE DUCTS ARE EXPOSED, THEY BE KEPT DRY. NO WATER SHOULD ENTER THE DUCTS.

1. REMOVE DECK CONCRETE FROM APPROXIMATELY THE TOP 1/3 OF THE CIRCUMFERENCE FOR THE LENGTH OF THE P.V.C. DUCT IN THE DECK (APPROXIMATELY 4 TO 7 METRES) AND CLEAN THE DUCT OF ALL RESIDUAL TAPE AND SEALANTS.

2. SPREAD OPEN THE SPLIT AT THE TOP OF THE DUCT AND INSPECT THE INSIDE FOR THE COMPLETENESS OF THE ORIGINAL GROUT INJECTION. IT MAY BE NECESSARY TO CUT AWAY SOME OF THE DUCT TO INSPECT THE TENDON AND TO CARRY OUT THE NECESSARY SPLICING AND GROUTING.

3. IF SOME OF THE STRANDS OF THE TENDON ARE NOT COVERED IN GROUT, LIGHTLY BLAST-GRIT THE STRANDS. INSPECT THE STRANDS FOR CORROSION. WHERE CORRODED, REMOVE THE CORROSION WITH A LIGHT GRIT BLAST. THE CONTRACT ADMINISTRATOR WILL DECIDE WHICH AND HOW MANY OF THE STRANDS MAY NEED TO HAVE NEW SECTIONS SPLICED INTO THEM. (ON THE WEST STRUCTURE IN 2005, A TOTAL OF 8 STRANDS AT 2 OF THE 28 LOCATIONS WERE SPLICED.) ENGAGE A SPECIALIST IN POST-TENSIONING REPAIR TO CARRY OUT THE STRAND SPLICING. THE REPAIRED STRANDS ARE TO BE TENSIONED TO ABOUT 37% OF THEIR ALLOWABLE WITH A RECENTLY CALIBRATED TORQUE WRENCH.

4. WHERE THE DUCTS BELOW THE DECK ARE NOT COMPLETELY FILLED WITH GROUT, INSERT INJECTION TUBE AS FAR DOWN THE DUCT INTO THE GIRDER AS POSSIBLE AND INJECT BY PRESSURE AS MUCH GROUT AS POSSIBLE FILLING FROM THE BOTTOM UP.

5. COVER ALL STRAND AND SPLICES THAT MAY HAVE BEEN INSTALLED AND UNCOVERED STRAND IN THE DECK, WITH GROUT.
6. CLEAN AND PRIME EXPOSED DUCT WITH A SOLVENT COMPATIBLE WITH THE MASTIC TYPE SEALANT USED IN THE NEXT STEP.

7. APPLY A SOLVENT-BASED (EMULSION TYPES WILL LIKELY NOT CURE FAST ENOUGH) MASTIC TYPE SEALANT TO EITHER SIDE OF THE SPLICE IN THE DUCT OR IF NO DUCT IS LEFT TO CLOSE, APPLY THE SEALANT TO THE TOP OF THE STRAND GROUT.

8. INSTALL AN OPEN WEAVE FIBREGLASS MEMBRANE INTO THE ABOVE MASTIC TYPE SEALANT BEFORE IT CURES.
9. APPLY A SECOND HEAVY COAT OF MASTIC TYPE SEALANT.
10. COVER THE SEALANT WITH A UV PROTECTANT IF THE SEALANT IS SUSCEPTIBLE TO BREAKDOWN UNDER UV LIGHT.

11. USING A STANDARD PREMIXED BAGGED GROUT, FILL THE RECESS ALONG THE EDGES OF THE PIPE TO KEEP WATER FROM PONDING IN THE RECESS.
