June 14, 2011

File No. 11-0107-01

RE: Harbourview Recreation Complex – Courtyard Restoration
• Site Investigation

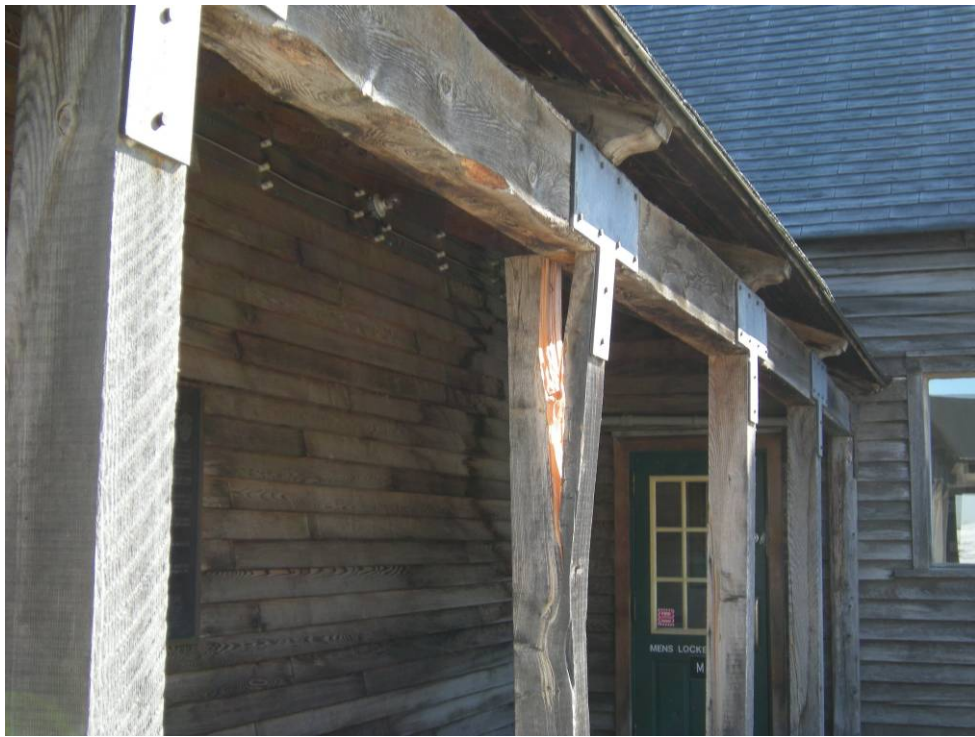
Photo 6

In a number of locations the wood handrails, light posts and canopy supports are in disrepair – Reference Photos 2, 3, 4, 5, 6, 10 and 11.

We recommend replacing the handrail and light posts along the retaining wall and replacing the canopy posts which are in disrepair. The canopy posts which have experienced significant frost jacking should be shortened to level the canopy. As noted above a handrail will not be required with the embankment option. Short term remedial work should be provided to address safety concerns if the handrail is not replaced at this time. Providing a mesh similar that existing in other locations is an option for short term repair.

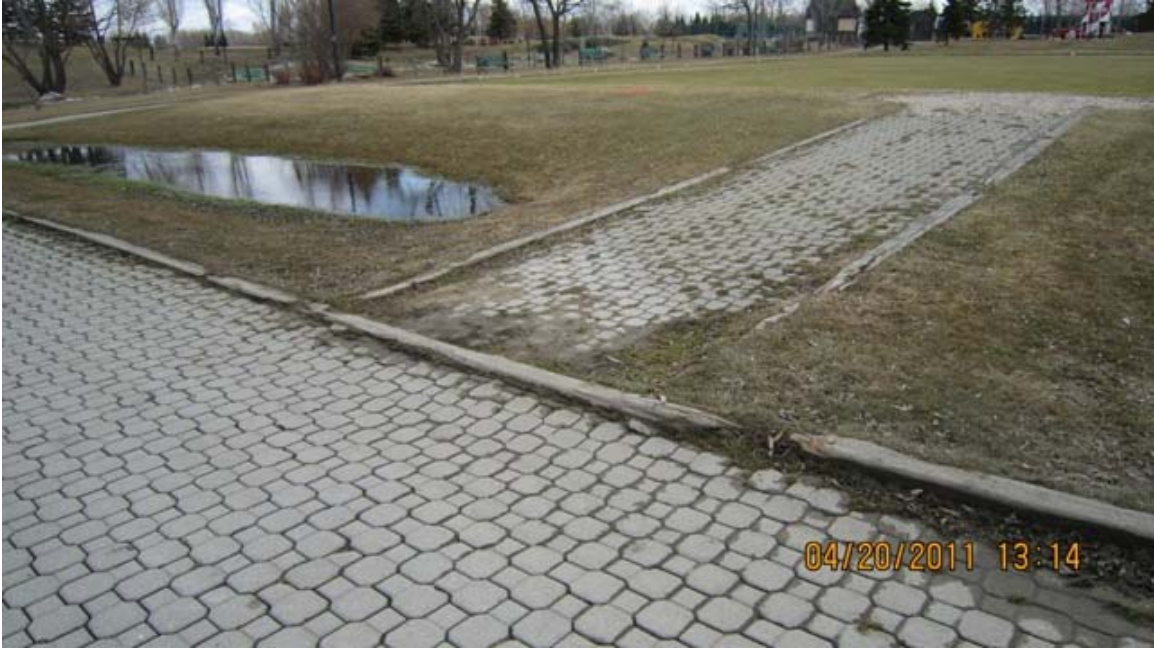
The paving stone courtyard between the building is approximately 535 sq. m. in area (Reference Figure 1). There is also a large area of paving stones to the east of the courtyard (Ref. Photo 15, 17 and 18). Elevations from site survey data are shown on Figure 1. The paving stones have settled in many areas and are missing in other locations (Ref. Photos 12, 13, and 14). There are two drains in the courtyard as noted on Figure 1. Drainage towards these drains as per the survey data, is poor. Rubber mats have been placed in some locations in which the paving stones are missing (Ref. Photo 16). These conditions have been identified by the City Public Works Department as public safety concerns.

Within the courtyard area we recommend that the existing paving stones and granular base be removed and replaced. The new base should be a combination of granular and crushed stone with a minimum total thickness of 450 mm. As there is limited gradient for proper surface drainage, consideration should be given to a permeable paving system which provides for subsurface drainage. The cost of replacing the paving stones and base is estimated to be

\$130 per sq. m. The total estimated cost for the courtyard repaving is \$70,000.00. If the paved area to the east of the courtyard is replaced, the cost would be over twice this amount.
