Roof Assessment Report:

**Pequis Pavilion
Kildonan Park
Winnipeg, Manitoba**

Date of Submission: July 6, 2011
Consultant File #4371-11

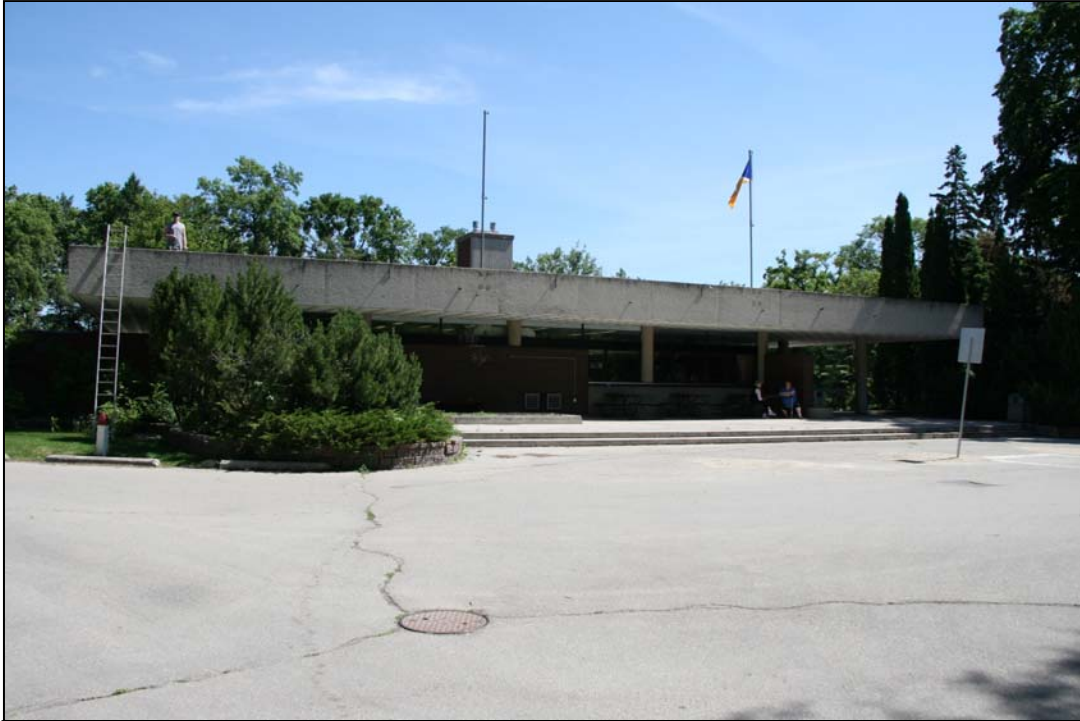
Photo # 1
This photo shows a front view of the building.

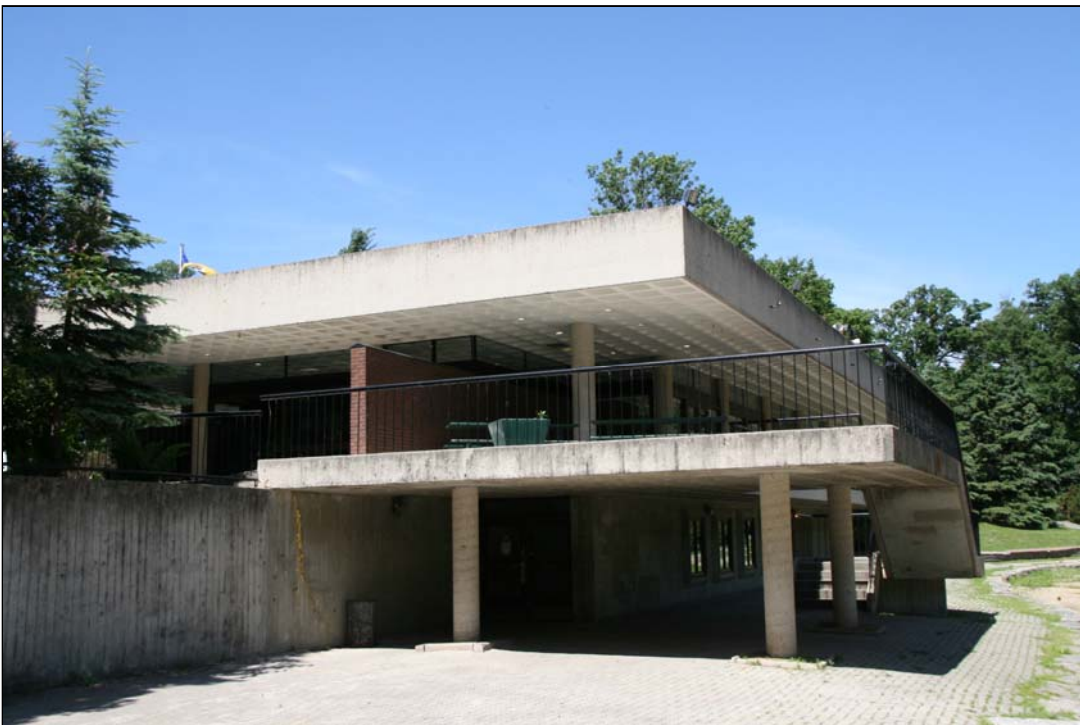
Photo # 2
This photo shows the rear and east elevations of the building.

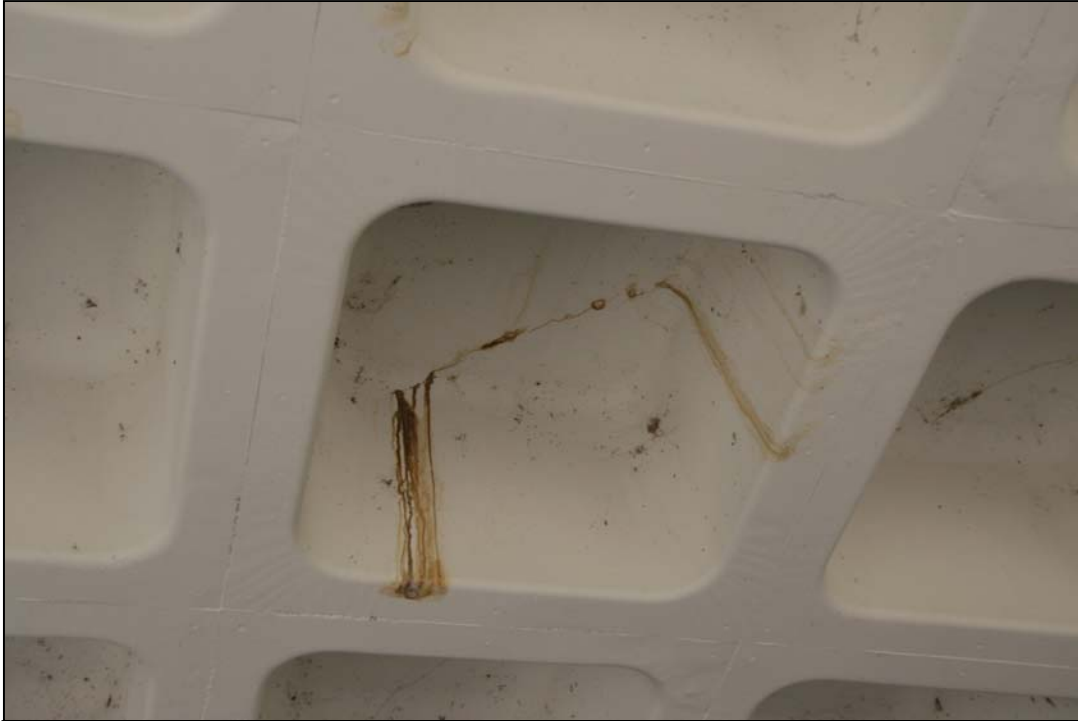
Photo # 3

The roof system was found to be in extremely poor condition. The roof appears to consist of mostly wet fiberglass and fiberboard insulation. The roof has obviously been leaking for numerous years for this amount of damage to have occurred. It usually takes a fair amount of time for water to migrate throughout a roof assembly. The underlying fiberglass insulation does allow the moisture migration to happen more rapidly than with other type of roof assemblies.

This photo shows some of the staining occurring on the underside of the concrete roof deck as the result of excessive moisture in the insulation system.

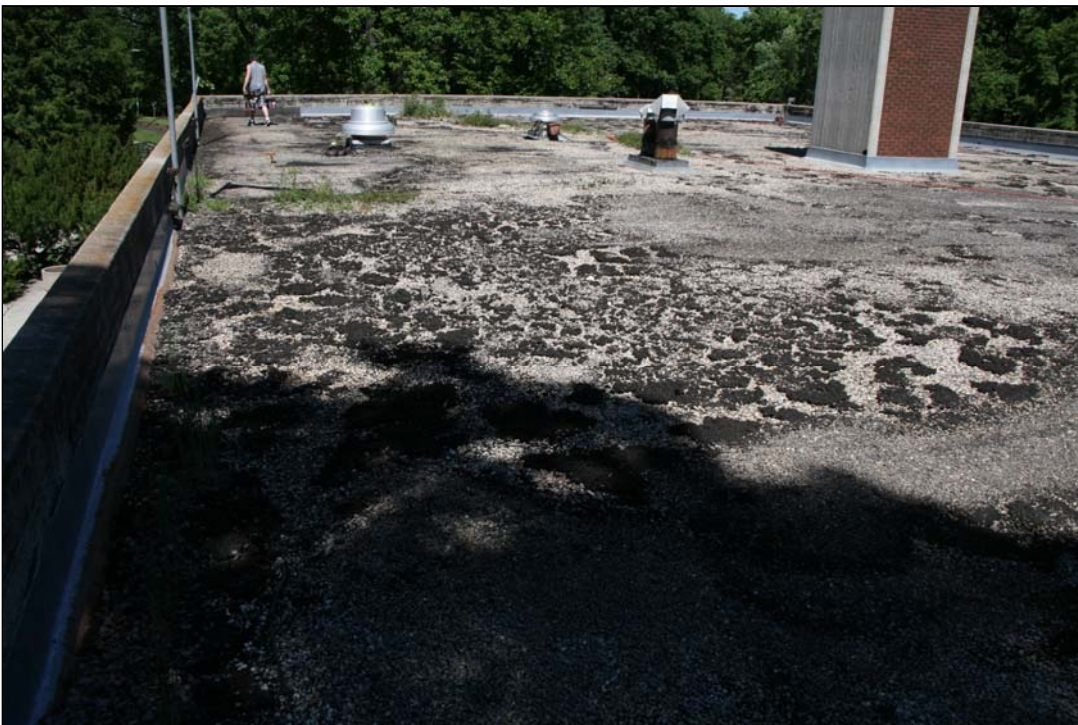
Photo # 4

This photo shows a partial view of the existing roof.

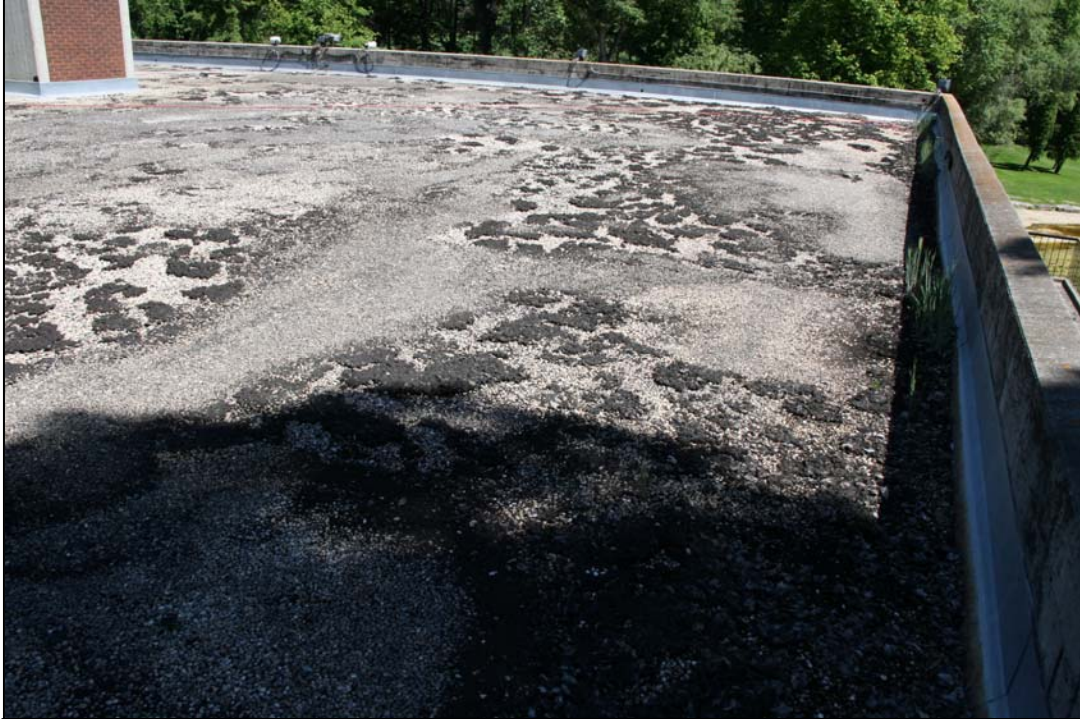
Photo # 5

The roof has no structural slope or slope within the insulation system. A single roof drain is present on the building. The roof drain is located on the southwest corner of the building. Extremely poor drainage appears to occur on the roof. Large amounts of dead leaf debris and algae debris are present throughout the entire roof. This is an indication that some fairly significant ponding water does develop after rainfalls. No significant rainfall had occurred for a period of time prior to this inspection and no water was currently sitting on the roof.

This photo shows the remaining portion of the existing roof. The buildup of dead leaves on the roof indicates some severe ponding water occurs.

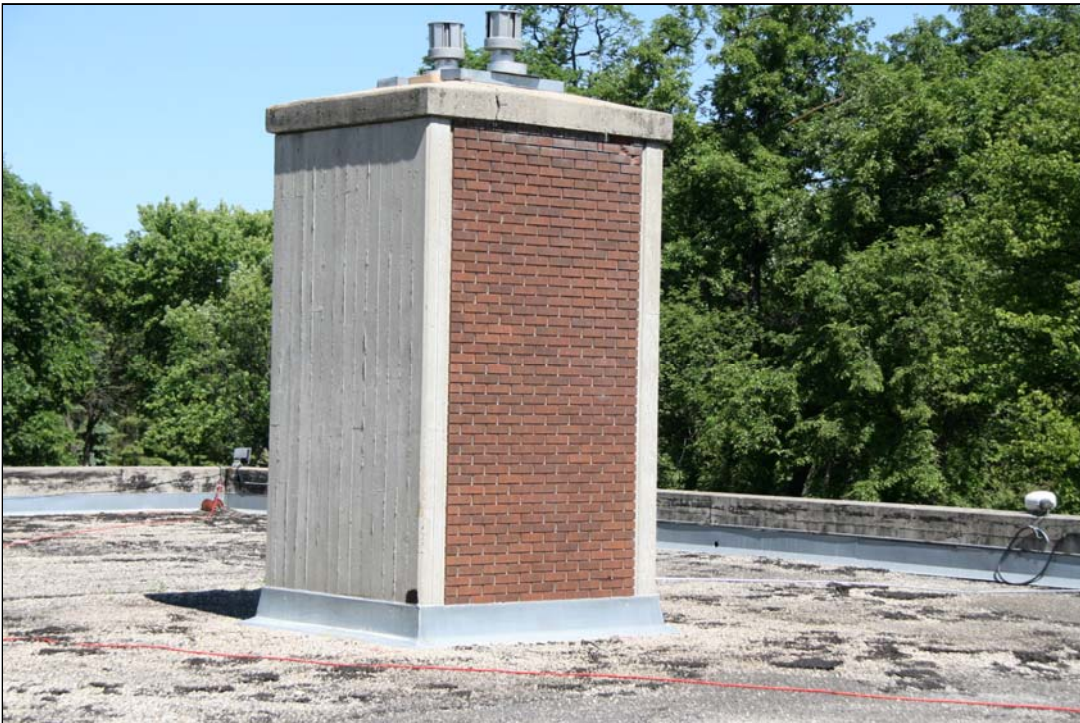
Photo # 6

This photo shows a view of the central chimney structure.

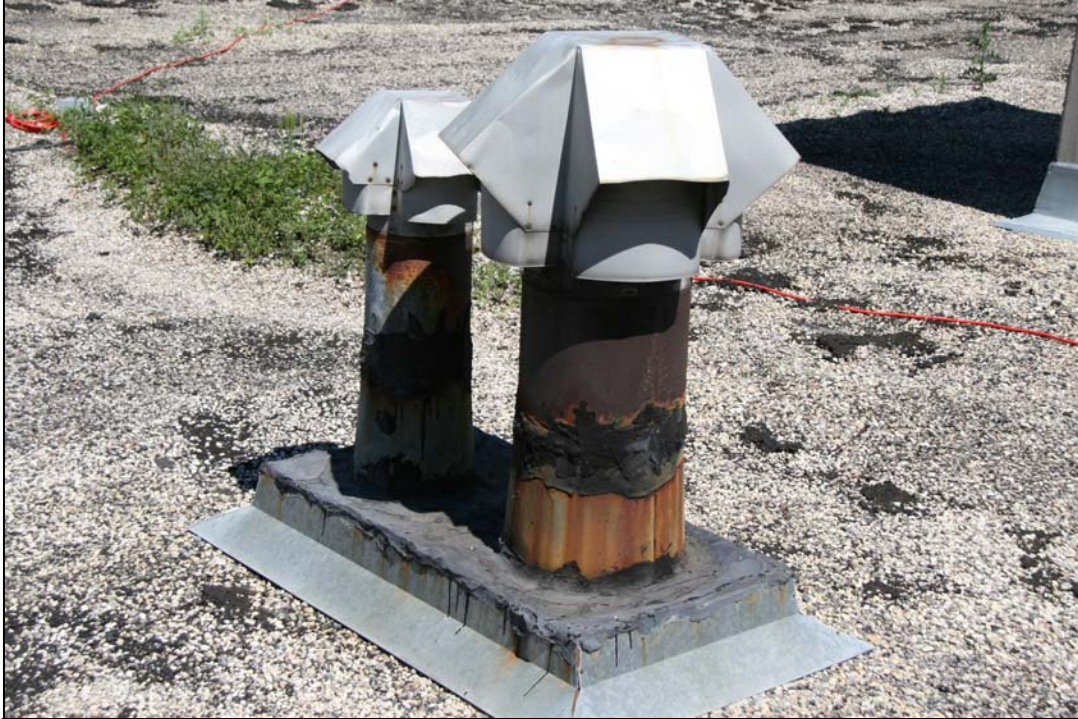
Photo # 7
This photo shows two existing old chimneys. No proper flashing or storm collars have ever been in place.

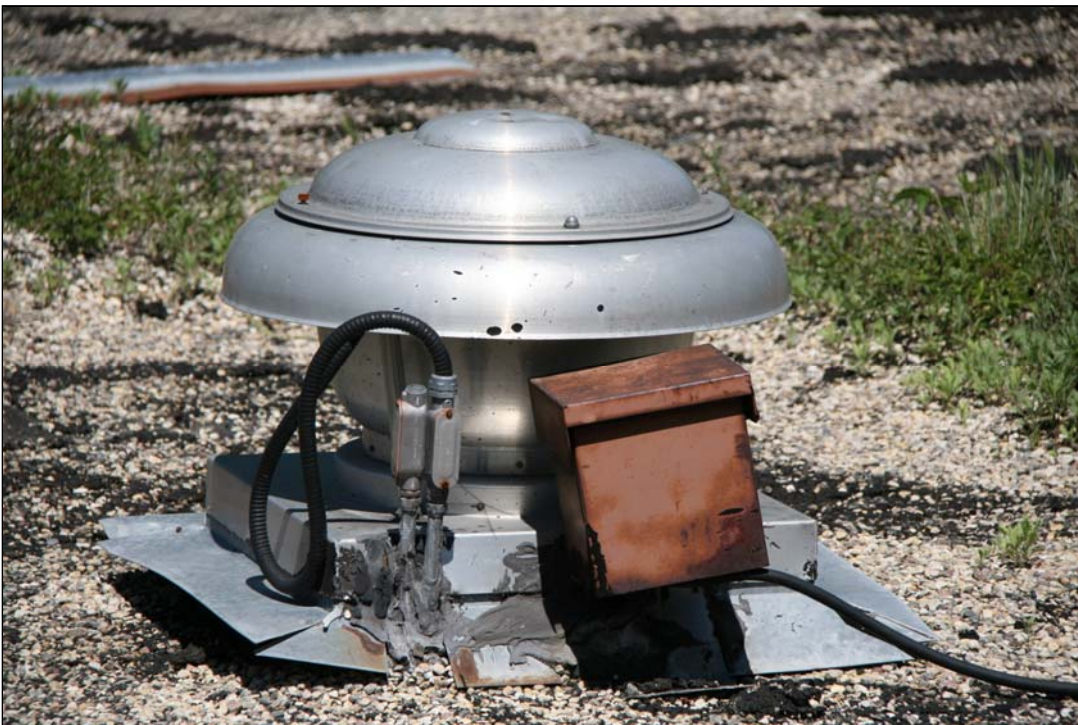
Photo # 8
This photo shows one of the fan units. Notice the conduits come up right against the unit and merely sealed with mastic. They should always penetrate the roof a minimum of 12" away so a proper pitch box can be installed.

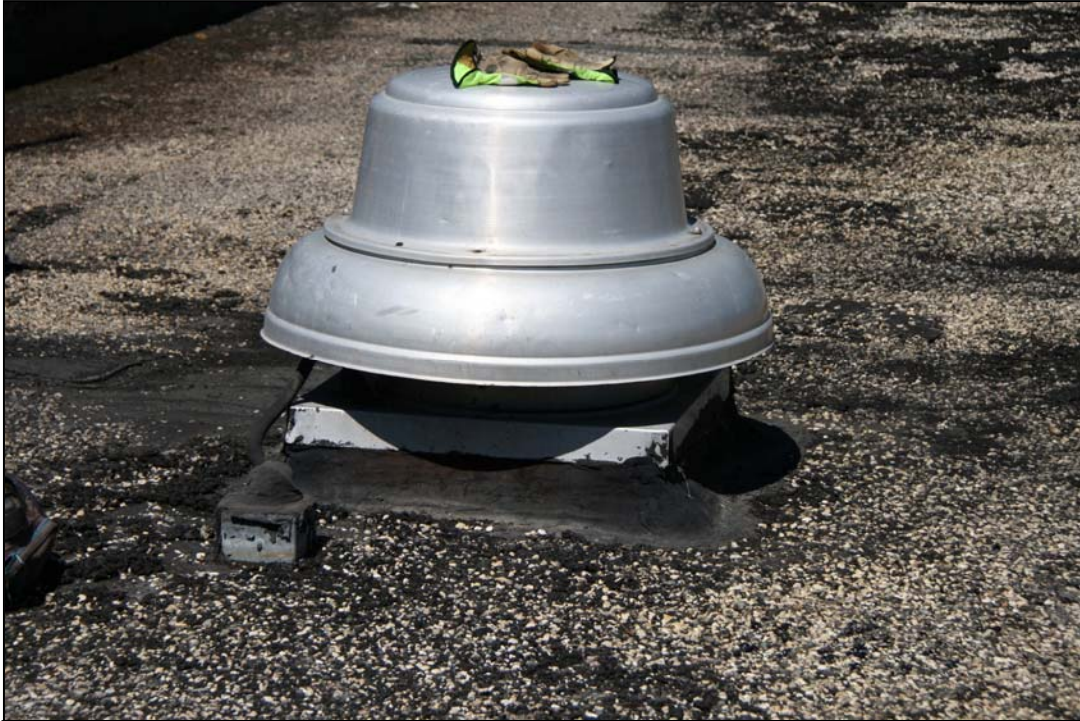
Photo # 9
This photo shows another fan unit with a proper pitch box in place.

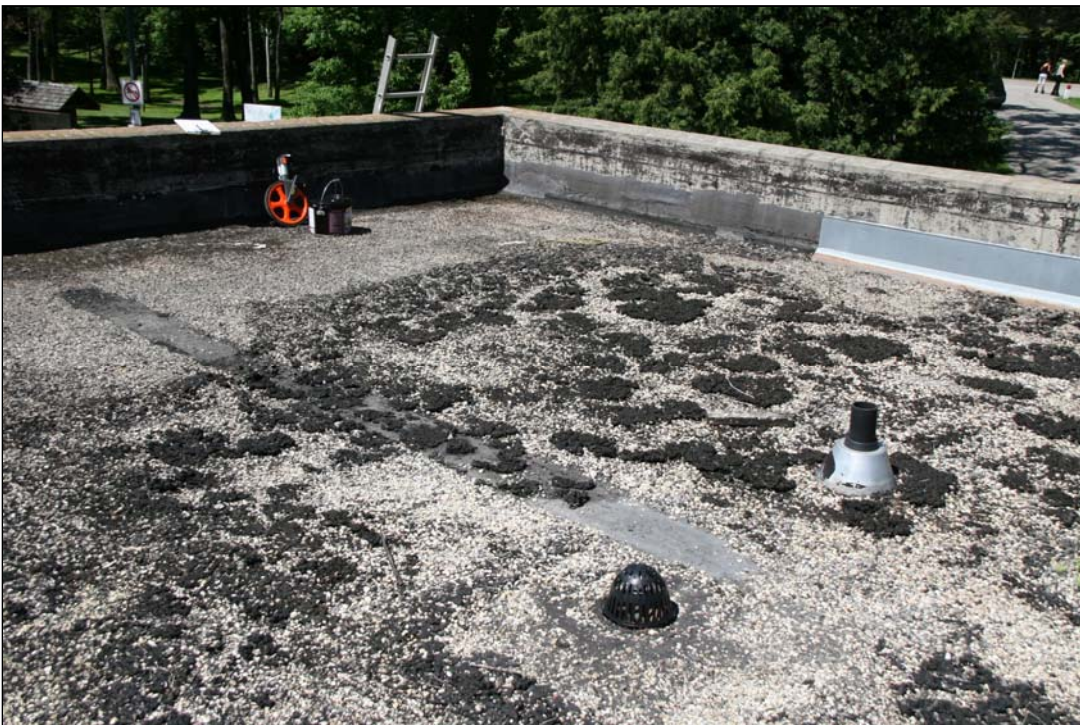
Photo # 10
This photo shows a location of the single roof drain. The roof drain is no where the middle of the roof and proper drainage does not occur.

The roof has extremely poor drainage. This is particularly the case of the one drain being installed so far off center of the main structure. I suggest the installation of two new roof drains, of which a sloped insulation system can be incorporated to provide positive drainage. This roof has fairly high concrete parapets and a sloped insulation can easily be incorporated into this structure. The enclosed roof plan indicates a suggested sloped insulation layout along with suggest roof drain locations.

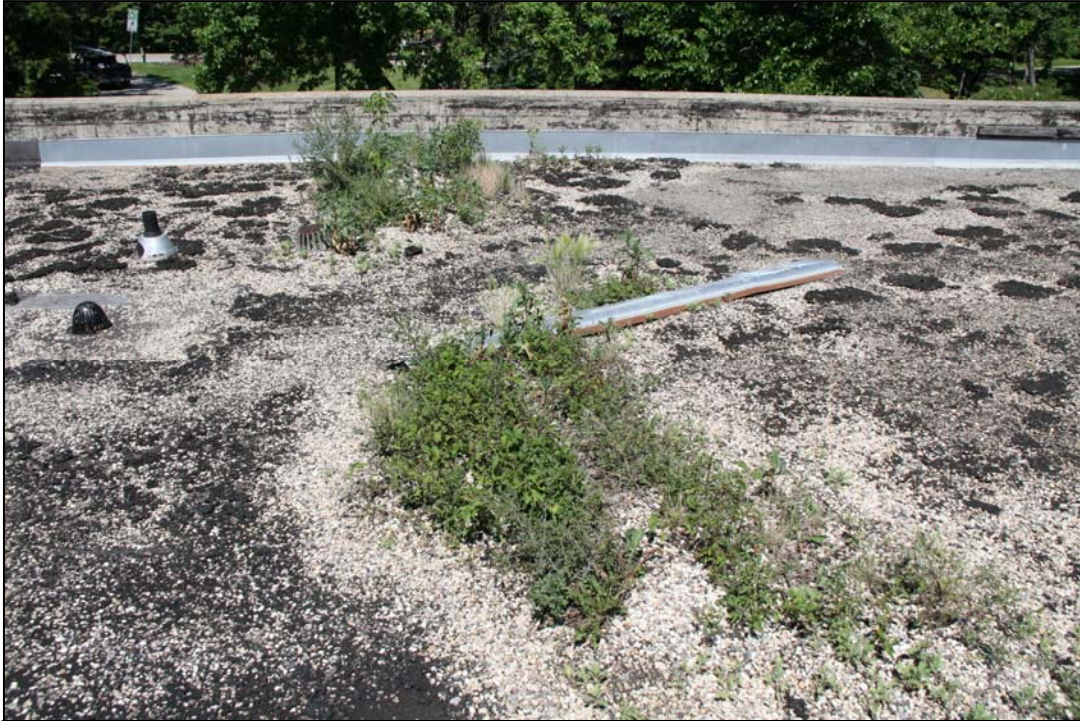
Photo # 11
This photo shows some of the plant growth on the roof.

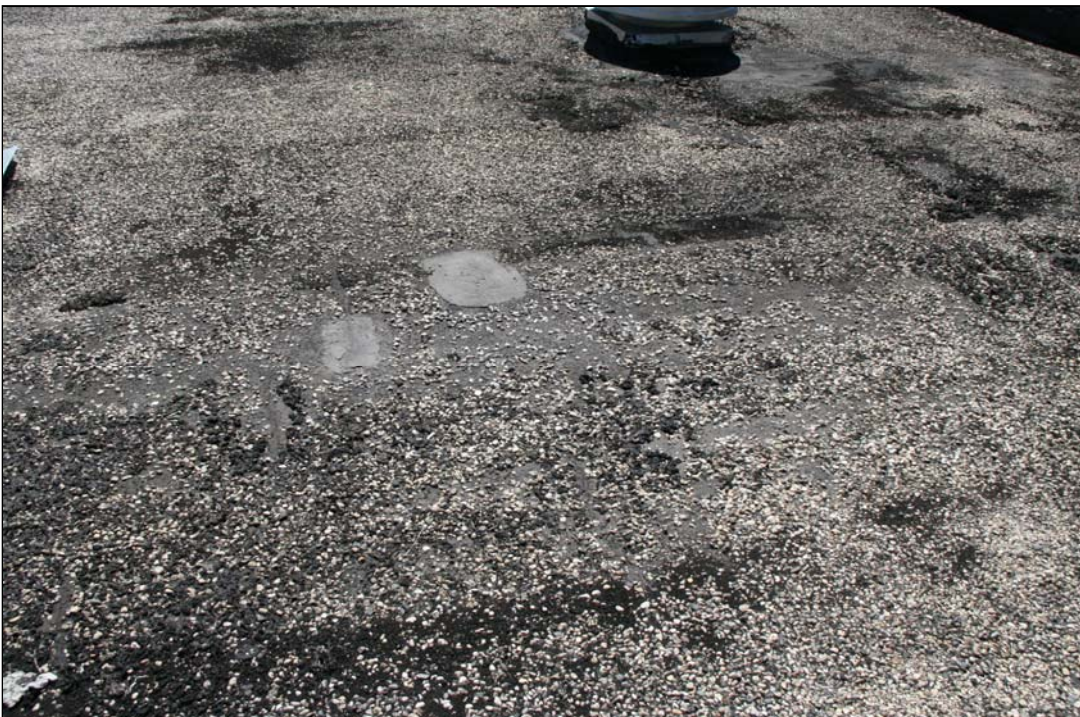
Photo # 12
This photo shows some of the numerous past repairs done on the roof.

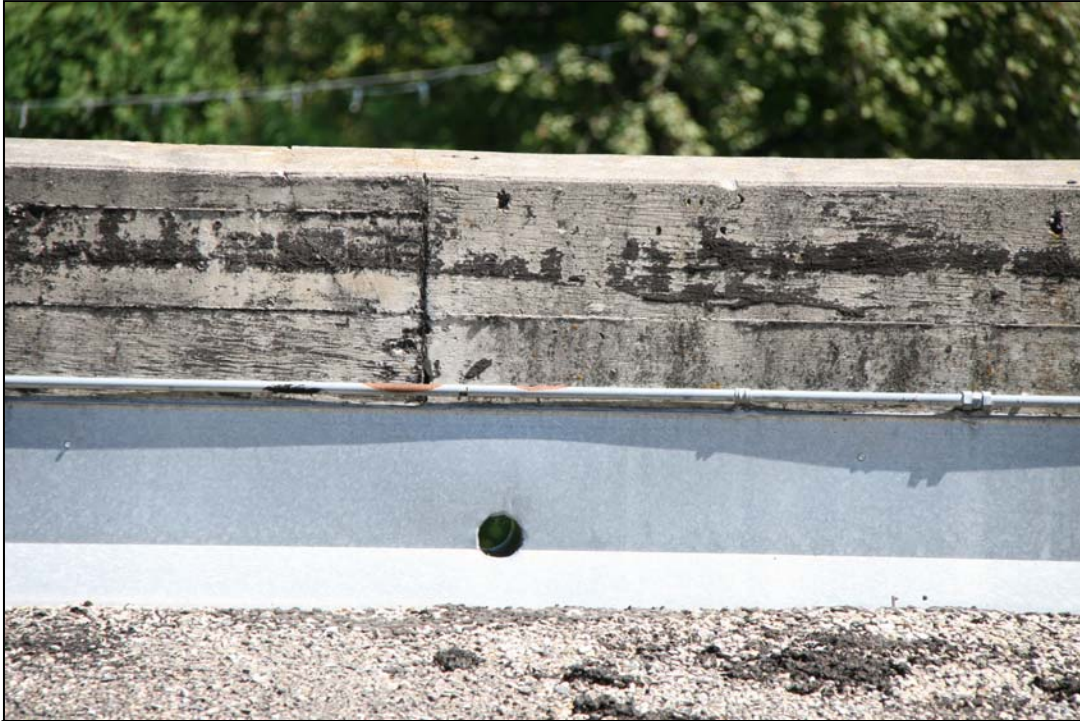
Photo # 13
This photo shows a view of the typical overflow scupper.

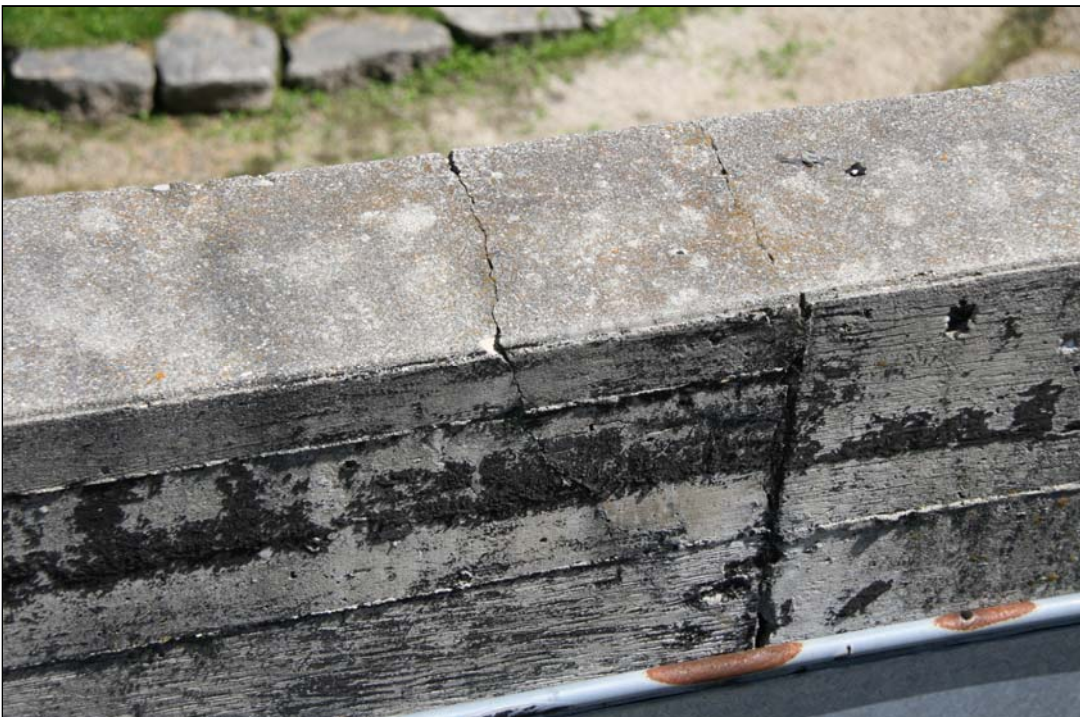
Photo # 14
This photo shows a fracture in the concrete parapet. The new roof should have the membrane carried up and over the parapet and a metal flashing installed.

The new membrane should also be carried up and onto the top of the parapets. Lumber blocking should first be installed on the top of the parapets to provide a good substrate to fasten any the metal flashing. A new sheet metal cap flashing should then be installed. Some fractures are present down the face and on top of the parapets and it would be best to carry the membrane up and over to ensure that the parapets are watertight and to reduce the chance of further freeze/thaw action.

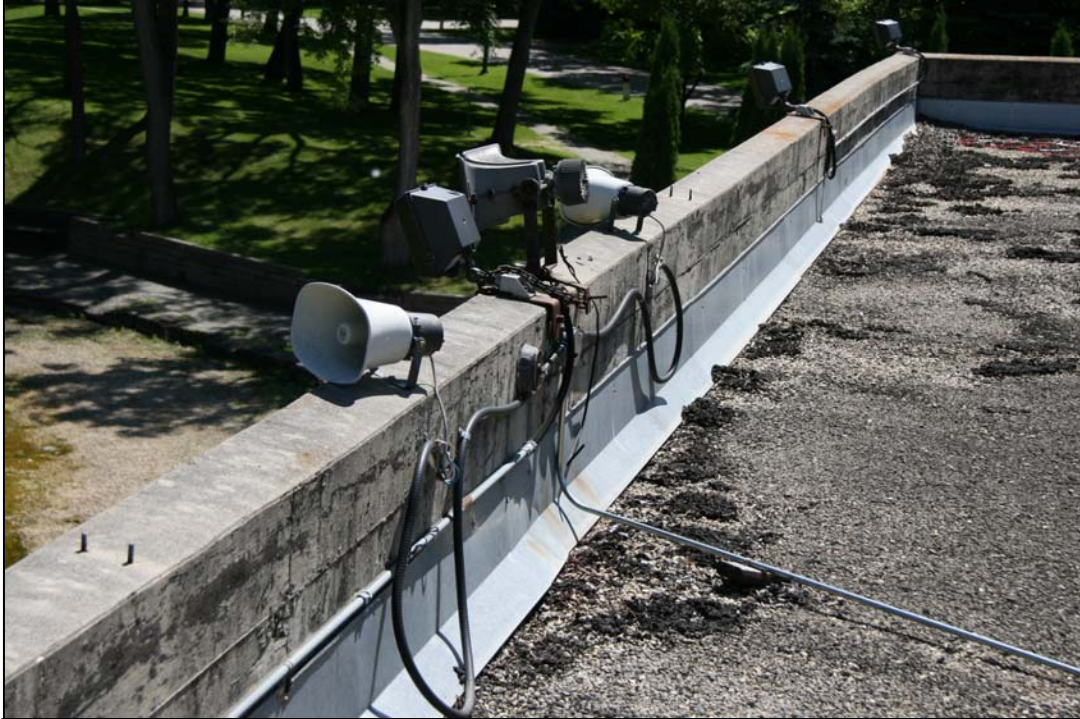
Photo # 15

This photo shows some items mounted on the parapet which would have to be removed to replace the roof.

The existing roof assembly should be removed in its entirety. This would also include for the removal of any loose old vapor barrier. Any loose vapor barrier must be removed to ensure good adhesion of the new vapor barrier and roof assembly. Any non-used mechanical equipment such as old chimneys or other such items should also be removed at this time. Any non-used electrical conduit and lightening fixtures should also be removed from the parapets themselves. There are also a couple of old flag poles, of which one does not appear to be any longer in use. This should also be removed if not required. The other flag pole would have to be temporarily removed to allow the installation of the new roofing.

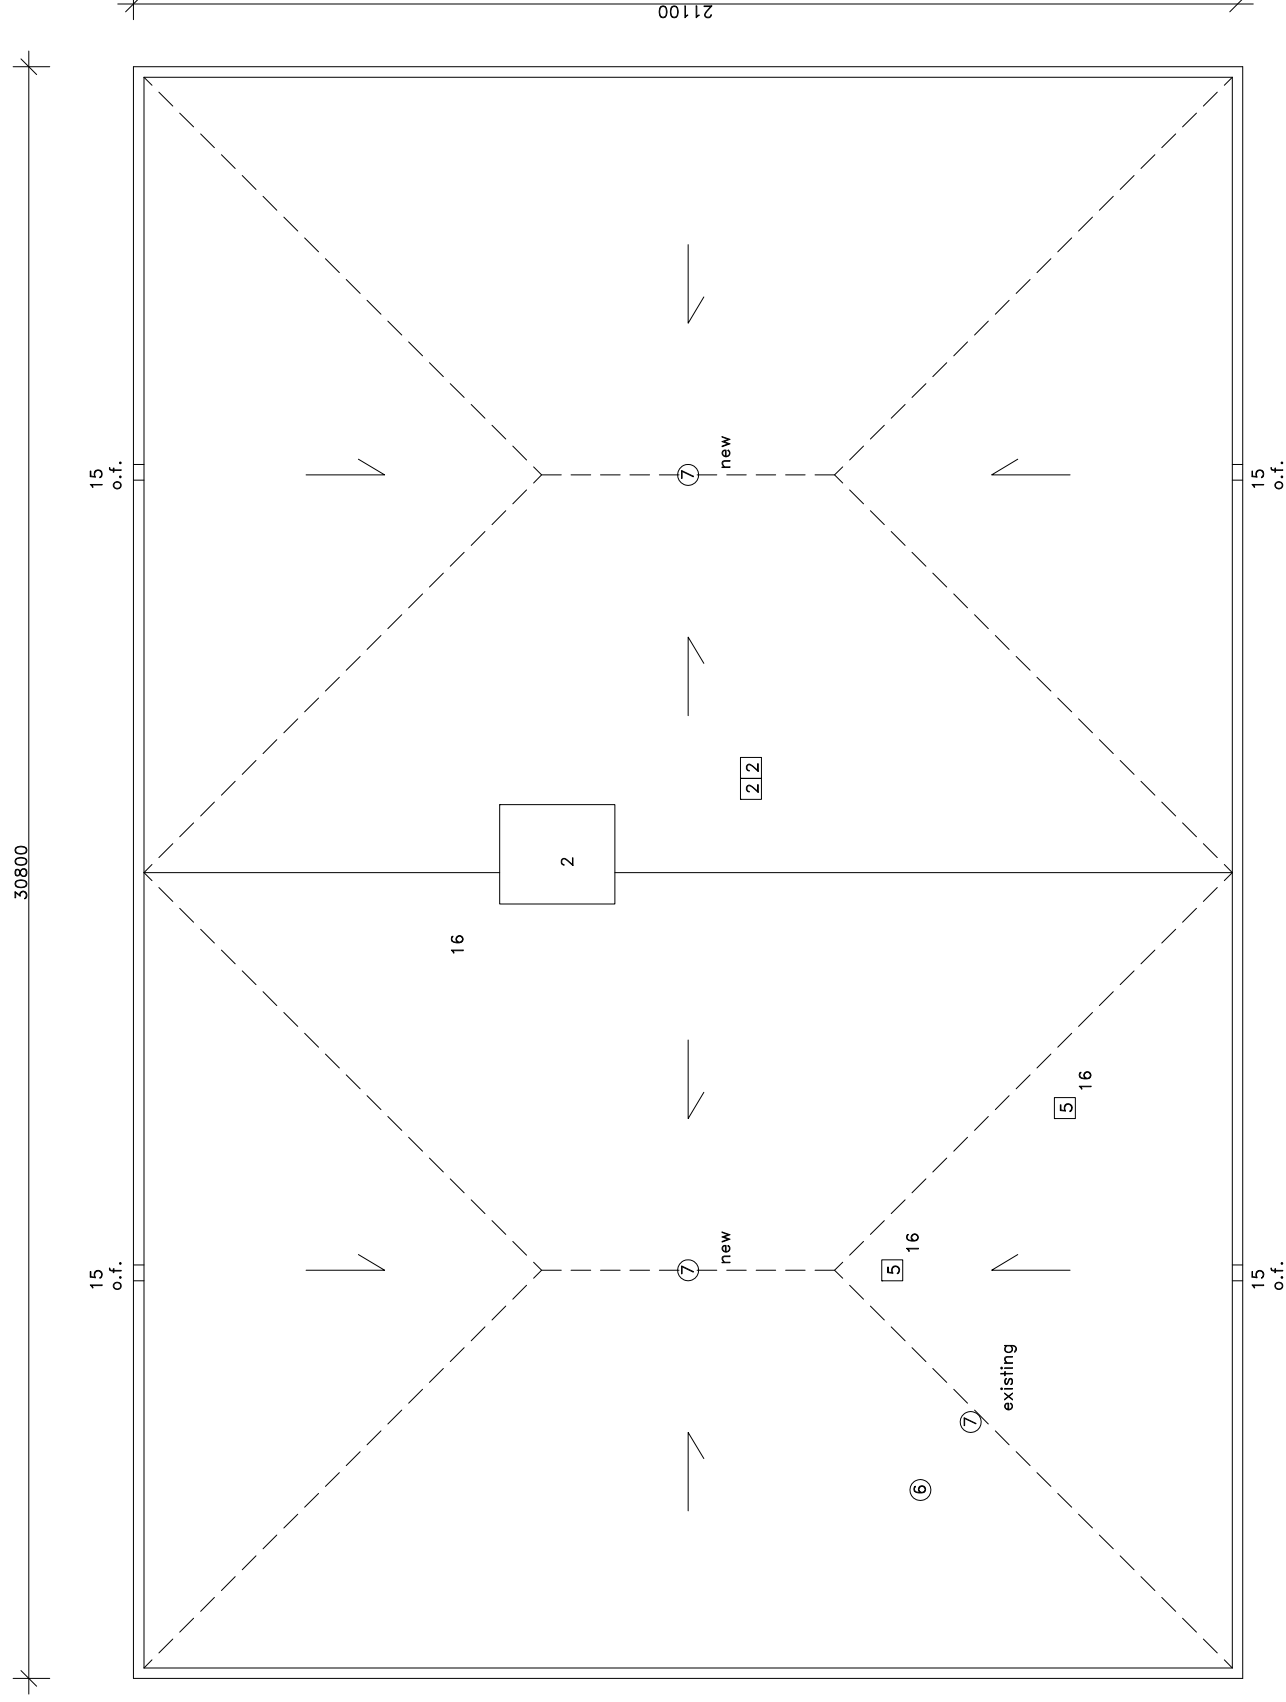
Drawing No. R-1

Roof Construction
cast concrete deck
felt vapor barrier
3" fiberglass
2" fiberboard
4 ply felt and asphalt
gravel
resaturant
gravel

Note: slope layout is only suggested
