June 14, 2011

File No. 11-0107-01

RE: Harbourview Recreation Complex – Courtyard Restoration
• Site Investigation

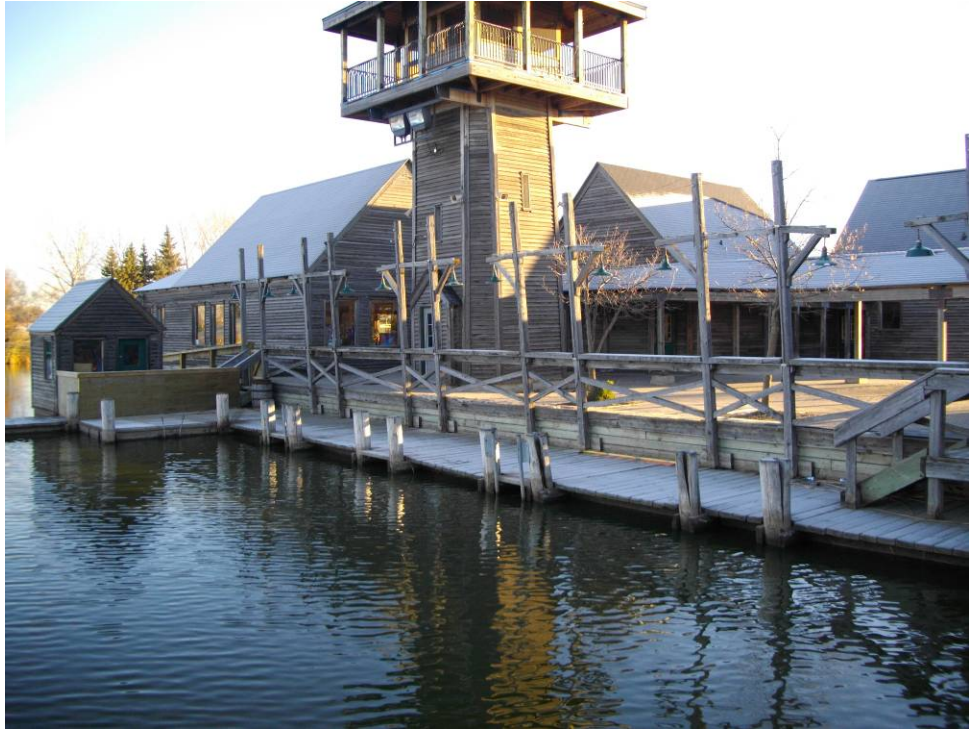
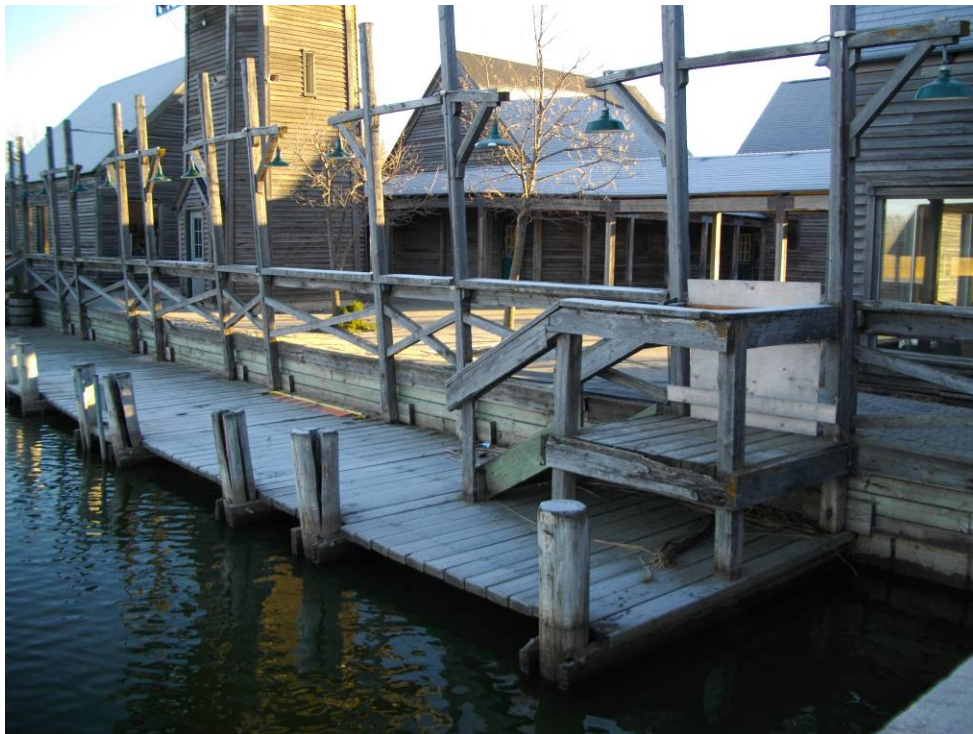
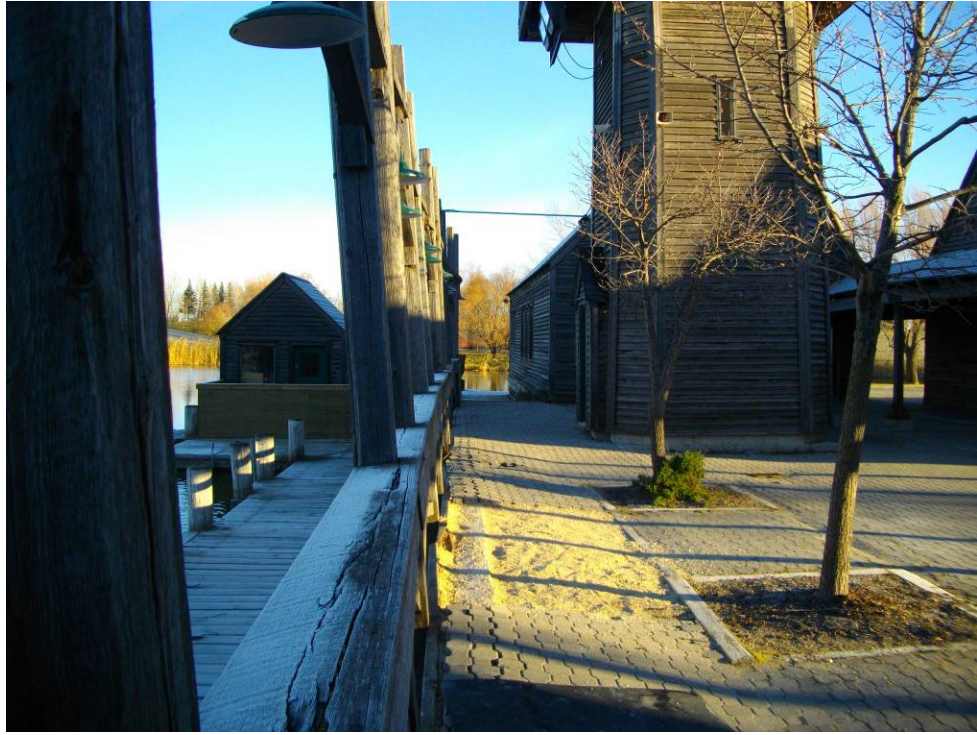
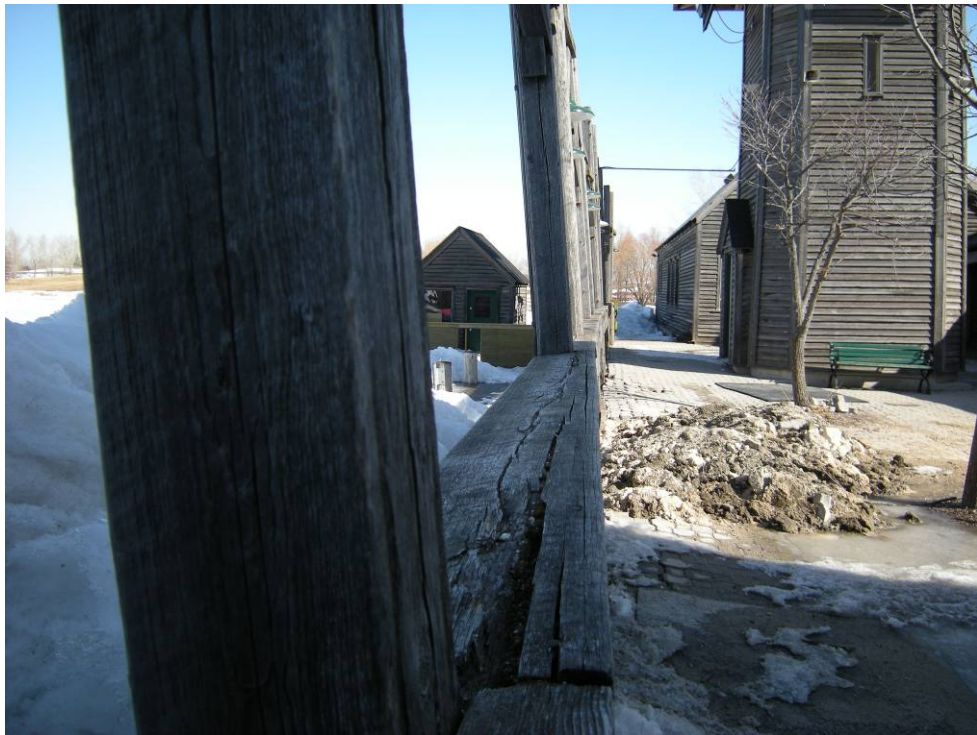
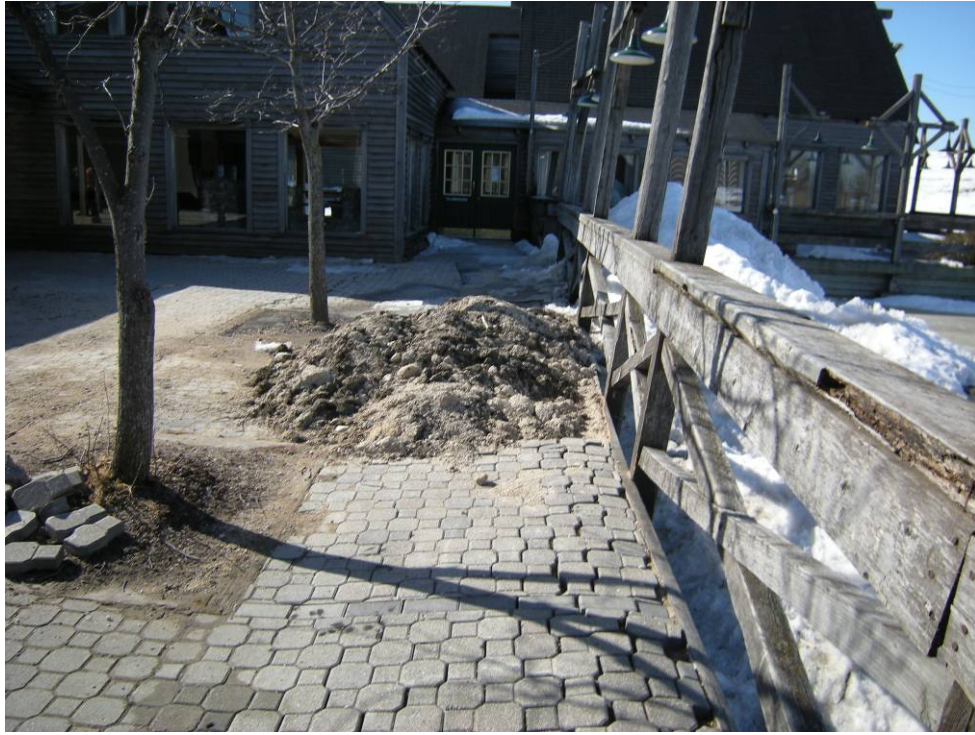
Figure 1 is a cross section through the retaining wall (also reference Photos 1 to 5). The counterfort and pile supports are spaced at 3400 mm o.c. The wall has rotated towards the retention pond to varying degrees along the length of the wall. With the assistance of Patio World, an area adjacent to the wall was excavated to

confirm where the rotation is occurring – i.e. has the counterfort separated from the footing; the footing separated from the top of the pile; or has the pile heaved from frost jacking and/or an upward pull on the pile. A portion of the counterfort was exposed. Unfortunately, the water level was still too high to expose the top of the pile and all of the information hoped for could not be obtained. The slope of the wall at the location of the excavation was measured to be approximately 1:12 (approximately 125 mm over the height of the wall). The concrete was found to be in good condition and there is no separation between the vertical face of the wall and the counterfort. The frost line is well above the top of the piles and frost jacking of the piles is, therefore, not considered to be the cause of the wall rotation.

The ultimate force required to pull up a 6000 mm long 400 mm diameter pile is estimated to be 65 kips based on an ultimate skin friction value and the yield strength of a 25 M reinforcing bar is approximately 47 kips. Judging from the condition of the concrete, our conclusion is that the separation is most likely occurring between the top of the pile and the underside of the footing and that the wall rotation is caused by soil over the height of the wall expanding with frost and exerting a pressure on the wall much higher than the normal soil design pressure. The movement resulting from this pressure will progressively increase with each annual frost cycle.

1. **Remedial Repair** – This option will minimize future wall movement but will not straighten the wall. Remedial work will consist of excavating behind the wall, placing a compressible low density Styrofoam on the inside vertical face of the wall and backfilling with a free draining granular fill. This work could be completed in conjunction with improvements to the paving. Overtime, with compression of the styrofoam, the benefits of this repair will be minimized. The estimated cost of this option is \$20,000.00

2. **Replacement** – The wall is constructed independent of the buildings at each end and can be removed and replaced without compromising these structures. The wall can be replaced with a new concrete wall with modifications to prevent frost movement. A concrete wall replacement is complicated by the need to draw down the retention pond or provide a cofferdam during construction. An earth berm is considered to be the most cost effective cofferdam option. A second wall option is a driven steel sheet pile wall or a wall constructed with driven steel soldier piles and lagging. The lagging could be pressure treated wood, concrete panels or composite material panels. This wall option will not require a cofferdam. The estimate cost of this is \$100,000.00 to \$150,000.00.

3. **Wall Removal and Embankment** – The existing wall provides a separation and transition to the dock structures. The dock structures have limited functional value and are an on-going maintenance expense. Plans are in place to remove the docks. With the docks removed an alternate to a retaining wall is an embankment to provide a transition and separation between the paved area and the waters edge. This option will not require a handrail and will require minimal maintenance overtime. The estimate cost of this option is \$70,000.00.

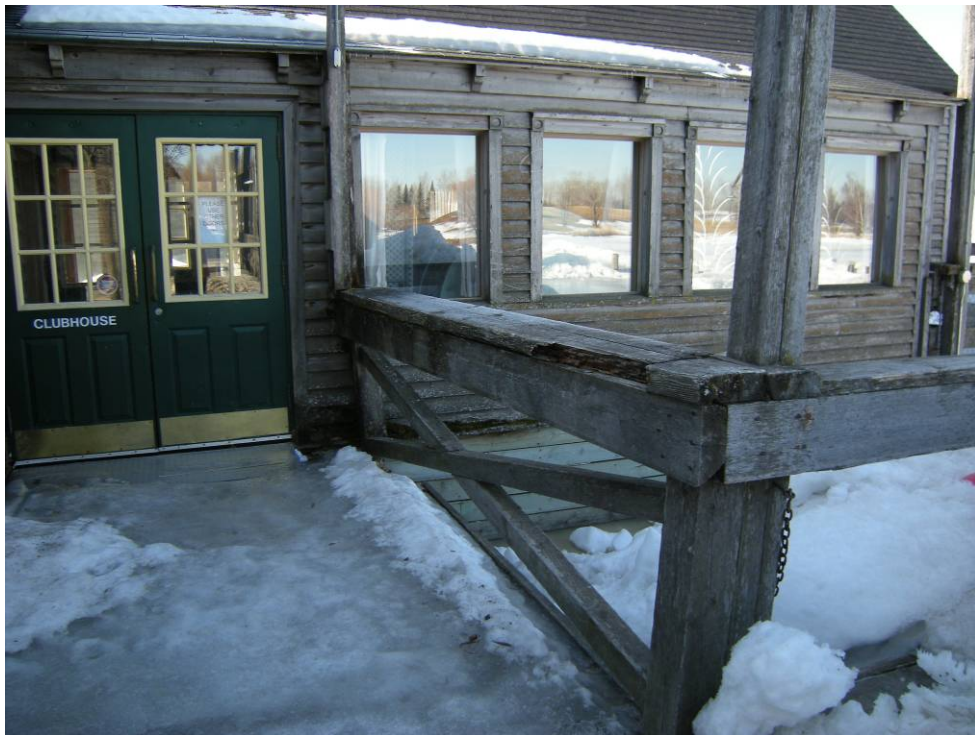
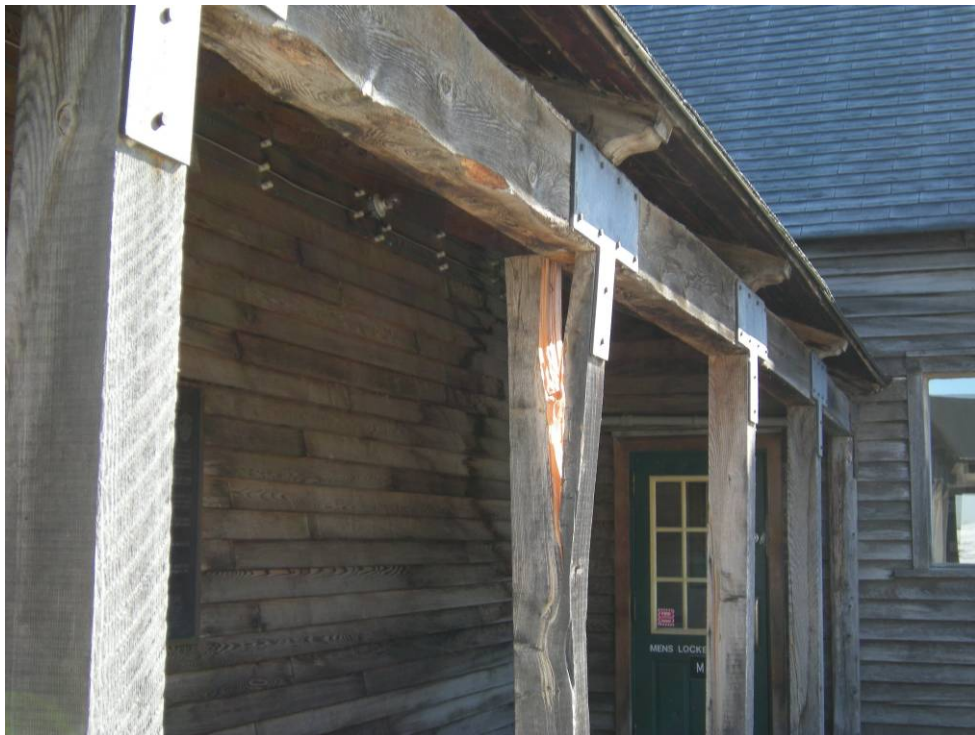
In a number of locations the wood handrails, light posts and canopy supports are in disrepair – Reference Photos 2, 3, 4, 5, 6, 10 and 11.

We recommend replacing the handrail and light posts along the retaining wall and replacing the canopy posts which are in disrepair. The canopy posts which have experienced significant frost jacking should be shortened to level the canopy. As noted above a handrail will not be required with the embankment option. Short term remedial work should be provided to address safety concerns if the handrail is not replaced at this time. Providing a mesh similar that existing in other locations is an option for short term repair.

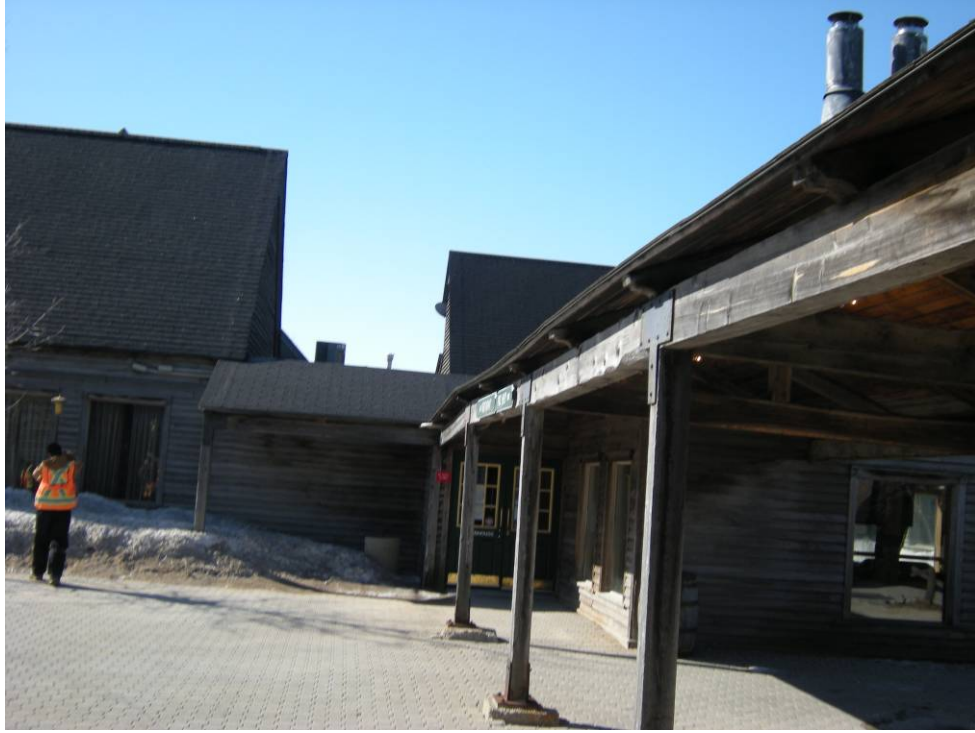
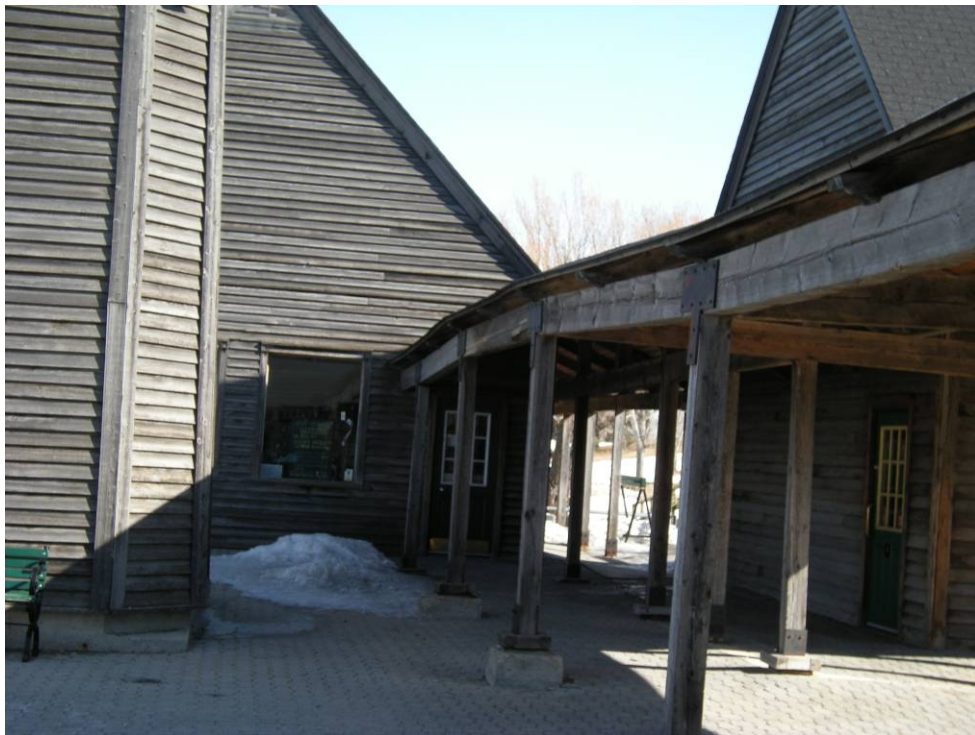
Survey data indicates that the relative difference in the elevation of the underside of the canopy at column support points is as much as 190 mm (Ref. Photos 7 and 8). The differences is attributed to frost jack of the piles which is not unexpected given the wet soil conditions surround the top of the piles. The piles are 400 mm in diameter by 5000 mm long. The required minimum pile length to resist frost jacking is typically considered to be 8500 mm.

We recommend that the top 1400 mm of the piles supporting the canopy posts be exposed and be wrapped with a double layer of 20 mill polyethylene with grease between the layers. This work could also be completed when upgrading the paving. Consideration should also be given to replacing the concrete pile caps at the base of the columns (Ref. Photo 11).

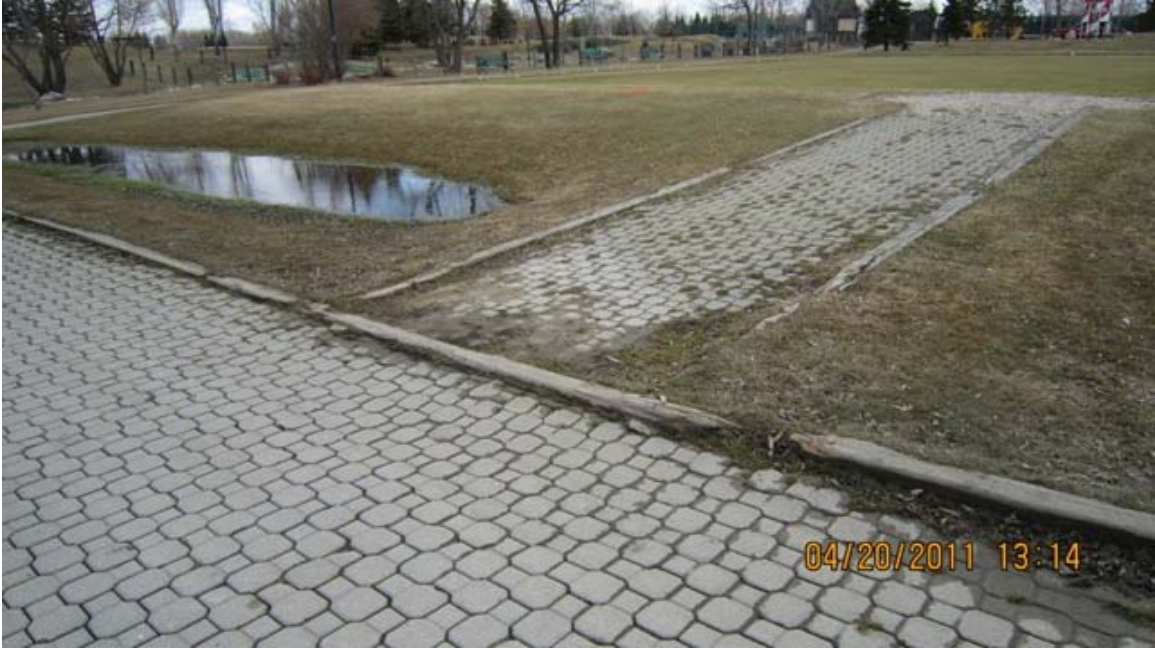
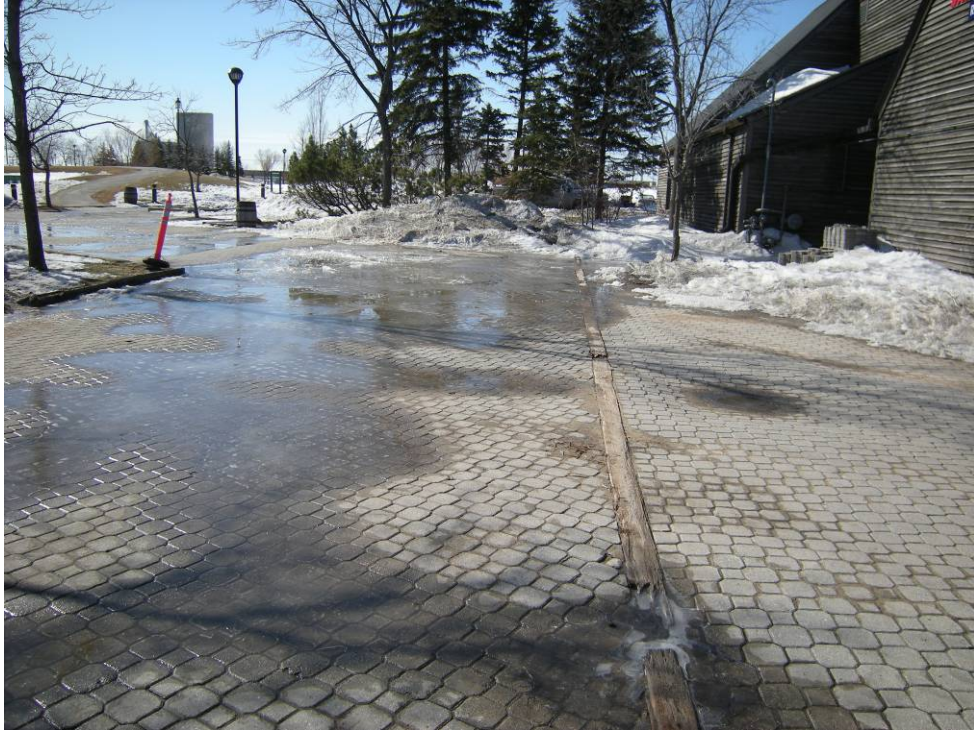
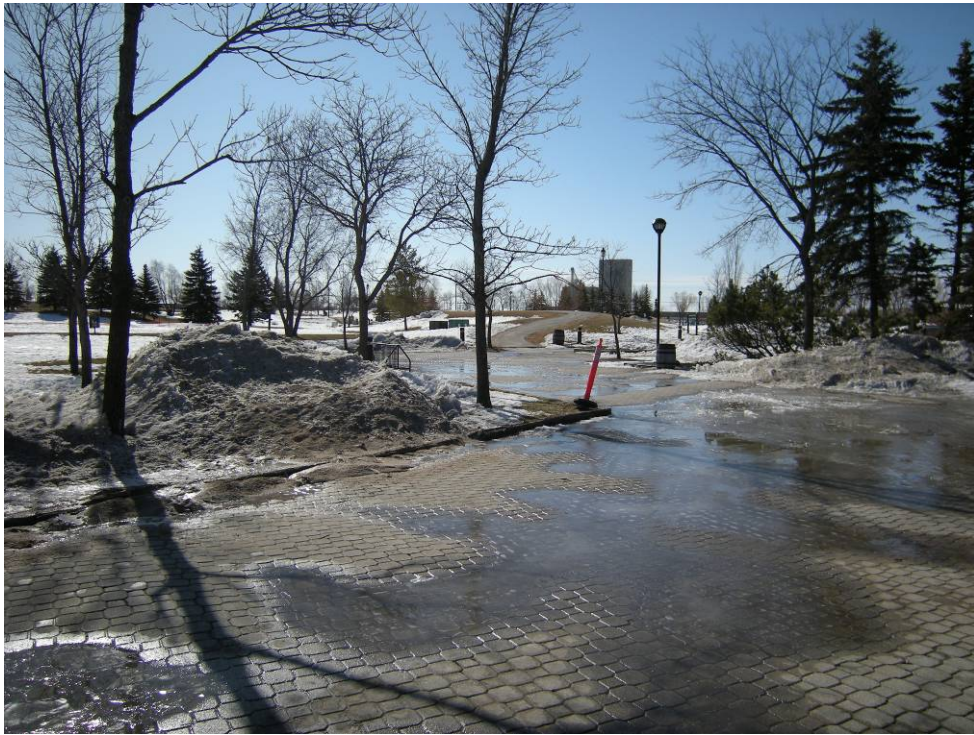
The paving stone courtyard between the building is approximately 535 sq. m. in area (Reference Figure 1). There is also a large area of paving stones to the east of the courtyard (Ref. Photo 15, 17 and 18). Elevations from site survey data are shown on Figure 1. The paving stones have settled in many areas and are missing in other locations (Ref. Photos 12, 13, and 14). There are two drains in the courtyard as noted on Figure 1. Drainage towards these drains as per the survey data, is poor. Rubber mats have been placed in some locations in which the paving stones are missing (Ref. Photo 16). These conditions have been identified by the City Public Works Department as public safety concerns.

Within the courtyard area we recommend that the existing paving stones and granular base be removed and replaced. The new base should be a combination of granular and crushed stone with a minimum total thickness of 450 mm. As there is limited gradient for proper surface drainage, consideration should be given to a permeable paving system which provides for subsurface drainage. The cost of replacing the paving stones and base is estimated to be

\$130 per sq. m. The total estimated cost for the courtyard repaving is \$70,000.00. If the paved area to the east of the courtyard is replaced, the cost would be over twice this amount.
