# ASBESTOS INVENTORY CONTROL

<b>Building Name:</b>	Pan Am Pool - Building	<b>Inspection Date:</b>	January 6, 2012
<b>Building Code:</b>	PI-13	<b>Inspected By:</b>	Nic DeMelo & Robert Chennells
<b>Building Address:</b>	25 Poseidon Bay	<b>Construction Date:</b>	1967

**PI-13**

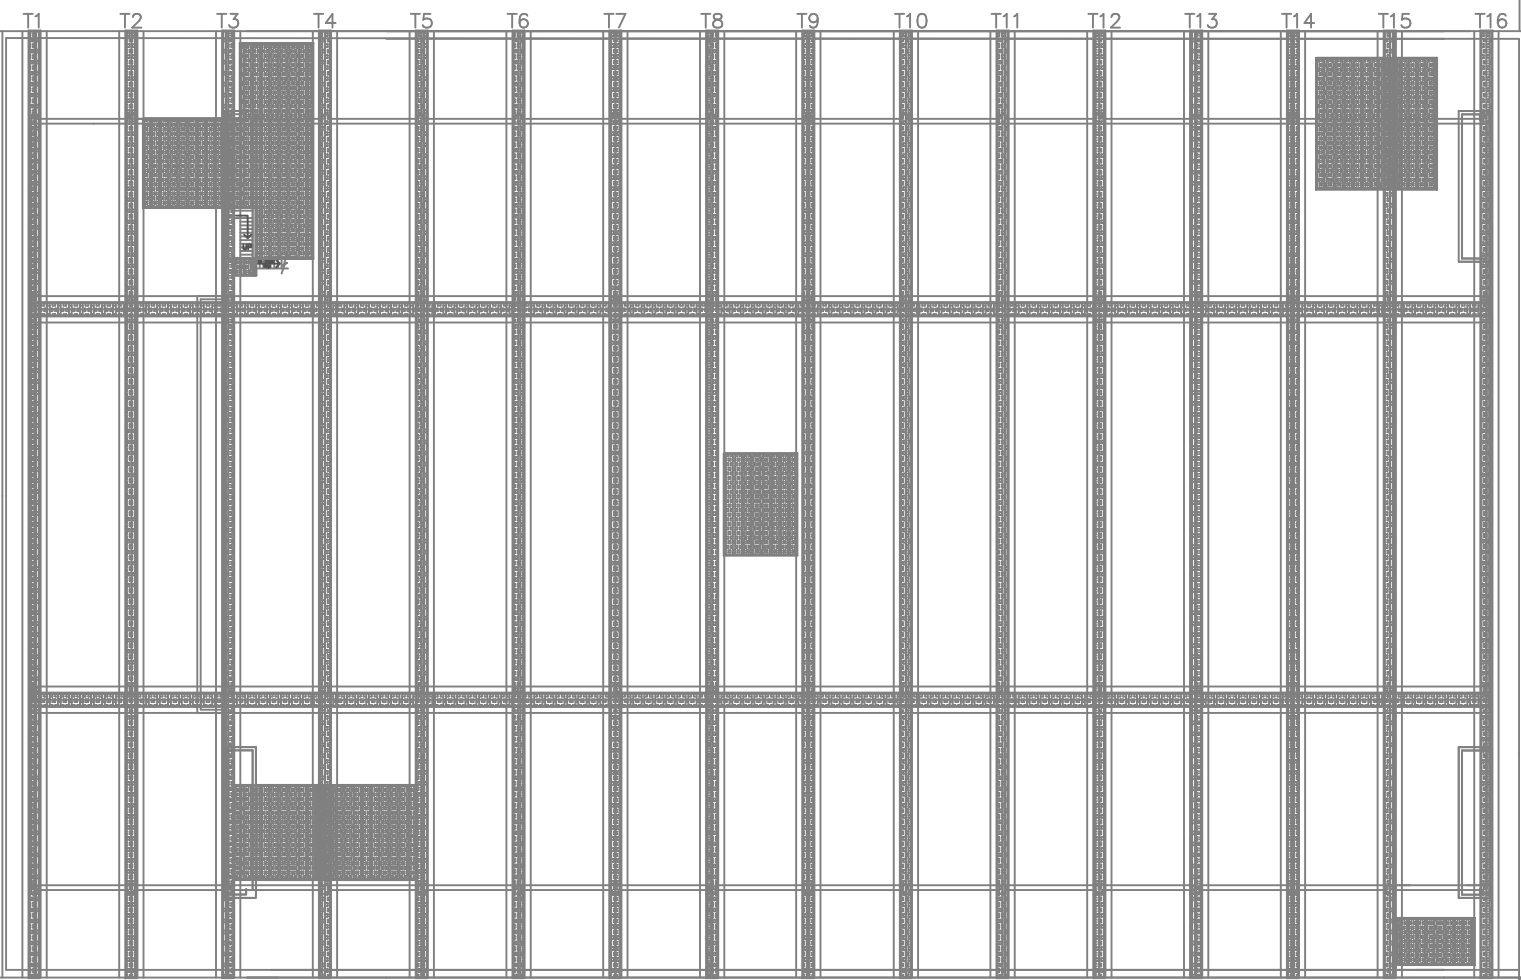
**ROOF CATWALK PLAN**

**Remark:**  
- Asbestos containing pipe fittings are through out catwalk area in various locations.

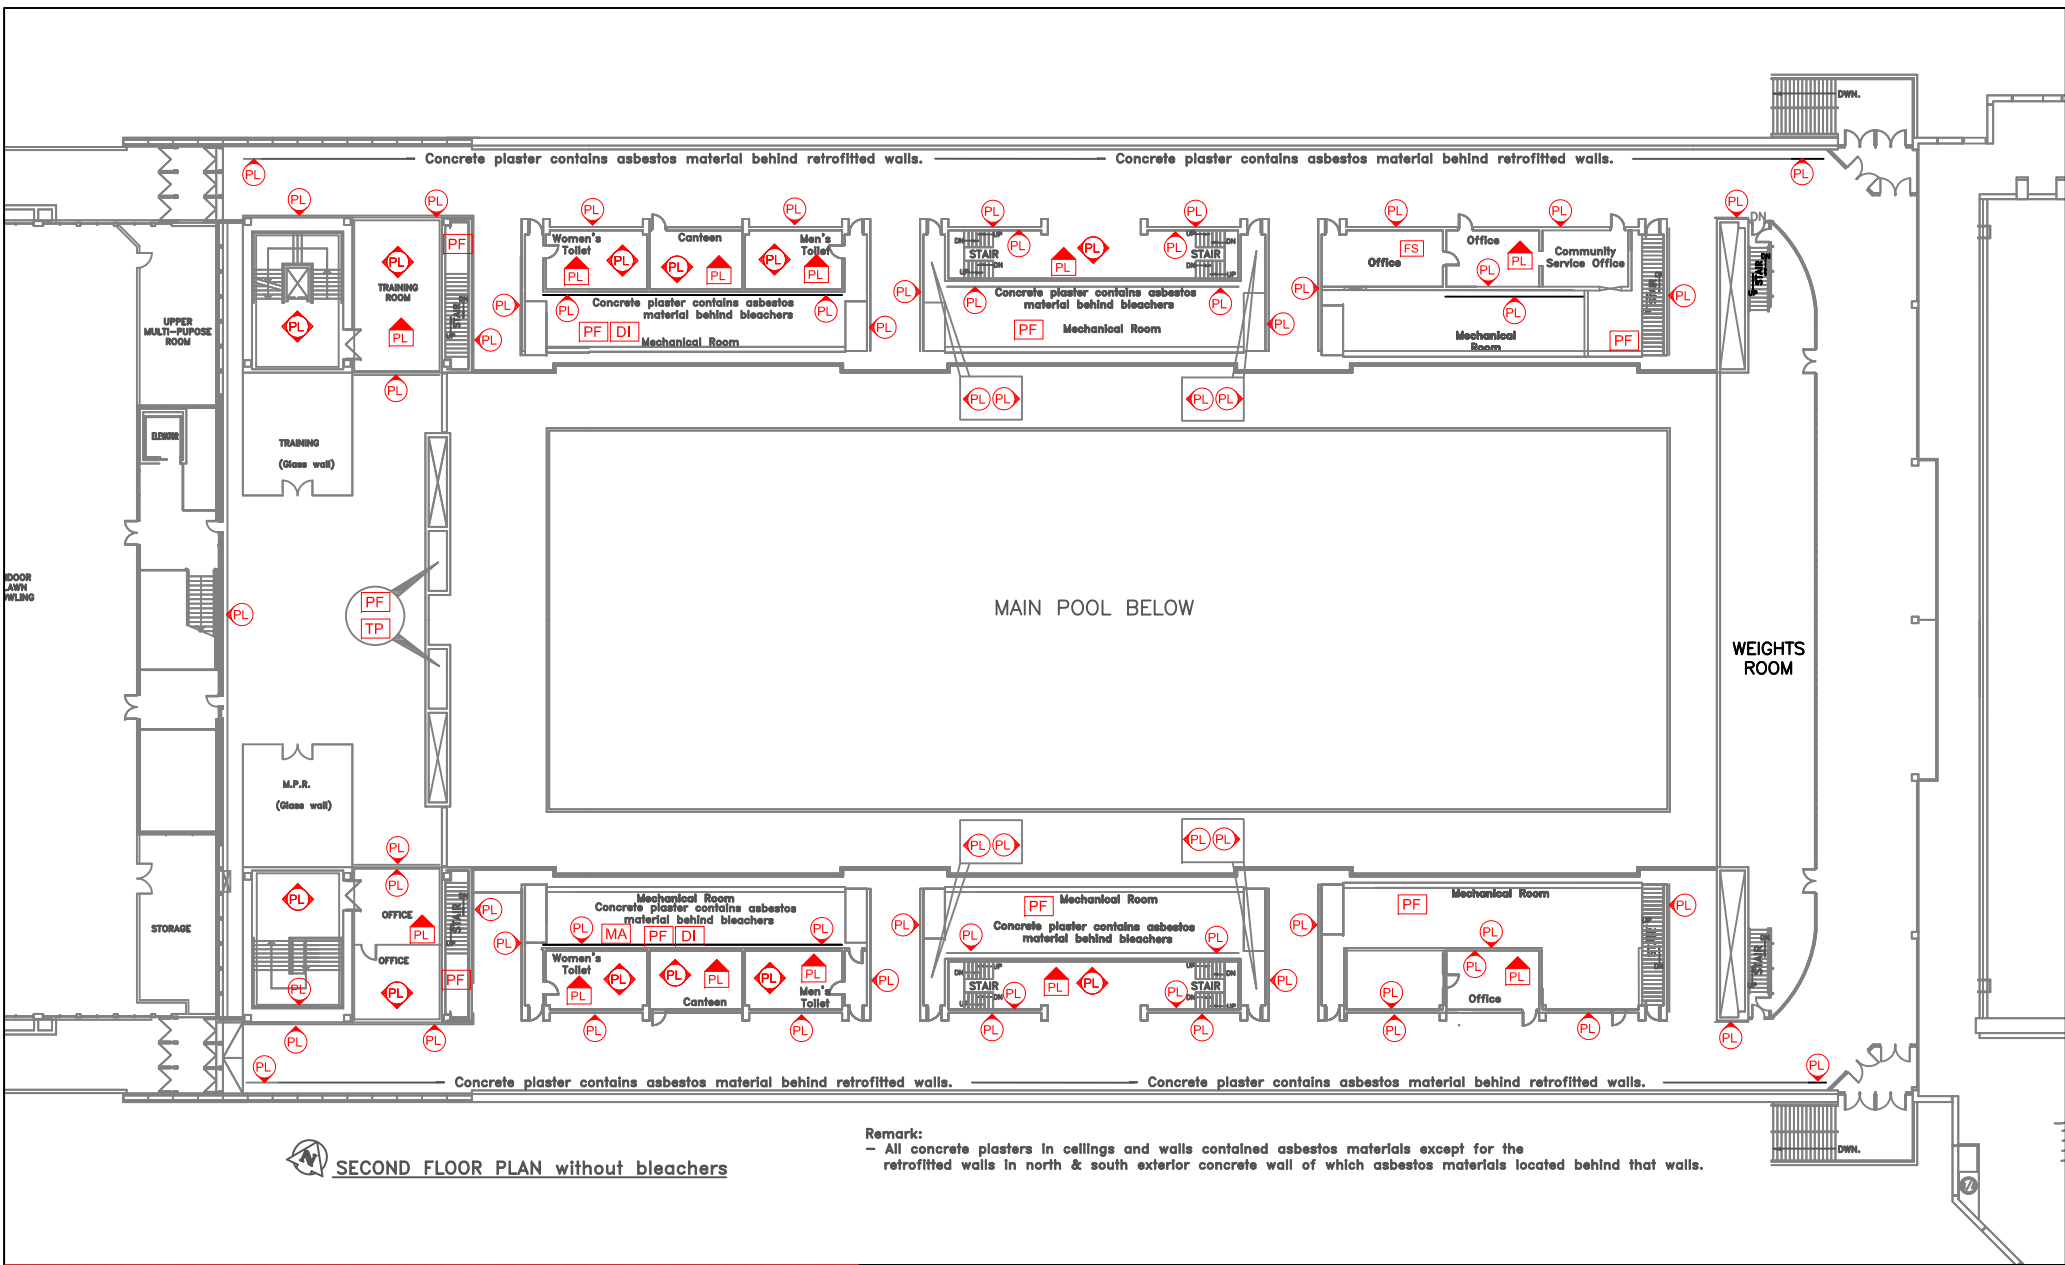
**SECOND FLOOR PLAN without bleachers**

**Remark:**  
 - All concrete plasters in ceilings and walls contained asbestos materials except for the retrofitted walls in north & south exterior concrete wall of which asbestos materials located behind that walls.

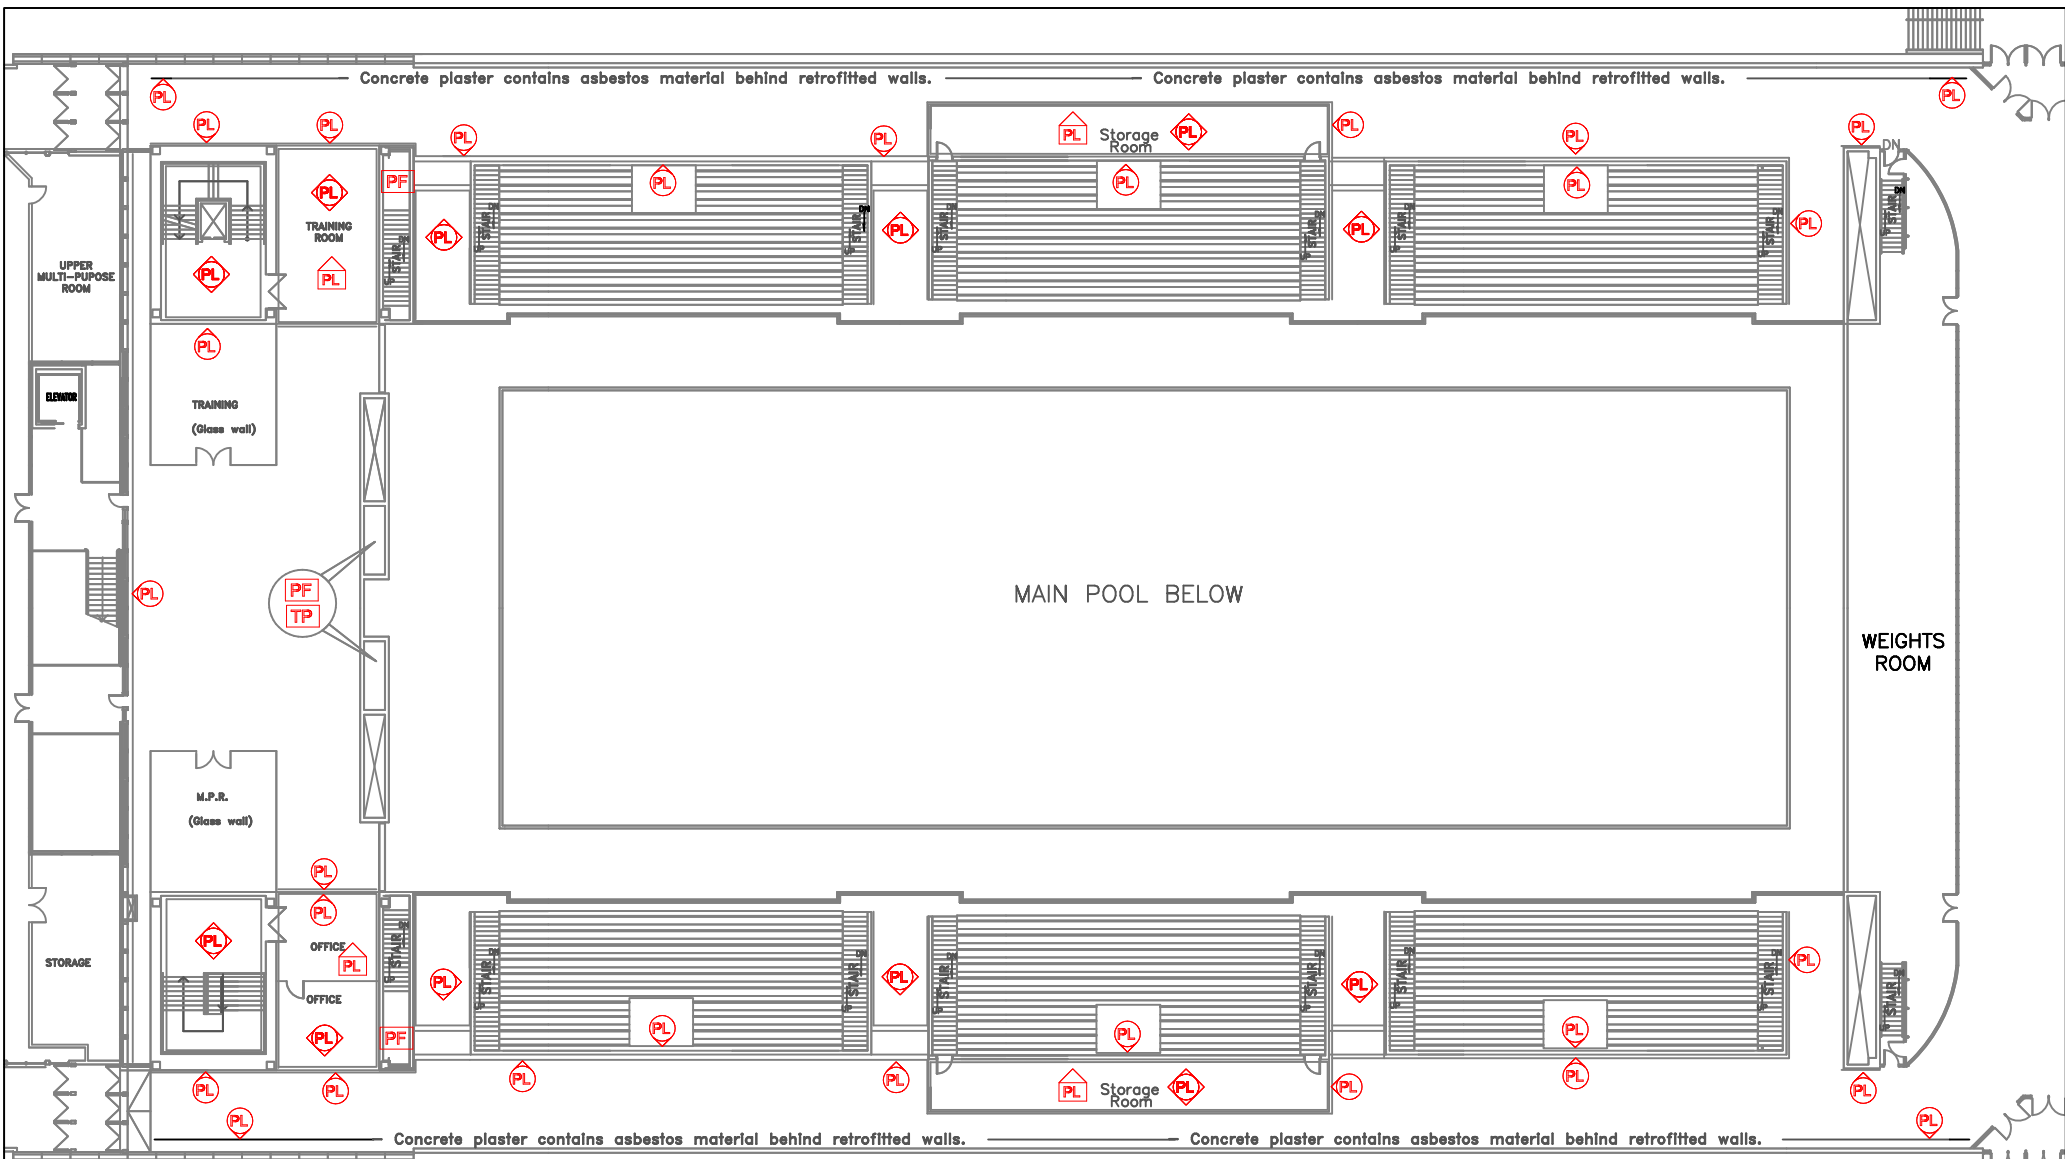
**SECOND FLOOR PLAN - Mezzanine level**

**Remark:**  
 - All concrete plasters in ceilings and walls contained asbestos materials except for the retrofitted walls in north & south exterior concrete wall of which asbestos materials located behind that walls.

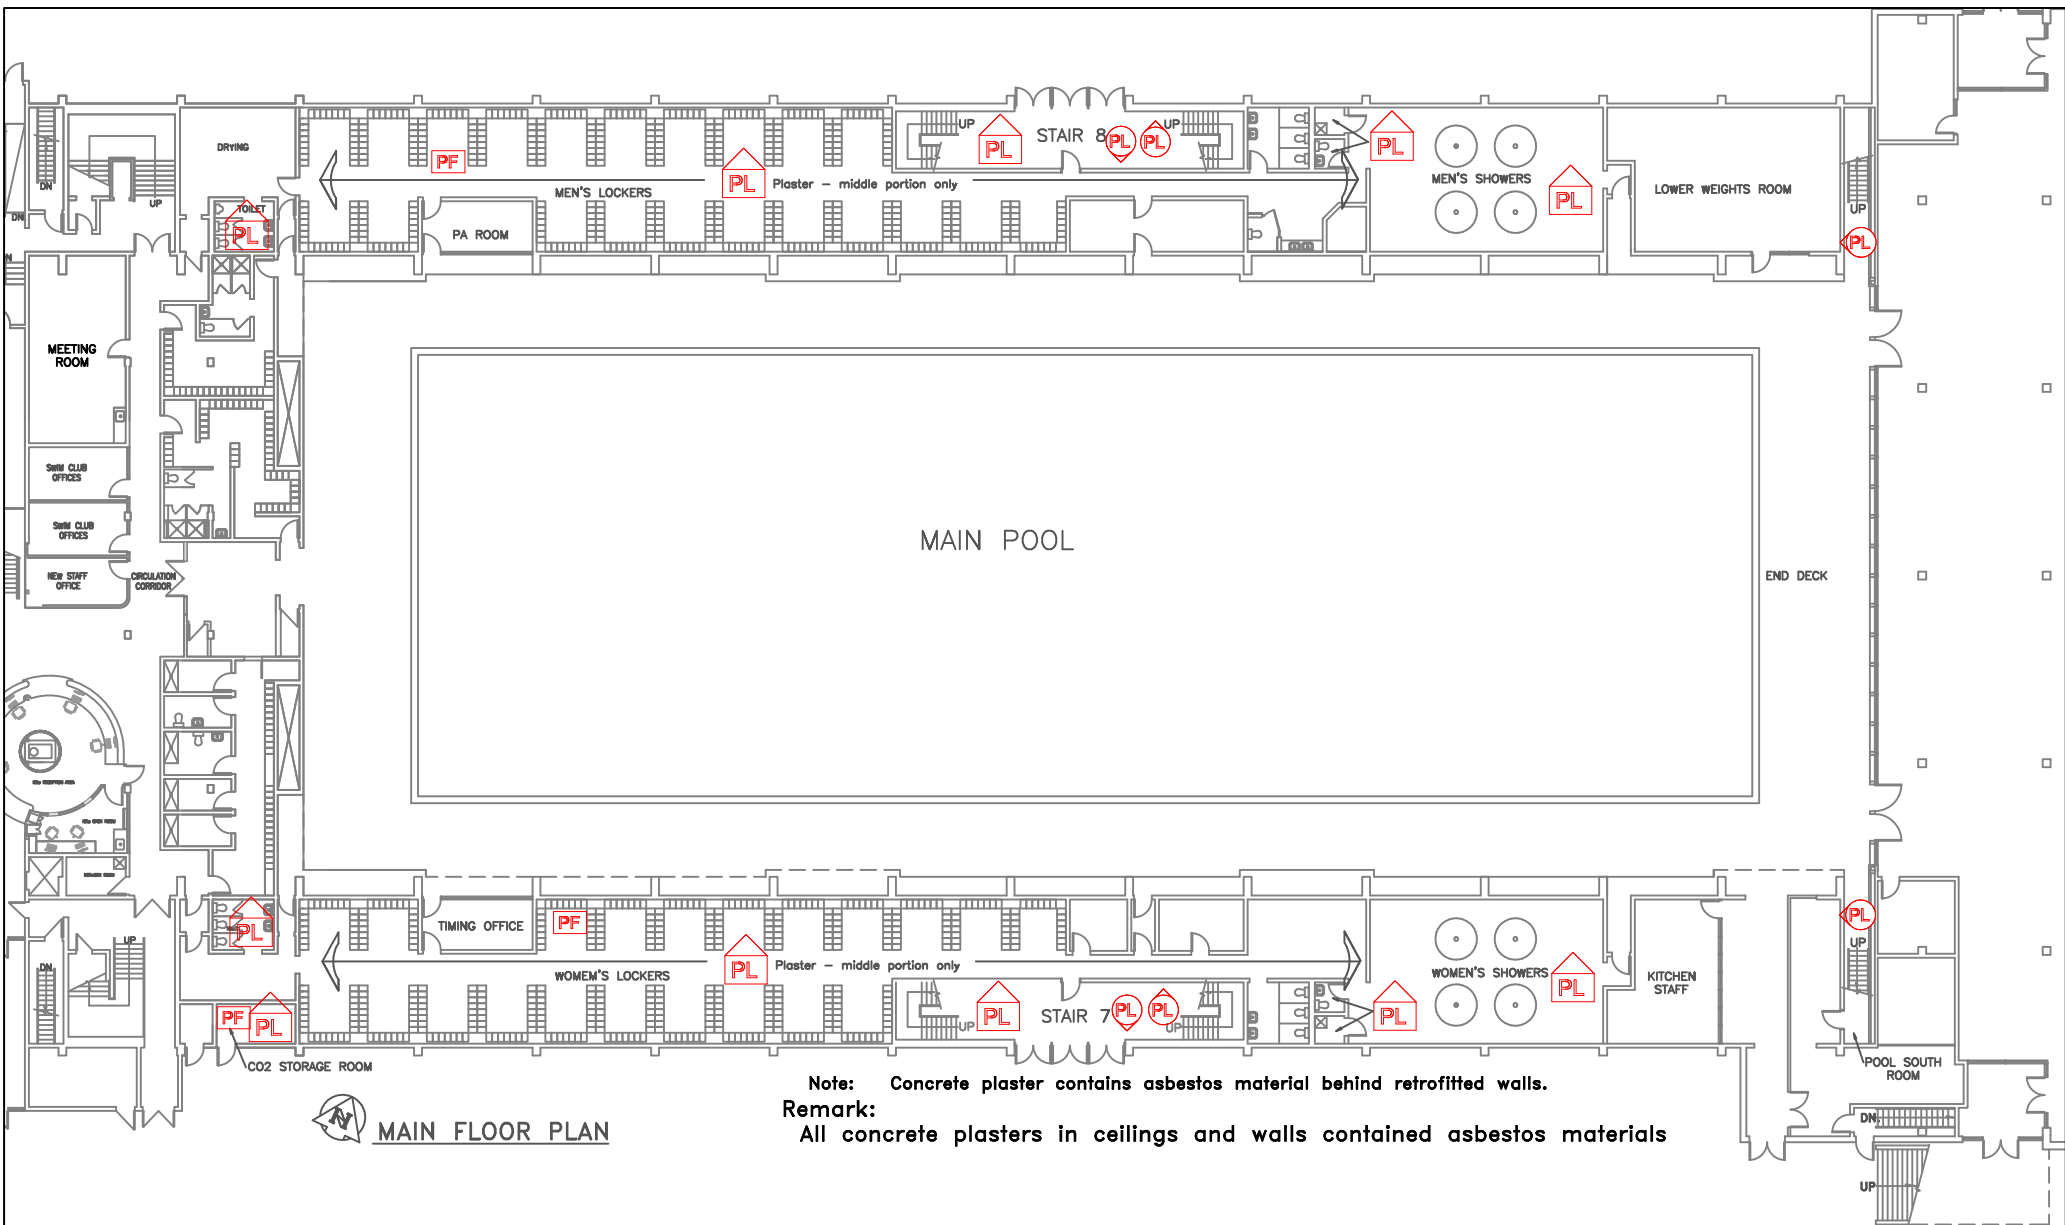
**MAIN FLOOR PLAN**

**Note:** Concrete plaster contains asbestos material behind retrofitted walls.  
**Remark:** All concrete plasters in ceilings and walls contained asbestos materials
