**APPENDIX C – SITE PHOTOGRAPHS**

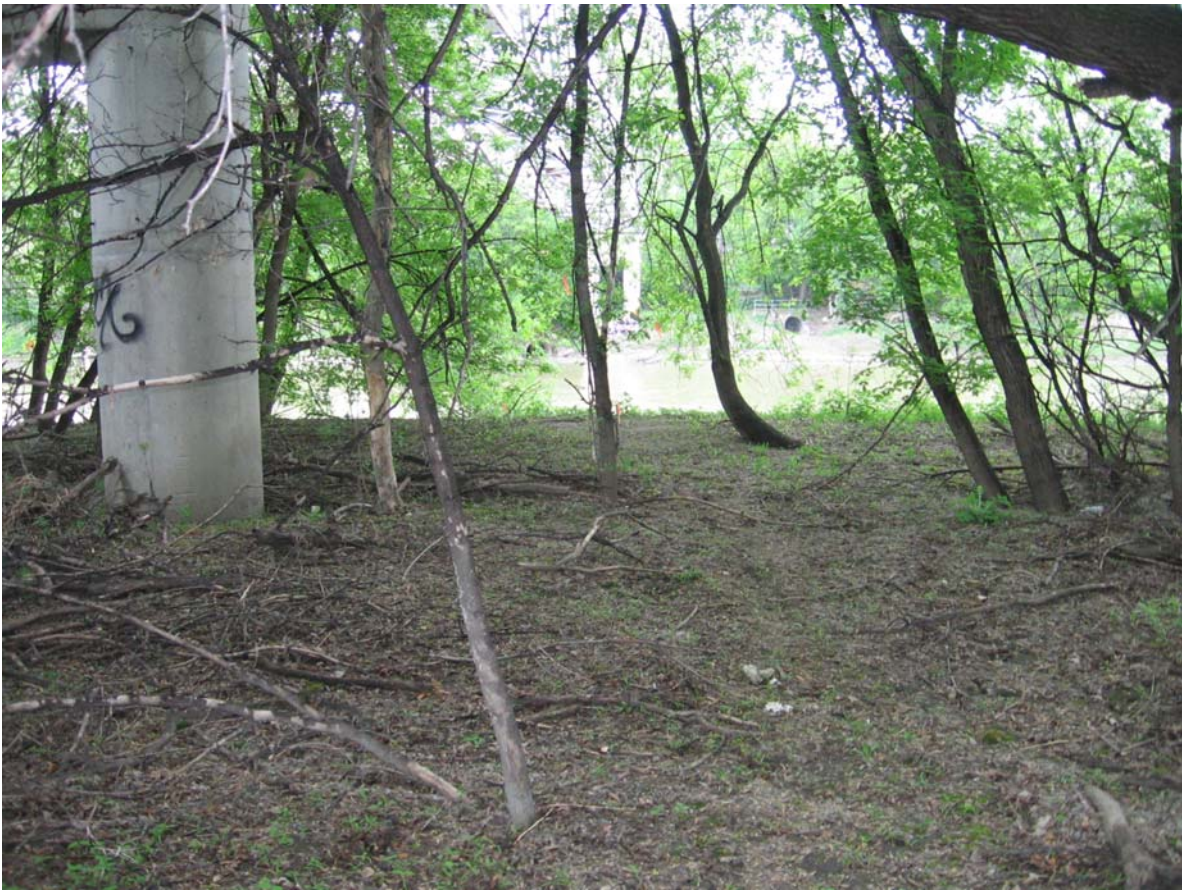
01\_S\_Bank\_Toe\_027\_080530\_DY.jpg

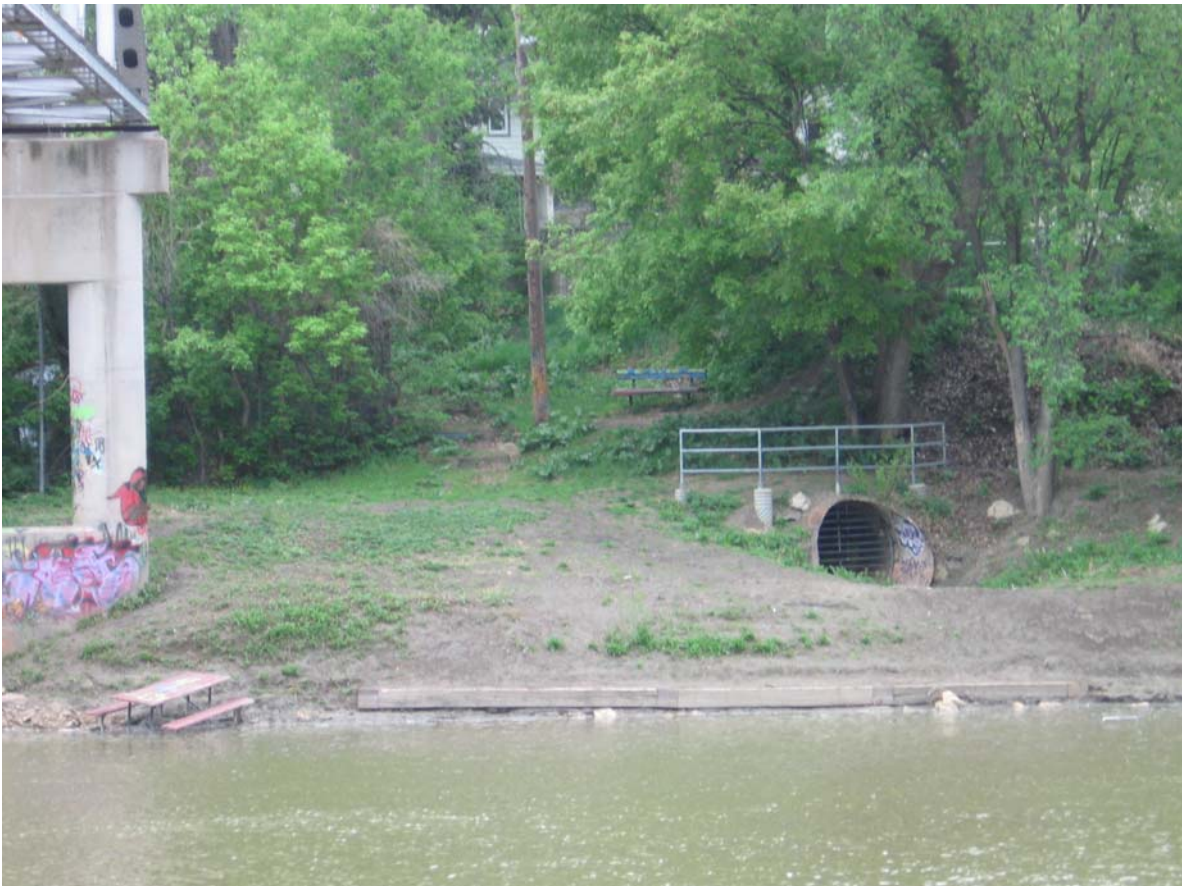
02\_N\_Bank\_From\_South\_041\_080530\_DY.jpg

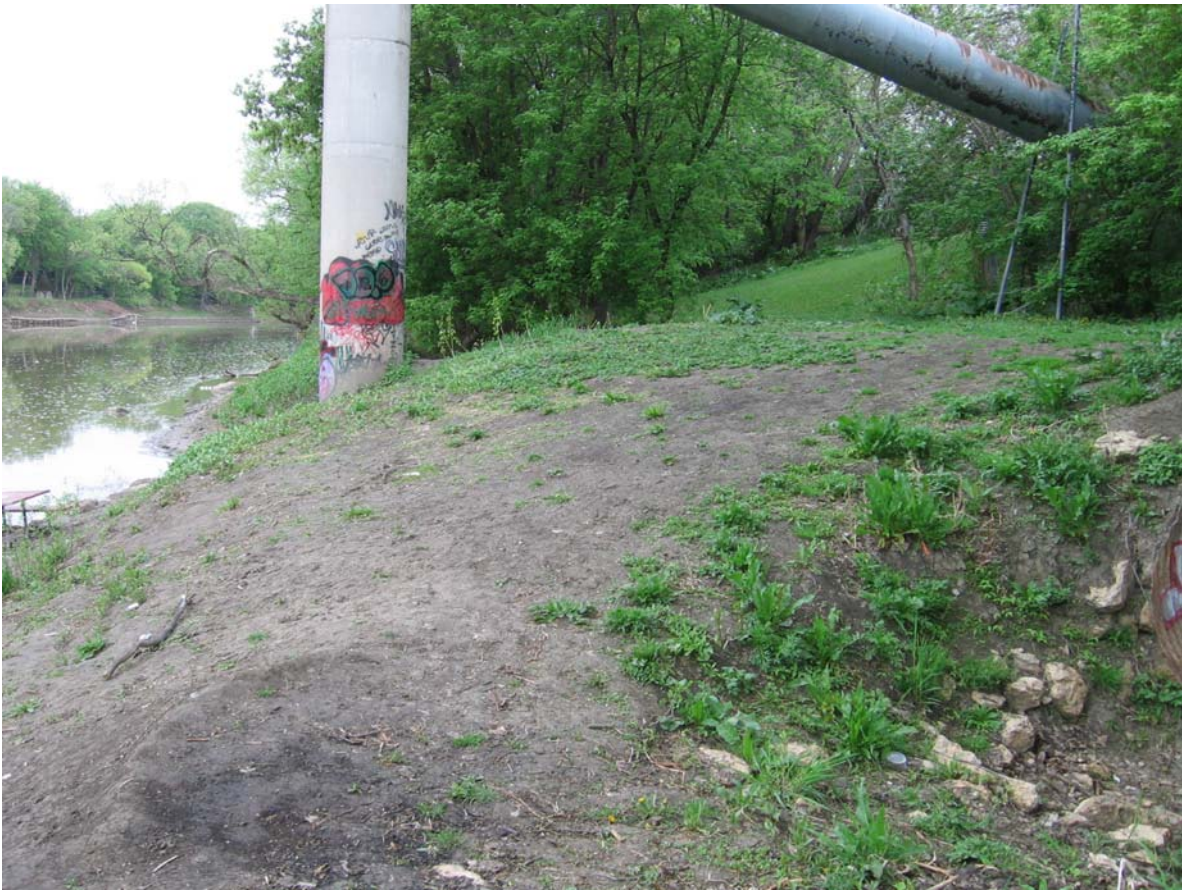
04\_N\_Bank\_Toe\_078\_080530\_DY.jpg

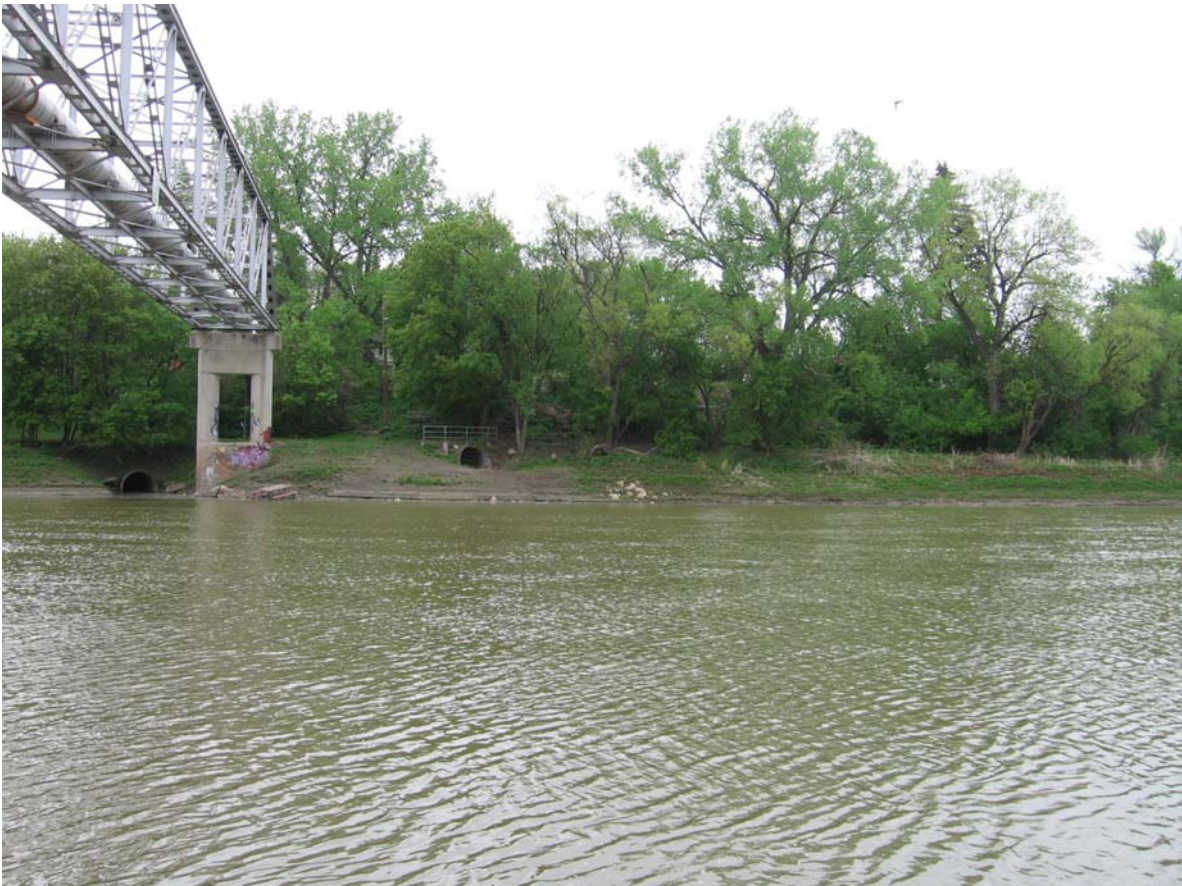
05\_N\_Bank\_From\_South\_044\_080530\_DY.jpg

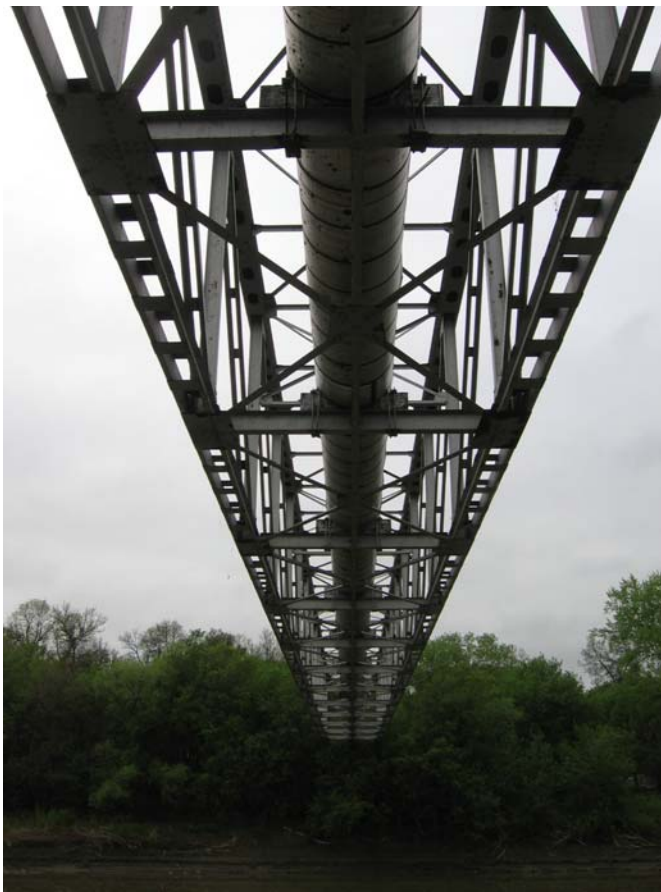
05\_N\_Bridge\_and\_Piers\_064\_080530\_DY.jpg

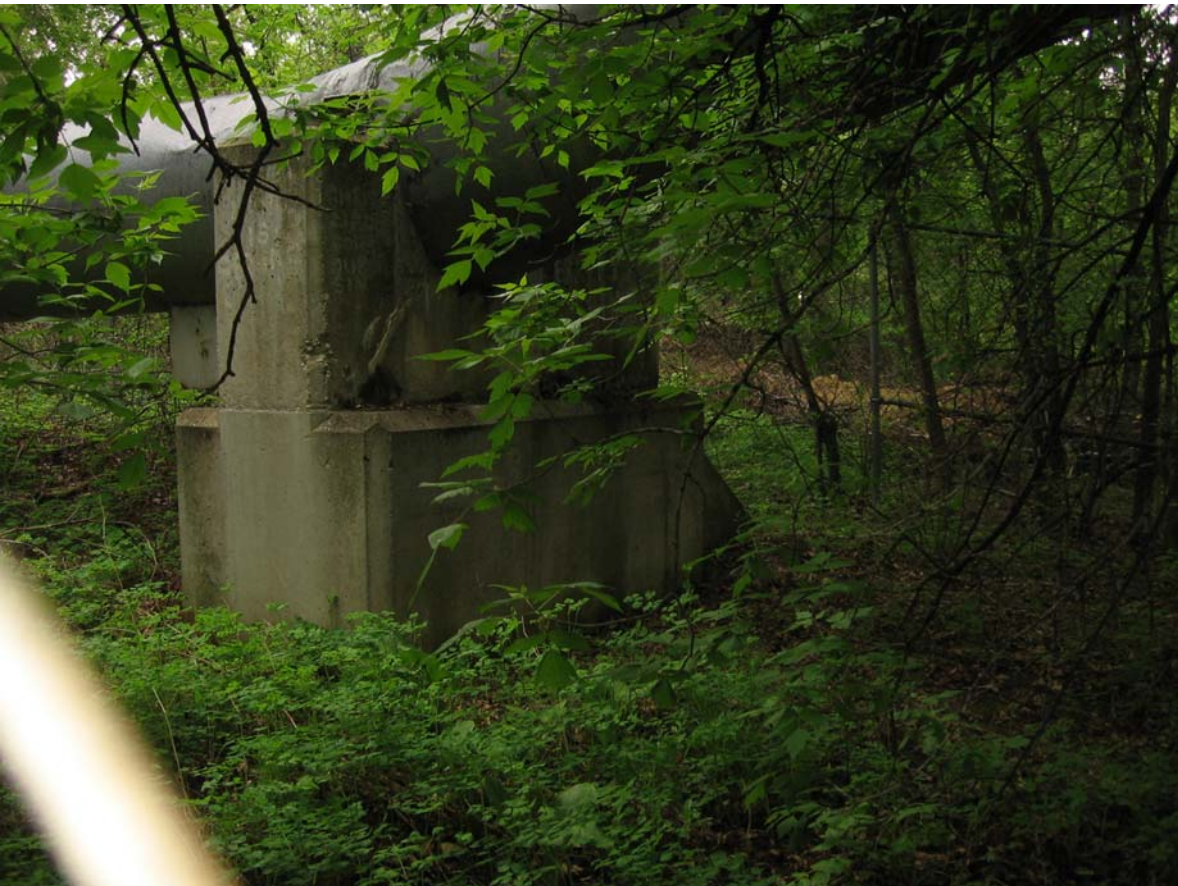
11\_S\_Pipe\_Approaches\_024\_080530\_DY.jpg

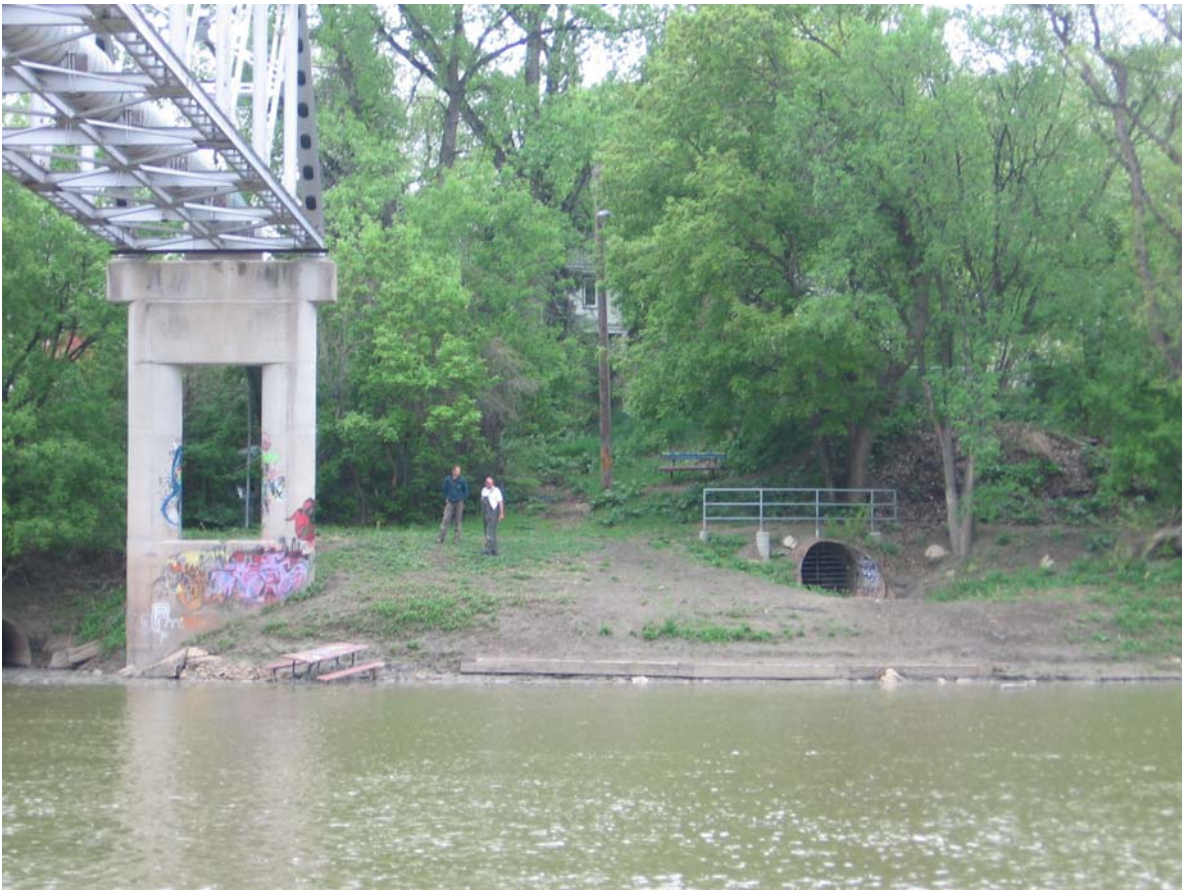
12\_N\_Bank\_From\_South\_053\_080530\_DY.jpg

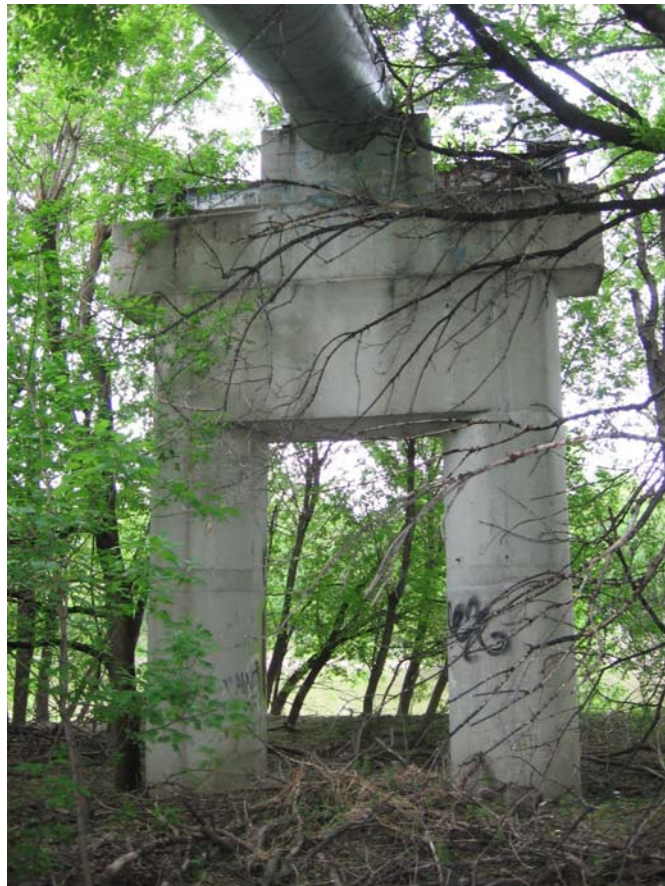
15\_S\_Bridge\_and\_Piers\_195\_080530\_DY.jpg

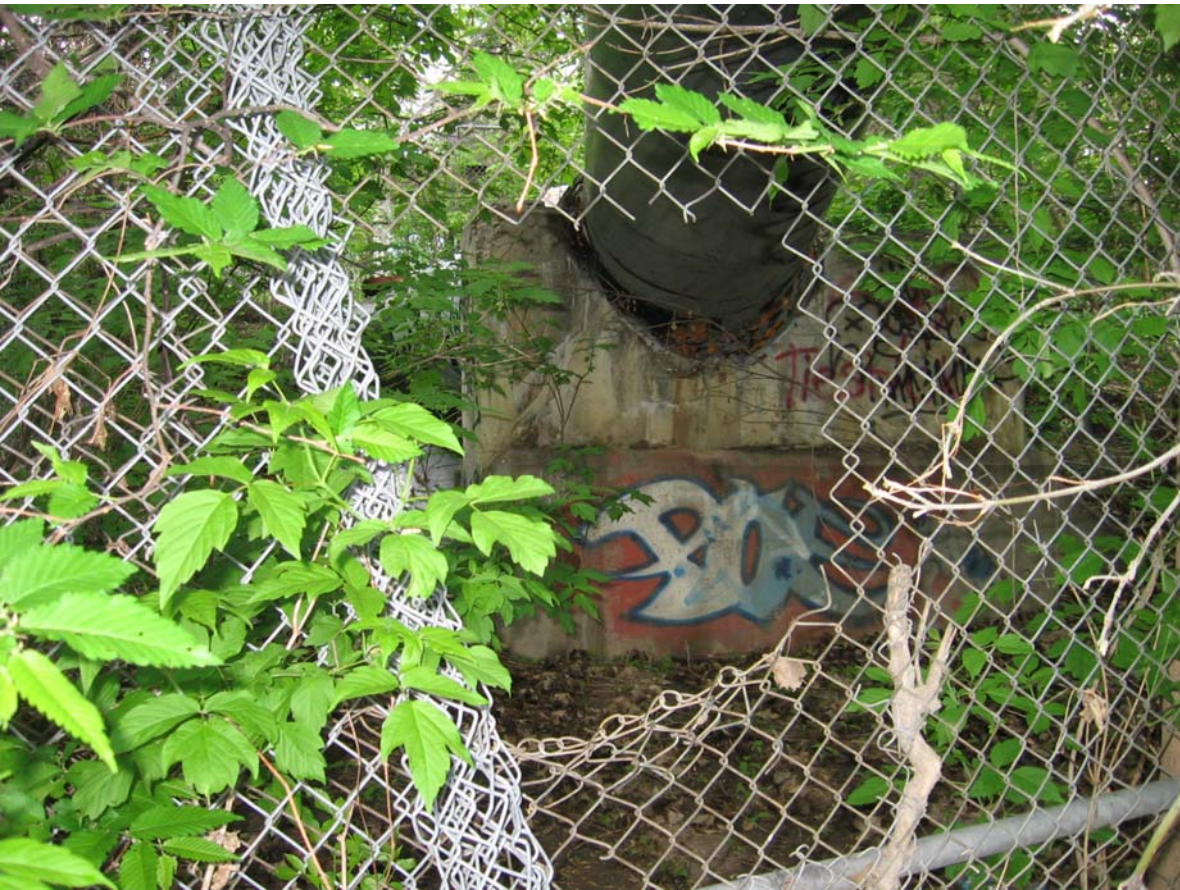
16\_N\_Pipe\_Approaches\_088\_080530\_DY.jpg

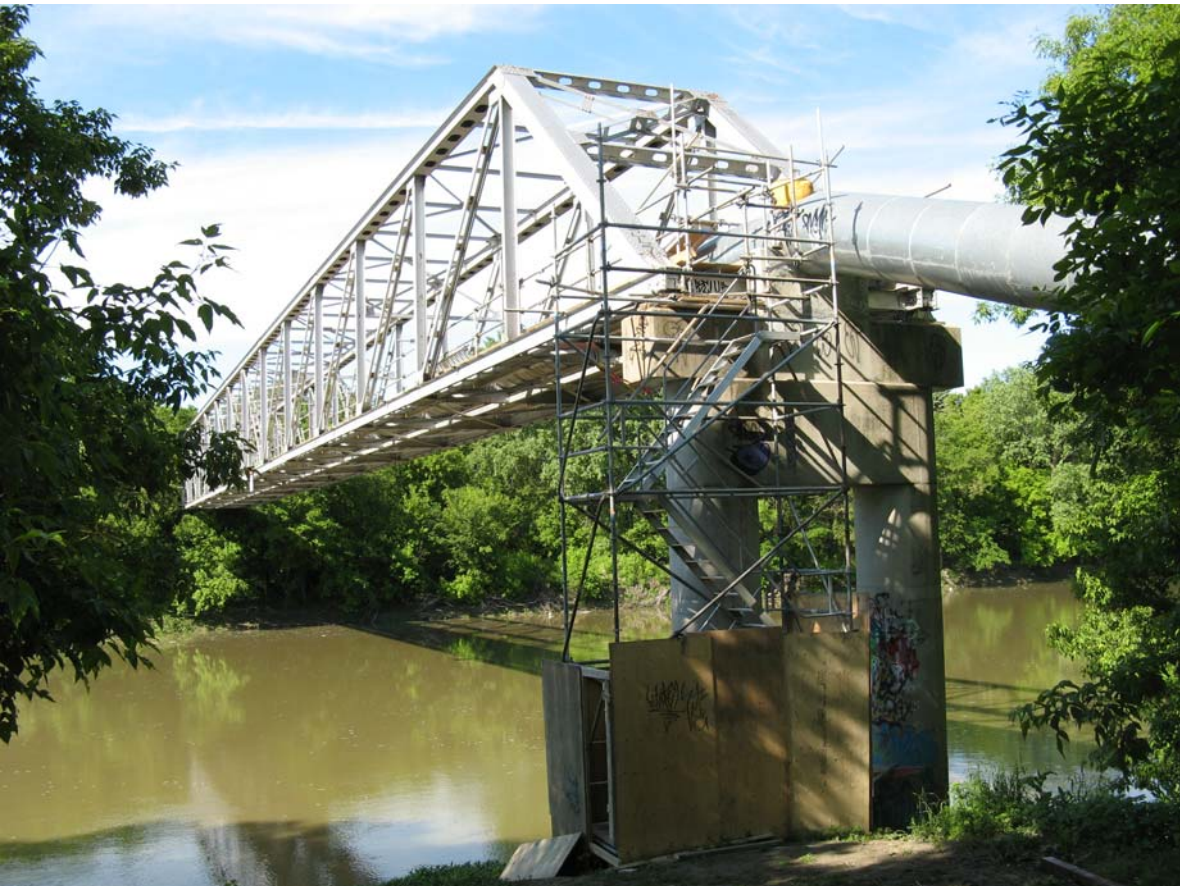
A3-01 - East Elevation form NE .JPG

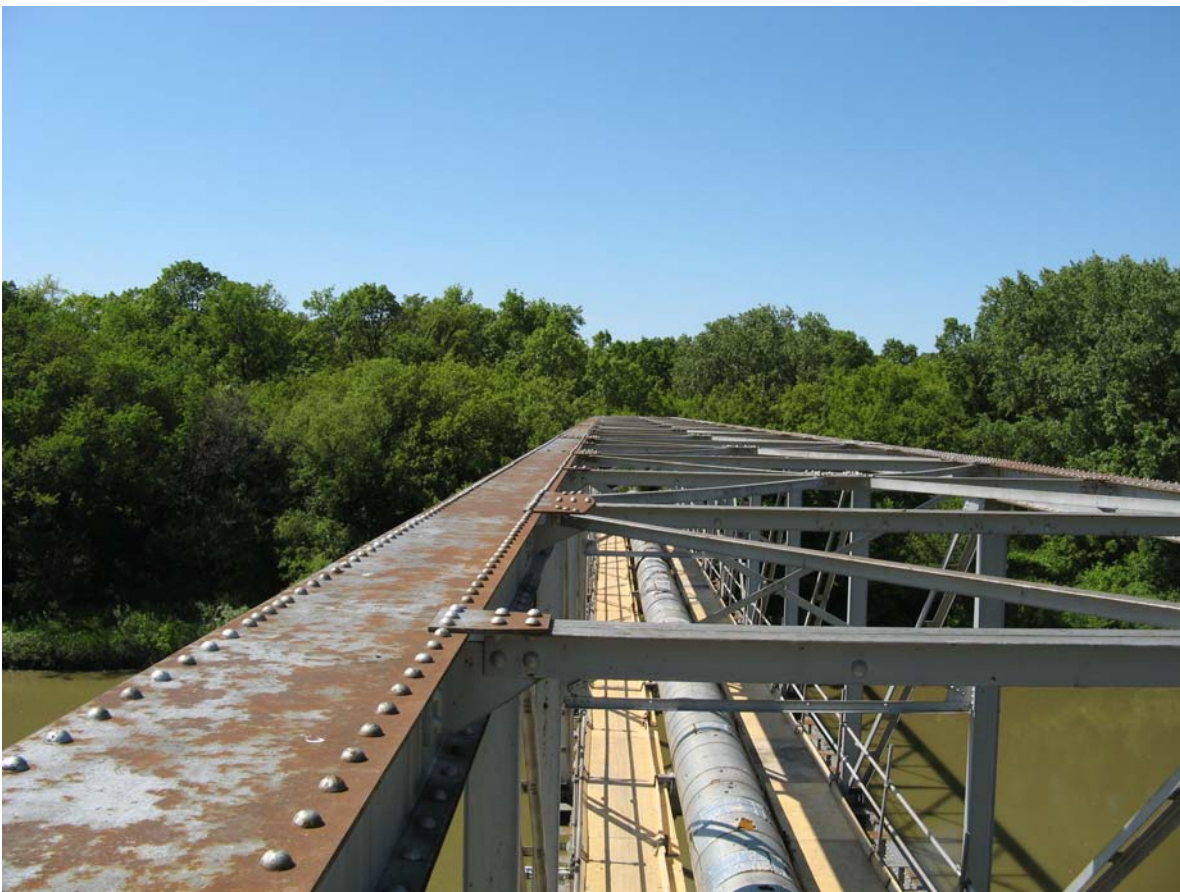
A3-06 - Top of Bridge East Half.JPG

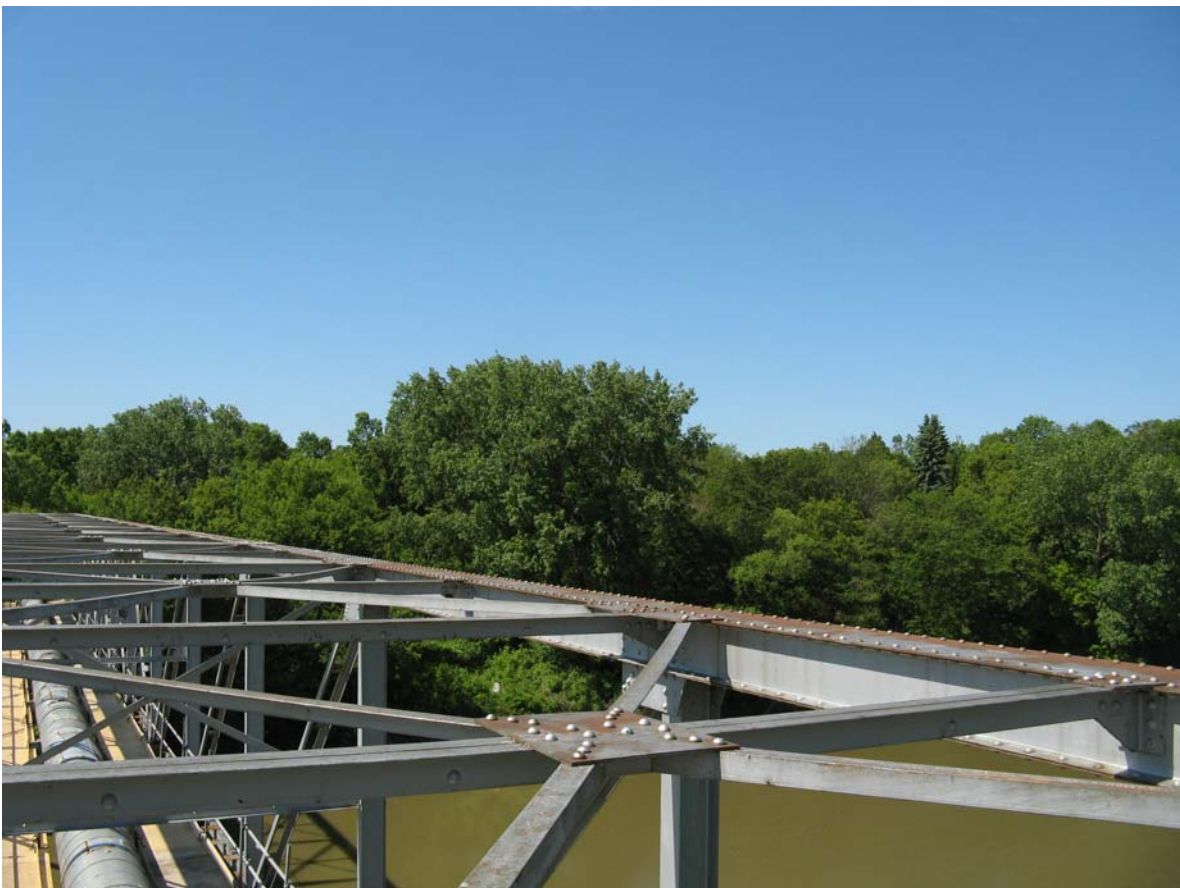
A3-07 - Top of Bridge West half.JPG

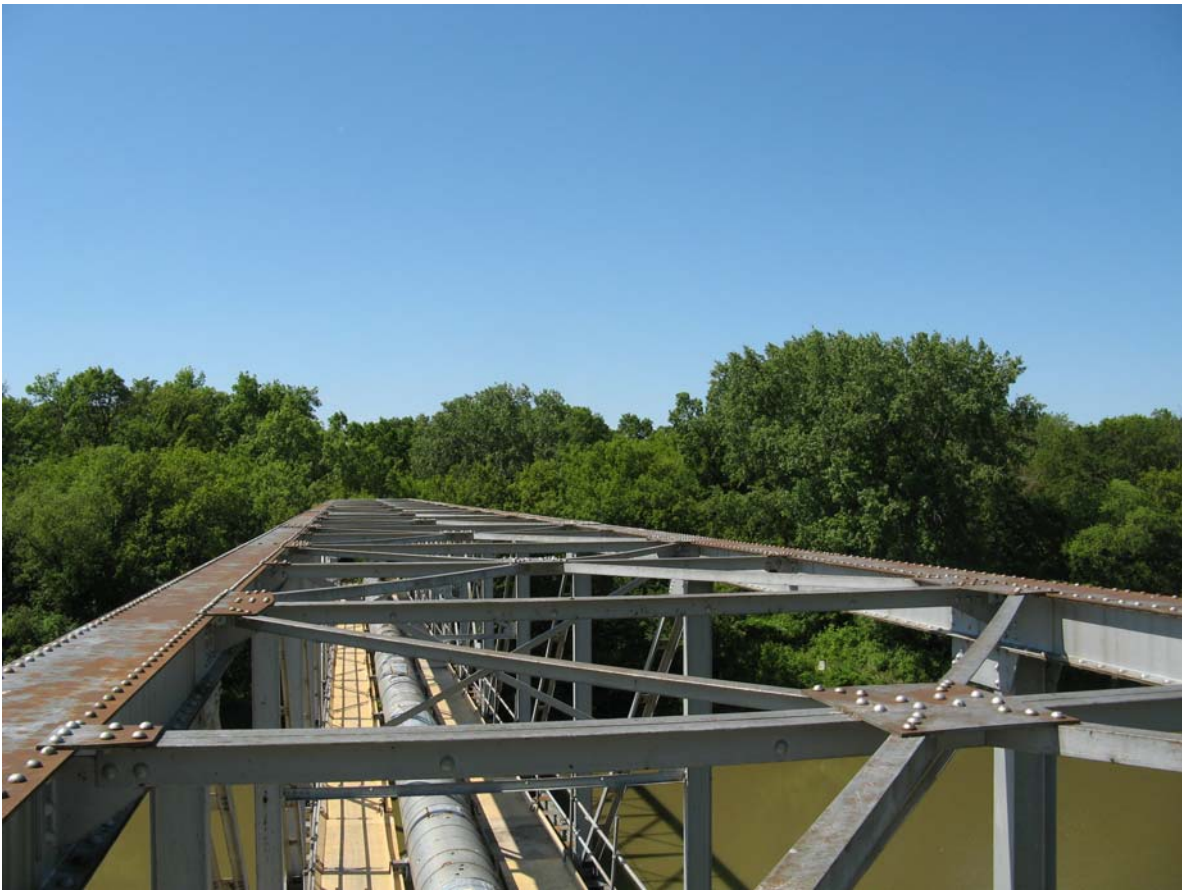
A3-08 - Top of Bridge.JPG

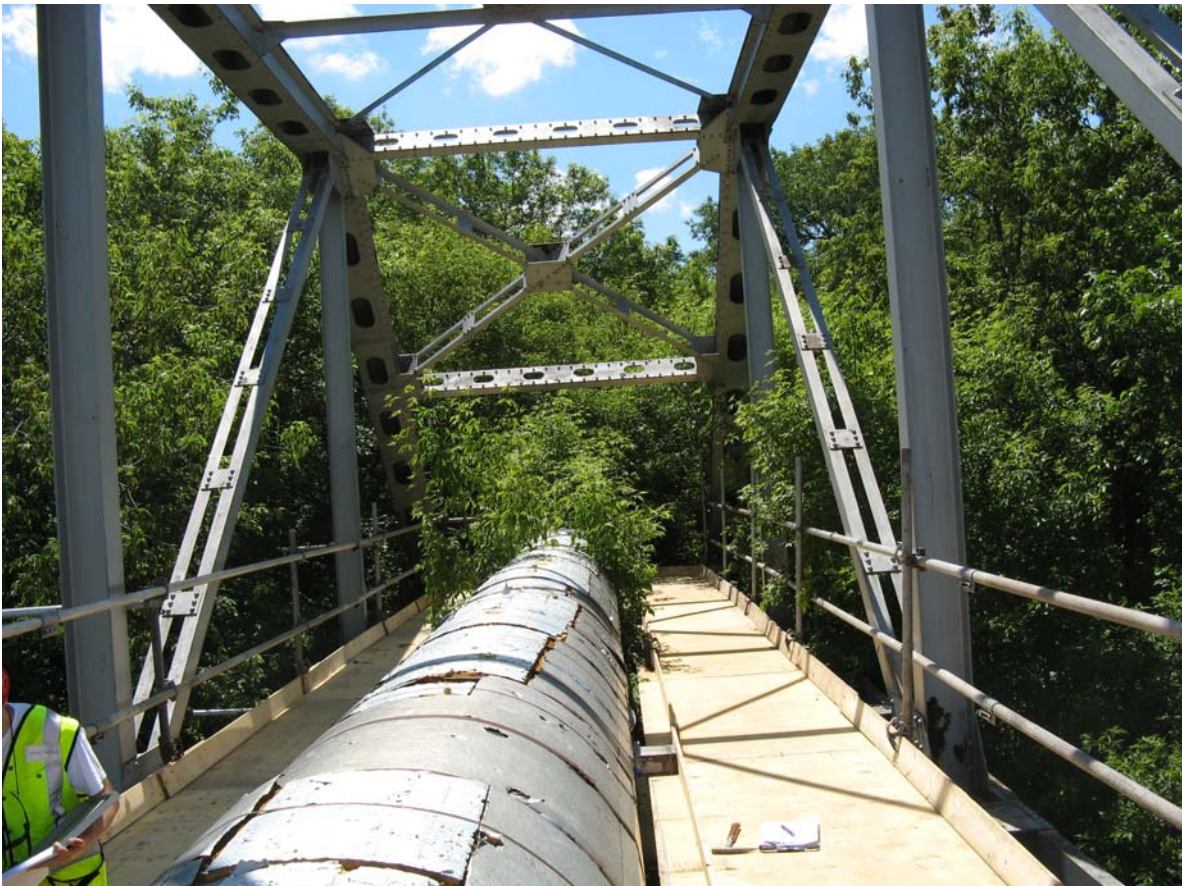
A3-09 - Pipe Insulation and Cladding-South End.JPG

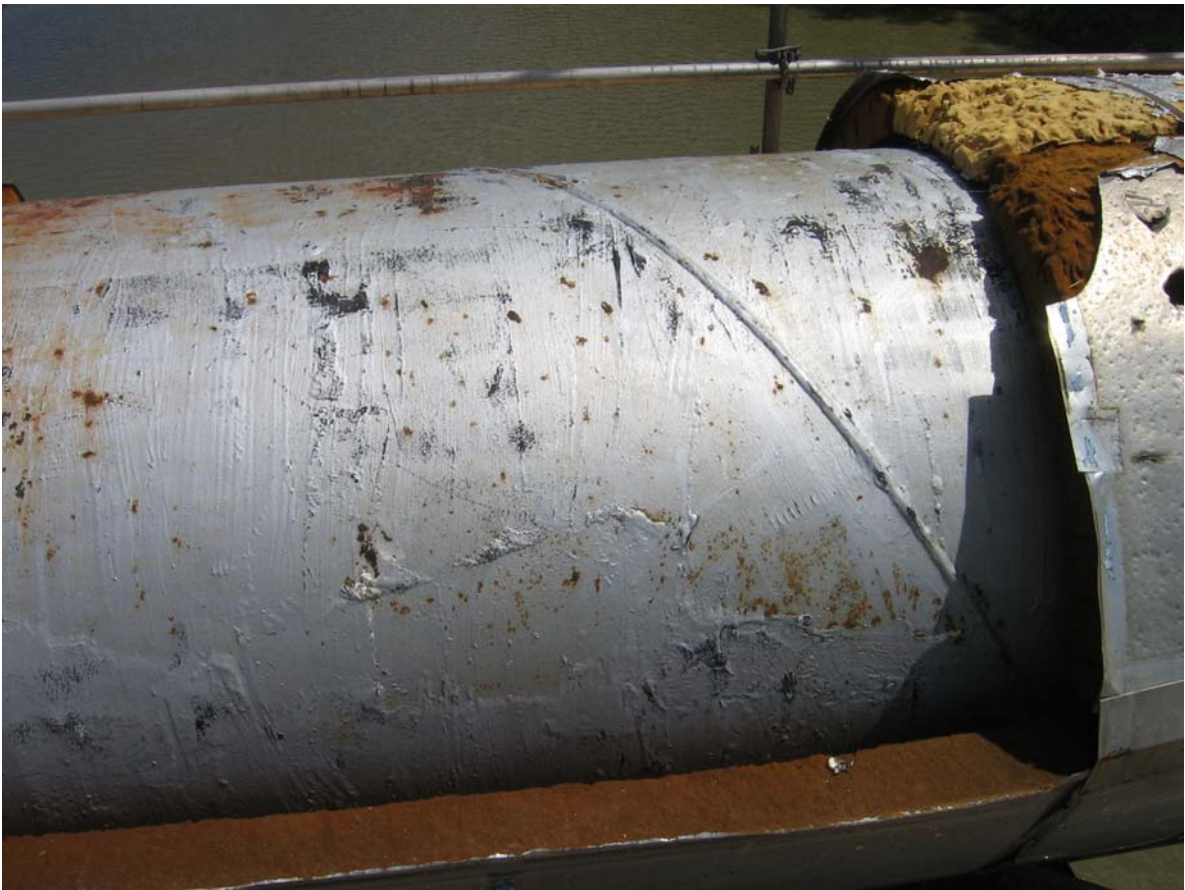
A3-12 - Existing Pipe Coating.jpg
