PROJECT:  
SLOPE STABILITY ASSESSMENT AND  
EROSION PROTECTION, BUNN'S  
CREEK PATHWAY, WINNIPEG, MB

DWG DESCRIPTION:  
PHOTOGRAPHS 7 TO 12

ENG-TECH DWG/FIG. No.:	No.:
G11

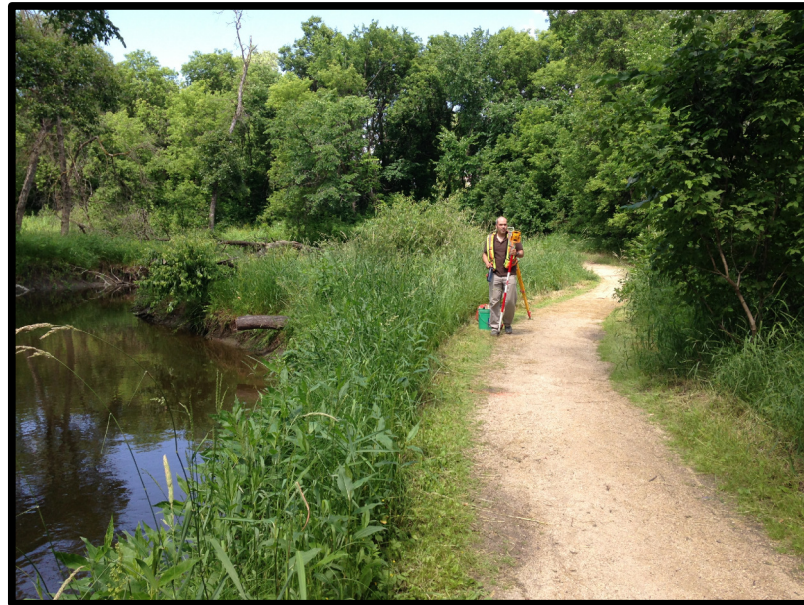
PHOTOGRAPH 7: ZONE G, FACING NORTH, SHOWING PATHWAY AND BUNN'S CREEK LOCATED ON LEFT SIDE OF PICTURE.

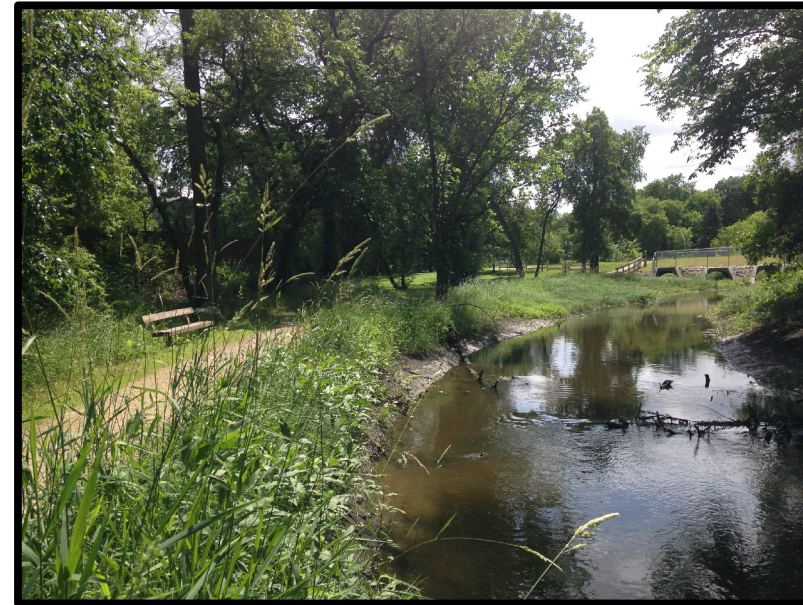
PHOTOGRAPH 8: ZONE G, FACING SOUTH, SHOWING BUNN'S CREEK SHORLINE AND CHANNEL.

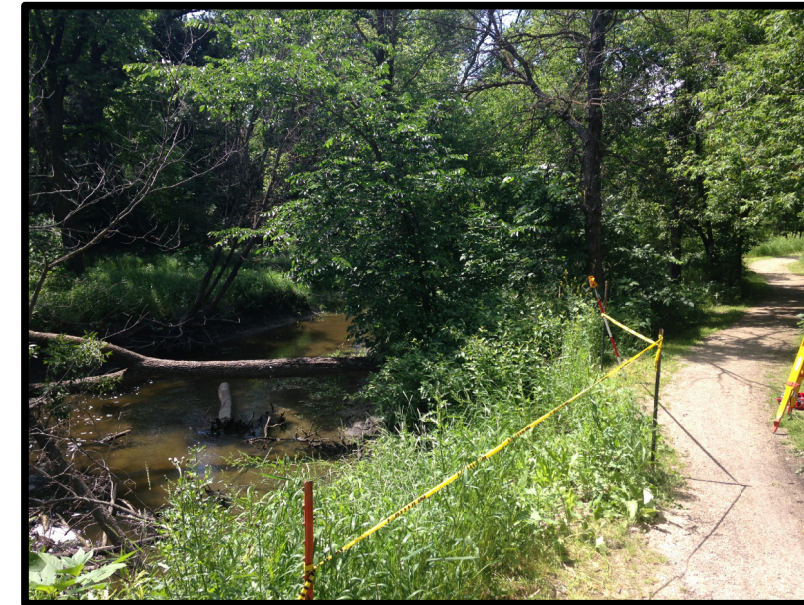
PHOTOGRAPH 9: ZONE H, FACING WEST, SHOWING FAILED REGION AT TOP OF BANK.

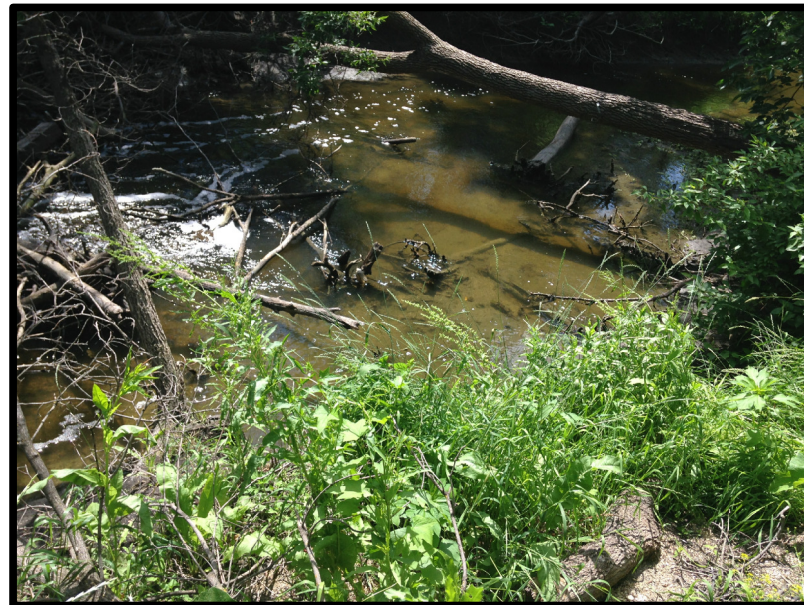
PHOTOGRAPH 10: ZONE H, FACING SOUTH, SHOWING STEEP INCLINE FROM TOP OF BANK (PATHWAY) TO CREEK SHORELINE AT FAILED REGION.

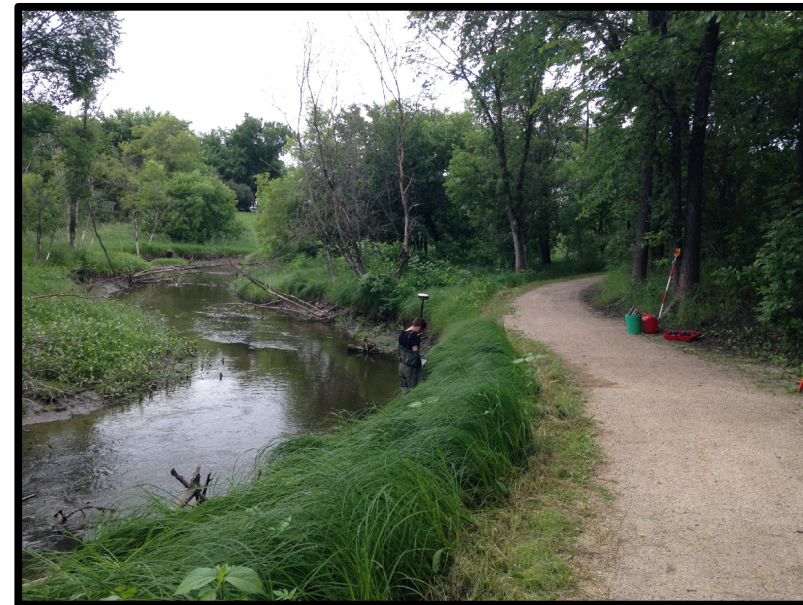
PHOTOGRAPH 11: ZONE I, FACING WEST, SHOWING PATHWAY AND BUNN'S CREEK LOCATED ON LEFT SIDE OF PICTURE.

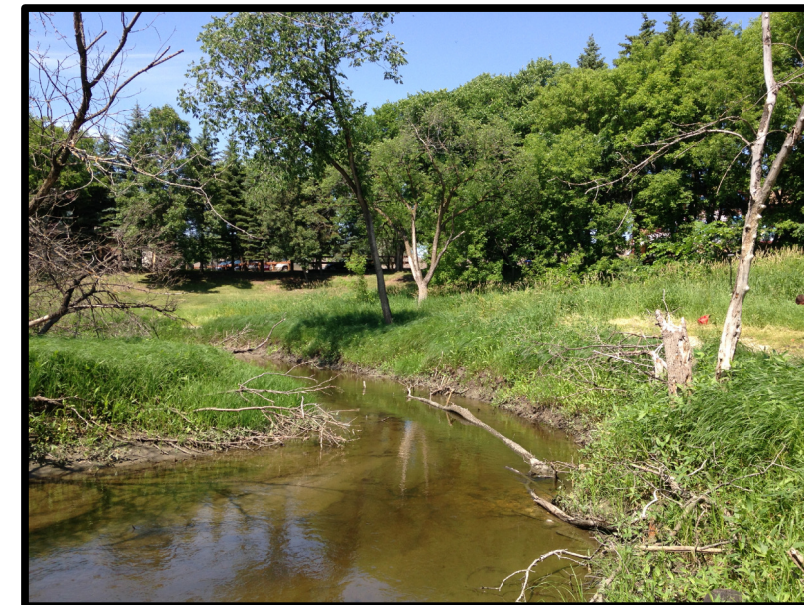
PHOTOGRAPH 12: ZONE J, FACING NORTHWEST, SHOWING BUNN'S CREEK SHORELINE AND CHANNEL.
