APPENDIX B (R1)

Crosier Kilgour & Partners Ltd.

January 6, 2016

**Re: Machray Park
Structural Assessment**

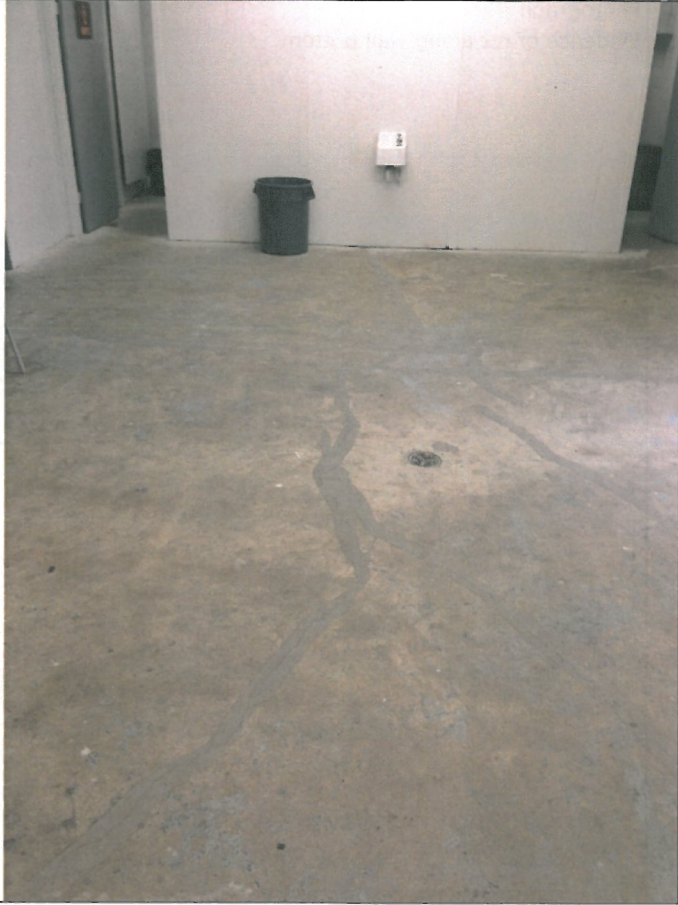
The floor system has experienced some cracking as a result of soil movement (see photograph Number 1). In 1978, during the addition of the storage room, a 2" concrete topping was added to the existing concrete floor, likely in an effort to cover up cracks and re-level the floor. This topping has also cracked and since been filled with a repair material. Although cracked, the floor remains in usable condition.

Photograph #1:
Repaired concrete slab-on-grade.

Any walls to be constructed on the slab-on-grade should be detailed with slip joints at the top to allow for future movement.

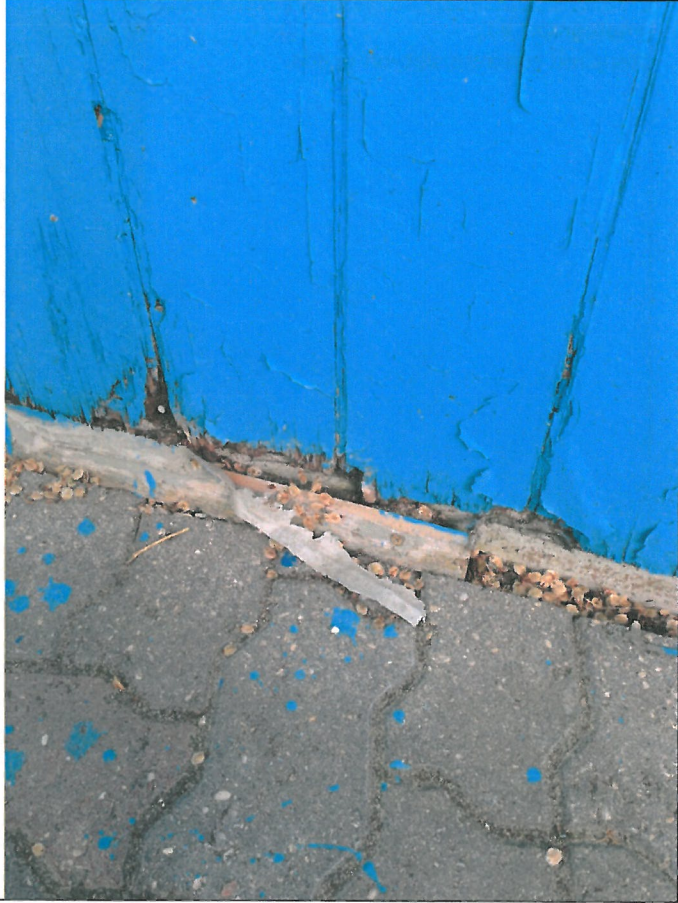
With the main floor elevation being at grade, the base of the exterior walls have been exposed to long term moisture. As a result, many areas of wood cladding have rotted. In some locations, this rot was observed to extend into the sill plate of the wood stud bearing wall (see photograph number 2).

Photograph #2:
Evidence of rot along wall bottom.

As part of any remedial work, an allowance should be carried to remove up to 36" of cladding to inspect all the sill plates around the perimeter and replace those that are rotted with pressure treated wood. To protect the wall system into the future, grading around the building should be redone to maintain drainage away from the structure.
