HAZARDOUS MATERIALS SURVEY

WINNIPEG TRANSIT GARAGE
566 BRANDON AVENUE, WINNIPEG, MB

Type of document: FINAL REPORT

Project no.: Project No. 5516057-000-EN1
Date: February 2017

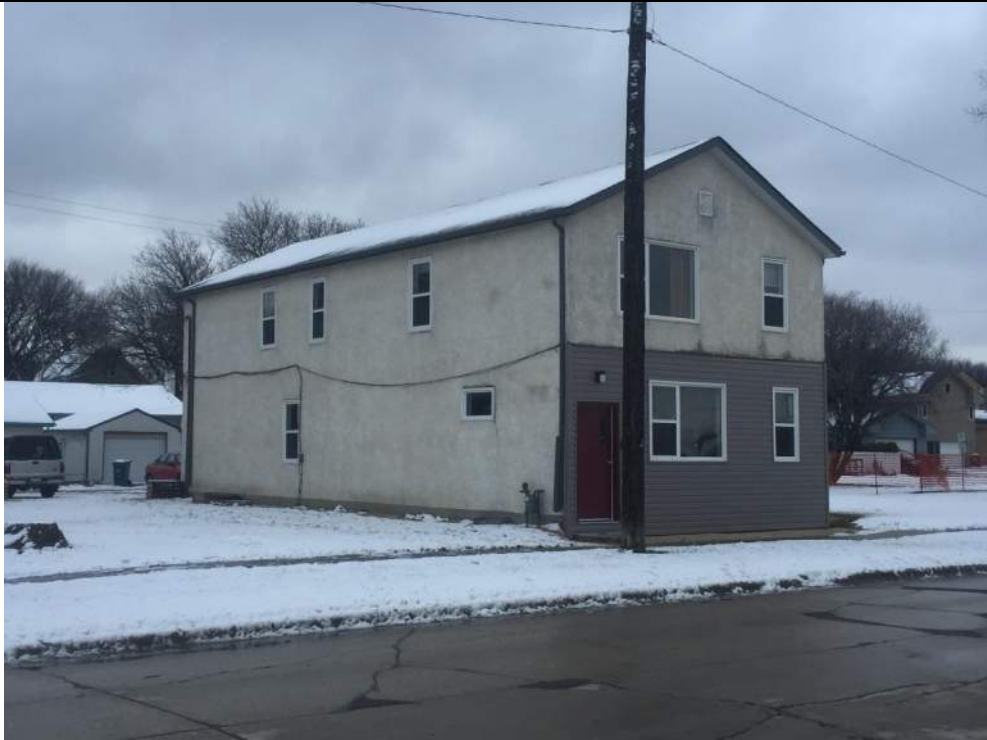
Photo 1. 566 Brandon Ave. Winnipeg, Exterior

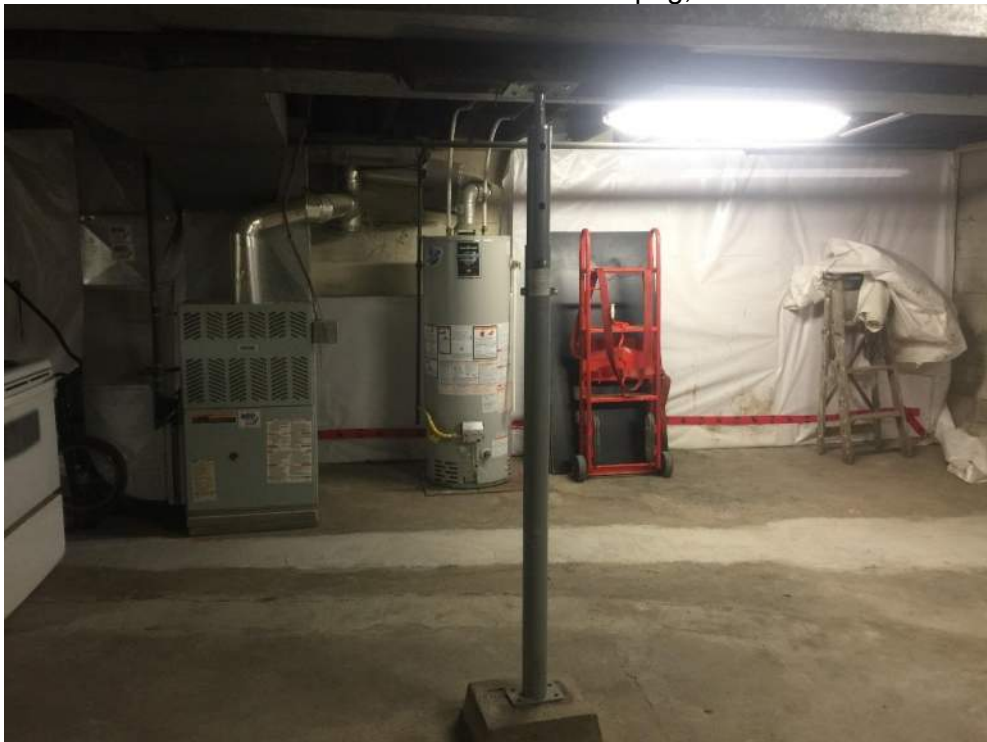
During the site visit, MMM visually inspected the Site for the presence of PCB and did not observe materials other than fluorescent light fixtures located in the basement. Based on visual inspection, the fluorescent light fixtures were in working order, did not appear to be damaged or leaking and newer in nature, it is likely that these fixtures are not PCB containing.

Photo 2. Unfinished Basement with utilities.

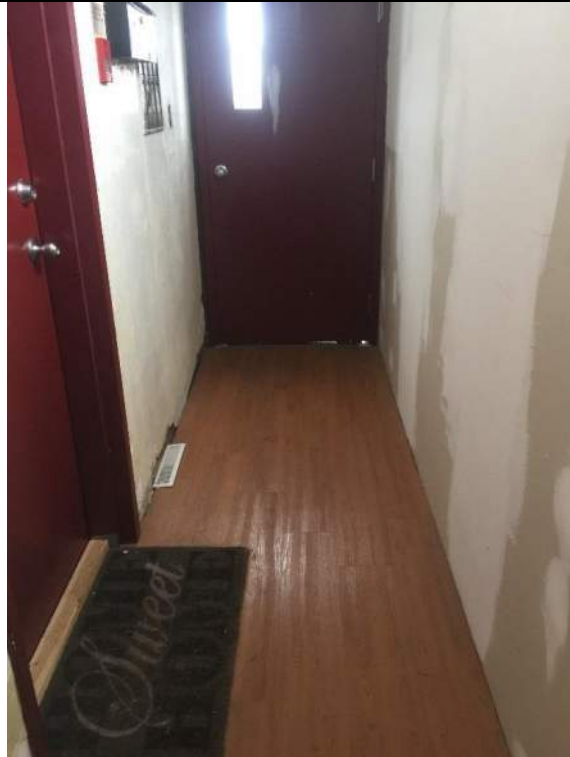
Photo 3. First Floor Hallway

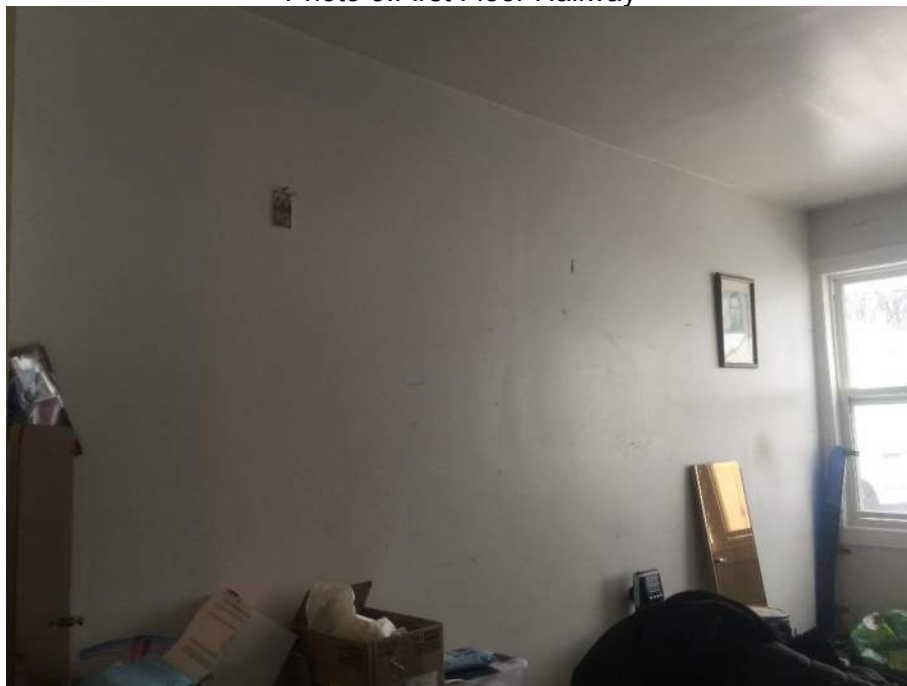
Photo 4. Suite 2 Main Floor.

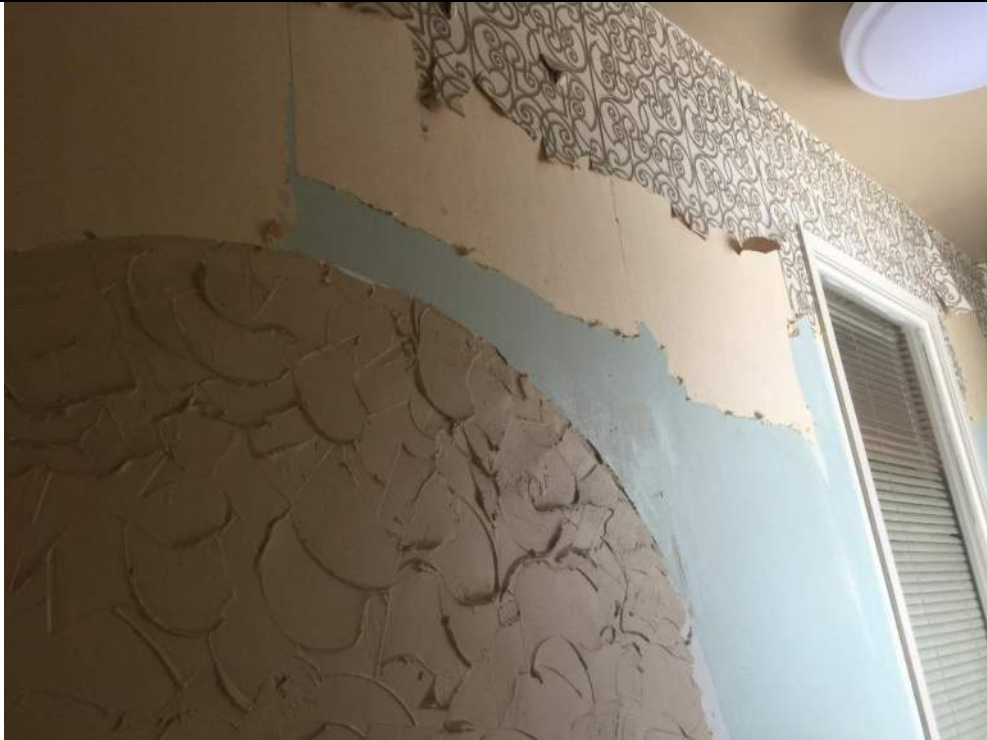
Sample ID	Sample Description	Lead Content	Lead Based
PNT-RM2-01-A	Room 2, white paint	1,250 mg/kg	Yes
PNT-RM2-01-B	Room 2, white paint	134 mg/kg	No
PNT-RM2-01-C	Room 2, white paint	172 mg/kg	No
PNT-RM3-01-A	Room 3 – Main hallway, white over tan, over white over blue paint.	242 mg/kg	No
PNT-RM3-01-B	Room 3 - Main hallway, white over tan, over white over blue paint.	230 mg/kg	No
PNT-RM3-01-C	Room 3 - Main hallway, white over tan, over white over blue paint.	213 mg/kg	No

Photo 5. Room 3, Main Hallway, blue paint under wall paper.

MMM recommends that demolition contractor must adhere to the LBP abatement specifications included in **Appendix D** along with implementing general dust control measures when these painted surfaces are disturbed so that particulate, that may contain lead, does not become airborne.

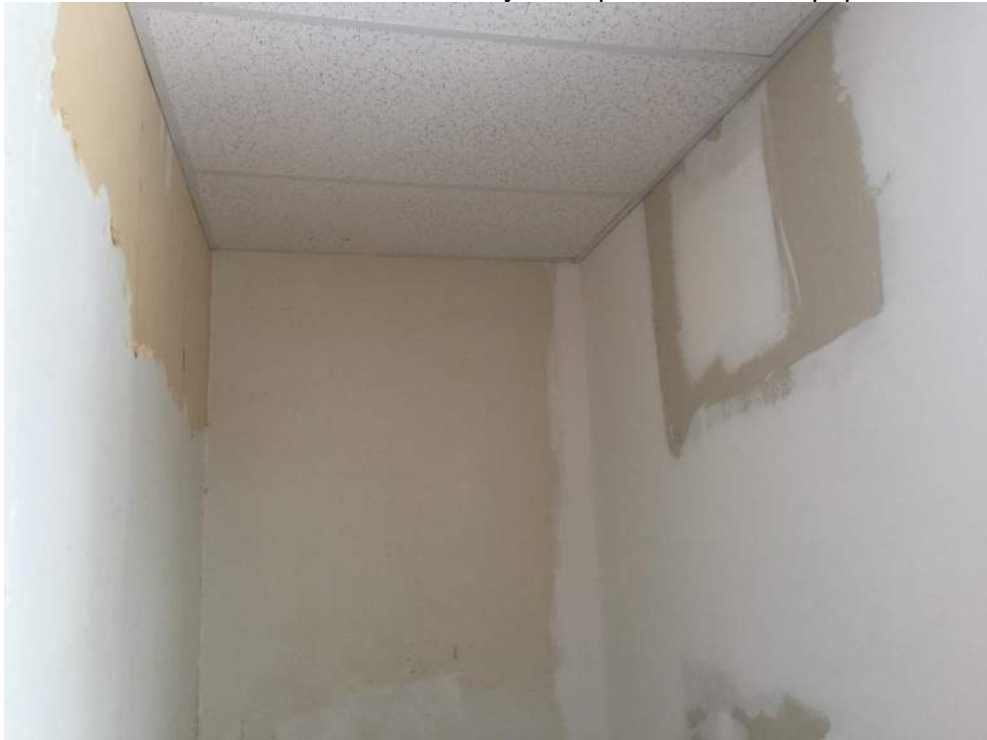
Photo 6. Second floor hallway, acoustic tiles.
