St. Boniface Rivertrail Tree Top Lookout and Sidewalk Expansion

> Riverbank Condition Assessment and Functional Design Report FINAL

> > KGS Group 15-0107-008 January 2016

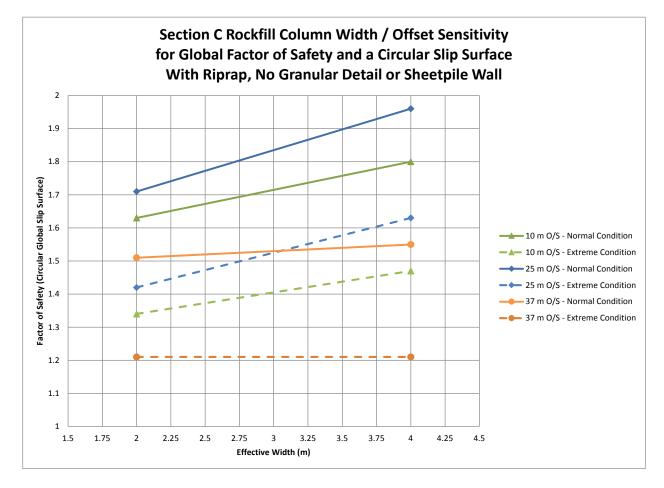
#### FIGURE 1 SENSITIVITY ON MID BANK ROCKFILL COLUMN EFFECTIVE WIDTH AND OFFSET (SECTION C) – GLOBAL CIRCULAR SLIP SURFACE

As shown on Figure 1, the minimum effective width of 2 m meets the FS criteria for a global circular slip surface (SS1) under both normal and extreme conditions anywhere in the offset range analyzed. However, as shown on Figure 2, a 2 m effective width rockfill column only meets the FS criteria for a block slip surface under both conditions at a 10 m or 25 m offset (for 25 m offset the estimated FS under the normal condition is 1.48). Based on the sensitivity analysis, ground elevation contours, existing trees, and proposed Tree Top Lookout location, the best option was determined to be 2 m effective width rockfill columns at a 25 m offset from the Taché Ave centreline in Area 1.

To achieve a FS criteria of 1.3 under normal conditions and 1.2 under extreme conditions, the additional set of rockfill columns would still be required in the mid bank to address the potential block slip surface SS5 (estimated Factors of Safety of 1.27 and 1.06 under each condition

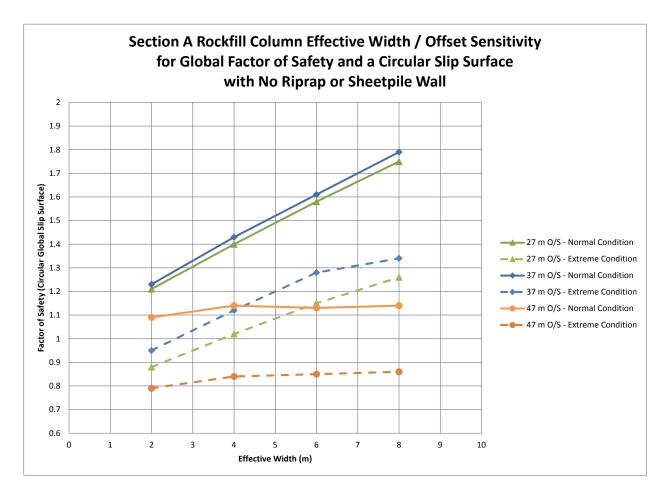
#### FIGURE 3 SENSITIVITY ON ROCKFILL COLUMN EFFECTIVE WIDTH AND OFFSET (SECTION A) – GLOBAL CIRCULAR SLIP SURFACE

As shown on Figure 3, the minimum total effective width to achieve a global FS of 1.5 under normal conditions and 1.2 under the extreme condition is 5 m, with an optimal offset of approximately 37 m from the Taché Ave centreline. Note that to achieve a FS criteria of 1.3 under normal conditions (i.e. if the sidewalk expansion is not constructed in this area), a 3 m total effective width would be required for global stability, as shown on Figure 3.

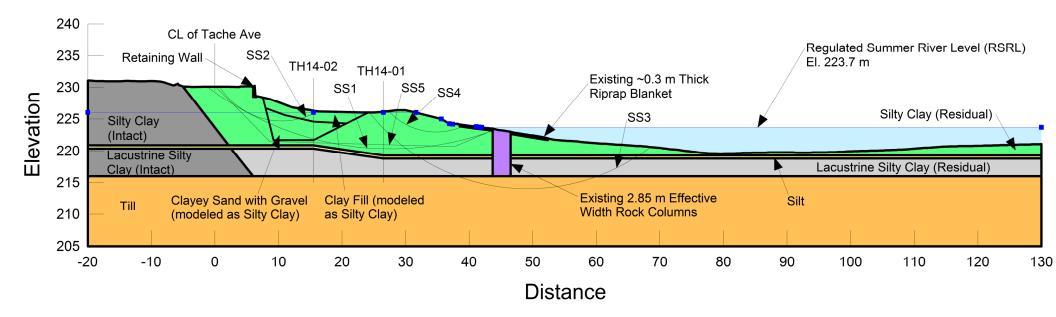
## AREA 1 - SECTION C Upgraded 0.6 m Thick Riprap Blanket 2 m Effective Width Rockfill Column at 25 m Offset from Tache Ave CL Sheetpile 4 m Offset from Tache Ave Curb Normal Steady State Conditions

An analysis was completed including the sheetpile embedded into the till unit, the 2 m effective width rockfill columns at a 25 m offset, and the upgraded riprap blanket, which resulted in an increase to both global and upper bank stability. In particular, the estimated upper bank (SS2) FS under normal and extreme conditions was increased to 2.93 and 2.35, respectively.
