ASBESTOS INVENTORY CONTROL

Building Name:	Council Building Civic Centre Complex	Inspection Date:	December 3, 2017
Building Code:	CB-60	Inspected By:	A Brodbeck & N Richardson
Building Address:	510 Main Street	Construction Date:	1964

CB-60
 COUNCIL BUILDING
 510 MAIN STREET
 WINNIPEG, MANITOBA

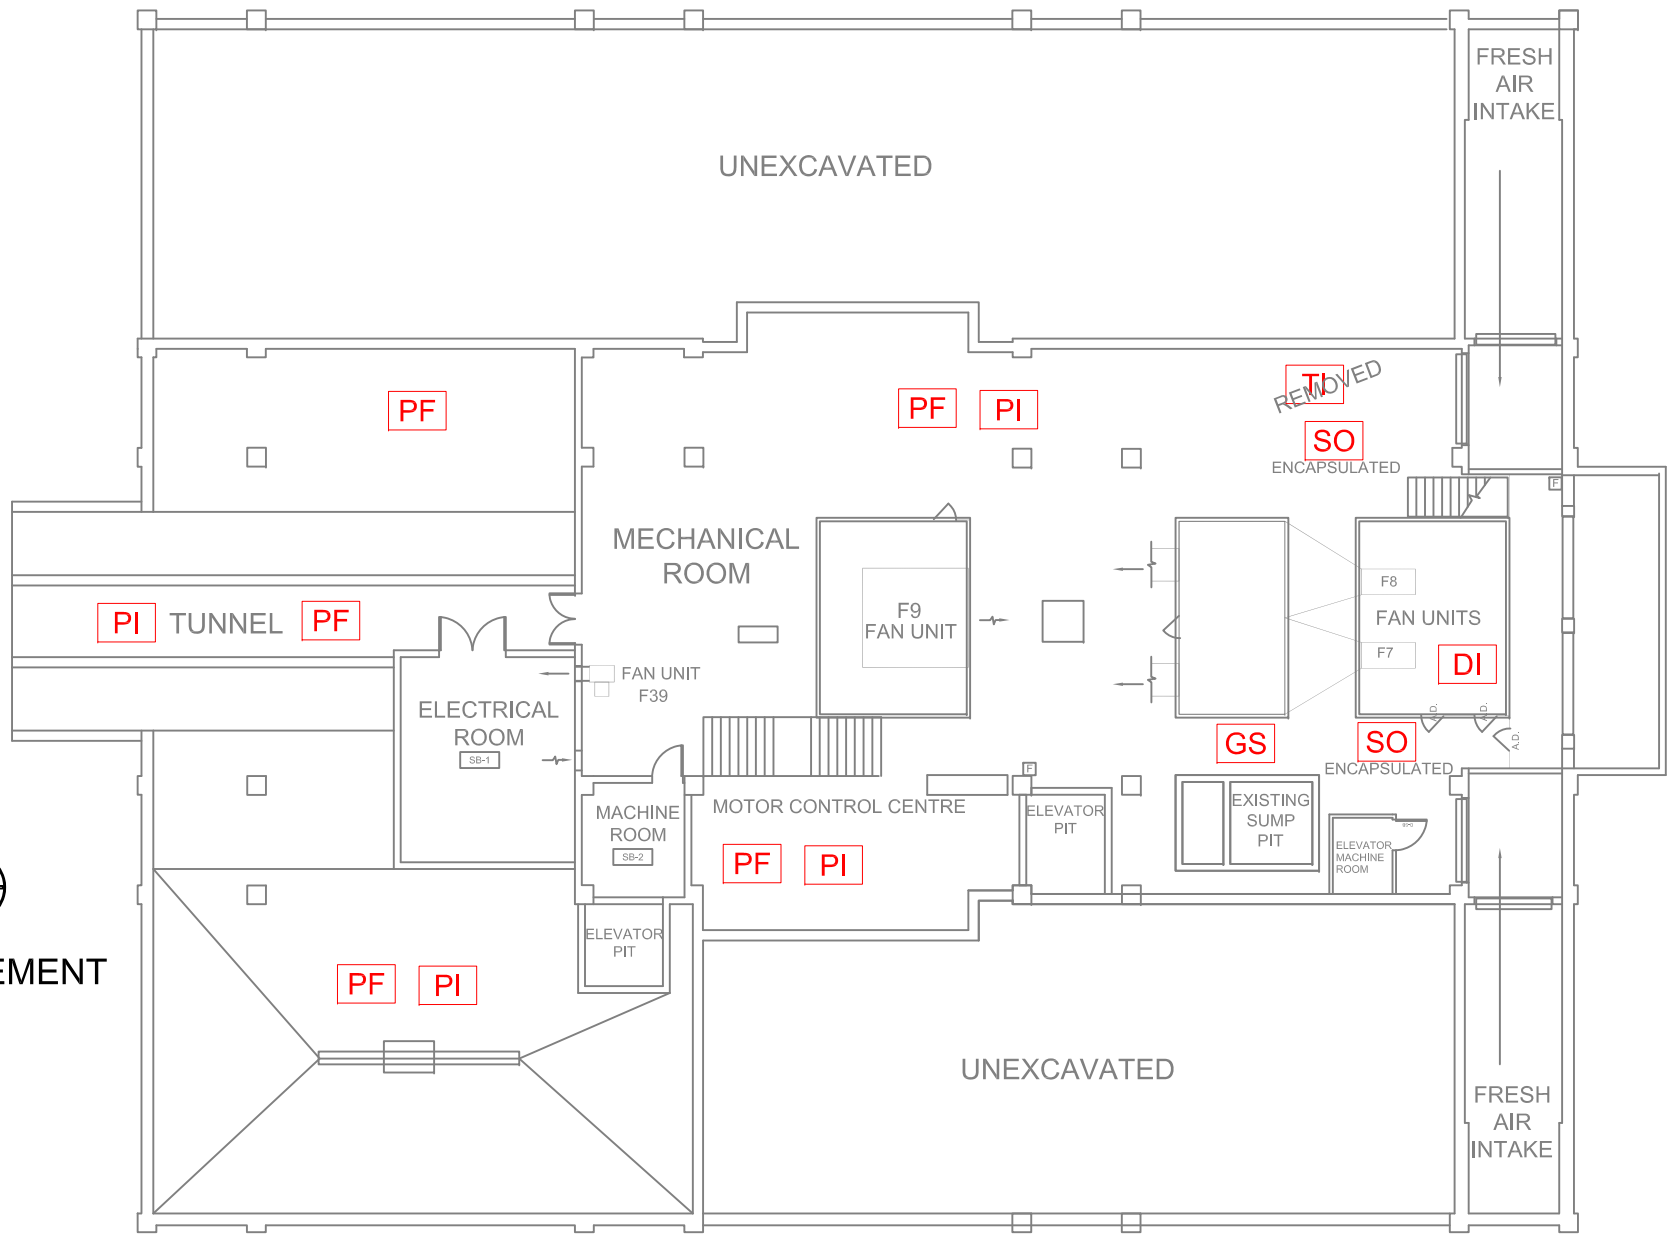
SUB BASEMENT

Material Location	Material Description	Drawing Label	Material Condition	Testing Status	Date M/Y	Test %	Est. %
	Columns/chases/structural beams along/between partition walls throughout may have asbestos containing fireproof spray-on insulation						
Sub Basement	Pipe Fitting Insulation	PF	Good	TESTED	Nov'12	15-50	
	Pipe Insulation (new Blue)			TESTED	Nov'12	0	
	Pipe Insulation (Green & Blue)	PI	Good	TESTED	Nov'12	15	
	Duct Insulation	DI	Good	TESTED	Jul'11	0	
	Duct Insulation at south fan unit	DI	Good				
	Tank Insulation	TI	Removed4/15				15-50
	Spray On Insulation - Steel Beam - Encapsulated	SO	Good				65
	Rope Pipe Insulation			TESTED	Nov'12	0	
	Gasket Seal	GS	Good	TESTED	Nov'12	40	
Sub Basement Tunnel	Pipe Fitting Insulation	PF	Good				
	Pipe Wrap (blue - sampled from removal of 2' section)			TESTED	Jul'18	0	
	Pipe Wrap (orange - sampled for removal of 2' section)			TESTED	Jul'18	0	
	Pipe Insulation	PI	Good

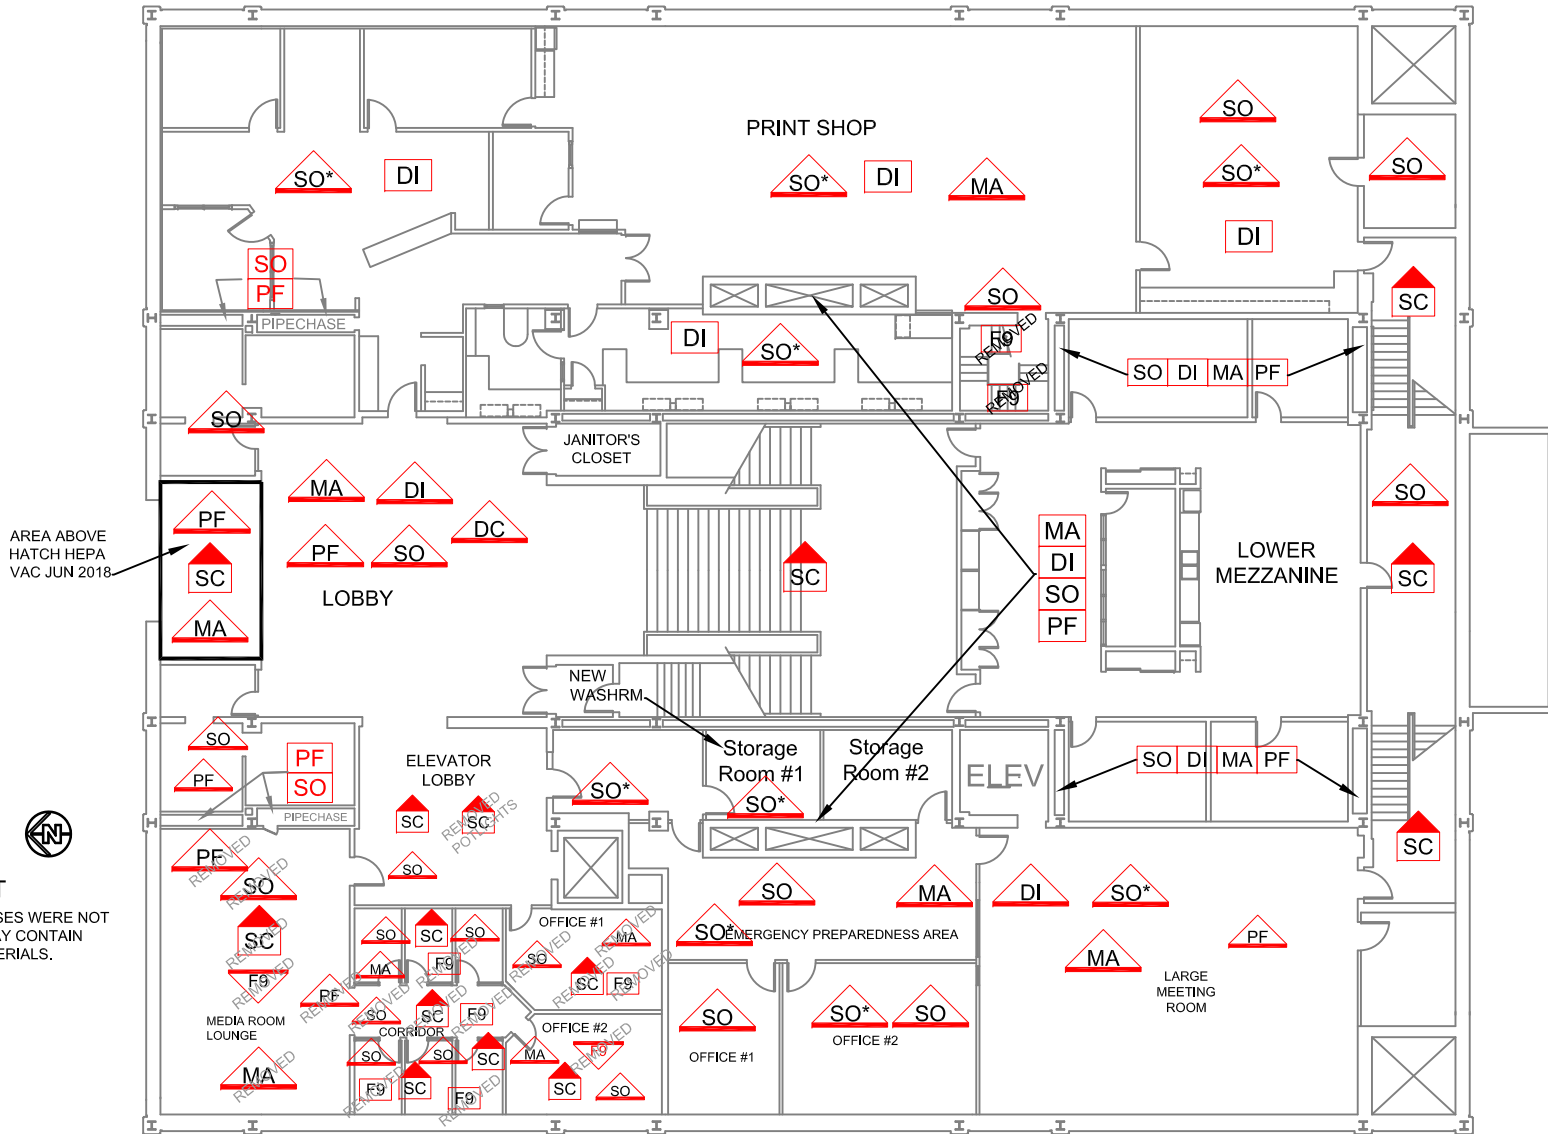
BASEMENT
NOTE: ALL CHASES WERE NOT ABATED AND MAY CONTAIN ASBESTOS MATERIALS.

Basement							
Lobby	Drywall Compound - Boxed up ceiling above lights	DC	Good				5
	Mastic on Duct Insulation	MA					10
	Stipple Textured Ceiling	SC					5
	Spray On Insulation - Above Ceiling	SO	Good				65
Elevator Lobby	Stipple Ceiling around Potlights	SC	Removed11/'12	TESTED	Nov'12	5	
	Spray On Insulation - Above Ceiling	SO					60
	Plaster and Scratch Coat - Walls (4 samples taken)			TESTED	Jun'15 Mar'15	0	
	Stipple Texture Ceiling	SC	Good				5
Main Stairs	Stipple Textured Ceiling	SC	Good				5

AREA ABOVE HATCH HEPA VAC JUN 2018

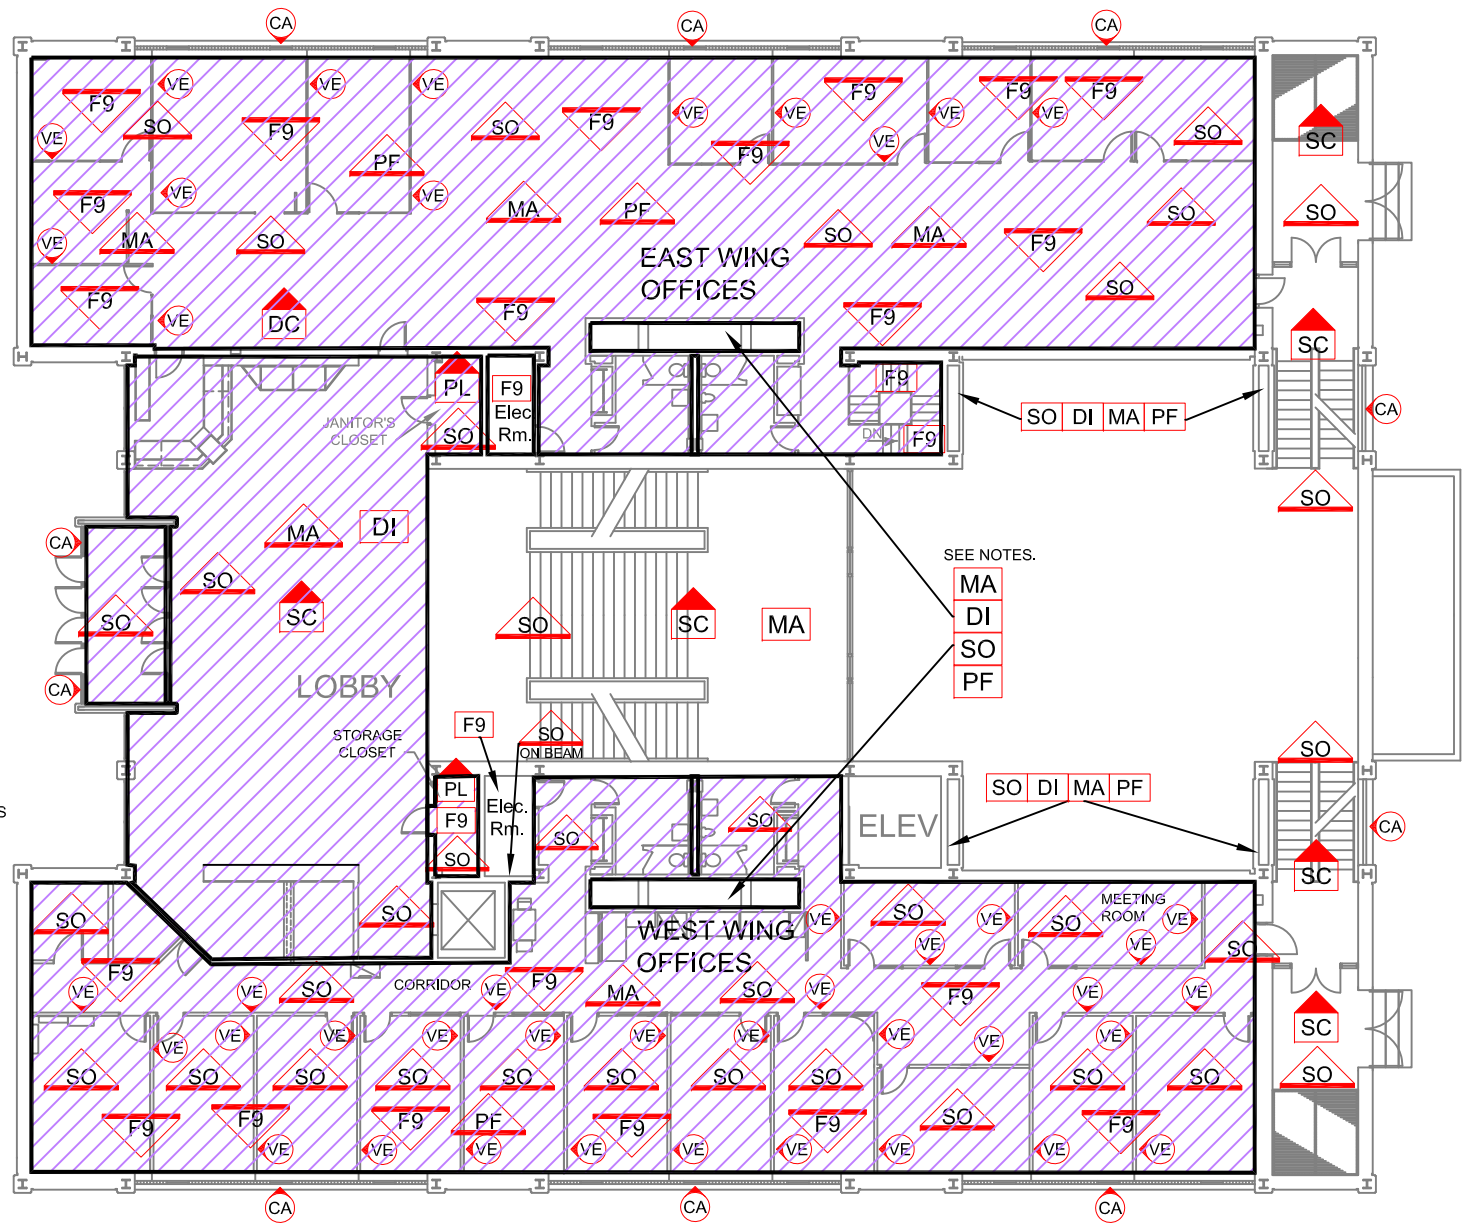
MAIN FLOOR

- NOTE:
1. ALL CHASES/ELEVATOR SHAFTS WERE NOT ABATED AND MAY CONTAIN ASBESTOS MATERIALS
 2. EXTERIOR WINDOWS: EXTERIOR/INTERIOR WINDOW CAULKING CONTAINS ASBESTOS.
 3. ASBESTOS CONTAINING FIREPROOF SPRAY-ON INSULATION MAY BE BEHIND OR BETWEEN WALLS/PARTITION/ELEVATOR SHAFTS

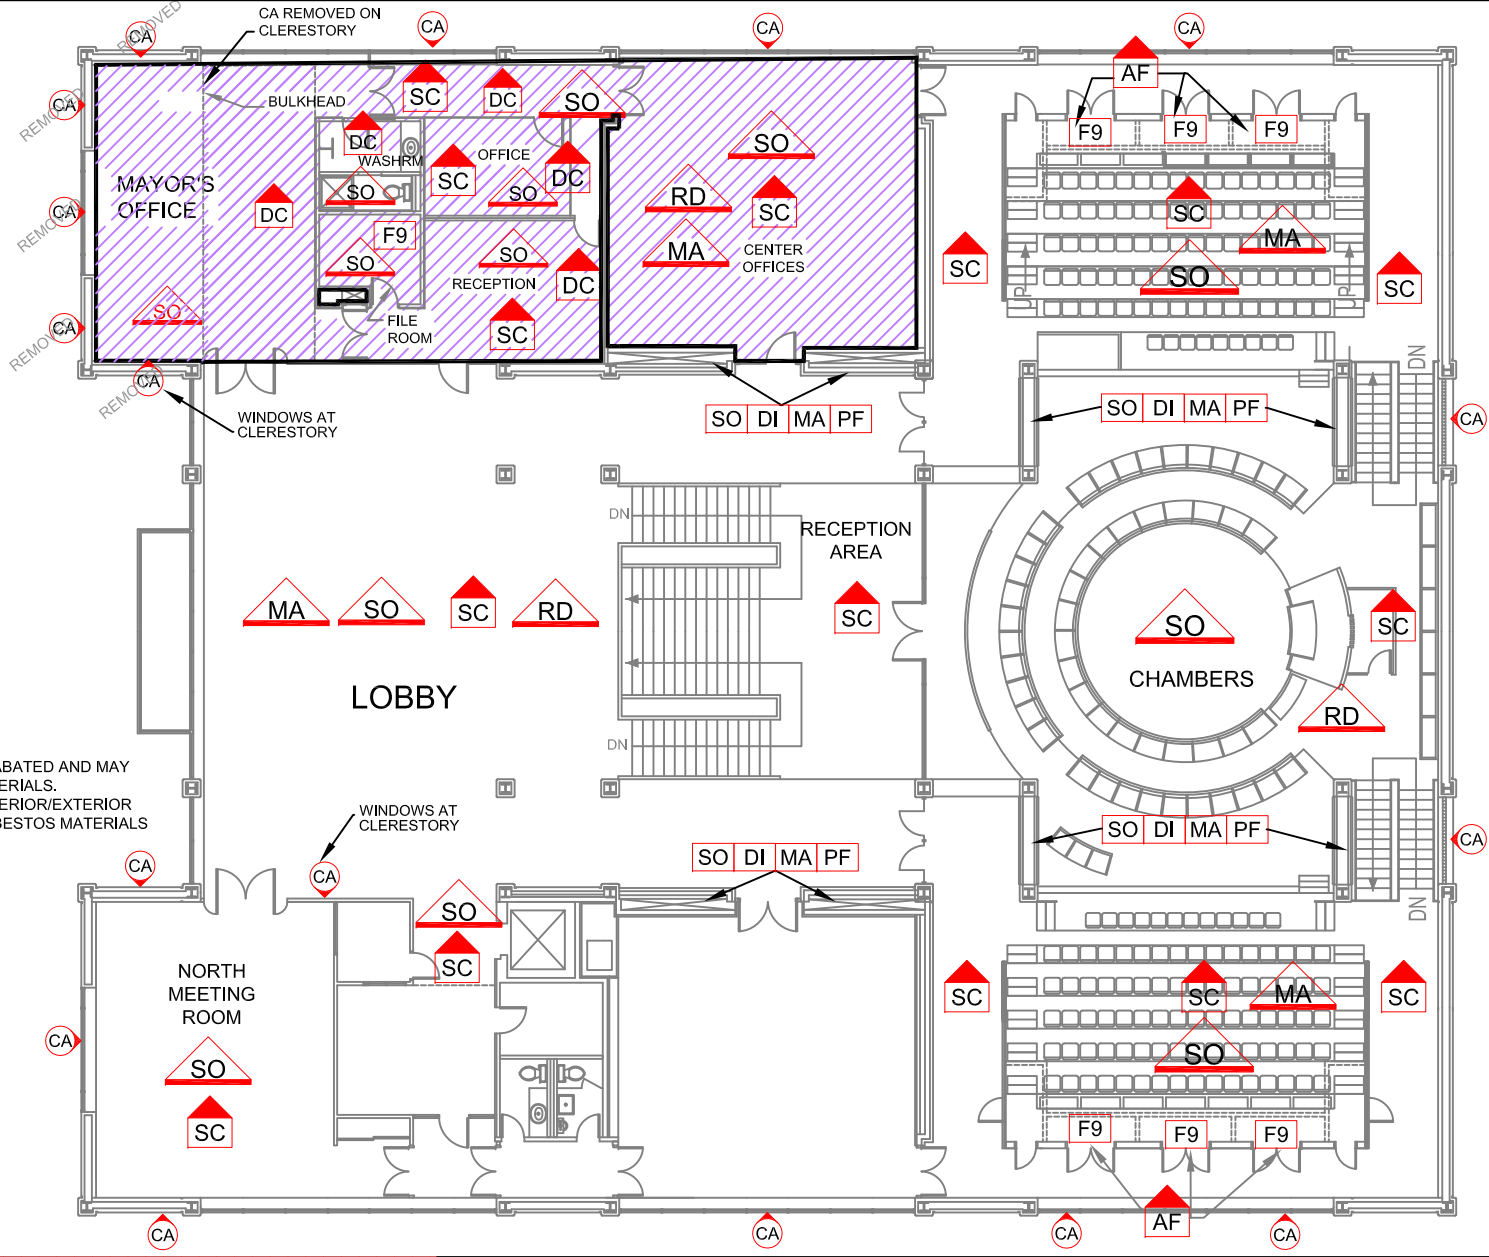
SECOND FLOOR

1. ALL CHASES WERE NOT ABATED AND MAY CONTAIN ASBESTOS MATERIALS.
2. EXTERIOR WINDOWS: INTERIOR/EXTERIOR CAULKING CONTAINS ASBESTOS MATERIALS

ASBESTOS REMOVED AUG 2016
