## **APPENDIX 'A' – PAVEMENT CORE REPORT**

### Pavement Core Report for Ellice Avenue

Table 1 - Pavement Investigation for Street Renewal - Ellice Avenue from Arlington Street to Maryland Street

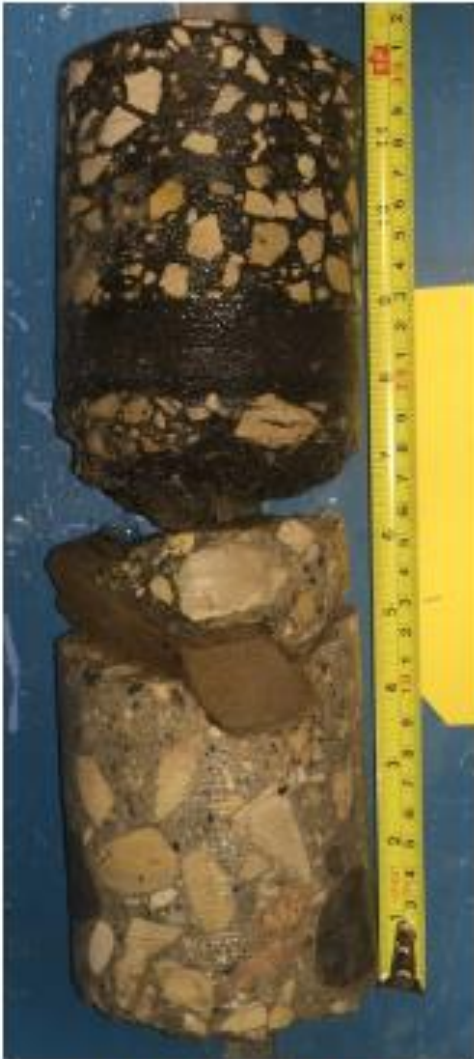
**Figure 1 - TH01 Core**

Testhole ID	Testhole Location	Pavement Surface		Comments
		Type	Thickness (mm)	
TH01	Ellice Avenue Westbound median lane, 34 m east of Arlington Street 6 m south of north curb	Asphalt	150	<ul style="list-style-type: none"> <li>• sound asphalt pavement from 0 to 150 mm</li> <li>• asphalt pavement not bonded to underlying concrete pavement</li> <li>• deterioration of concrete pavement from 150 to 210 mm</li> <li>• sound concrete from 210 to 300 mm</li> <li>• crushed limestone base below concrete pavement</li> </ul>
		Concrete	150	
TH02	Ellice Avenue Eastbound curb lane, 10 m east of Home Street 3 m north of south curb	Asphalt	160	<ul style="list-style-type: none"> <li>• sound asphalt pavement from 0 to 160 mm</li> <li>• asphalt pavement not bonded to underlying concrete pavement</li> <li>• deterioration of concrete pavement from 160 to 210 mm</li> <li>• sound concrete from 210 to 260 mm</li> <li>• crushed limestone base below concrete pavement</li> </ul>

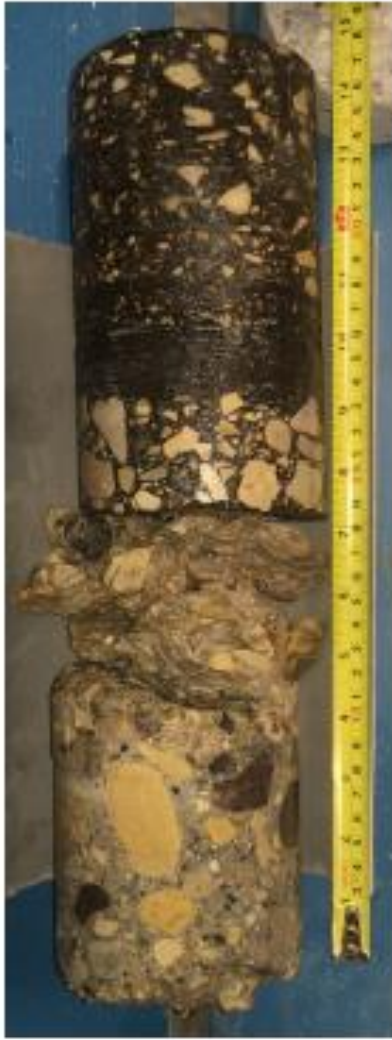
Figure 3 - TH03 Core

Concrete	120	
TH03	Ellice Avenue Westbound median lane, 8 m west of Simcoe Street 5.5 m south of north curb	Asphalt	180	<ul style="list-style-type: none"> <li>• sound asphalt pavement from 0 to 180 mm</li> <li>• asphalt pavement not bonded to underlying concrete pavement</li> <li>• severe deterioration of concrete pavement from 180 to 260 mm</li> <li>• sound concrete from 260 to 360 mm</li> <li>• crushed limestone base below concrete pavement</li> </ul>
		Concrete	180	
TH04	Ellice Avenue Eastbound curb lane, 54 m east of Toronto Street 3 m north of south curb	Asphalt	170	<ul style="list-style-type: none"> <li>• sound asphalt pavement from 0 to 200 mm</li> <li>• asphalt pavement not bonded to underlying concrete pavement</li> <li>• severe deterioration of concrete pavement from 200 to 260 mm</li> <li>• sound concrete from 260 to 310 mm</li> <li>• crushed limestone base below concrete pavement</li> </ul>

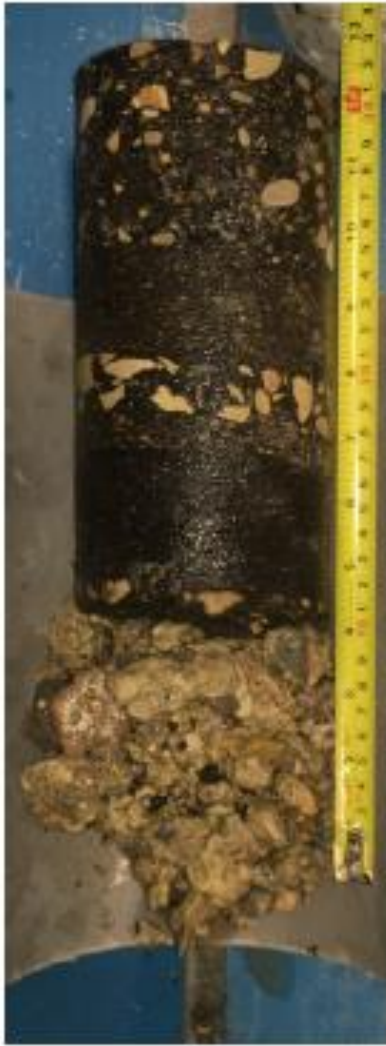
Figure 5 - TH05 Core

Concrete	140	
TH05	Ellice Avenue Westbound curb lane, 10 m west of Toronto Street 1.25 m south of north curb	Asphalt	200	<ul style="list-style-type: none"> <li>• sound asphalt pavement from 0 to 200 mm</li> <li>• asphalt pavement not bonded to underlying concrete pavement</li> <li>• severe deterioration of concrete pavement from 200 to 305 mm</li> <li>• crushed limestone base below concrete pavement</li> </ul>
		Concrete	105	
TH06	Ellice Avenue Eastbound curb lane, 8 m east of Toronto Street 3 m north of south curb	Asphalt	140	<ul style="list-style-type: none"> <li>• sound asphalt pavement from 0 to 140 mm</li> <li>• asphalt pavement not bonded to underlying concrete pavement</li> <li>• deterioration of concrete pavement from 140 to 160 mm</li> <li>• sound concrete from 160 to 260 mm</li> <li>• crushed limestone base below concrete pavement</li> </ul>
		Concrete	120	
TH07	Ellice Avenue Westbound median lane, 16 m west of Victor Street 6 m south of north curb	Asphalt	180	<ul style="list-style-type: none"> <li>• sound asphalt pavement from 0 to 180 mm</li> <li>• asphalt pavement not bonded to underlying concrete pavement</li> <li>• severe deterioration of concrete pavement from 180 to 230mm</li> <li>• sound concrete from 230 to 360 mm</li> <li>• crushed limestone base below concrete pavement</li> </ul>

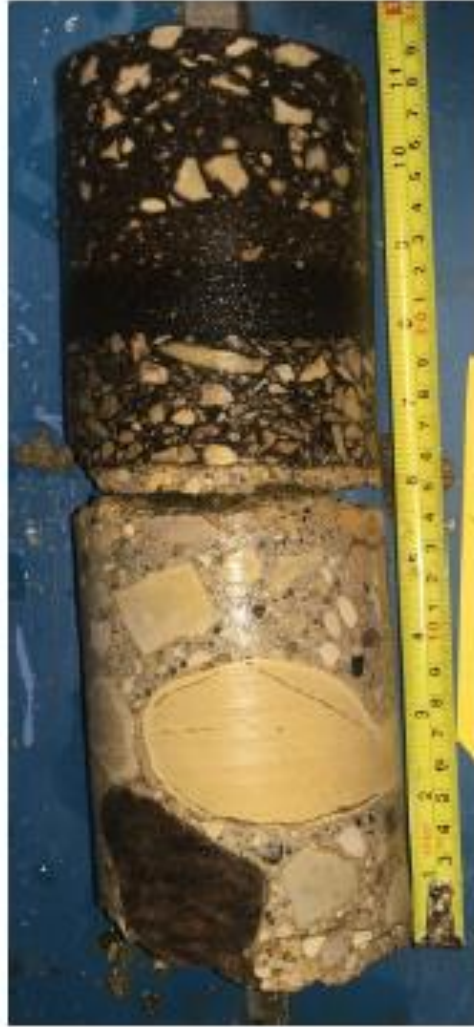
Figure 8 - TH08 Core

Concrete	180	
TH08	Ellice Avenue Eastbound median lane, 15 m west of Agnes Street 6 m north of south curb	Asphalt	125	<ul style="list-style-type: none"> <li>• sound asphalt pavement from 0 to 125 mm</li> <li>• asphalt pavement bonded to underlying concrete pavement</li> <li>• sound concrete from 125 to 260 mm</li> <li>• crushed limestone base below concrete pavement</li> </ul>
		Concrete	155	
TH09	Ellice Avenue Westbound curb lane, 36 m east of Agnes Street 3 m south of north curb	Asphalt	40	<ul style="list-style-type: none"> <li>• sound asphalt pavement from 0 to 40 mm</li> <li>• asphalt pavement bonded to underlying concrete pavement</li> <li>• sound concrete from 40 to 290 mm</li> <li>• crushed limestone base below concrete pavement</li> </ul>
		Concrete	250	
TH10	Ellice Avenue Eastbound curb lane, 2 m east of Mcgee Street 3 m north of south curb	Asphalt	170	<ul style="list-style-type: none"> <li>• sound asphalt pavement from 0 to 170 mm</li> <li>• asphalt pavement not bonded to underlying concrete pavement</li> <li>• severe deterioration of concrete pavement from 170 to 270 mm</li> <li>• crushed limestone base below concrete pavement</li> </ul>
