## 1.0 LIFT STATION INFORMATION

<b>Station Name:</b>	<u>Westwood Lift Station</u>
<b>Location of Station:</b>	<u>482 Westwood Drive</u>
<b>Date of Inspection:</b>	<u>February 10, 2010</u>
<b>Inspected By:</b>	<u>Damir Muhurdarevic, EIT</u>
<b>Inspecting Firm:</b>	<u>MMM Group Limited (MMM)</u>
<b>Client:</b>	<u>City of Winnipeg – Water and Waste Department</u>

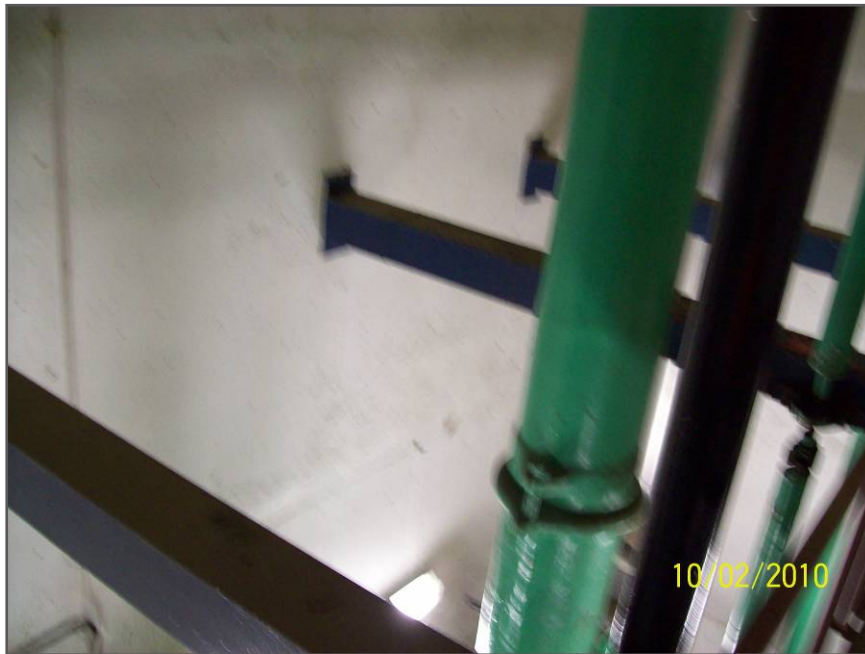
**Photograph No. 1**

A total of five (5) W150x22 beams are located on the third floor below ground, in the pump room. They each span 3360mm from wall to wall and are welded to vertical steel plates that are anchored to the wall on each end with anchor bolts. They are constructed horizontally and their top halves are filled with concrete.

The W150x22 beams located three floors below ground in the pump room were analyzed for moment resistance of the beams and the shear resistance in the wall connections. The moment resistance of 2.4 tons governed in all five (5) beams. A factor of safety of 2.5 was applied to all beams yielding a **load rating of 1.0 tons**.

Lifting beams located on the bottom floor

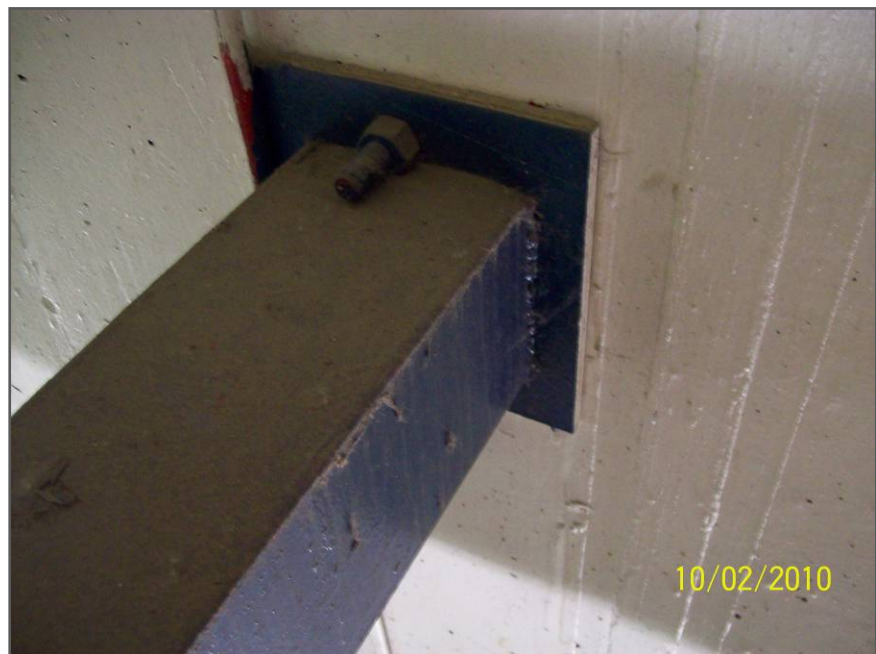
**Photograph No. 2**

Wall connection details of the 5 lifting beams on the bottom floor

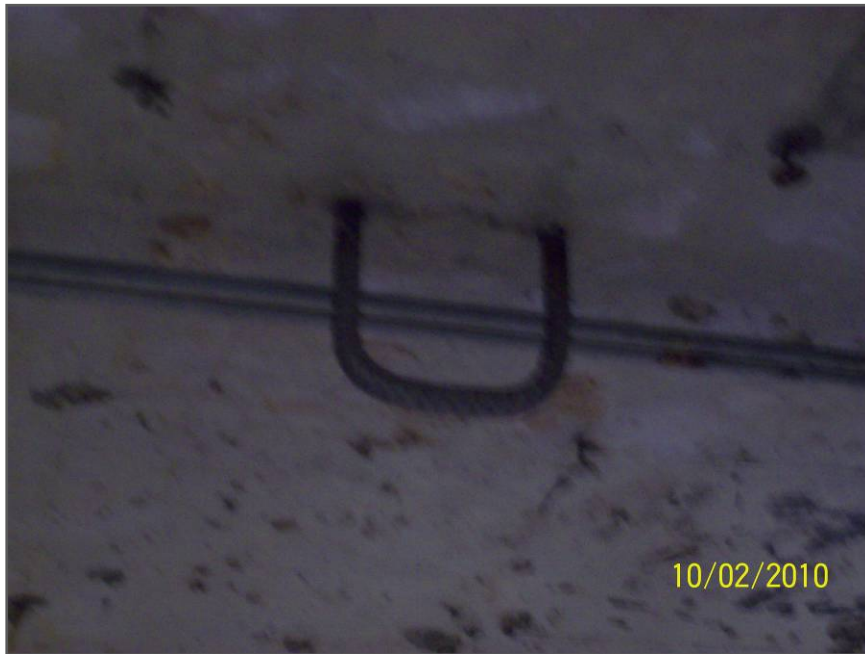
**Photograph No. 3**

The motor room two floors below ground has one U-shaped lifting hook which is fabricated of 25mm diameter steel rod and is embedded into underside of the first floor below ground cast-in-place concrete slab.

The U-shaped lifting hook located in the motor room was analyzed for pullout resistance of the embedment and tensile resistance of the hook. The thickness of the cast-in-place concrete slab from the floor above was not observed and therefore the embedment length of the hook was only estimated. The concrete was estimated to be 200mm thick and an embedment length of 150mm was used. The governing factor in the hook was the pullout resistance, which was calculated to be 8.3 tons. However, a factor of safety of 4.0 was applied to yield a **load rating of 2.0 tons**.

U-shaped lifting hook located in the motor room

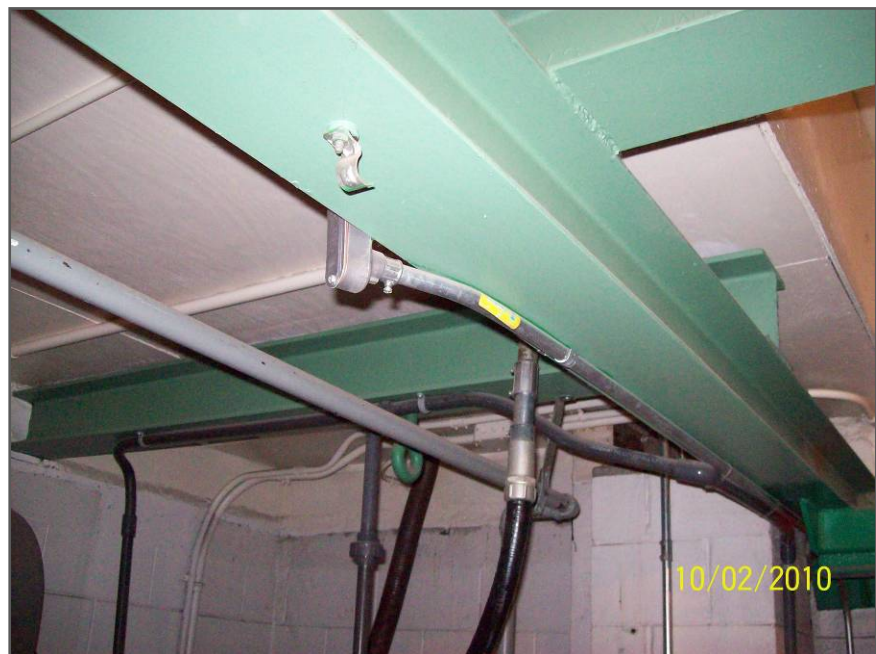
**Photograph No. 4**

The main floor has a beam system consisting of another a total of 5 beams all connected to each other. Four (4) of the five (5) beams are W150x22. and three (3) of the five (5) beams run parallel to each other and perpendicular to the other two (2). They are welded to each other (top flange to bottom flange) and at ends they are welded to steel plates that are anchored into the walls. Three (3) of the five (5) beams have U-shaped lifting hooks welded to the bottom flanges. One (1) of the five (5) beams has a sliding beam component that carries one of the three (3) hooks. This beam consists of a cut HSS89x89x6.4 that has the bottom half of an S200x27 inserted inside and attached with wheels.

In the main floor beam system, each beam was analyzed for moment resistance and each hook was analyzed for tensile and weld resistance. The moment resistance of one of the W150x22 beams governs the system with a resistance of 4.0 tons. However, this was a complex structural system, thus a factor of safety of 4.0 was applied, to yield a **load rating of 1.0 tons**.

Lifting beam system located on the main floor

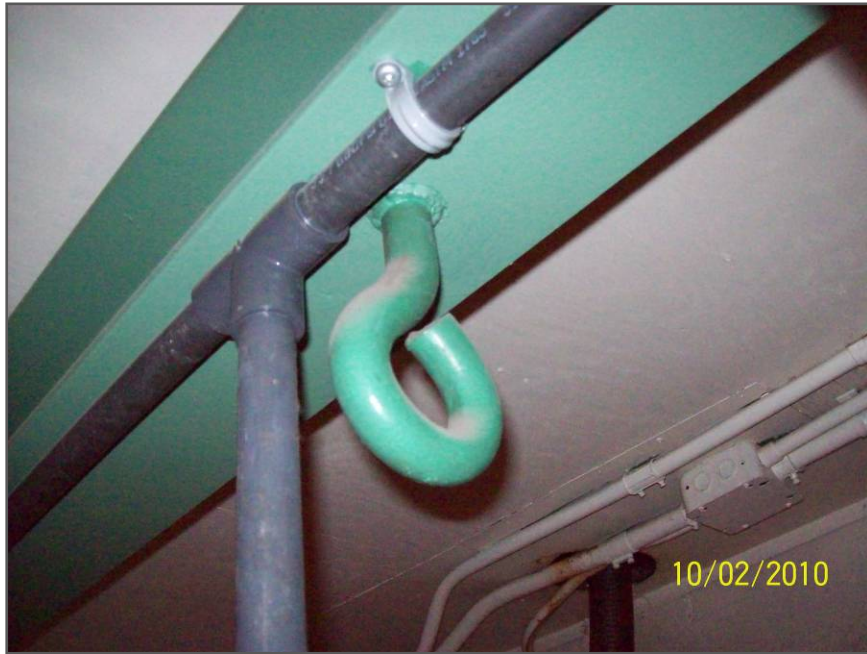
**Photograph No. 5**

Eye hook welded to the bottom flange of on the beams  
in the beam system located on the main floor

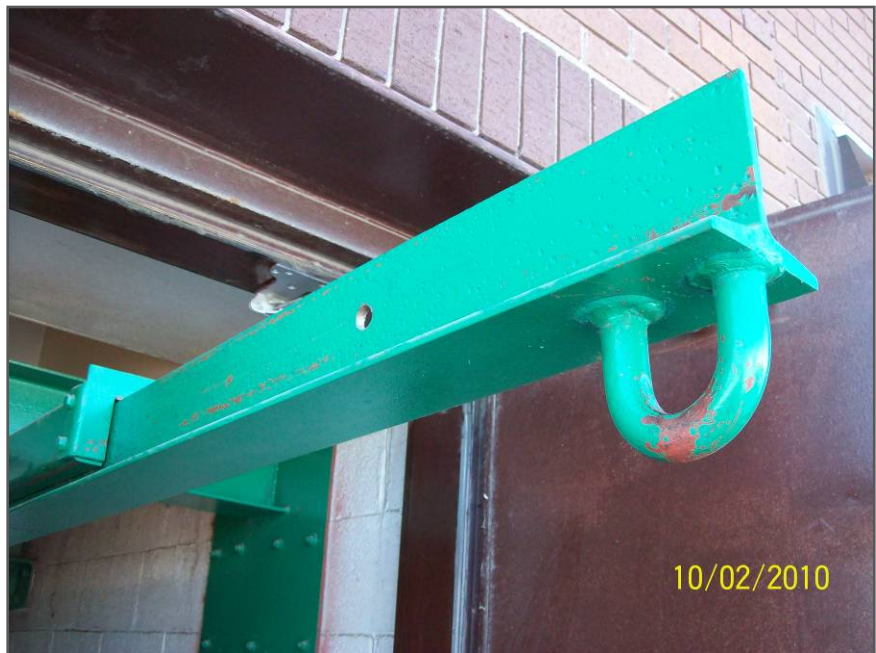
**Photograph No. 5**

Sliding beam component with a hook welded to the flange,  
located in the beam system on the main floor
