March 5, 2018

Our File No. 2018-0224

**Re: Carlton Street North Skywalk
Vehicle Impact**

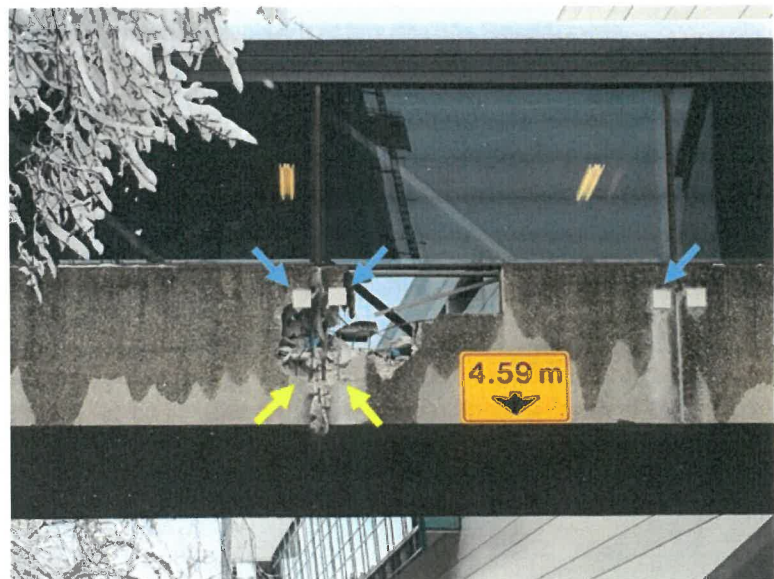
Figure 1: Partial North Elevation

On March 5, 2018, the north elevation of the skywalk connecting the RBC Winnipeg Convention Centre (WCC) with the Delta Hotel was hit by the boom of a construction bin delivery vehicle travelling southbound on Carlton Street. The point of impact was approximately at the join between the third and fourth precast cladding panels from the east end of the west span (see Figure 1). The impact location also corresponded to the location of the vertical truss member.

Supplemental top anchors (blue arrows)

Approximate location of bottom anchors (yellow arrows)

As can be seen in Figure 1, the impact has caused substantial structural damage to two precast cladding panels, including the upper anchors. The original precast panel shop drawings indicate that the bottom anchors are located approximately 1'-2" from the bottom of the panel in each corner. Based on the visible damage to the panels, it is likely that the bottom anchors have also been compromised and the panels are currently being supported by the remaining two anchors. To address concerns that the affected panels could be potentially unstable, Carlton Street immediately below the area has been closed to traffic. The skywalk has also been closed to pedestrian traffic.

The point of impact corresponded to the location of the vertical truss member. Although no obvious damage was observed, a follow up site inspection is required once the debris has been removed to confirm the condition of the truss members.

To address the immediate concerns of the stability of the precast panels, it is recommended that all loose areas of concrete be removed, and temporary supports be provided to replace the lost anchors. Although further design would be required, the temporary anchors could consist of an angle bracket bolted to the back of the precast panel and secured to the existing concrete floor. Alternatively, the two affected panels could be removed. Note that the existing strip windows are supported on the precast panels. Thus, temporary support for the glazing will also be required.
